Bantam Lake

Conservation & Management of a
Premier Recreation Destination in
Northwest Connecticut

Bantam Lake Watershed

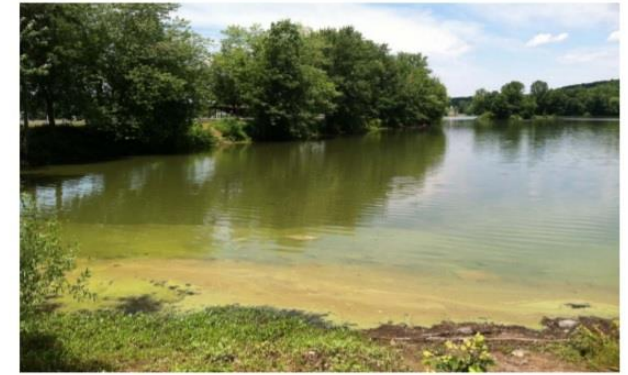
Figure 1: Open water view of bloom conditions at Fisher Meadow Pond, Avon CT, in June 2015. View across shoreline and into a cove.

BACKGROUND AND PURPOSE
 Blue-green algae, also known as cyanobacteria, occur naturally in lakes and ponds throughout Connecticut. These microscopic organisms are components of the aquatic food chain. In ordinary circumstances, cyanobacteria cause no apparent harm, however warmer water temperatures and high nutrient concentrations may induce a rapid increase in their abundance. This response is commonly called a "bloom" because algal biomass increases to the extent that normally clear water becomes markedly turbid. This tainted water takes on a green, blue-green or reddish-brown colored hue (See Figures 1-3).
