Rippowam/Mill River Watershed Study Annual Report

**Comprehensive
Characterization Report**
Rippowam/Mill River Watershed
Management and Infrastructure
Program

City of Stamford,
Connecticut

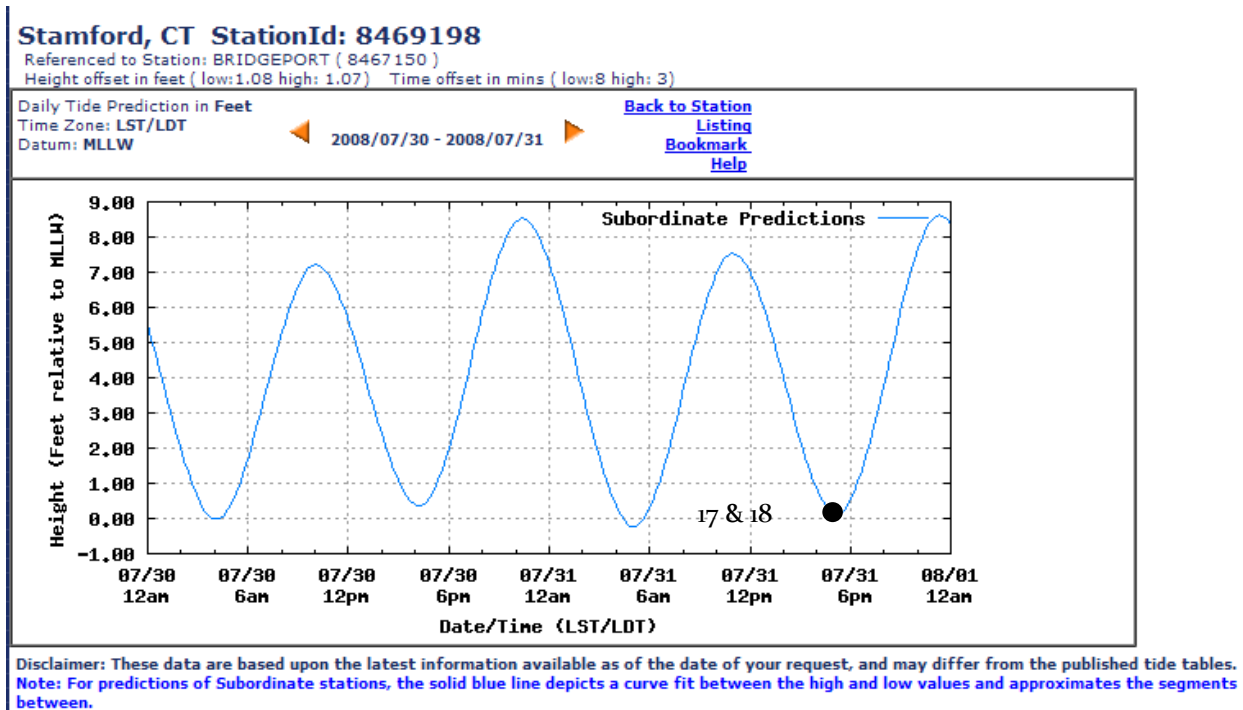
Figure 3-2: Tidal data for Partial Dry Weather Event #1

Sampling stations near the Stamford Harbor (17 and 18) are periodically influenced by tidal influx. The plot **Figure 3-2** below shows the tidal record for the Stamford Harbor on July 30-31 with annotation to show approximately when field teams visited stations 17 and 18.
