Case Study involving sodium runoff to Groton Utilities lower reservoirs September 18, 2017

Groton Terminal Reservoir System

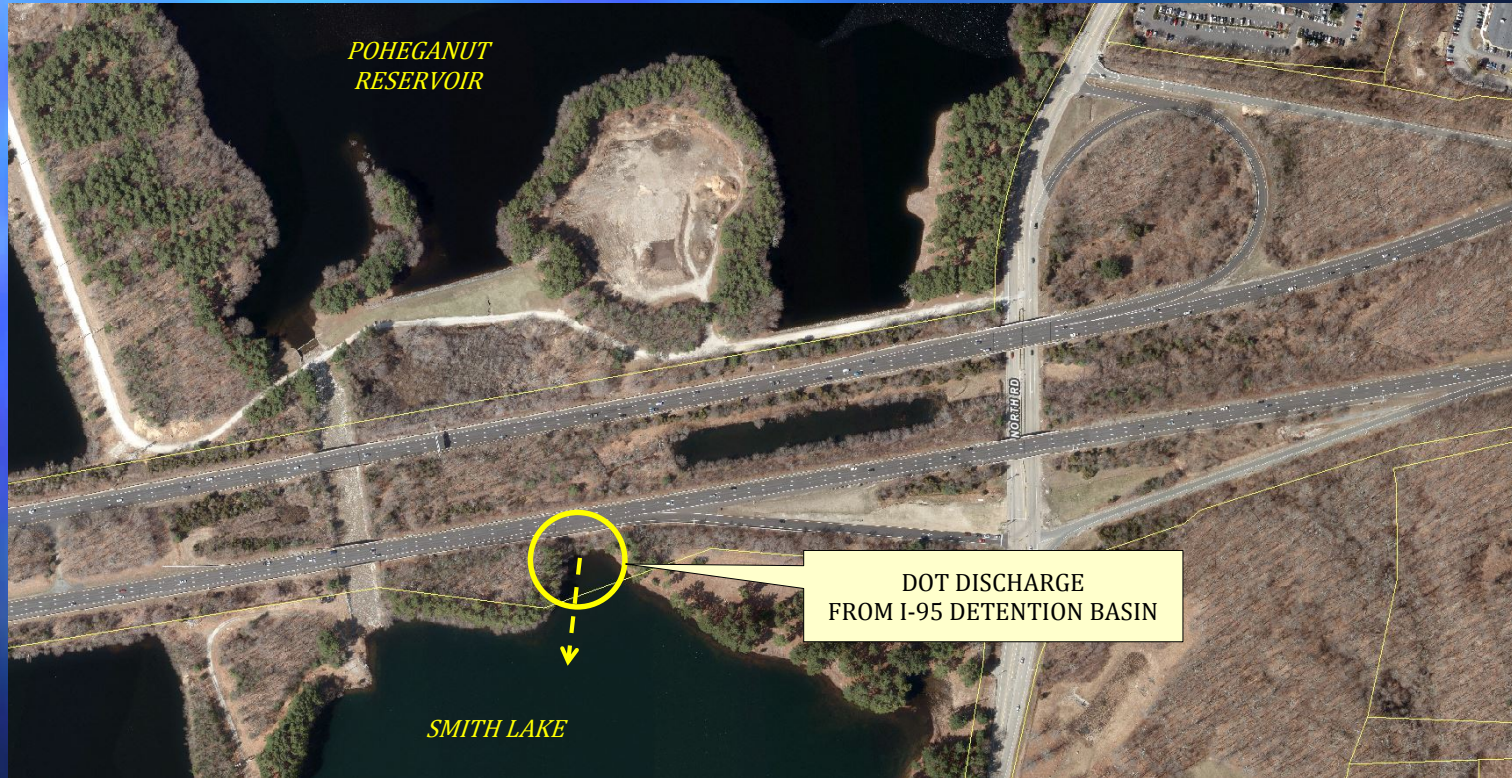
DISCHARGE FROM DOT DETENTION BASIN
SMITH LAKE

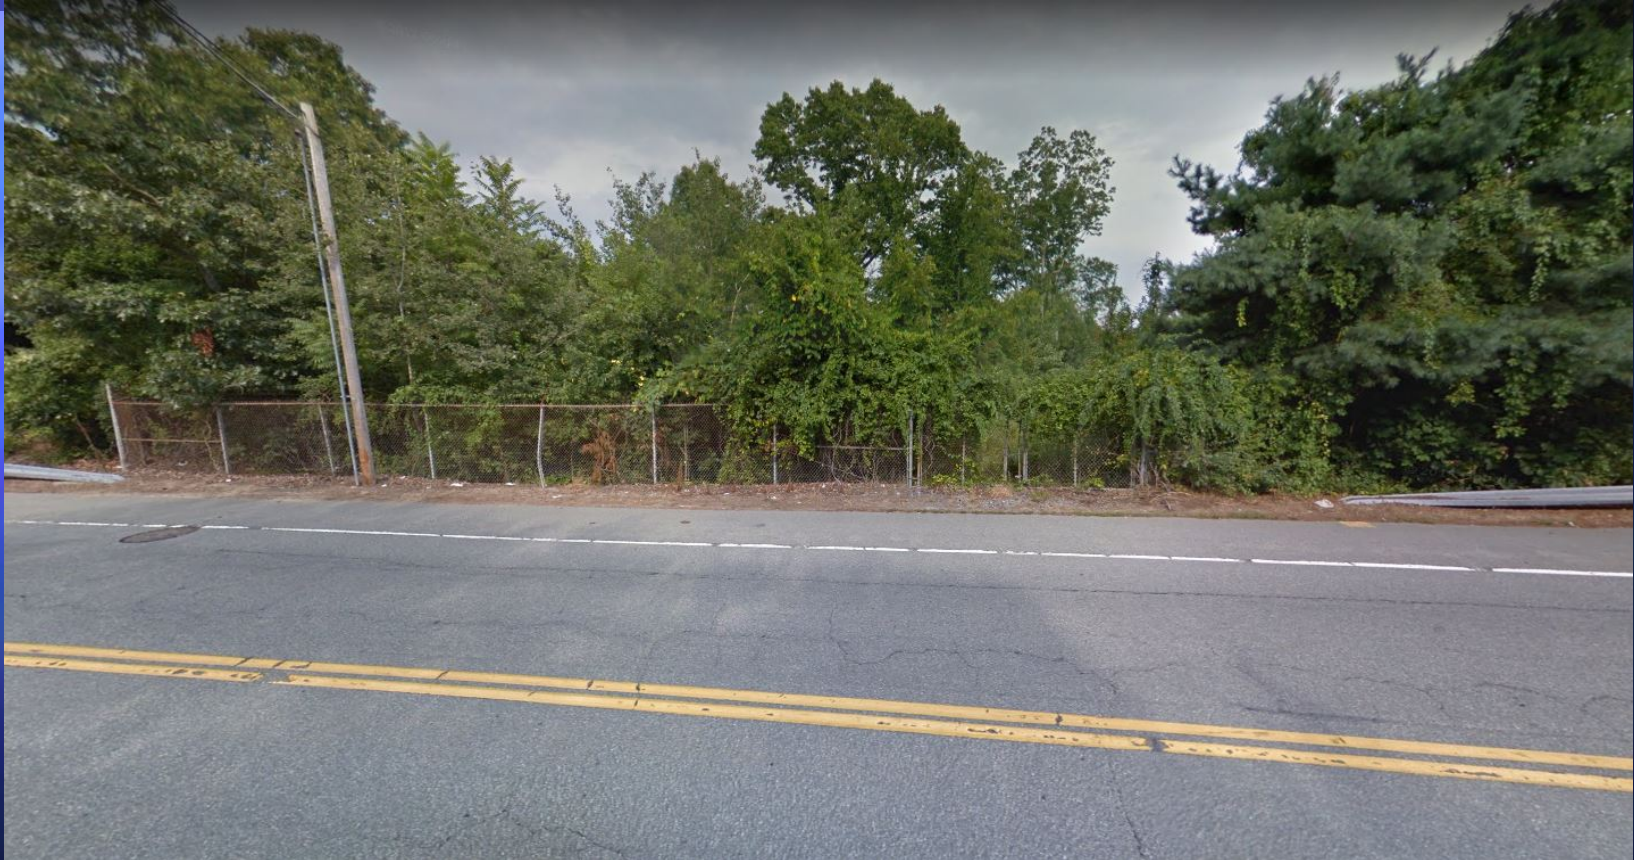
**MAINTENANCE ISSUES
VIEW FROM BUDDINGTON ROAD / LOOKING EASTERLY
BETWEEN NORTH & SOUTH-BOUND I-95 LANES**

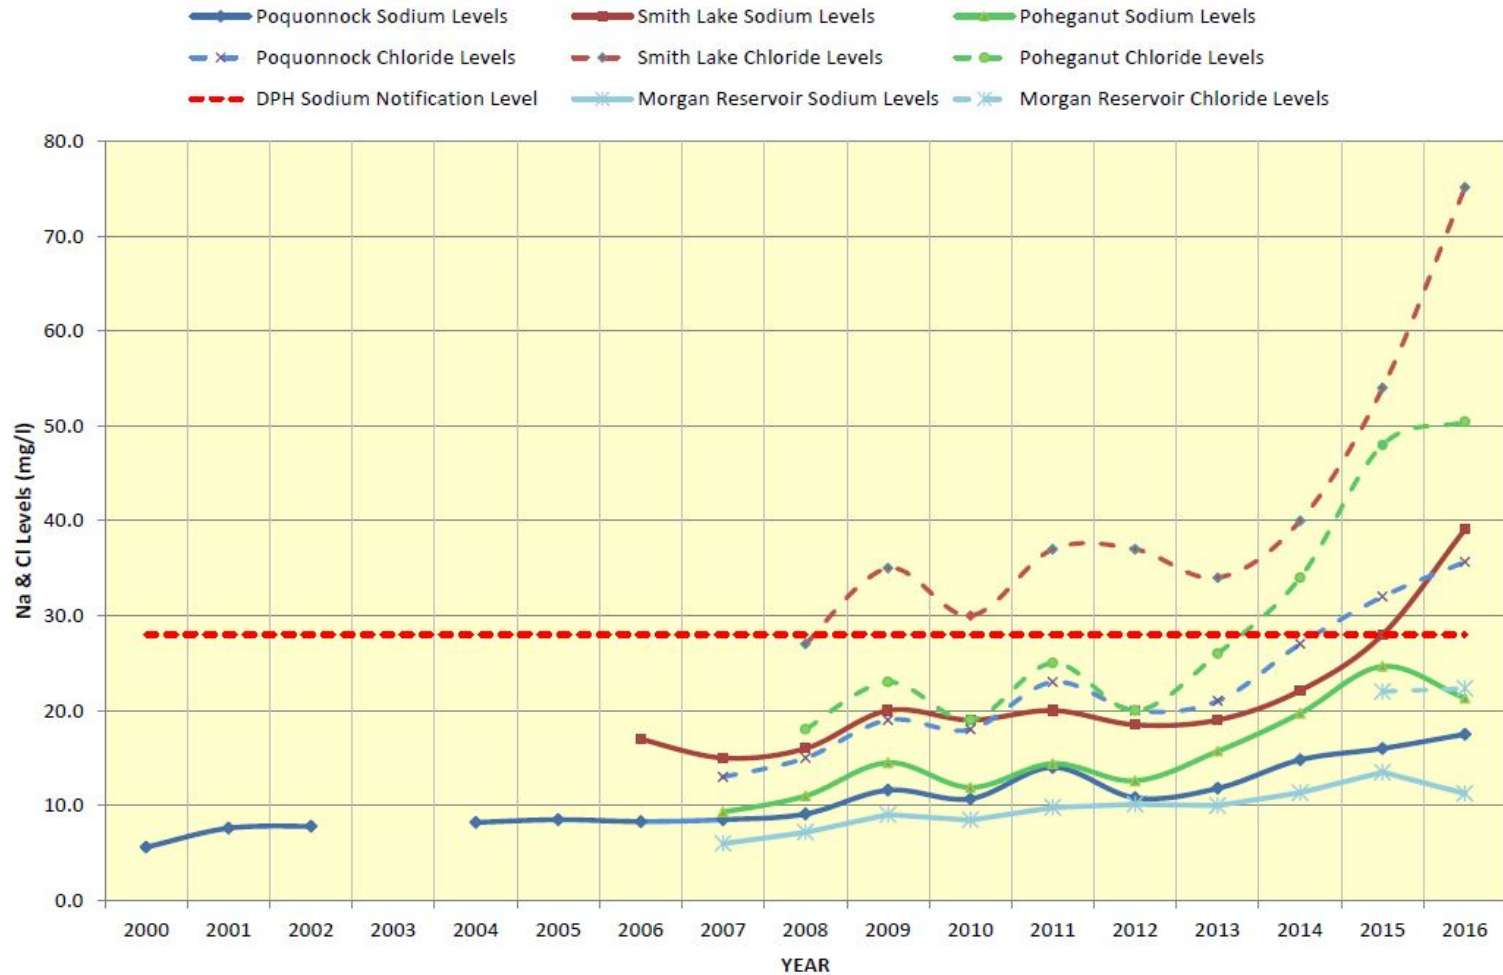
Poquonnock, Morgan, Smith & Poheganut Reservoirs / Sodium & Chloride Level Trends
2000 - 2016

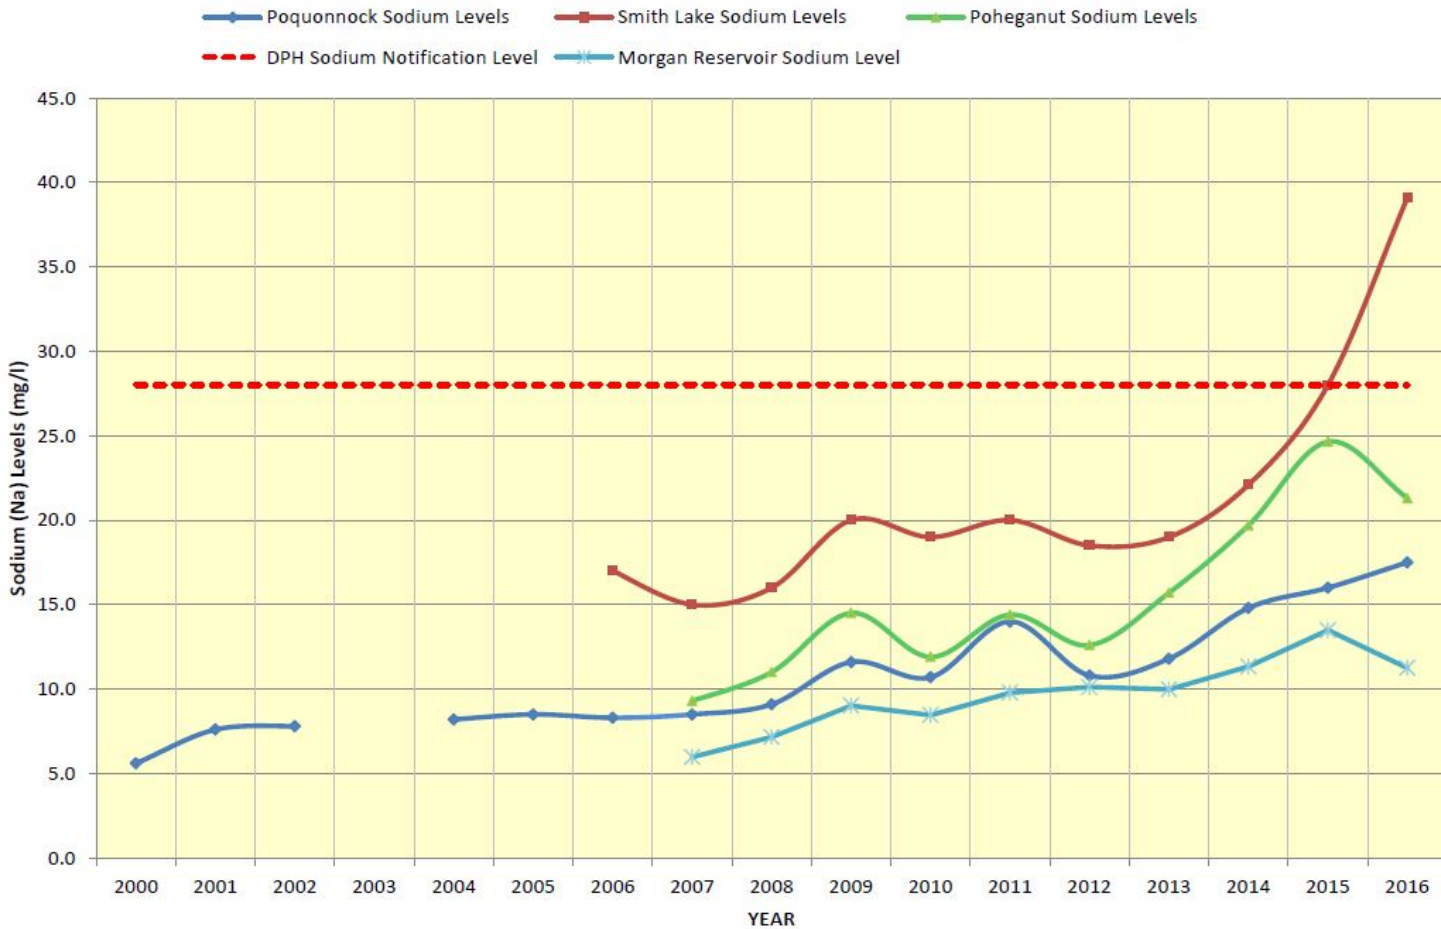
Poquonnock, Smith, Morgan & Poheganut Reservoirs / Sodium Level Trends 2000 - 2016
