# Ansonia

Main Street - Route 115 – Road Safety Audit

October 25, 2016

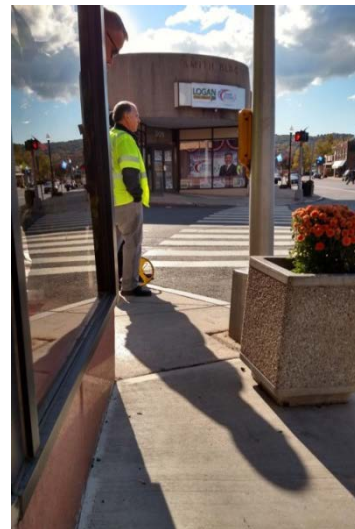
Figure 5. Planter Creating a Pinch Point

- There is a planter that creates a pinch point for pedestrians on the northeast corner (Figure 5).

1. Contact CTDOT to fix the broken pedestrian signals.
2. Add bus stop signs, where missing.
3. Remove the planter on the northeast corner of Bridge Street.

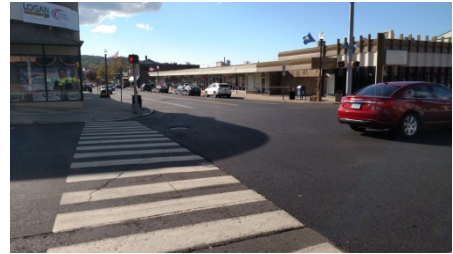
Figure 6. Bridge Street Intersection

- There are ramps on each corner of the intersection but they do not have tactile warning strips. The ramps on the northern corners do not have sufficient landing areas. All ramps are diagonal instead of directional (Figure 6).
- There are crosswalks on all four legs and the signal has an exclusive pedestrian phase. There are pedestrian signals, but they are not countdown or audible. There can be a significant delay when activated.
- The pedestrian signal has a 20 second duration, with 14 seconds during the flashing hand. This does not appear to be enough time to cross the 69 foot length at the longest crossing.
- In the northwest corner, the pedestrian signal to cross Main Street flashing hand is not functioning.

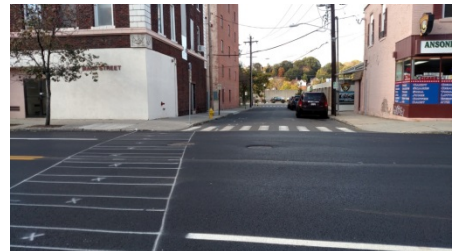
Figure 7. Kingston Drive Intersection

- This is an unsignalized intersection with crosswalks on the Water Street leg and the southern leg of Main Street. The crosswalk on Main Street is on a diagonal (Figure 7).
- The Main Street crossing has a pedestrian crossing sign on the northbound approach only. It is not retroreflective.
- There are ramps but no tactile warning strips. The southwest ramp is on a diagonal.

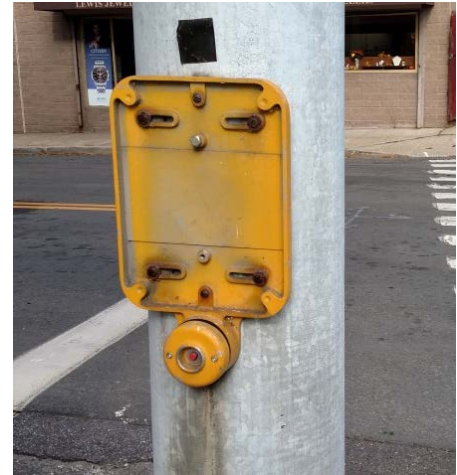
Figure 8. Push Button Missing Placard

- This signal has an exclusive pedestrian phase. It comes on quickly when pushed. There are pedestrian signals, but they are not countdown or audible.
- The pedestrian signal to cross has a 16 second duration, with 11 seconds during the flashing hand. This does not appear to be enough time to cross the 48 foot length at the longest crossing.
- On the southwest corner the pedestrian signal to cross Kingston Drive flashing hand is not functioning.
- The pedestrian push button on the southeast corner is missing the placard (Figure 8).
- The traffic control box on the northwest corner has rusted off its foundation (Figure 9).

10. Retime signals to meet current MUTCD standards for pedestrian crossings.
11. Replace missing pushbutton placard.
12. Replace the rusted out traffic control box.

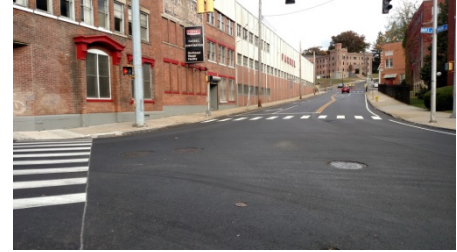
Figure 11. Maple Street Intersection

- This signal has crosswalks across all three roadway legs.
- There are ramps on each corner of the intersection but many lack sufficient landing areas. None of the ramps have tactile warning strips. (Figure 11).
- This signal has an exclusive pedestrian phase. There are pedestrian signals. They are not countdown but they are audible.
- The pedestrian signal has a 14 second duration, with 7 seconds during the flashing hand. This does not appear to be enough time to cross the 40 foot length at the longest crossing.
- On the southwest and northwest corners the pedestrian signal to cross Maple Street flashing hand is inoperative.
- There is no turn on red on northbound Main Street.
- The northbound stop bar and crosswalk are set back from the intersection.

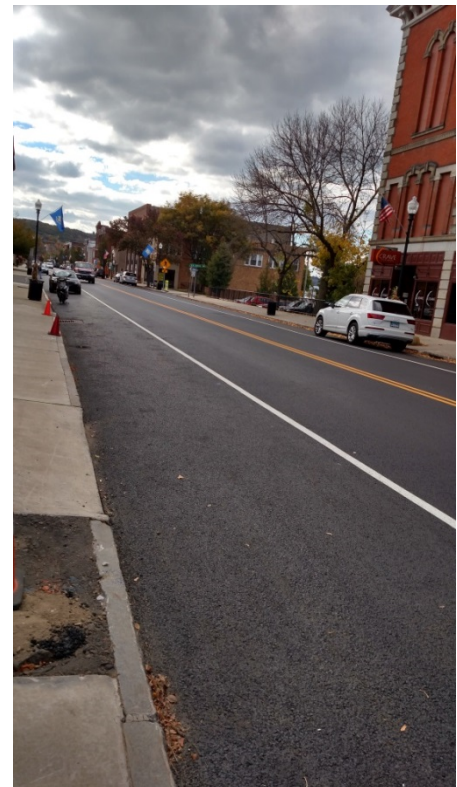
Figure 12. Main Street With Parking

- There is on street parking along both sides of the road but no tick marks to delineate spots (Figure 12).
- The catch basin grates are not bicycle friendly
- Previously there was a bus stop shelter at the stop just north of Bridge Street on the west side of Main Street. It was removed a few years ago when hit by a car and has not been replaced. The pad for it still exists. There is no bus stop sign for this stop.

4. Paint tick marks to delineate on street parking spots.
5. Paint areas where on street parking is not allowed (Figure 17).
6. Add sharrow markings on Main Street (Figure 18).

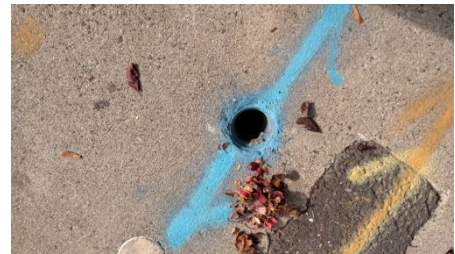
Figure 14. Handhole Missing Cover

- In front of the old Valley Electric Supply and Lighting shop there is a water valve in the sidewalk missing its lid (Figure 14).
- Utilities along Main Street are underground.

7. Install pedestrian crossing signs for mid-block crossings (Figure 19).
8. Replace faded and worn out signs with new retroreflective ones.
9. Contact Aquarian to fix the missing valve cover.

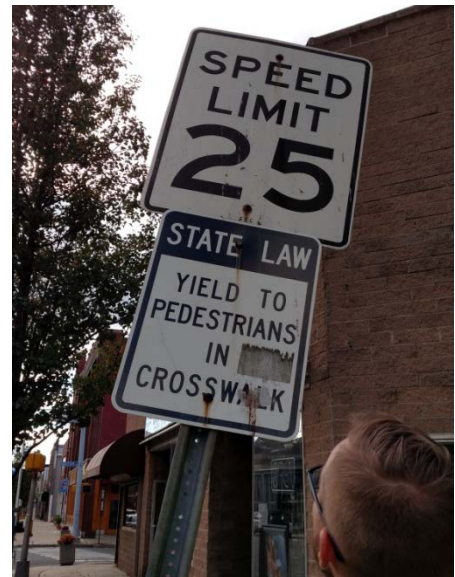
Figure 15. Sign Does Not Meet Height Requirements

- The street light poles are 150 feet apart providing minimal lighting. The bulbs are not LED.
- The speed limit and yield to pedestrians in crosswalk sign just north of the Kingston Drive intersection is leaning and does not meet minimum height requirements (7 feet) (Figure 15).

13. Contact DOT to get catch basins cleaned.
14. Raise sign heights to seven feet when in the sidewalk.
15. Trim trees with low canopies over the sidewalk.

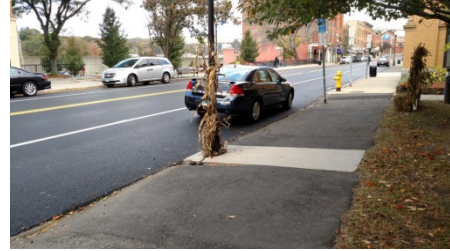
Figure 16. Curbcut in Front of Senior Center

- In front of the senior center there is a large curbcut and asphalt sidewalk with no curb. This was previously a parking area (Figure 16).

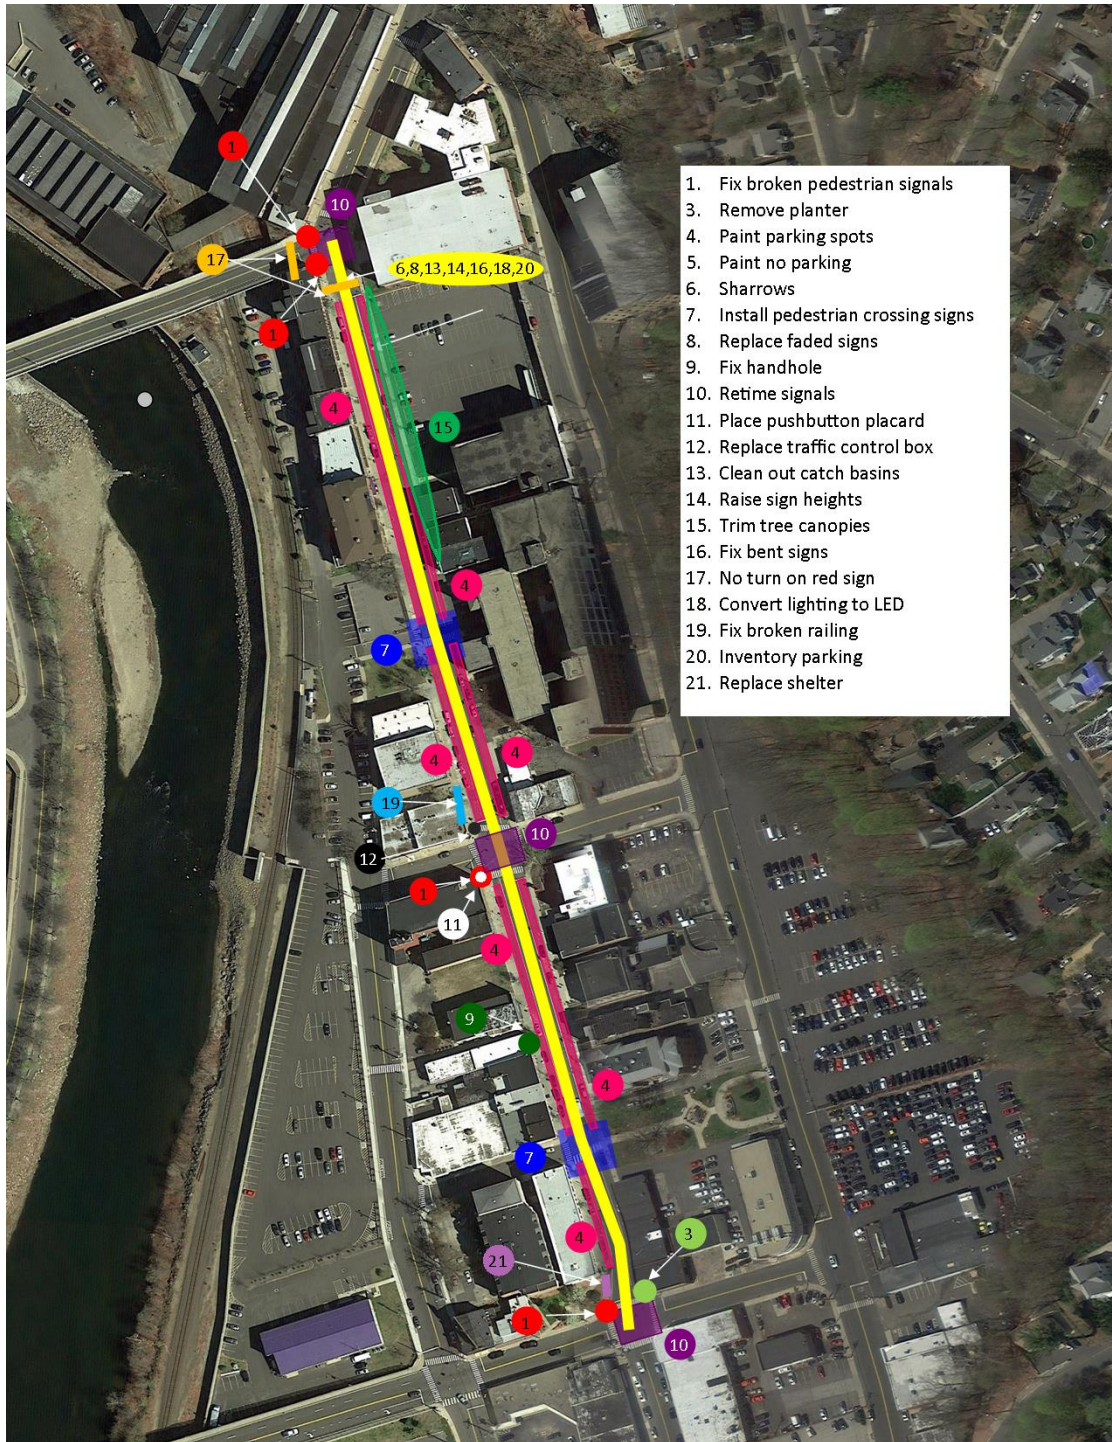
Figure 21. Short Term Recommendations

Figure 21 depicts these recommendations.

16. Fix signs that are bent.
17. Add a "No turn on red" sign on Maple Street as well as on Main Street heading northbound.
18. Reach out to UI to convert to LED bulbs.
