Avon

West Main Street/East Main Street (Route 44) from Dale
Road to Waterville Road – Road Safety Audit

August 25, 2016

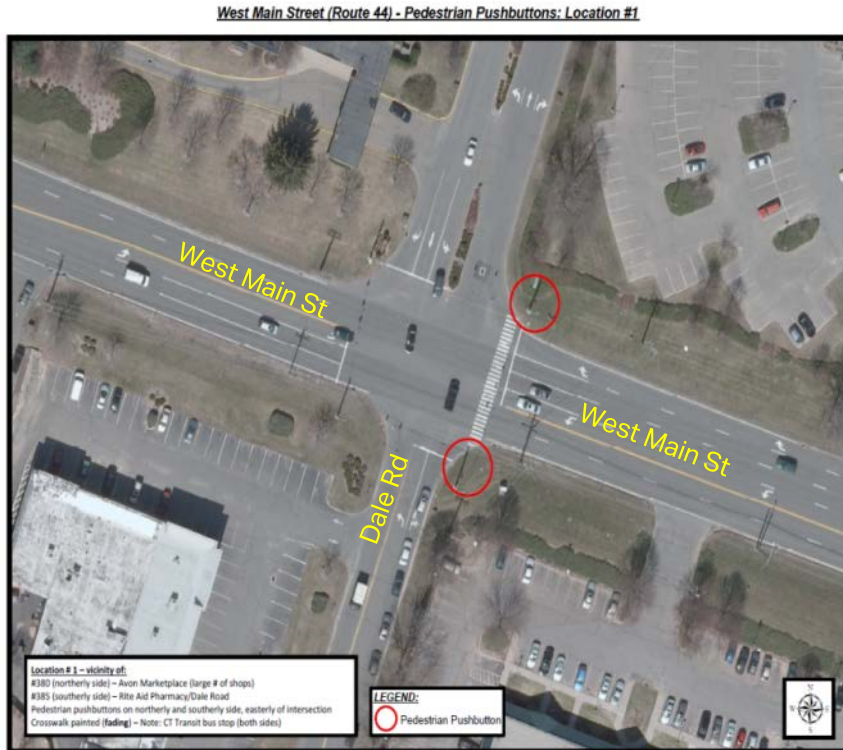
Figure 6. Location #1 - Intersection of West Main Street and Dale Road

Location #1: Intersection of West Main Street (Route 44), Dale Road and Simsbury Commons/Avon Marketplace Driveways: This is a four-way signalized intersection with a crosswalk on the east leg of West Main Street and pedestrian pushbuttons on each side of the crosswalk (Figure 6). The crosswalk is connected to the sidewalks on both sides, which only serve the adjacent businesses. The east leg of the West Main Street has four approach lanes. Avon Marketplace Driveway and the west leg of the West Main Street have three approach lanes. Dale Road has two approach lanes.

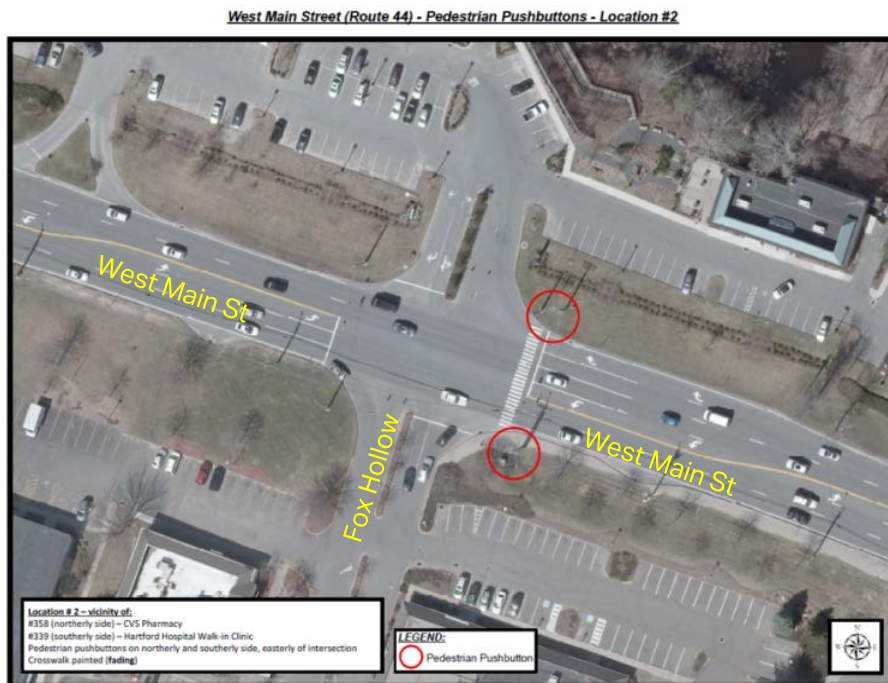
Figure 7. Location #2 - Intersection of West Main Street and Fox Hollow

Location #2: Intersection of West Main Street (Route 44), Fox Hollow and Avon Marketplace Driveway: This is a four-way signalized intersection with a crosswalk on the east leg of West Main Street and pedestrian pushbuttons on each side of the crosswalk (Figure 7). Sidewalk is provided on the south side along the east leg of West Main Street, and it continues to the south along Fox Hollow to service the Hartford Hospital Family Health Center building. The westbound West Main Street approach has four approach lanes and the eastbound approach has three lanes. Fox Hollow and Avon Marketplace Driveway both have two approach lanes and a median. Fox Hollow serves the Hartford Hospital facility as well as a residential subdivision. The Avon Marketplace Driveway serves a CVS, and connects to Avon Marketplace.

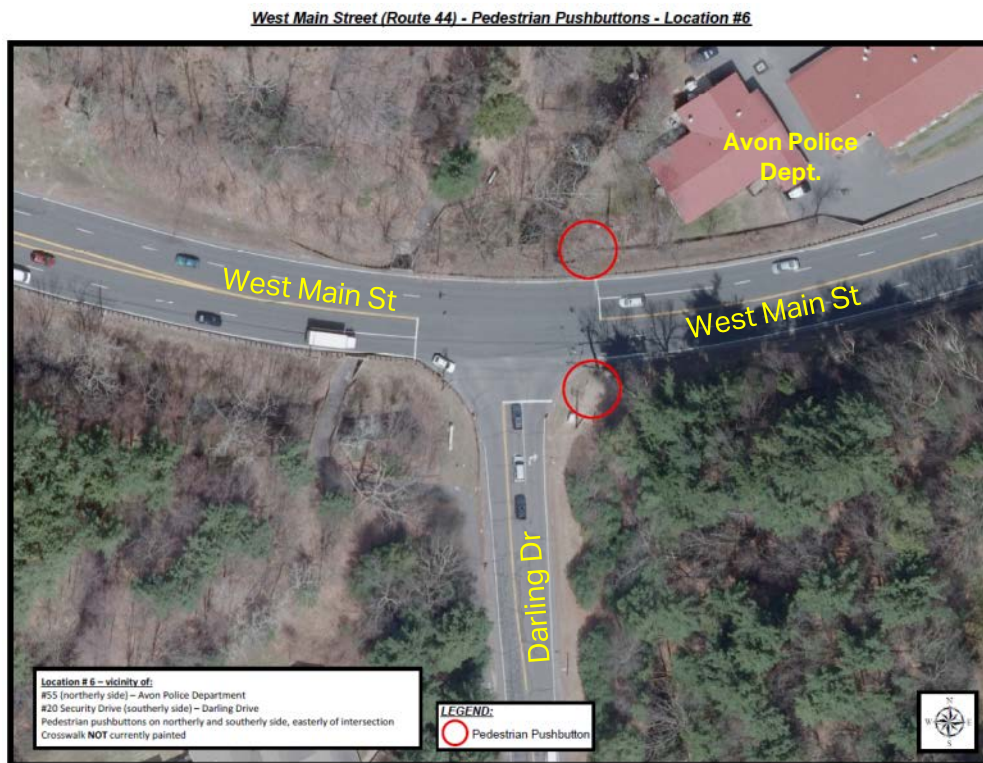
Figure 11. Location #6 – Intersection of West Main Street and Darling Drive

Location #6 - Intersection of West Main Street (Route 44) and Darling Drive: This is a three-way signalized intersection (Figure 11). There are no painted crosswalks and no sidewalks at this location. The pedestrian pushbuttons are located on the north and south sides of the east leg of West Main Street. The Avon Police Department is located along the north side of the east leg of West Main Street. Each leg of the intersection has two approach lanes.

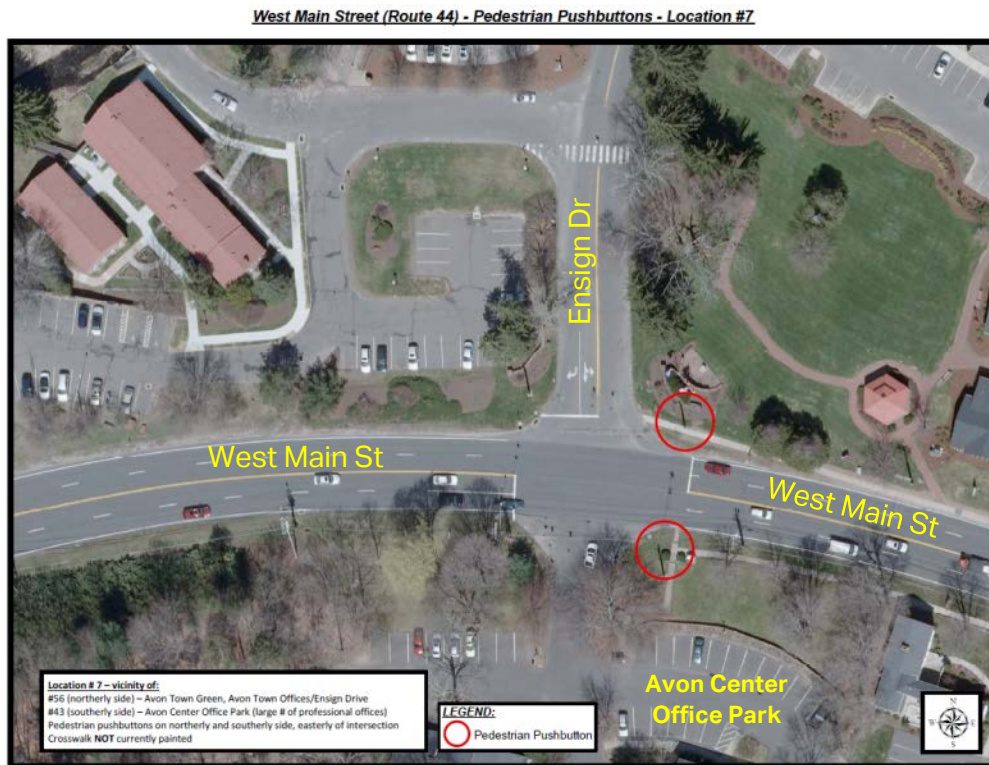
Figure 12. Location #7 – Intersection of West Main Street and Ensign Drive

Location #7 - Intersection of West Main Street (Route 44) and Ensign Drive: This is a four-way signalized intersection of West Main Street, Ensign Drive and the Avon Center Office Park driveway (Figure 12). There are no painted crosswalks at this location. Sidewalks and pedestrian pushbuttons are located on the north and south sides of the east leg of West Main Street, and turn into Ensign Drive and the Avon Center Office Park. Ensign Drive serves Avon Town offices, Avon Town Green and several other businesses. The Avon Center Office park serves Farmers Insurance and other businesses.

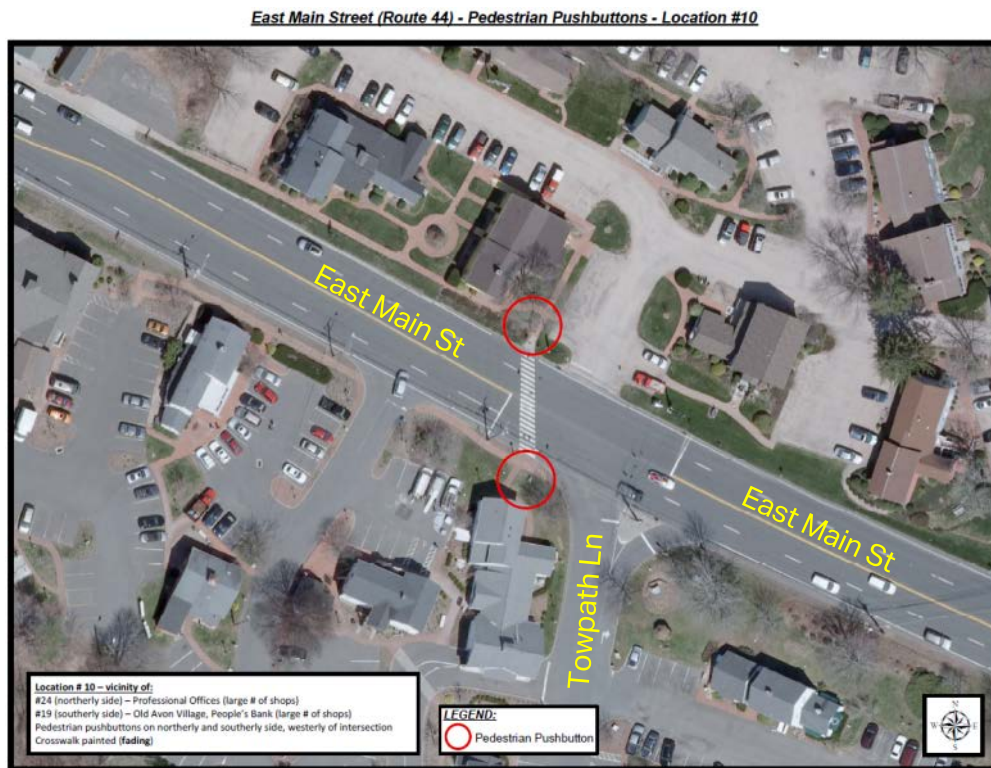
Figure 15. Location #10 – Intersection of East Main Street and Towpath Lane

Location #10 - Intersection of East Main Street (Route 44) and Towpath Lane: This is a four-way signalized intersection of East Main Street, Towpath Lane and a driveway on the north side that serves professional offices (Figure 15). Towpath Lane serves a large number of shops including Old Avon Village and People's Bank. There is a crosswalk on the west leg of East Main Street, which is connected to sidewalks on both sides. Sidewalks continue into the developments to the north and south, but do not continue east of this intersection. Pedestrian pushbuttons are provided at each end of the crosswalk. Each approach has two lanes except the south approach, which has one lane and a channelized right turn lane.

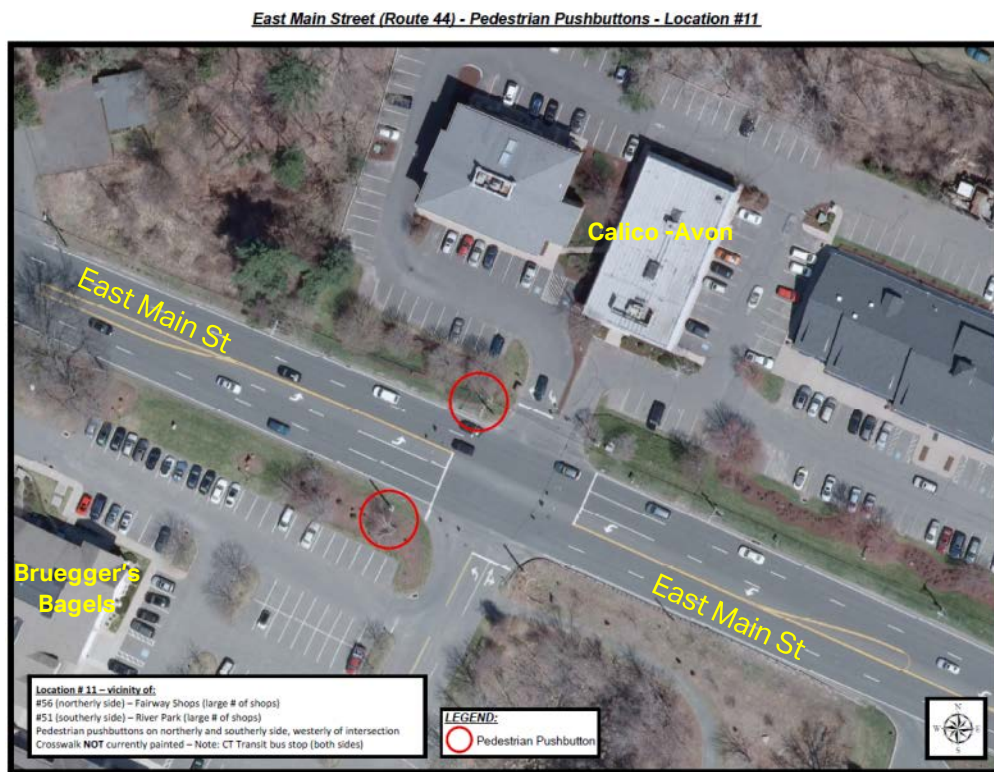
Figure 16. Location #11 – Intersection of East Main Street, and Fair Shops and River Park Driveway

Location #11 - Intersection of East Main Street (Route 44), Fairway Shops and River Park Driveways: This is a four-way signalized intersection of East Main Street, the Fairway Shops driveway on the north and River Park driveway on the south (Figure 16). This intersection has no painted crosswalks and no sidewalks. There are pedestrian pushbuttons on the north and south side of the west leg of East Main Street. There are CT Transit bus stops on both sides of the intersection. East Main Street has three approach lanes on both legs and the driveways have two approach lanes.

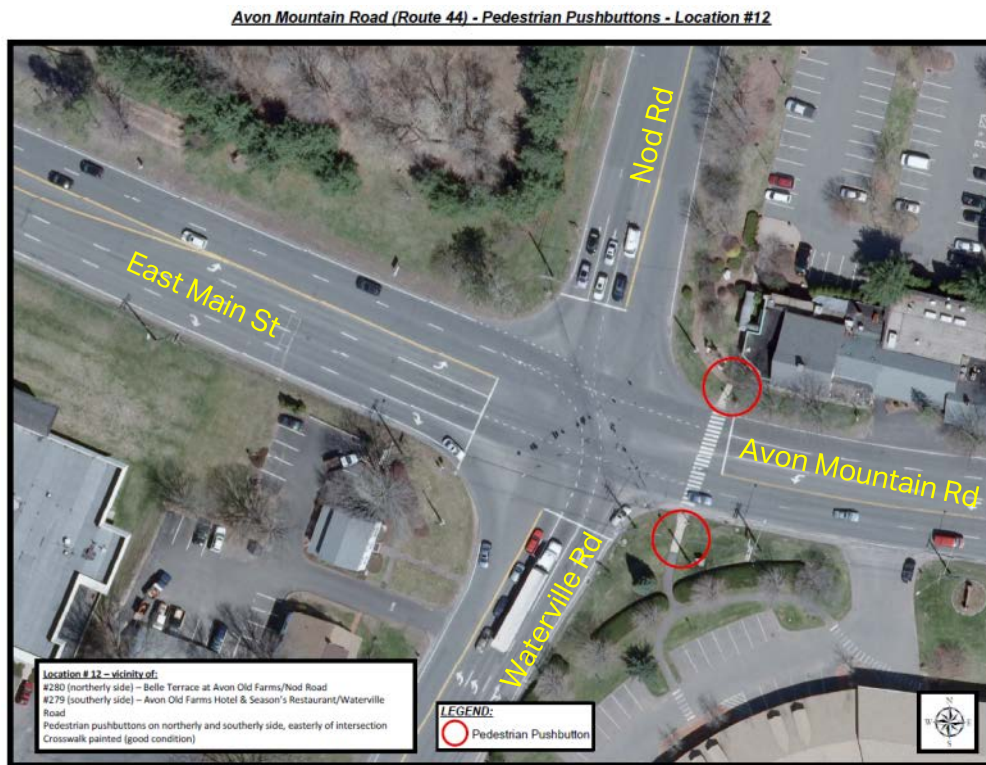
Figure 17. Location #12 – Intersection of East Main Street, Waterville Road and Nod Road

Location #12 - Intersection of East Main Street, Avon Mountain Road (Route 44), Waterville Road and Nod Road: This is a four-way signalized intersection with a crosswalk on the east leg of Avon Mountain Road (Figure 17). Pedestrian pushbuttons are located at each end of the crosswalk. There are no other sidewalks along any of the roads. The crosswalk connects with sidewalks that provide access to the restaurant on the north and the Avon Old Farm Hotel on the south. Each leg has three approach lanes except for the eastbound approach of East Main Street which has four approach lanes.

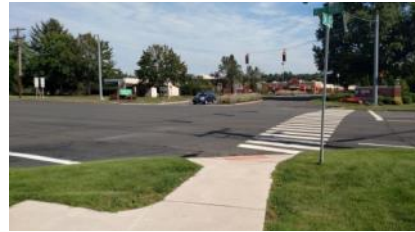
Figure 19. Intersection of Route 44 and Dale Road

- The crosswalk on the east leg of the intersection has handicap ramps and detectable warning strips. This is the only crosswalk at this intersection (Figure 19). The ramp on the northeast corner is incorrectly angled at 45 degrees. The sidewalk on the northeast corner turns into a four foot wide stone dust path that connects to the development to the north, but that is not as well maintained. There is a five foot wide concrete sidewalk on the southeast corner that connects to the development to the south.

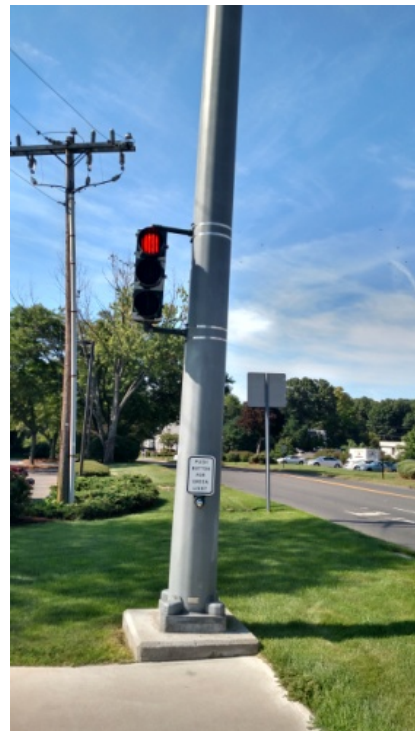
Figure 20. Pedestrian pushbutton on the east leg of West Main Street

- The pedestrian crossing phase is concurrent.
- There are accessible pedestrian "Push for Green" buttons (Figure 20) to cross the east leg of the intersection. The pedestrian signals are vehicle signal heads.

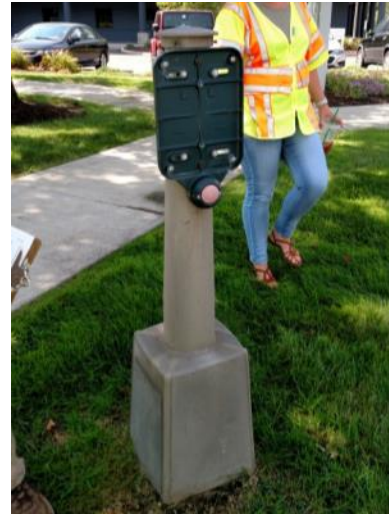
- There are pedestrian pushbuttons on the east leg of the intersection. The pushbutton on the southeast corner is located too far from the sidewalk to meet ADA requirements, the button is turned away from the sidewalk and the placard is missing. No pedestrian signals are provided (Figure 21).

Figure 21. Inadequate pedestrian pushbutton in the south east corner at Fox Hollow

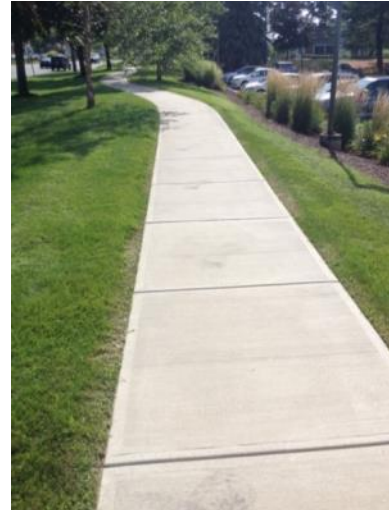
Figure 22. New Sidewalk on Route 44 east of Fox Hollow

- The Town would like to coordinate with the incoming restaurant on the northeast corner to provide a handicap ramp and sidewalk.
- There is a new five-foot wide concrete sidewalk on the south side of Route 44 between Fox Hollow and Nod Brook Mall (Figure 22). New ramps and detectable warning strips are provided at Bailey Road.

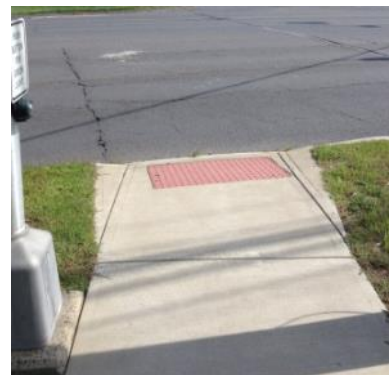
- There are no crosswalks. There is a handicap ramp and detectable warning strip on the southwest corner (Figure 23). There are no ramps on any other corners.

Figure 23. Handicap ramp on the southwest corner of Route 44/Nod Brook Mall

- a. Install handicap ramps where missing;
 - b. Upgrade ramps that do not meet ADA requirements;
 - c. Provide crosswalks at side streets and across Route 44 at pedestrian signals where missing.

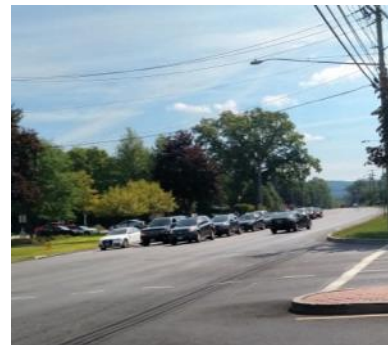
Figure 25. Traffic queuing to take a left turn into Wal-Mart Plaza

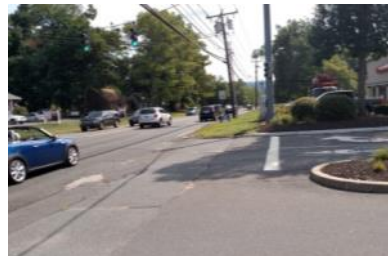
Figure 26. Intersection of West Main Street and Plaza 44

Location #5 Intersection of West Main Street (Route 44), Lawrence Avenue (east) and Plaza 44 Driveway (Figure 26):

- A future sidewalk on Route 44 would have to transition to the north side in this area due to wetlands on the south side.
- There is a wide grass buffer strip between the edge of the roadway and buildings. It may be possible to install a multi-use trail here.

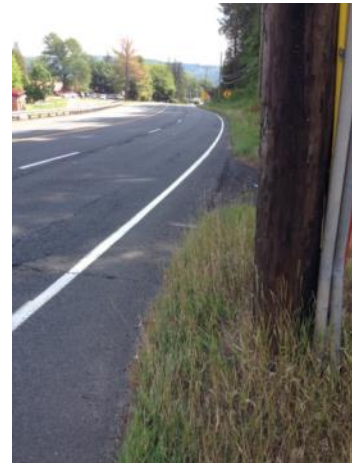
Figure 28. Long grass on the south side of Route 44 east of Darling Drive

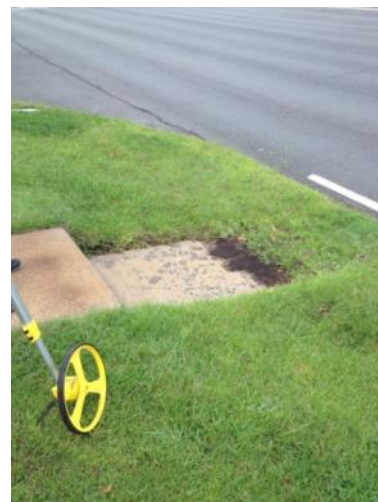
Figure 29. Stepped sidewalk on the southeast corner of Route 44/Ensign Drive

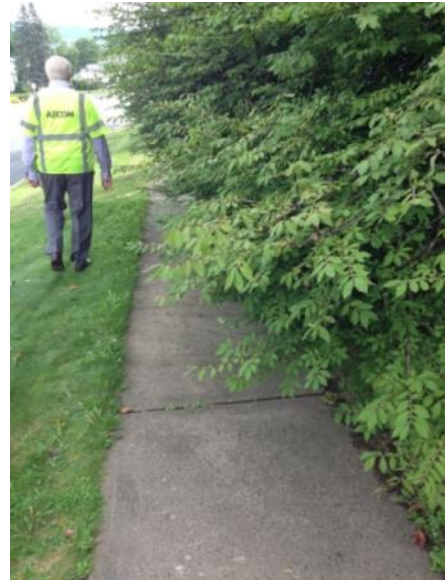
Figure 30. Overgrown vegetation on sidewalk on south side of Rt. 44 east of Ensign Drive

9. The town will trim vegetation on the south sidewalk east of Ensign Drive.
10. The town is to request CTDOT repair the broken pedestrian walk signal on the southeast corner facing West Main Street/Old Farms Road.

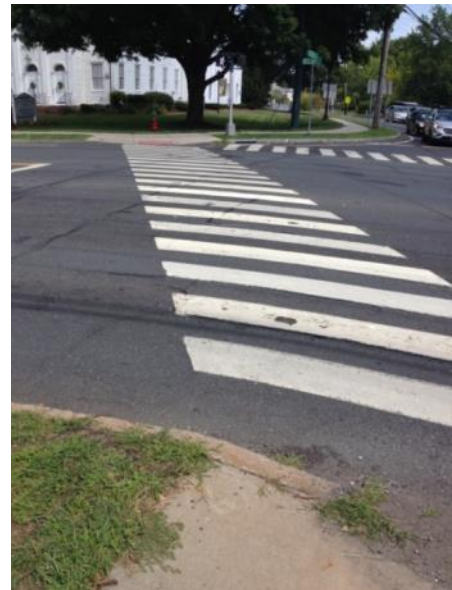
Figure 31. Crosswalk on Rt. 44 west of

- Crosswalks, handicap ramps, pedestrian buttons and signals are provided on each intersection leg and corner. Some ramps lack tactile warning strips (Figure 32). Pedestrian signals are not ADA compliant and lack countdown heads.
- The crosswalks are long on all four intersection legs due to multiple lanes and skewed angles (Figure 31).
- There are sidewalks on both sides of Route 44 and Simsbury Road. There are no sidewalks on Old Farms Road. Sidewalk on south side of Route 44 heading east becomes brick surface.
- The pedestrian phase is exclusive (all red phase).
- The walk signal on the southeast corner facing west is not functioning.
- Tree branches on the southeast corner obscure the visibility of the pedestrian signal head.

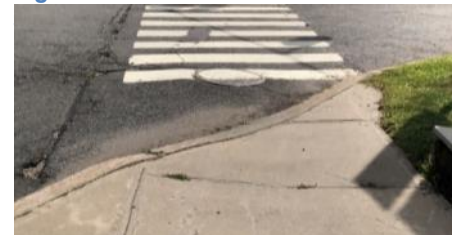
Figure 32. Lack of detectable warning strips

13. The town will coordinate with CTDOT to install missing detectable warning strips at handicap ramps at intersections as needed throughout the Route 44 corridor.

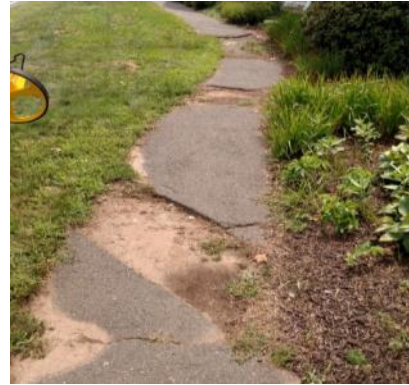
- Brick sidewalks are on both sides of Route 44 west of Towpath Lane. There is broken bituminous sidewalk on the south side of Main Street, in front of #1-45 Avon Village East (Figure 33).

Figure 33. Broken sidewalk at Avon Village East

4. Coordinate with businesses at Nod Brook Mall and Westridge Shops to provide a sidewalk and handicap ramps in the future.
5. The town is to coordinate with business at #1-45 Avon Village East Main to repair broken bituminous sidewalk on the south side of Main Street.

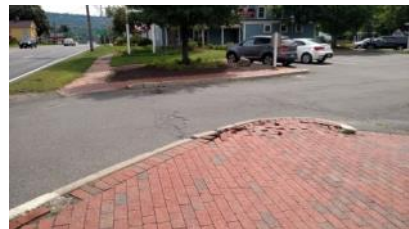
- There are no handicapped ramps at Old Avon Village driveway (unsignalized) or Towpath Lane (signalized) on south side of Route 44 (Figure 34).
- There is an angled crosswalk on the west leg of the intersection that causes a long crossing distance. A concrete handicap ramp and detectable warning strip is provided on the north side and a brick ramp with no detectable warning strip is on the south side (Figure 35).

Figure 34. Missing Ramps at Old Avon Village

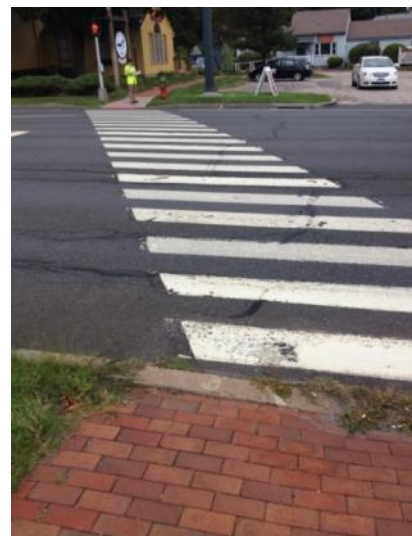
Figure 35. Angled cross on East Main Street west of Towpath Lane with no detectable warning strip on south side

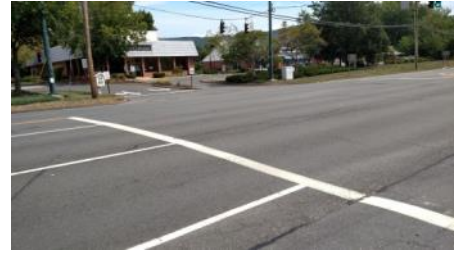
- CT Transit bus stops are located on the Route 44 eastbound and westbound approaches to the intersection.
- There are no sidewalks or crosswalks (Figure 36).
- There are pedestrian pushbuttons on the west leg of the intersection. No pedestrian signals are

Figure 36. Intersection of Route 44 and Fairway Shops

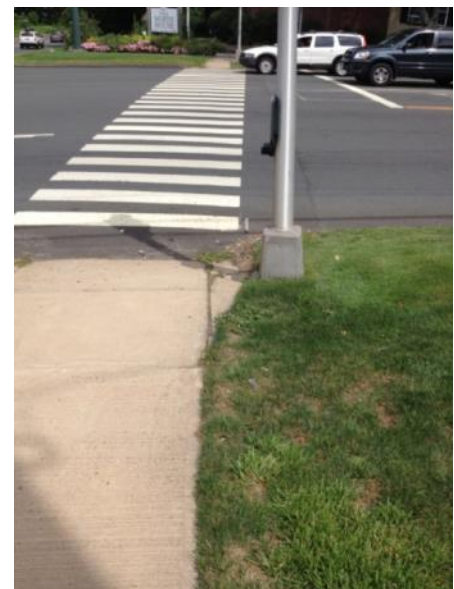
- There is a crosswalk on only the east leg of Route 44. Sidewalks are only provided as connections to the North House on the northeast corner and Avon Old Farms Hotel on the southeast corner (Figure 36).
- Pedestrian buttons and vehicle signals are provided on both ends of the crosswalk.
- The pedestrian signal time for crossing was measured to be 30 seconds green time and 3 seconds of yellow time, which appeared adequate.
- The handicap ramps are not ADA compliant. There are no detectable warning strips. The ramp on the north side is narrow and on the south side is steep.
- Traffic was noted traveling at high speed on Route 44.

Figure 37. Crosswalk between Avon Old Farms Hotel (near side) and North House (far side) across Rt. 44 east of Old Farms Road

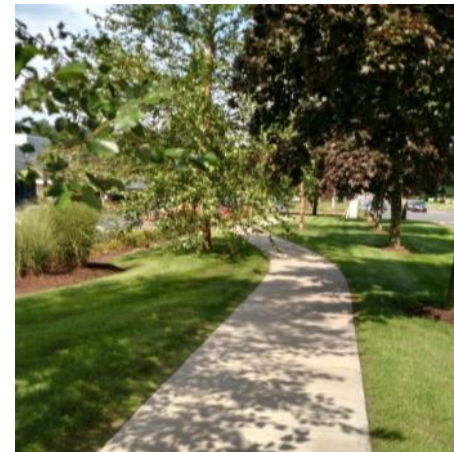
- Between Fox Hollow and Bailey Road there are several tree canopies that block the sidewalk (Figure 38).
- At Bailey Road there are ramps and detectable tactile warning strips, but no crosswalks (Figure 39). The stop bar is faded and in front of the crosswalk.

Figure 38. Vegetation blocking the sidewalk

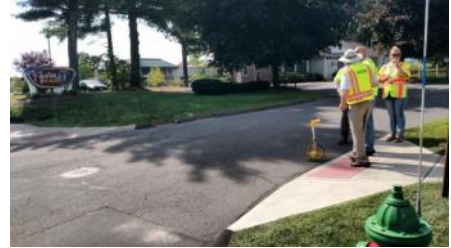
Figure 39. Bailey Road crossing

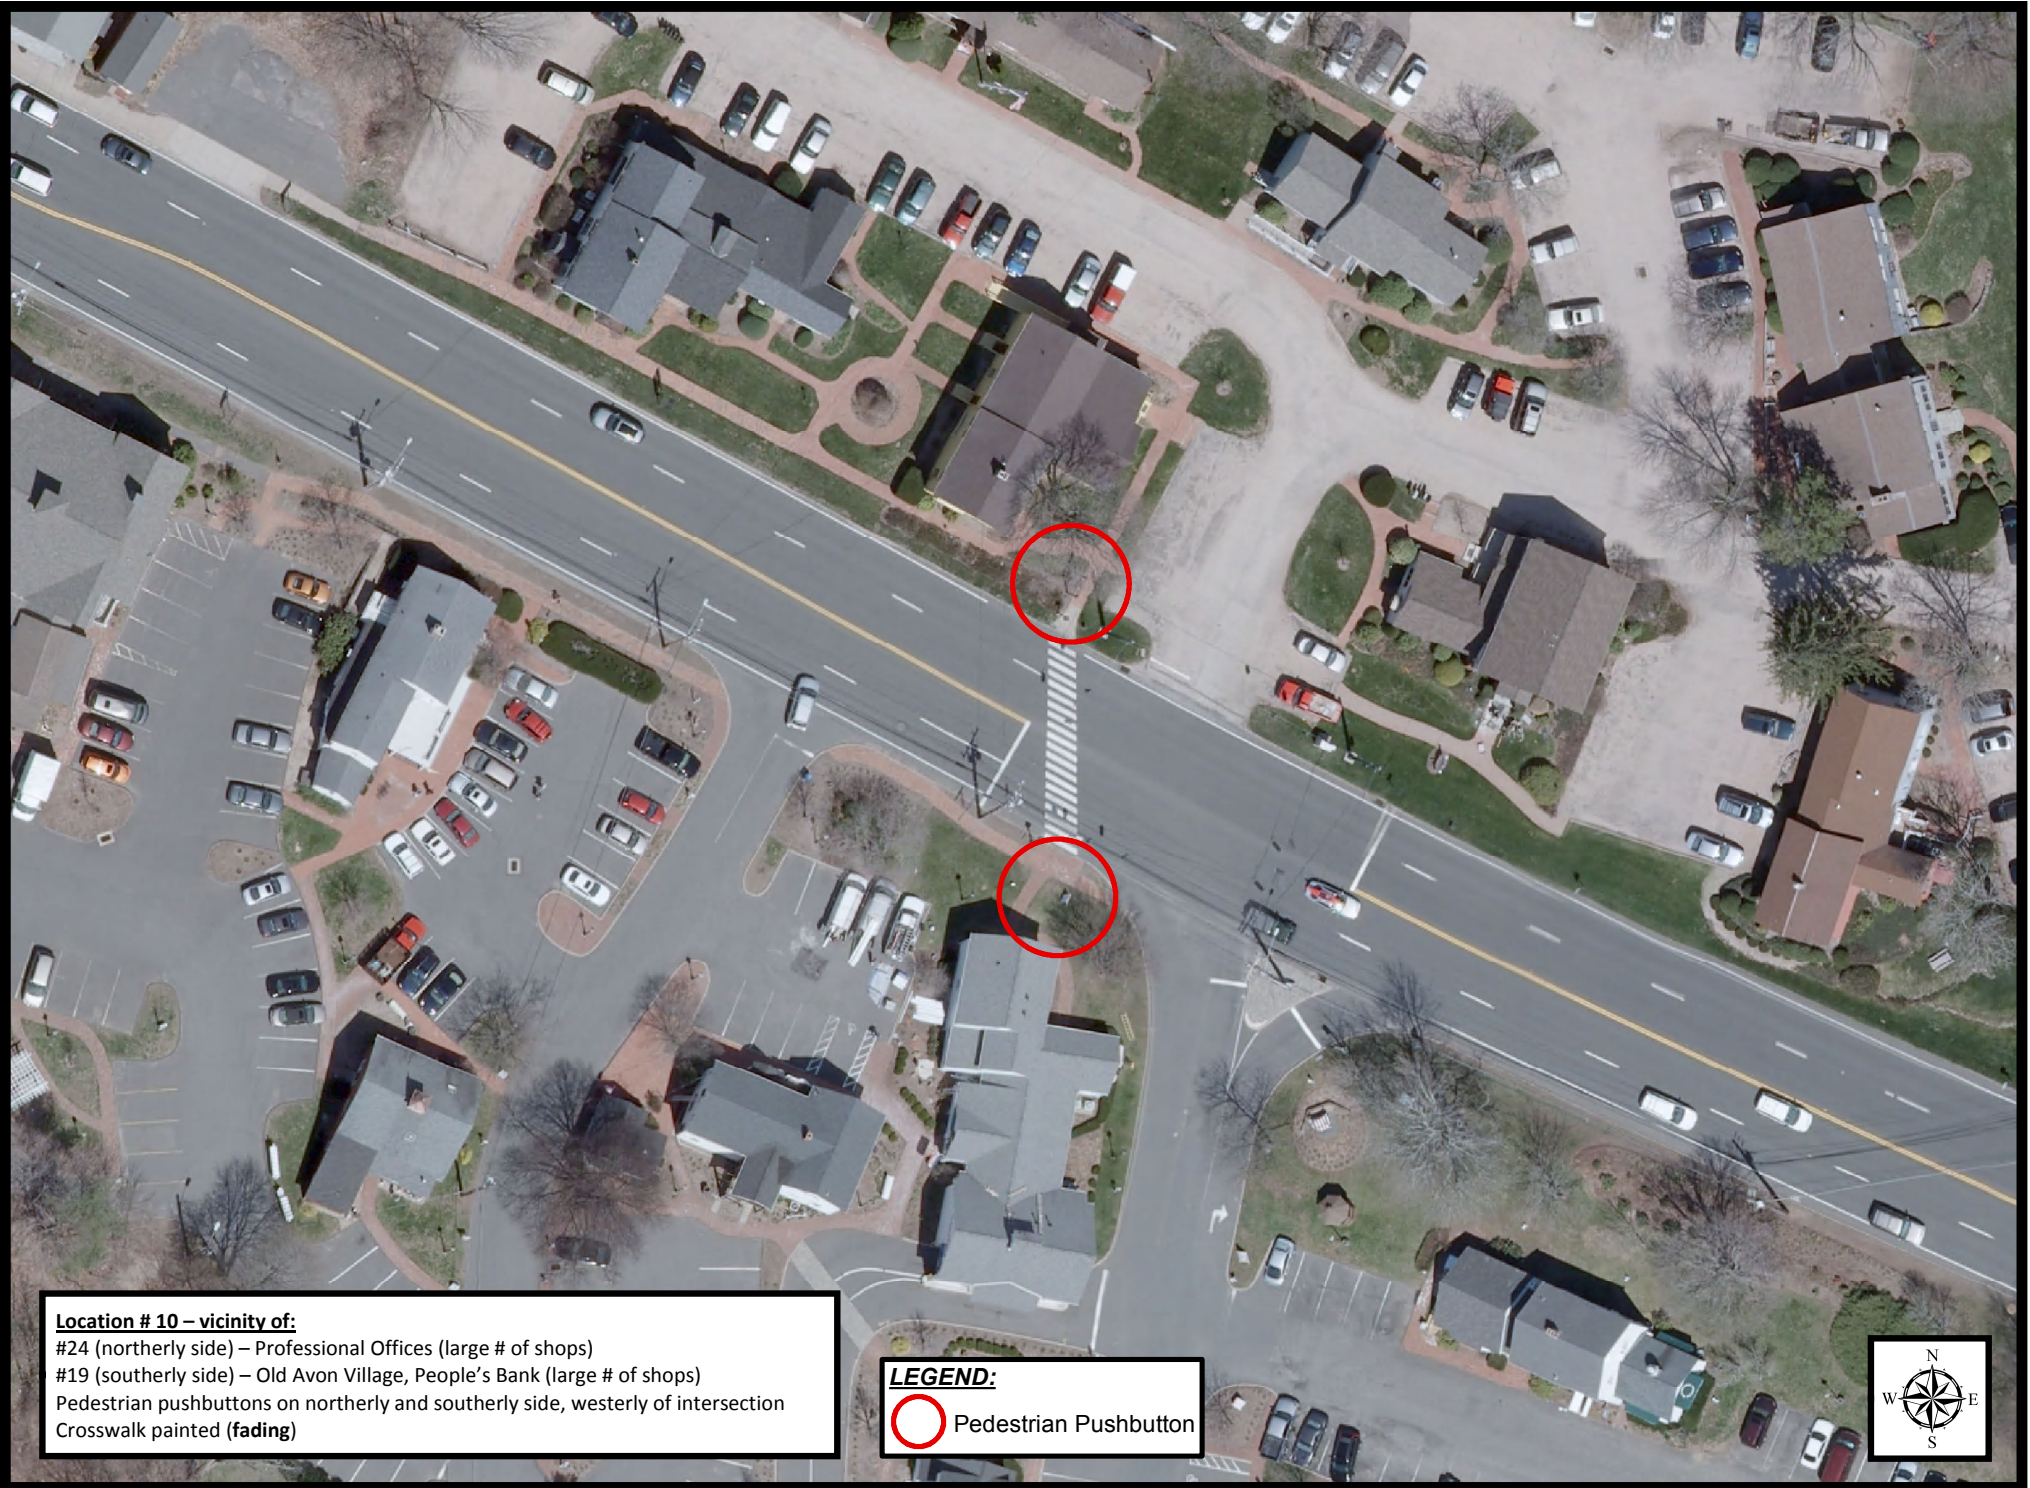
East Main Street (Route 44) - Pedestrian Pushbuttons - Location #10

- #24 (northerly side) – Professional Offices (large # of shops)
- #19 (southerly side) – Old Avon Village, People’s Bank (large # of shops)
- Pedestrian pushbuttons on northerly and southerly side, westerly of intersection
- Crosswalk painted (**fading**)

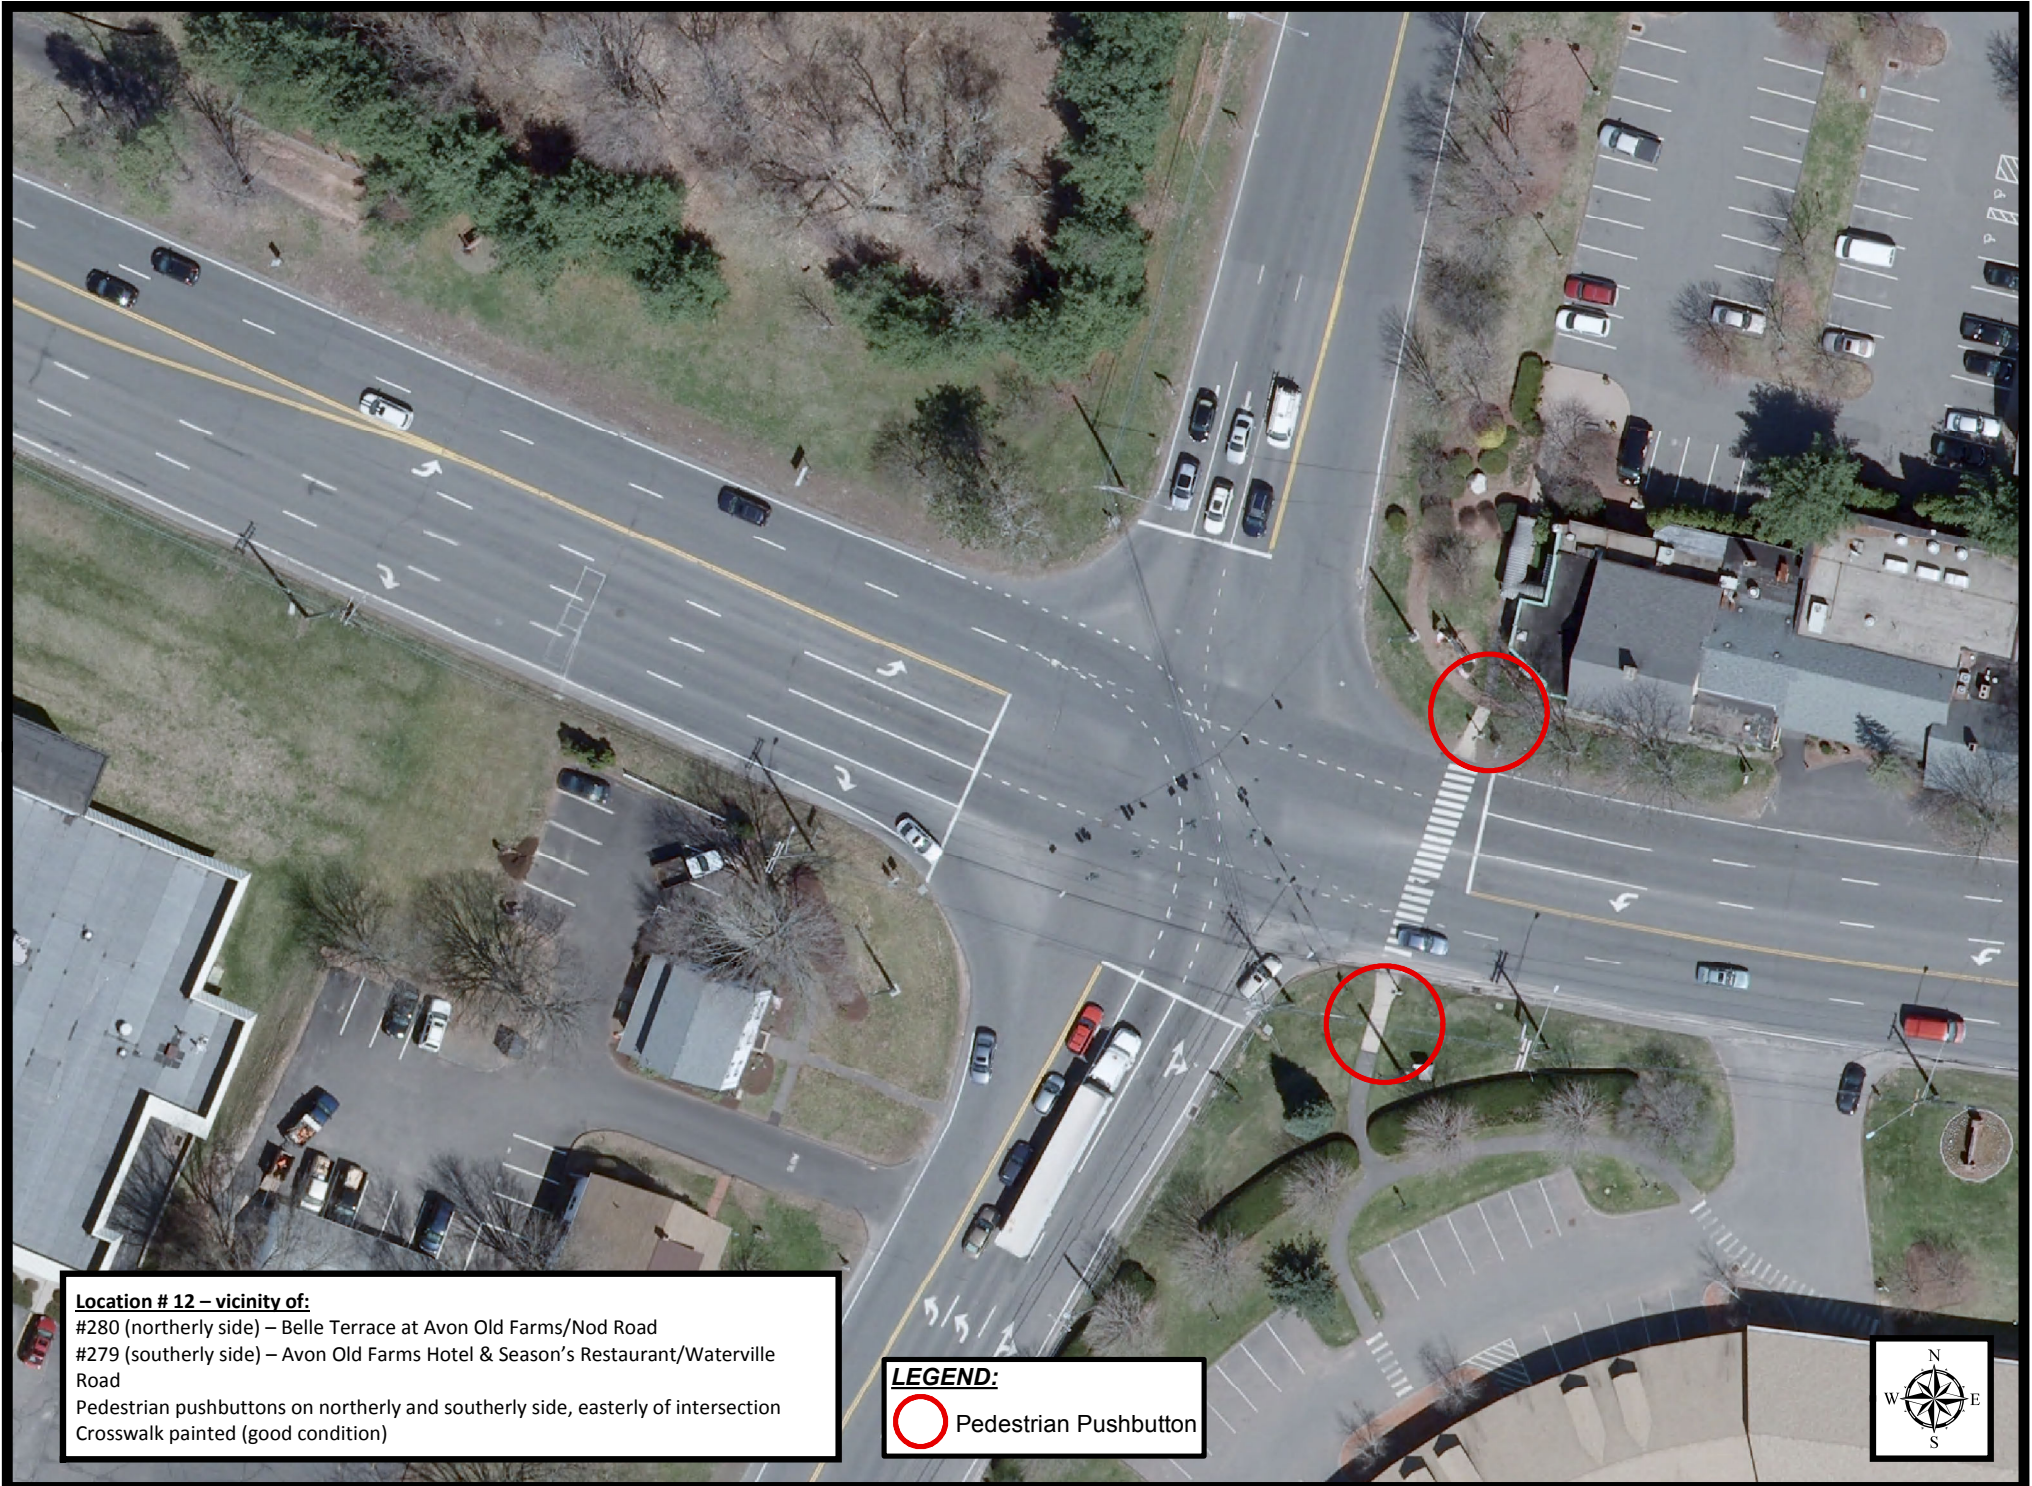
Avon Mountain Road (Route 44) - Pedestrian Pushbuttons - Location #12

#280 (northerly side) – Belle Terrace at Avon Old Farms/Nod Road

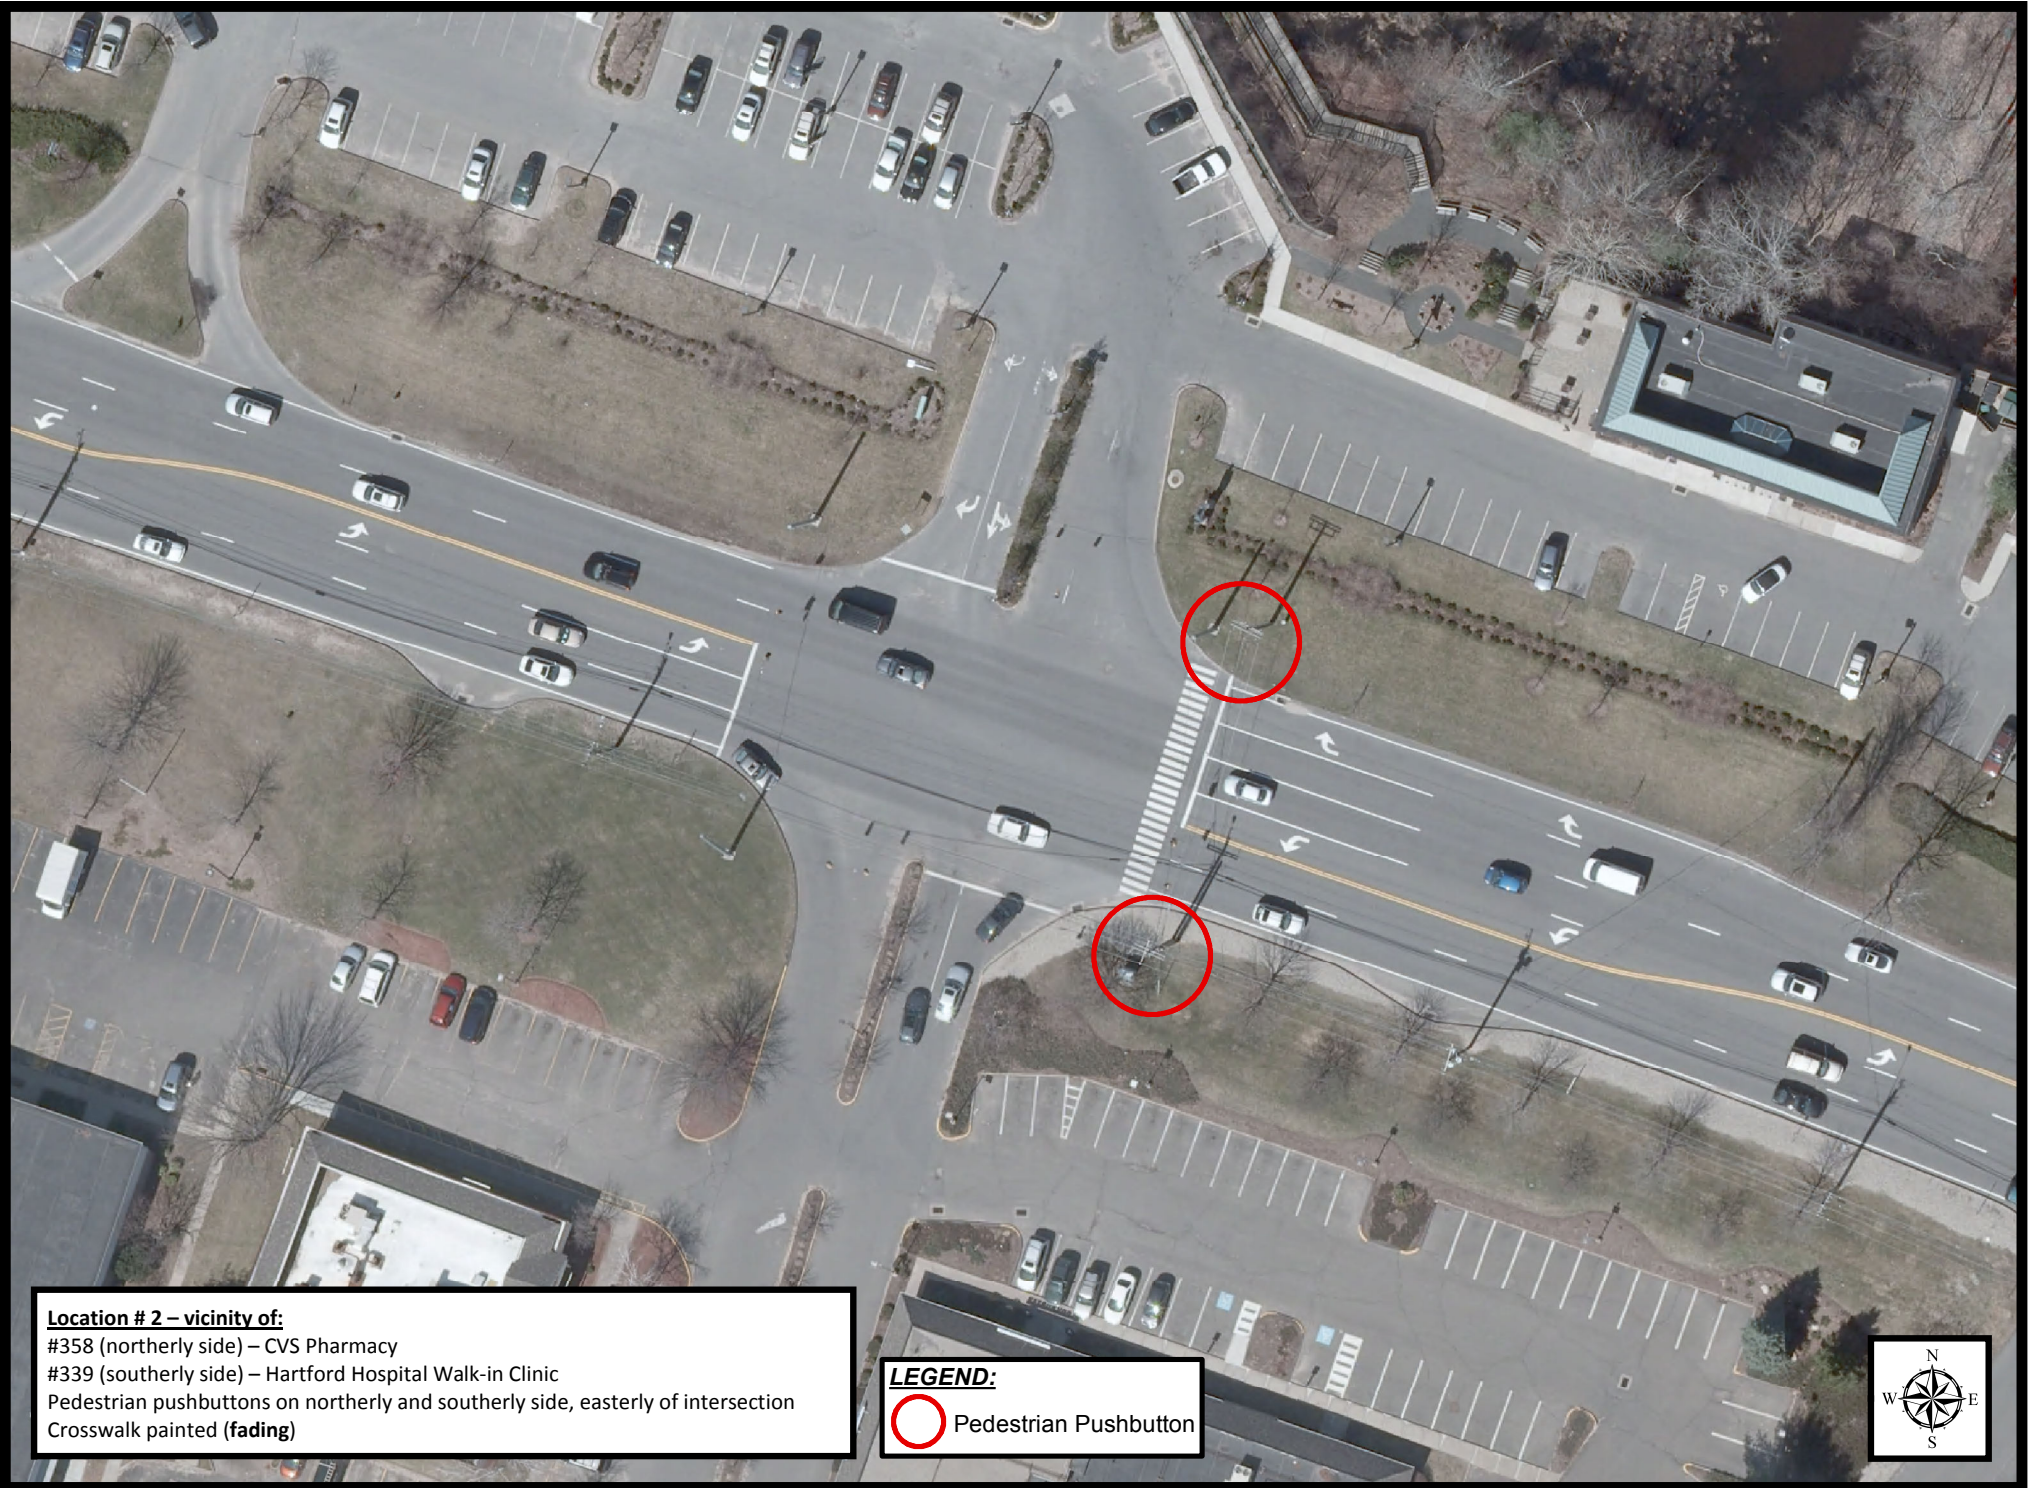
West Main Street (Route 44) - Pedestrian Pushbuttons - Location #2

#358 (northerly side) – CVS Pharmacy
