Avon

West Main Street/East Main Street (Route 44) from Dale
Road to Waterville Road – Road Safety Audit

August 25, 2016

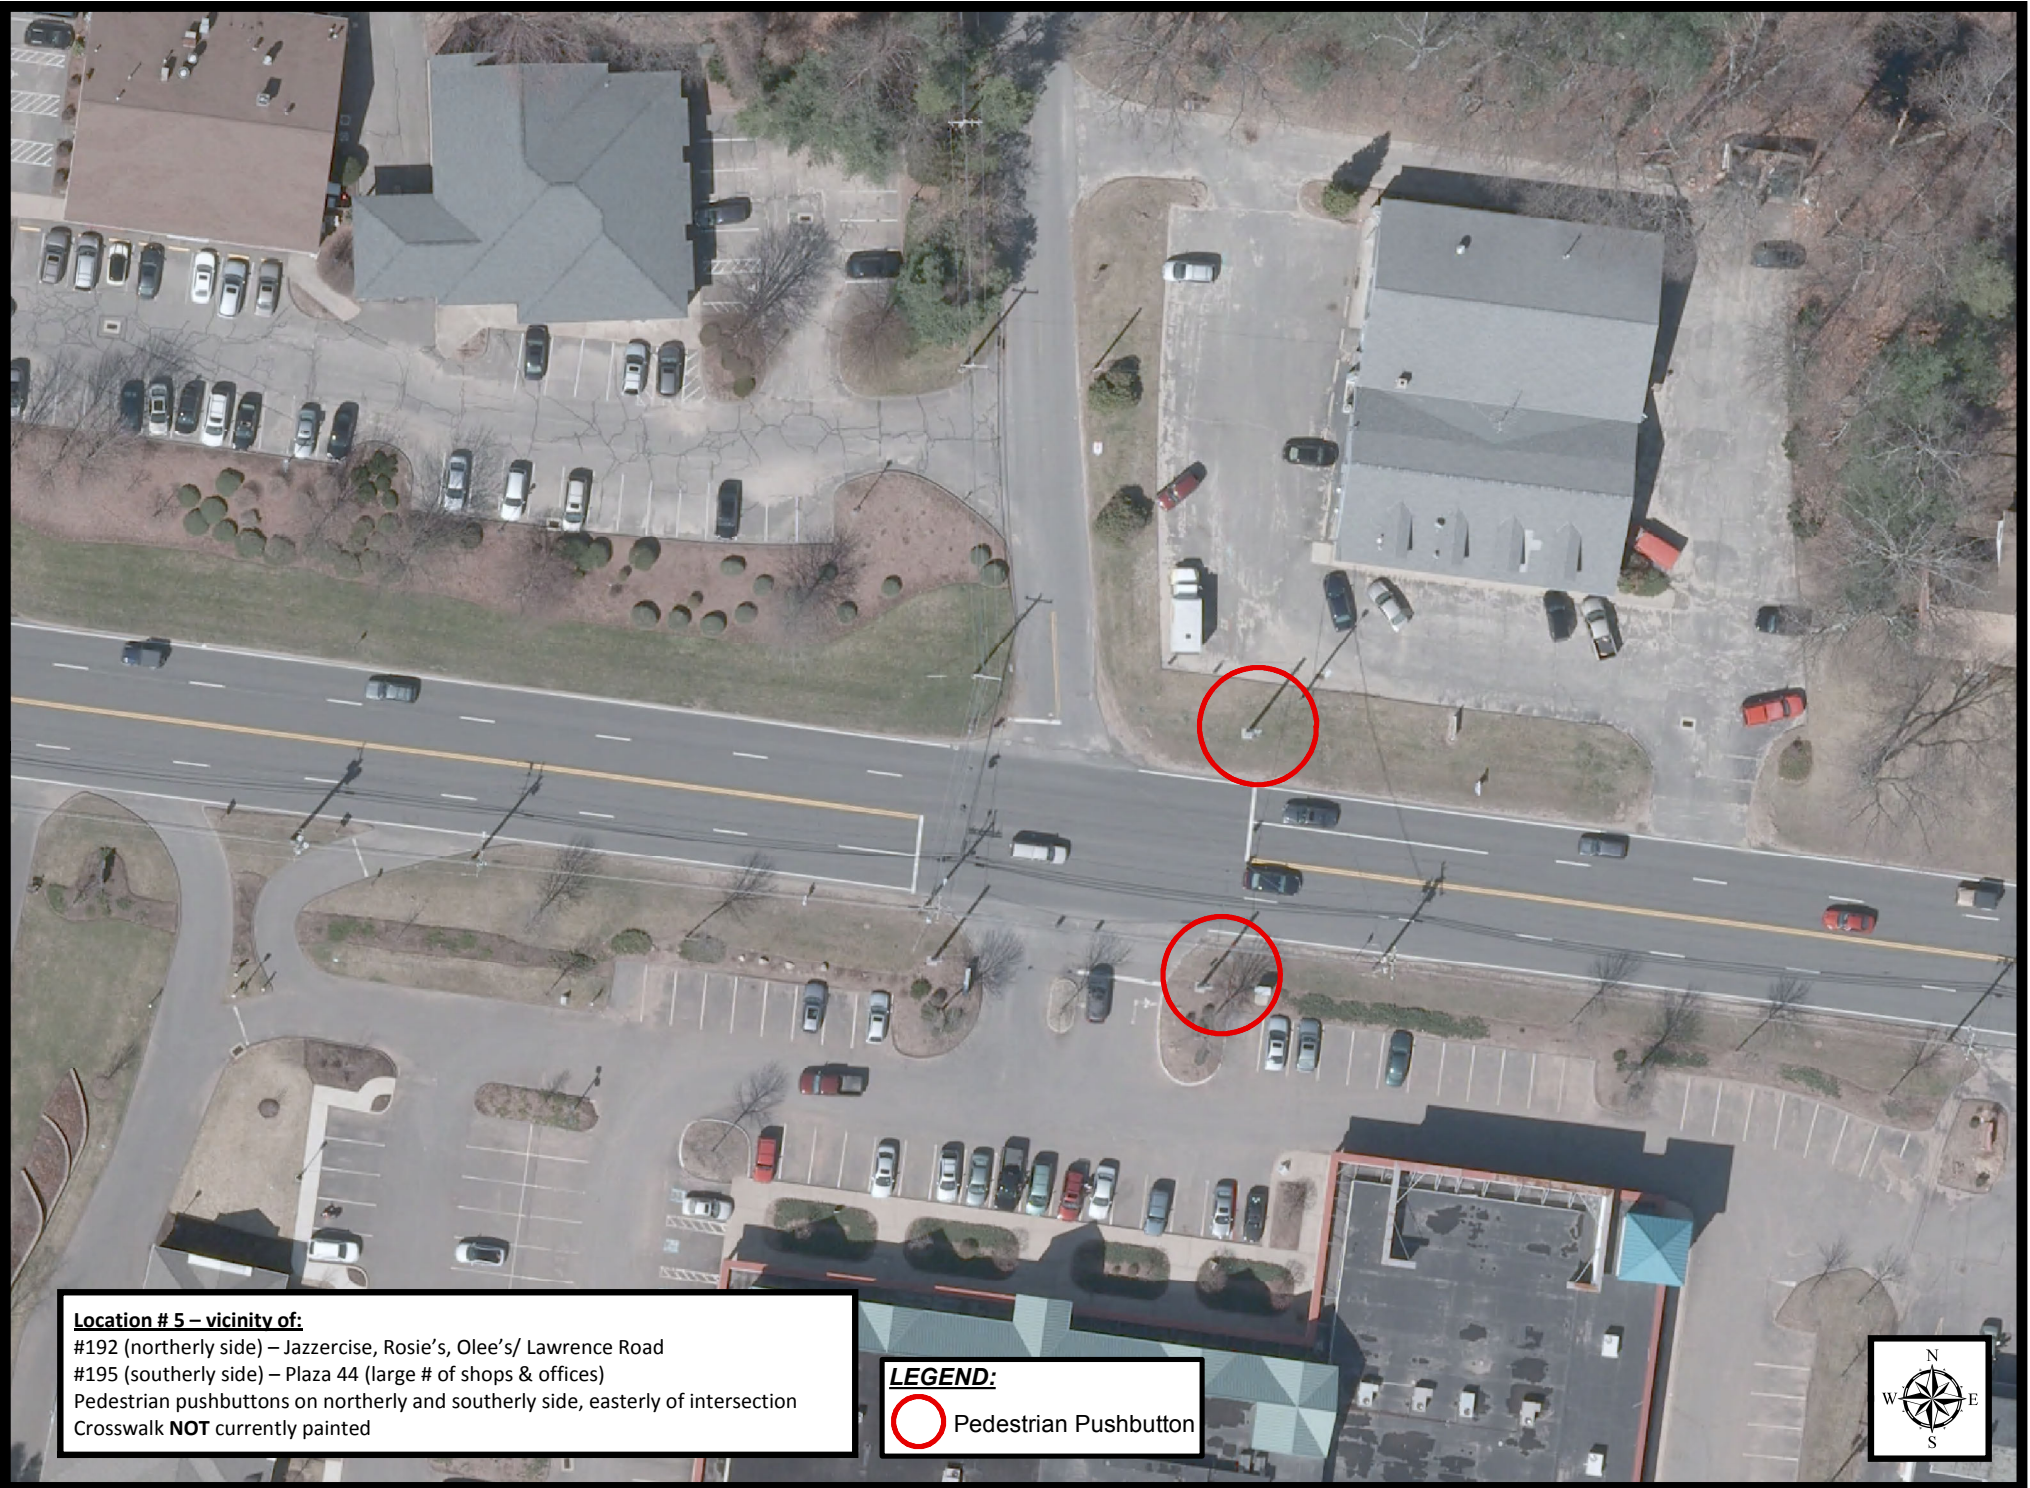
West Main Street (Route 44) - Pedestrian Pushbuttons - Location #5

#192 (northerly side) – Jazzercise, Rosie’s, Olee’s/ Lawrence Road

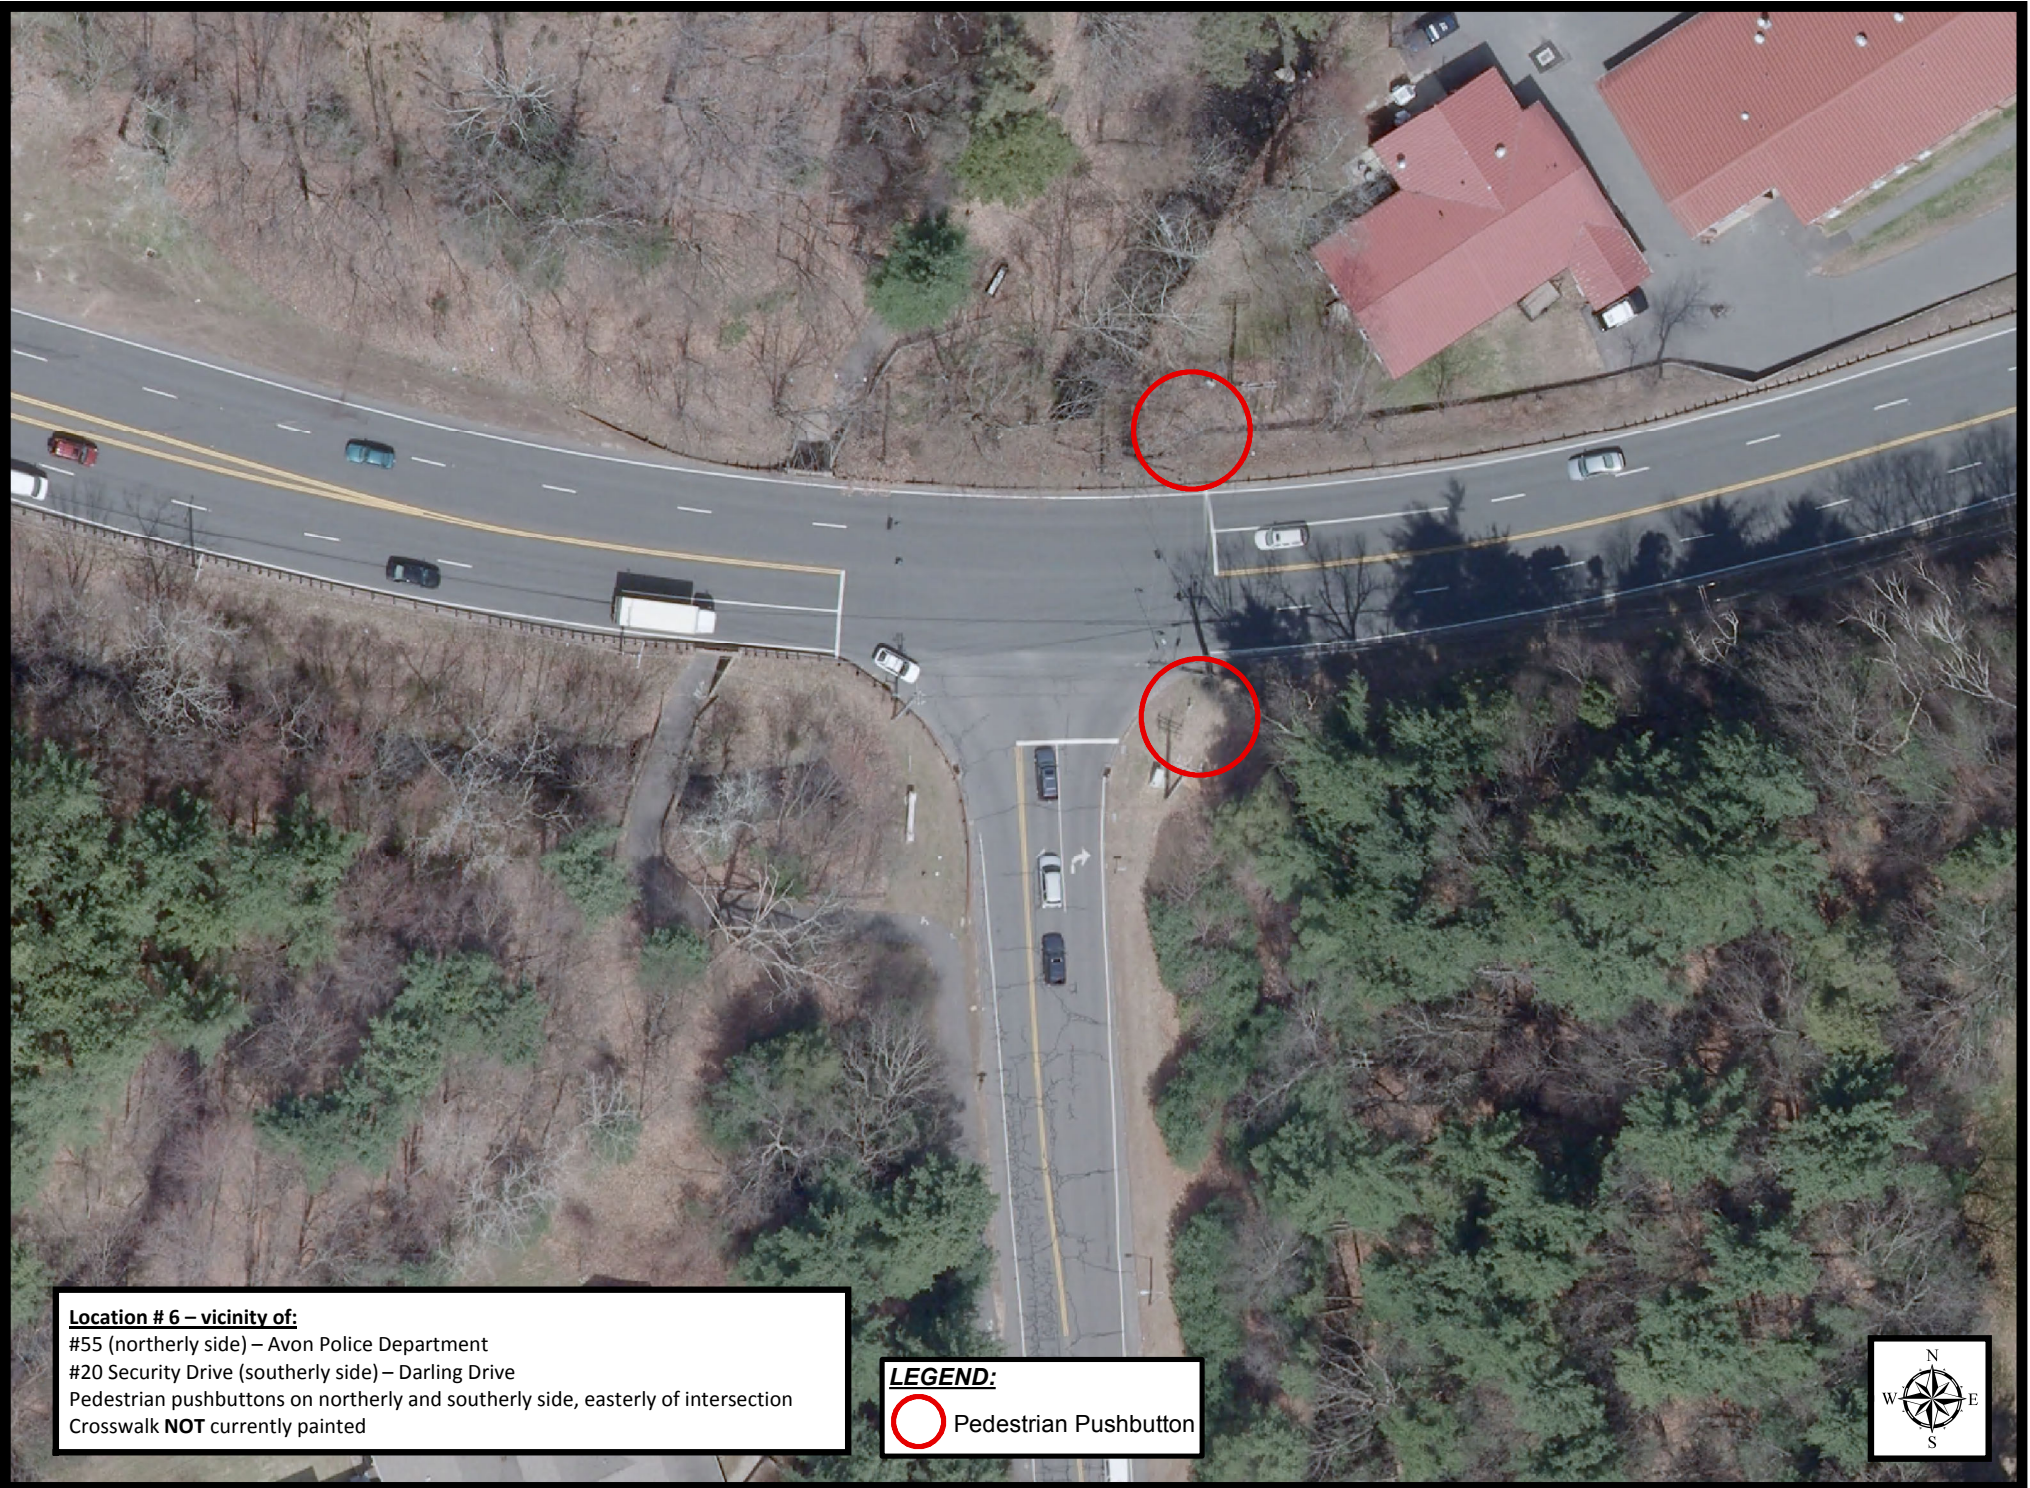
West Main Street (Route 44) - Pedestrian Pushbuttons - Location #6

#55 (northerly side) – Avon Police Department
#20 Security Drive (southerly side) – Darling Drive
Pedestrian pushbuttons on northerly and southerly side, easterly of intersection
Crosswalk **NOT** currently painted

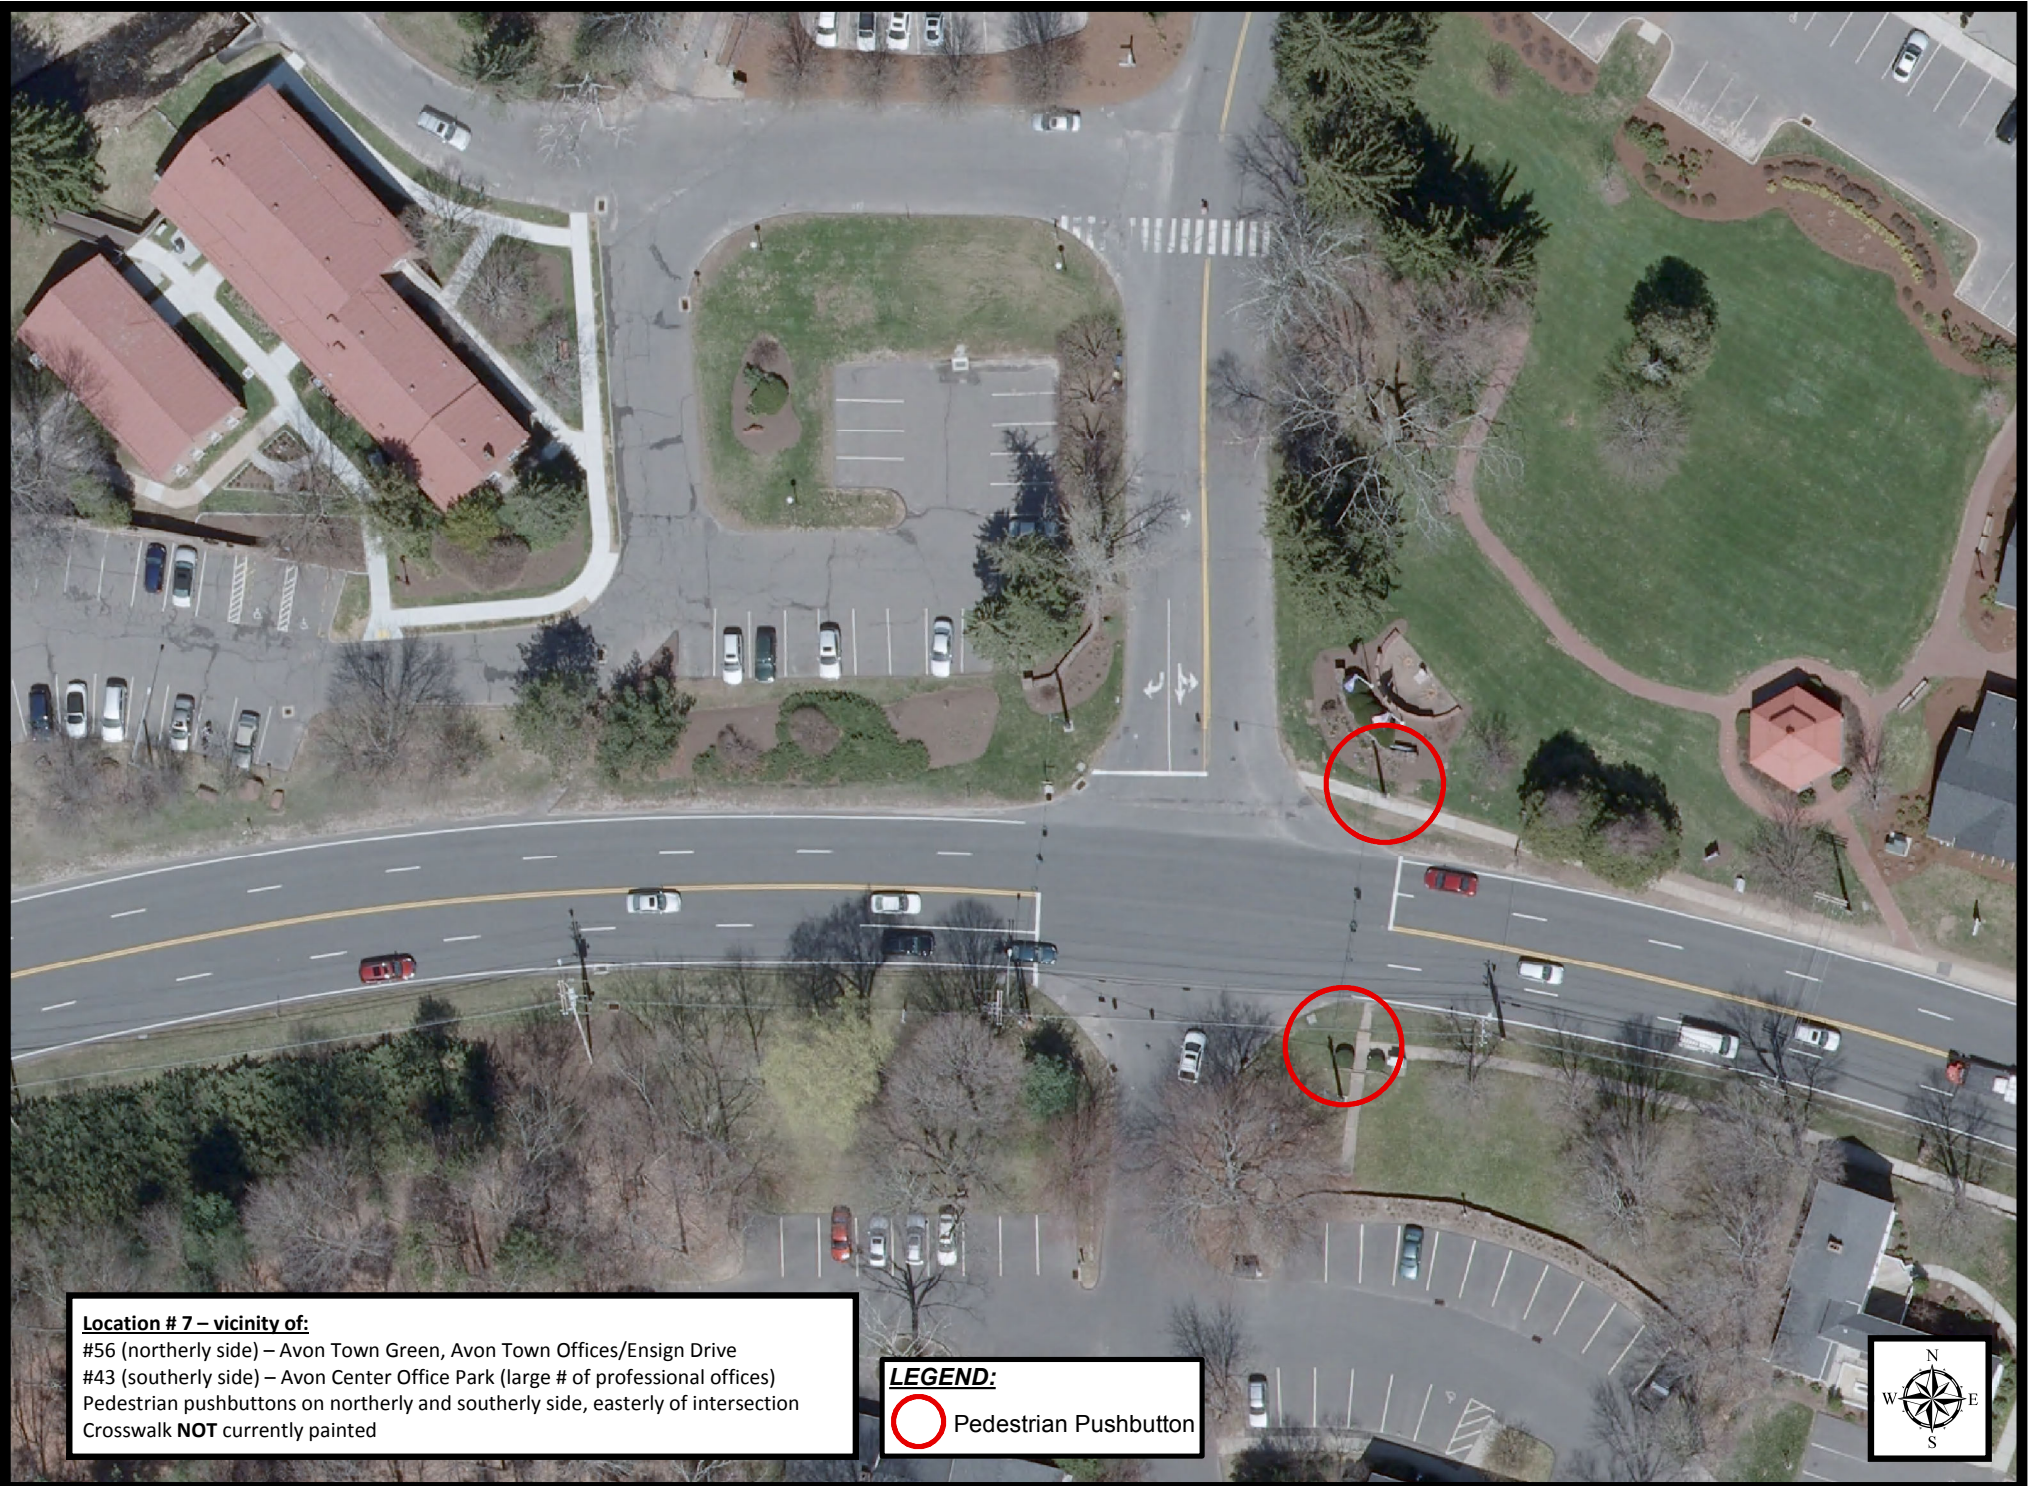
West Main Street (Route 44) - Pedestrian Pushbuttons - Location #7

#56 (northerly side) – Avon Town Green, Avon Town Offices/Ensign Drive
#43 (southerly side) – Avon Center Office Park (large # of professional offices)
Pedestrian pushbuttons on northerly and southerly side, easterly of intersection
Crosswalk **NOT** currently painted
