COMMUNITY
connectivity program

Bethany

Amity Road (Route 63) – Road Safety Audit

June 23, 2016

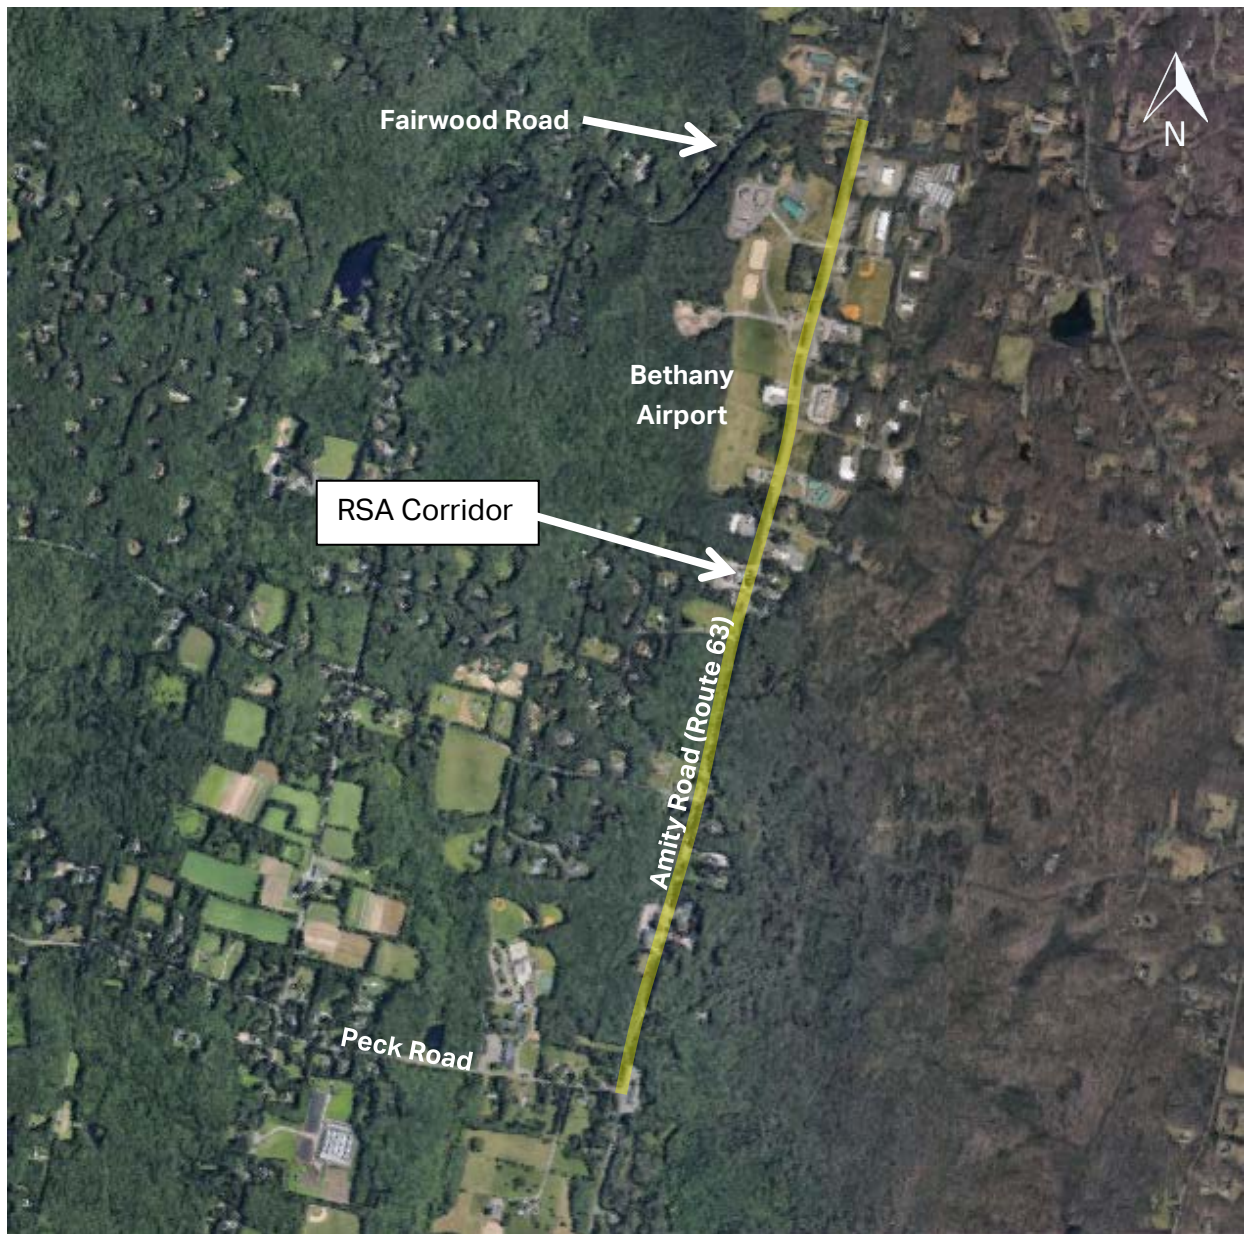
Figure 1. Location Map – RSA Corridor: Amity Road (Route 63)

The site is the 1.6 mile long section of Amity Road from Peck Road to Fairwood Road (Figures 1 and 2). The Amity Road ADT is 7,600 vehicles per day (vpd). This is an average volume of traffic for a roadway of this design to process.

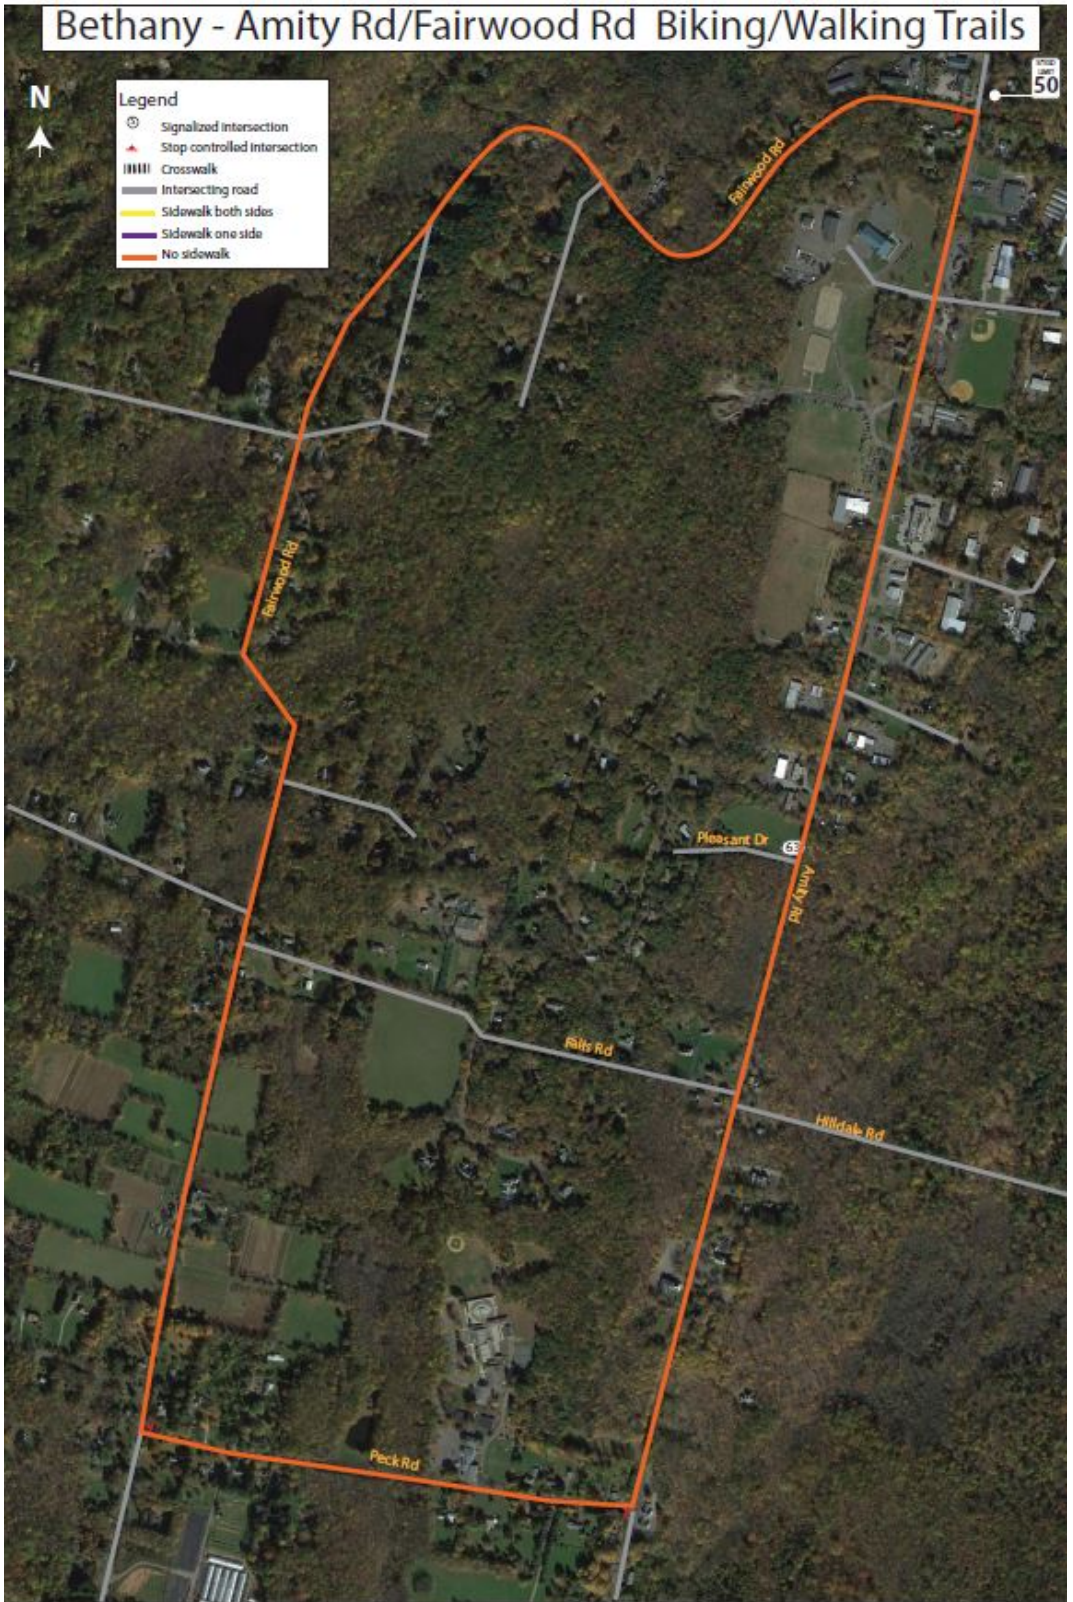
Figure 3. Amity Road (Route 63) Roadway Geometrics

The roadway consists of a single lane in each direction between 12 and 13 feet wide and shoulders that are generally 3 to 4 feet wide. In some sections of the study area, the shoulders are up to 7 feet wide or as narrow as 1.5 feet wide. There are no turning lanes and no signalized intersections in the study corridor. The roadway characteristics are summarized in Table 3.

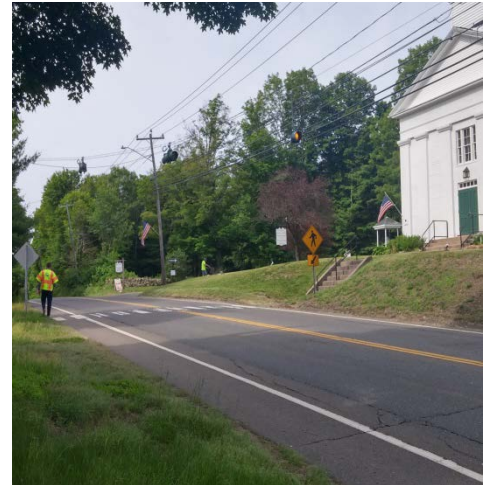
Figure 5. Flashing Beacon and Crosswalk

- There is a flashing beacon at the crest of the hill on Amity Road at the church and historical society (Figure 5).
- A crosswalk between the historical society and church is located directly under the flashing beacon (Figure 5).
- There is no landing area on the east side of the crosswalk (Figure 7).
- Vehicles traveling north on Amity Road have a poor sight line to the crosswalk.
 - Sight line measured as 290 feet.
 - Branches and bushes block the view of pedestrians waiting on the east side of the crosswalk (Figure 6).
 - If the town would like to keep a crosswalk in this area it may be more accessible to pedestrians if relocated further north on Amity Road.
- Vehicles traveling south on Amity Road have a good sight line to the crosswalk (Figure 7).
- The total road width of Amity Road was measured at 32 feet in this area.

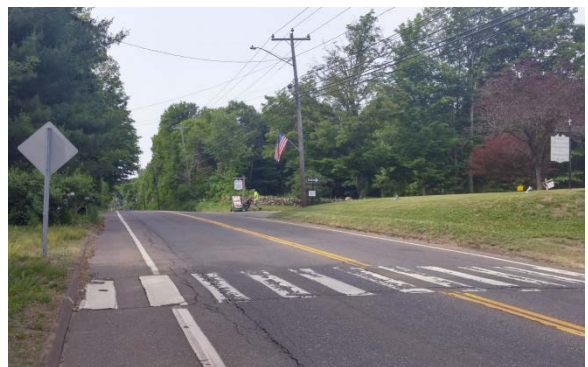
Figure 6. Poor Sightline

1. There are a number of issues regarding the crosswalk between the Bethany Historical Society and the Church of Christ:
 - a. Vehicles traveling north on Amity Road do not have a long enough sight line to this crosswalk. This is largely due to vehicles traveling uphill and the crosswalk being located after the crest of the vertical alignment of the road.
 - b. A landing area is not provided for pedestrians on the east side of the crosswalk.

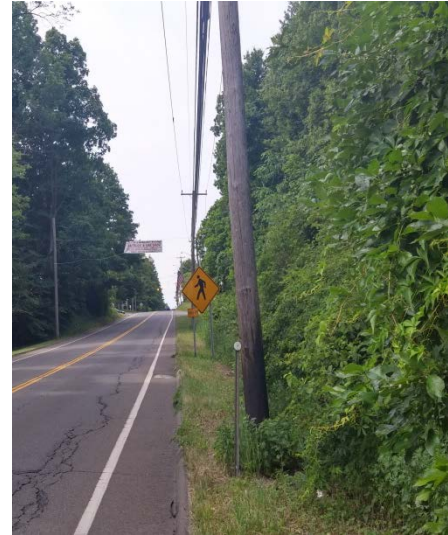
Figure 8. Utility Poles Close in on Roadway

- It was discussed that a sidewalk on the west side of Amity Road would be the preferred side if a sidewalk is desired in this area.
 - This would require the embankment on the west side in front of the church to be cut into.
 - Where the utility poles close in on the road they would need to be relocated to install a sidewalk (Figure 8).

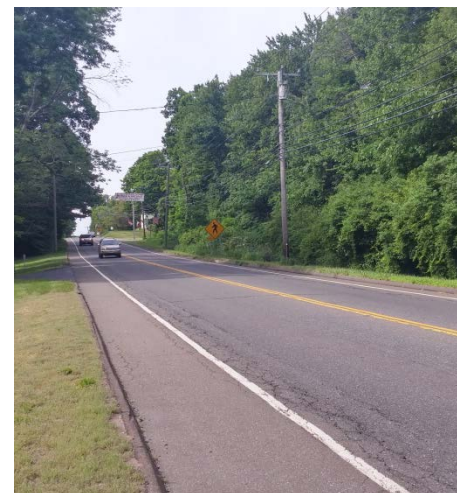
Figure 9. Good Sightlines for Northbound Traffic at Library

- It was acknowledged that a sidewalk between the church and library would be expensive due to the relocation of utilities.
- The Town may be able to extend their trail network to have an outlet across from the library.
 - May need an easement through private properties.
 - This would provide the desired connection between the school and the library.
- A goat path between the church and library could be a shorter term and less costly option to connect the two destinations.
 - The town road crew could clear brush.
 - This could be done as a community project.
- A crosswalk at the driveway to the library would have great sightlines for approaching traffic. (Figure 10 and Figure 11).

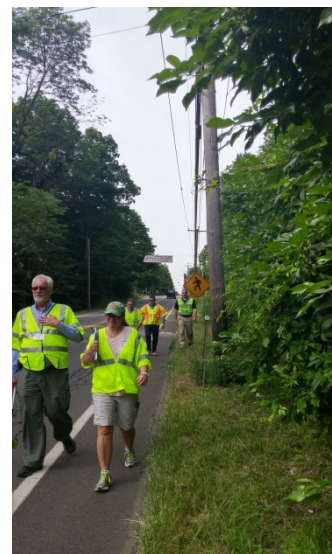
Figure 12. Walking in Shoulders to Avoid Obstacles

2. There is no pedestrian connection between the church and the library. Currently pedestrians must either walk in the shoulder of the road or on the grass on the side of the road. During the walk audit there were spots where participants had to walk in the shoulder due to signage or landscaping.
