Notch Road, Bolton Center Road, Brandy Street, Loomis Road and Hebron Road – Road Safety Audit

July 22, 2016

1 Introduction to Notch Road, Bolton Center Road, Brandy Street, Loomis Road and Hebron Road, Bolton RSA

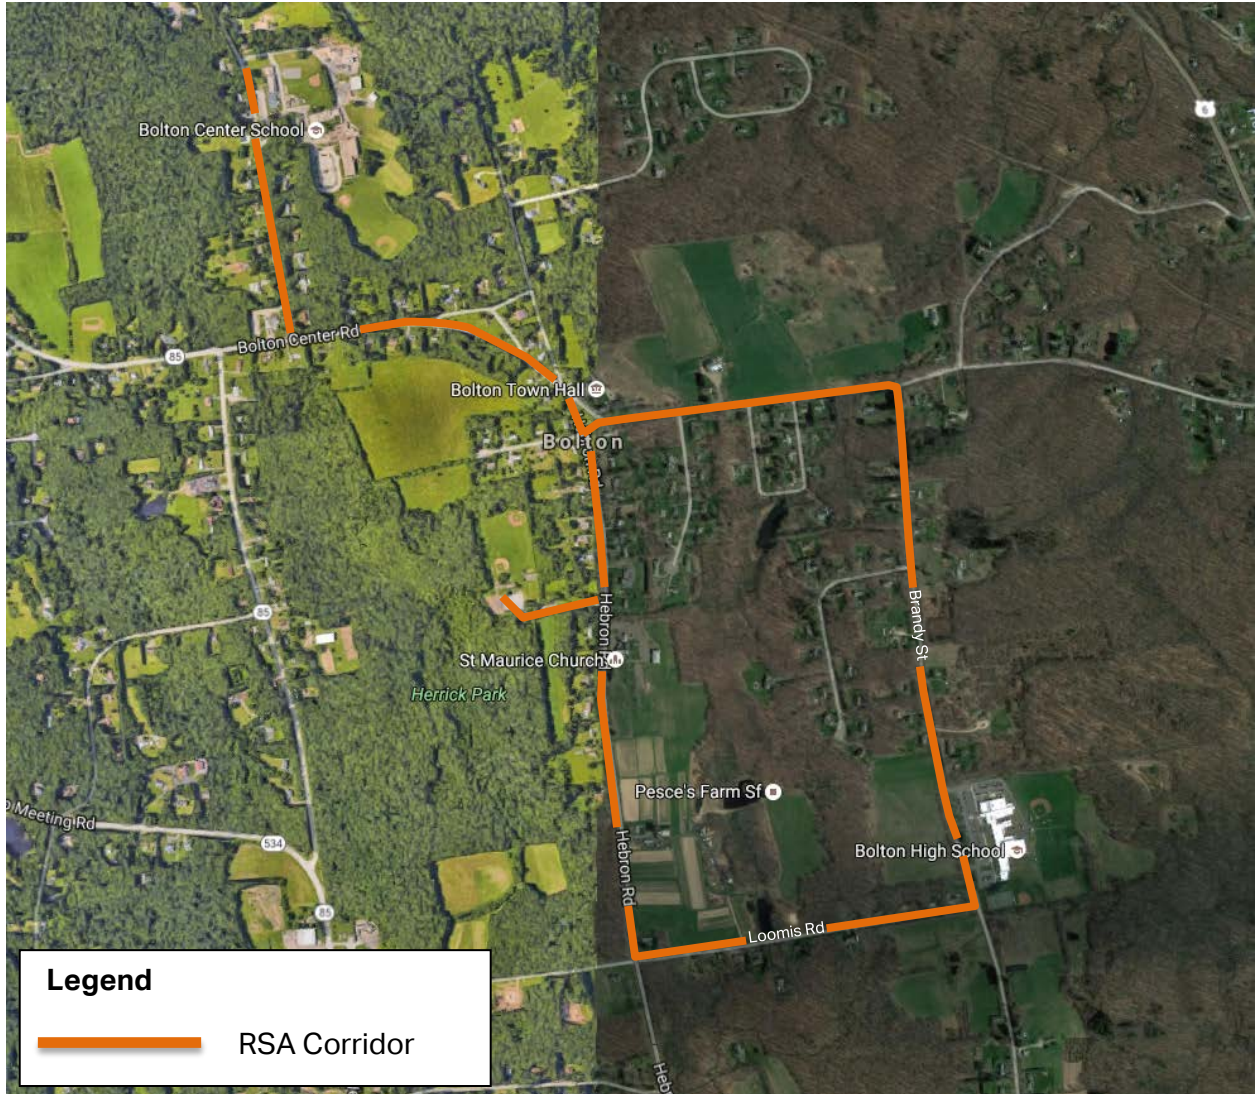
Figure 1. Notch Road, Bolton Center Road, Brandy Street, Loomis Road and Hebron Road, Bolton

The RSA corridor includes Notch Road, Bolton Center Road, Brandy Street, Loomis Road and Hebron Street (Figure 1). Figure 2 shows the study area in a regional context. Notch Road is a local road and provides north-south connection from Bolton Center Road to Routes 44, 6 and I-384 to the north. Bolton Center Road runs east-west through the town center. East of Hebron Road, Bolton Center Road is classified as a local road and west of Hebron Road, it is classified as a collector road. The Average Daily Traffic (ADT) on Bolton Center Road west of Route 85 is 6,300 vehicles per day (vpd) and east of Route 85 is 4,700 vpd. These are considered low to moderate for rural roadways. Hebron Road is a collector road and runs north-south from the town center to the Town's southern boundary line. Brandy Street is a local road and runs north-south past Bolton High School. Loomis Road is a local road and runs east-west between Brandy Street and Route 85. All the roads in the RSA corridor have single lanes in each direction. All intersections throughout the study area are controlled by stop signs.

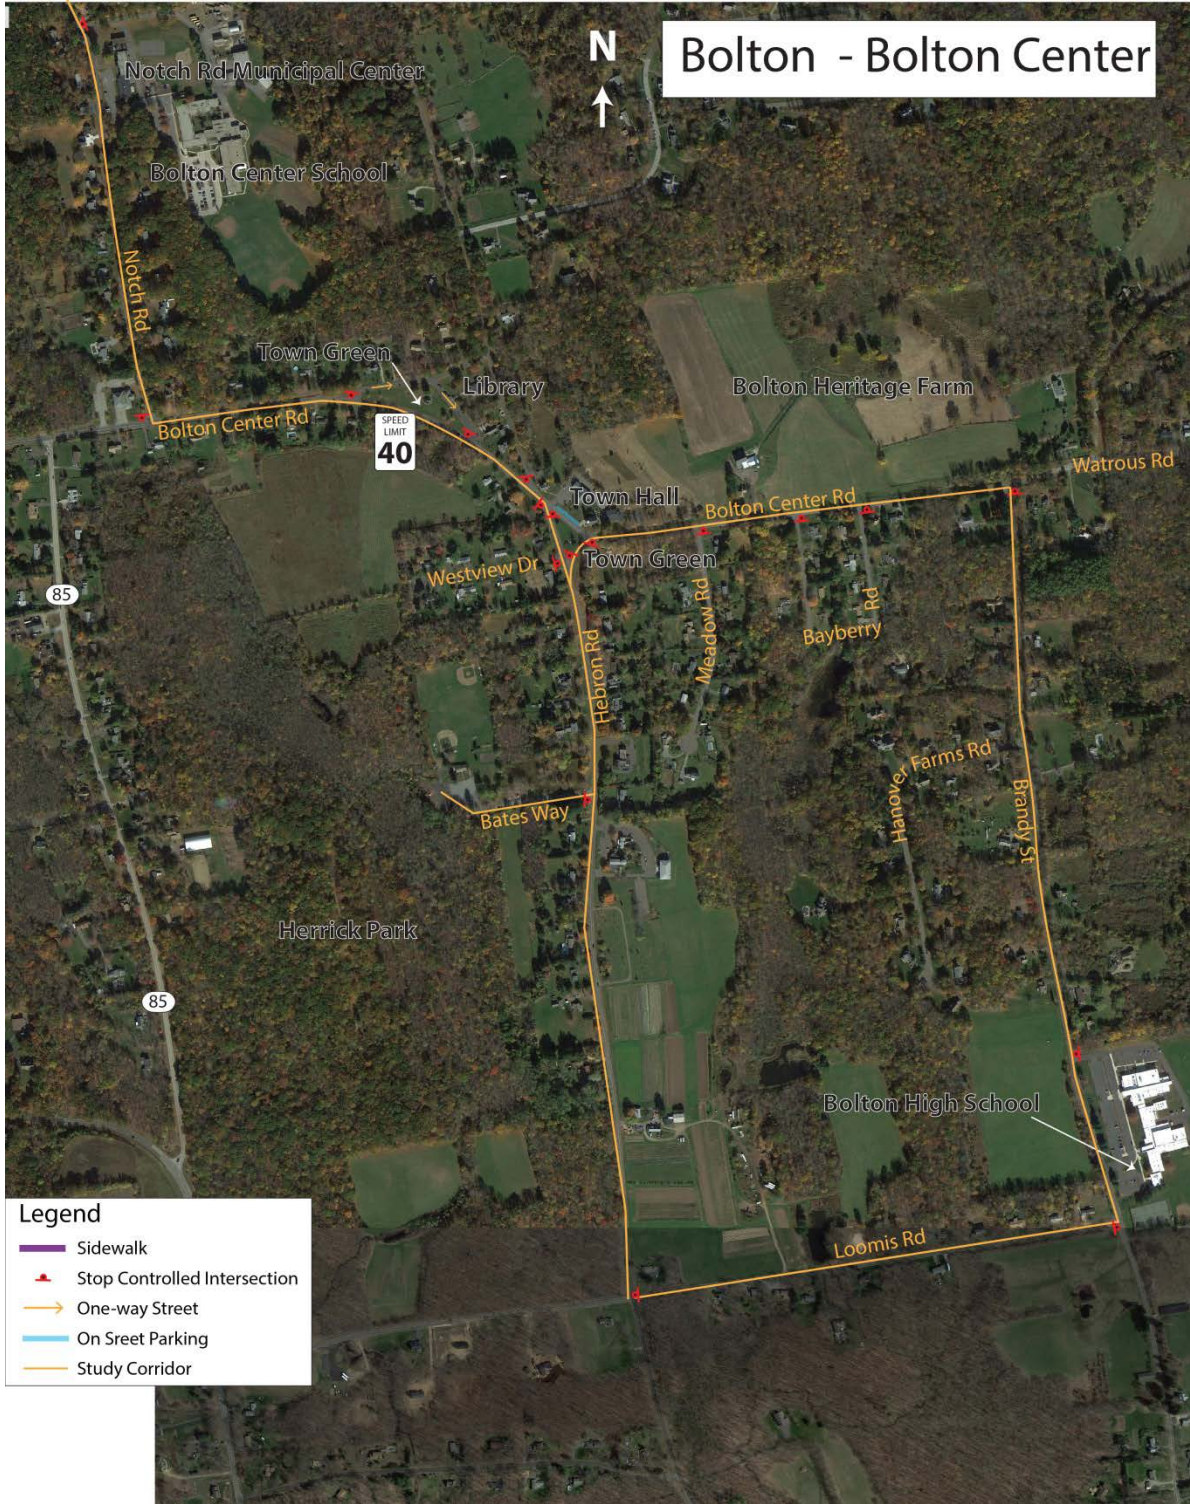
Figure 4. Notch Road, Bolton Center Road, Brandy Street, Hebron Road - Road Geometrics

Notch Road has single lanes in each direction and shoulders on both sides. The posted speed limit on Notch Road is 35 mph. At Bolton Center School, the shoulders on Notch Road are 2.5 feet wide and the travel lanes are 11 to 12 feet wide.

The intersection of Notch Road and Bolton Center Road is a T-intersection controlled by a stop sign on Notch Road. Bolton Center Road is the eastbound/westbound approach and Notch Road is the southbound approach to the intersection. Both Bolton Center Road and Notch Road have 11-foot single lanes in each direction. The Bolton Center Road west leg has 4 foot wide shoulders on both sides. The Bolton Center Road east leg and Notch Road have three-foot wide shoulders on both sides. The intersection has no crosswalk.

The intersection of Bolton Center Road and Hebron Road in front of the Town Hall is a three-way intersection controlled by stop signs on all approaches. Bolton Center Road is the eastbound/westbound approach and is classified as a collector west of Hebron Road and as a local road east of Hebron Road. Hebron Road is the northbound approach to the intersection. Bolton Center Road and Hebron Road have single lanes in each direction (11 feet wide) and shoulders on both sides. Hebron Road has four-foot wide shoulders on both sides. Bolton

Center Road has three to six foot wide shoulders on the north side and three to five foot wide shoulders on south side. On-street parking is located in front of the Town Hall along the north side of Bolton Center Road westbound approach. There are no crosswalks at this location.

Brandy Street has single travel lanes in each direction. At Bolton High School, the lanes on Brandy Street are 10 feet wide in each direction and shoulders are one-foot wide on both sides. The posted speed limit in this area is 25 mph. There are no crosswalks at this location.

The intersection of Hebron Road and Loomis Road is a four-way intersection with stop signs on Loomis Road. Hebron Road is the northbound/southbound approach with single lanes (11 feet wide) in each direction and three-foot wide shoulders on both sides. Loomis Road is the eastbound/westbound approach with single lanes (10 feet wide) in each direction and one to two-foot wide shoulders on both sides.

Roadway geometrics for study area roadways and intersections are shown in Figure 4. An inventory of existing conditions of the intersection can be found in Table 3.

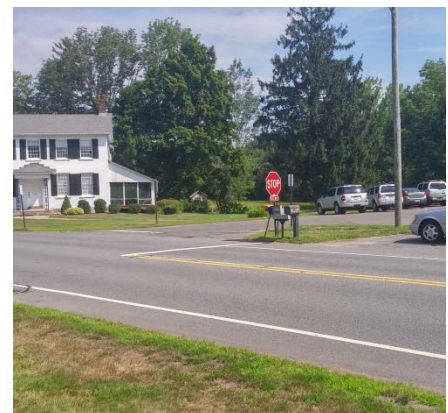
Figure 5. Bolton Center Road East Leg at Hebron Road

- The Town has a plan to realign Hebron Road and Bolton Center Road to create a T-intersection.
- A crosswalk across the Bolton Center Road east leg would be beneficial (Figure 5):

- There would need to be advanced pedestrian crossing signage installed.
 - On-street parking in front of the Town Hall would need to be shifted east or one space may need to be removed.

1. Stripe a crosswalk across the east leg of Bolton Center Road at the intersection of Hebron Road:
 - a) Move the stop bar back to make room for crosswalk.

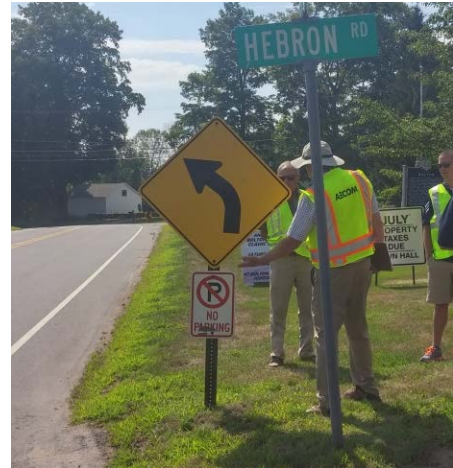
Figure 6. Low Mounted Street Sign

- Drainage is not a concern in the town center area.
- All signs in the town center are mounted below seven feet (Figure 6).
- The stop sign on the Hebron Road approach is set far back from the intersection (Figure 7).

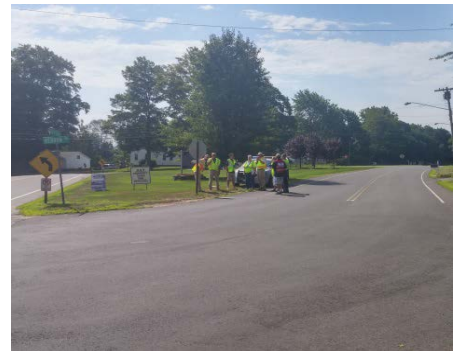
Figure 7. Hebron Road Approach Stop Sign

- If moved up it would force drivers to come to a stop at the intersection.
 - Currently drivers do not stop at this stop sign if there is no oncoming traffic.

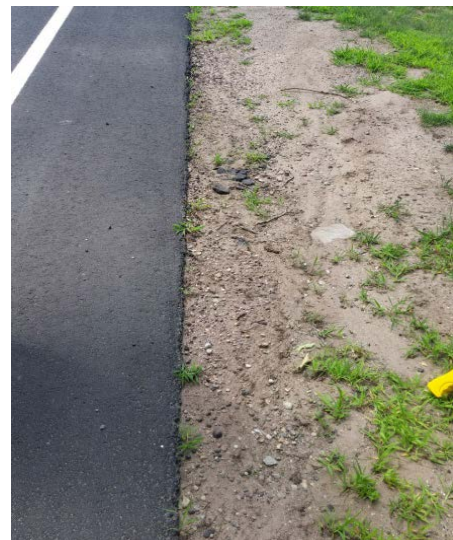
Figure 8. Drainage Issue on Notch Road

- There were multiple drainage issues identified within the study area:
 - The west side of Notch Road in the vicinity of the Fire Department;
 - The open drainage on the south side of Bolton Center Road in front of the Fire Department;

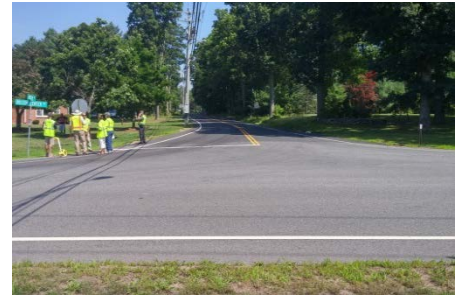
Figure 9. Intersection of Notch Road and Bolton Center Road

- At this location on Notch Road the shoulders are three feet wide and the travel lanes are 11 feet wide.
 - A three foot shoulder is the minimum for a bike to use the shoulder.
- There is a drainage issue on the west side of Notch Road (Figure 8).
- The stop bar on Notch Road is set back from the intersection with Bolton Center Road, which limits sight distance.
- The lane at the stop bar widens significantly and drivers treat it as two lanes (right and left turn onto Bolton Center Road) (Figure 9).
- The intersection is wide. Across the opening of Notch Road at Bolton Center Road it is 112 feet wide.
- An open drainage ditch on the south side of Bolton Center Road is in the recovery area (Figure 10).

- The intersection of Notch Road and Bolton Center Road is wide with a large turning radius. This allows drivers to turn onto Notch Road at high speeds. In addition, the Notch Road approach to Bolton Center Road is wide which allows vehicles to use the lane simultaneously for right and left turns.

7. Restripe the Notch Road approach at Bolton Center Road to reduce the approach to one lane wide and increase the shoulder width. Move up stop bar.
8. Repaint the stop bar on the Bates Way approach to Hebron Road.

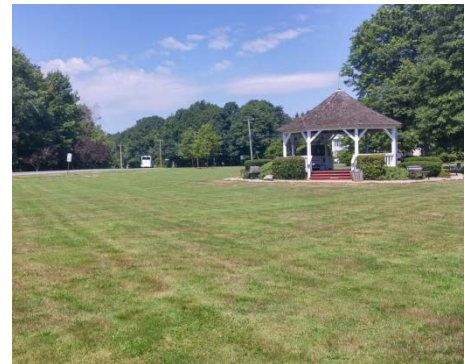
Figure 11. Bentley Memorial Library and Green

- The Town frequently hosts community events on the green such as concerts and markets (Figure 11).
 - The green is often wet so vehicles cannot park on it.

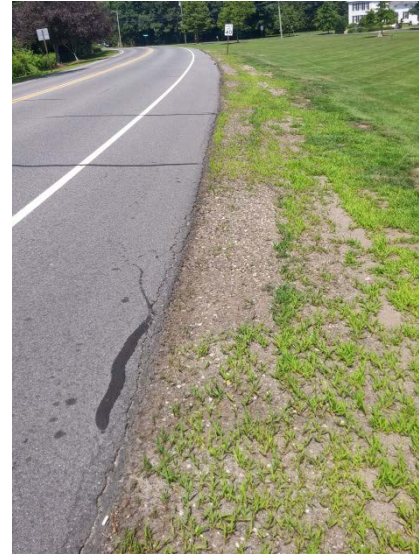
Figure 12. Drainage Issues by Library Green

- Cars park on surrounding side roads during events.
- The library has a bike rack.
- There are drainage issues on the Bolton Center Road side of the green (Figure 12).
- Old Bolton Road is a one-way street and the stop sign intersection with Bolton Center Road has limited visibility for left turns due to posts with reflectors.
- Reflectors on posts along with chevrons make Bolton Center Road feel like a highway and the Town will look into removing them.
- The Town does not want to install concrete sidewalks, but would like a connection between library green and the Town Hall area with a crushed stone, gravel or stone dust path.
 - There may be concerns about vehicles parking on any created gravel path.
 - A buffer can be left between the pathway and road to discourage parking.

- The north side of Bolton Center Road bordering the Bentley Memorial Library and Green;
 - Both sides of Brandy Street in the vicinity of Bolton High School.

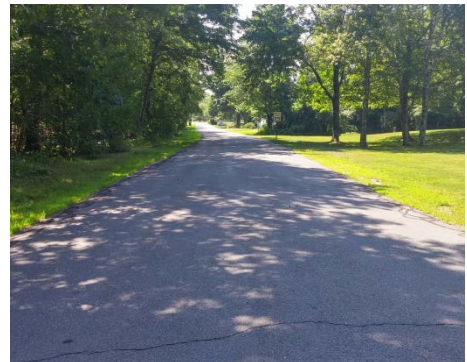
Figure 13. South Toomey Road Cross Section

- Once connection is made, wayfinding could be installed to guide pedestrians to the preferred route.
- Traffic volume and speeds on Toomey Road are low so no formal bicycle and pedestrian facilities are needed.
- Two of the three approaches have a stop control at the intersection of Toomey Road and Summer Road.
- The width of Toomey Road is 21.5 feet with no centerline, shoulder or curbing (Figure 13).

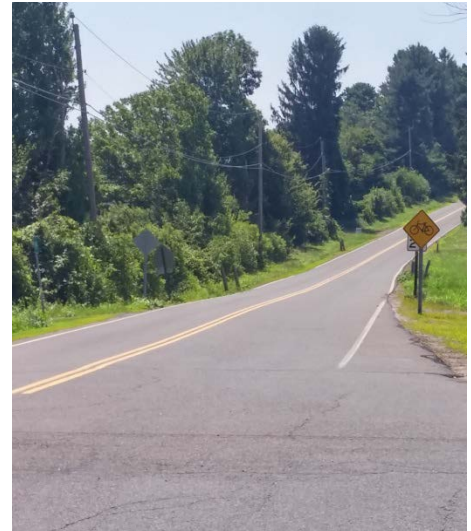
Figure 14. Bike Route Signage on Brandy Street

- Brandy Street has 10-foot wide travel lanes and one-foot wide shoulders.
- The shoulder lines are faded.
- The speed limit in this area is 25 mph.
- There is bike route signage (Figure 14).
- There are drainage issues on the road side.
- There are good sightlines in front of the high school.
- Consider adding crosswalks and school ahead signage.

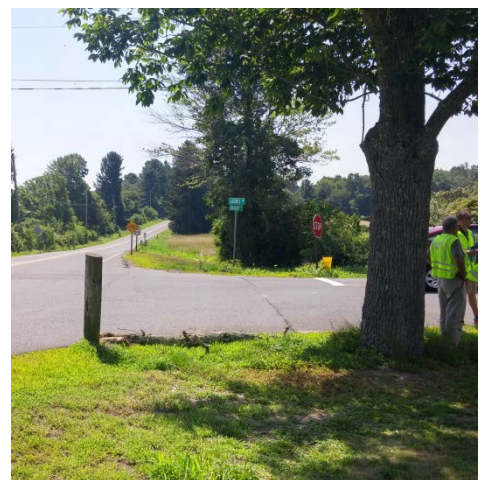
Figure 15. Loomis Road Approach Stop Bar at Brandy Street

- The stop bar for the Loomis Road approach is set back and sightlines are blocked by the tree on the northwest corner (Figure 15).
- Loomis Road lane widths consist of 10-foot travel lanes and one foot shoulders.
- Loomis Road is flat and straight which encourages speeding. Consider striping narrower lanes (Figure 16).

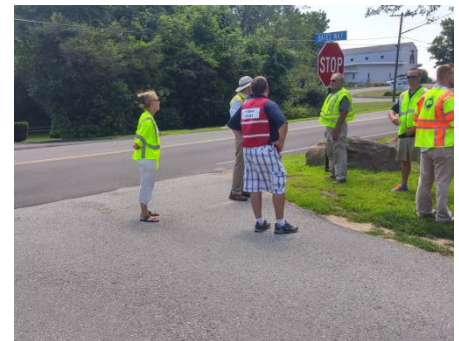
Figure 17. Bates Way Faded Stop Bar

- Faded stop bar paint on Bates Way approach (Figure 17).
- Hebron Road at this location includes 11-foot travel lanes with two-foot shoulders (Figure 18).
 - Consider striping narrower lanes to 10-foot travel lanes which would increase the shoulders to three feet wide.
 - Further north on Hebron road near the curve the widths change to 11 and 11.5-foot travel lanes with 12 and 18 inch shoulders.

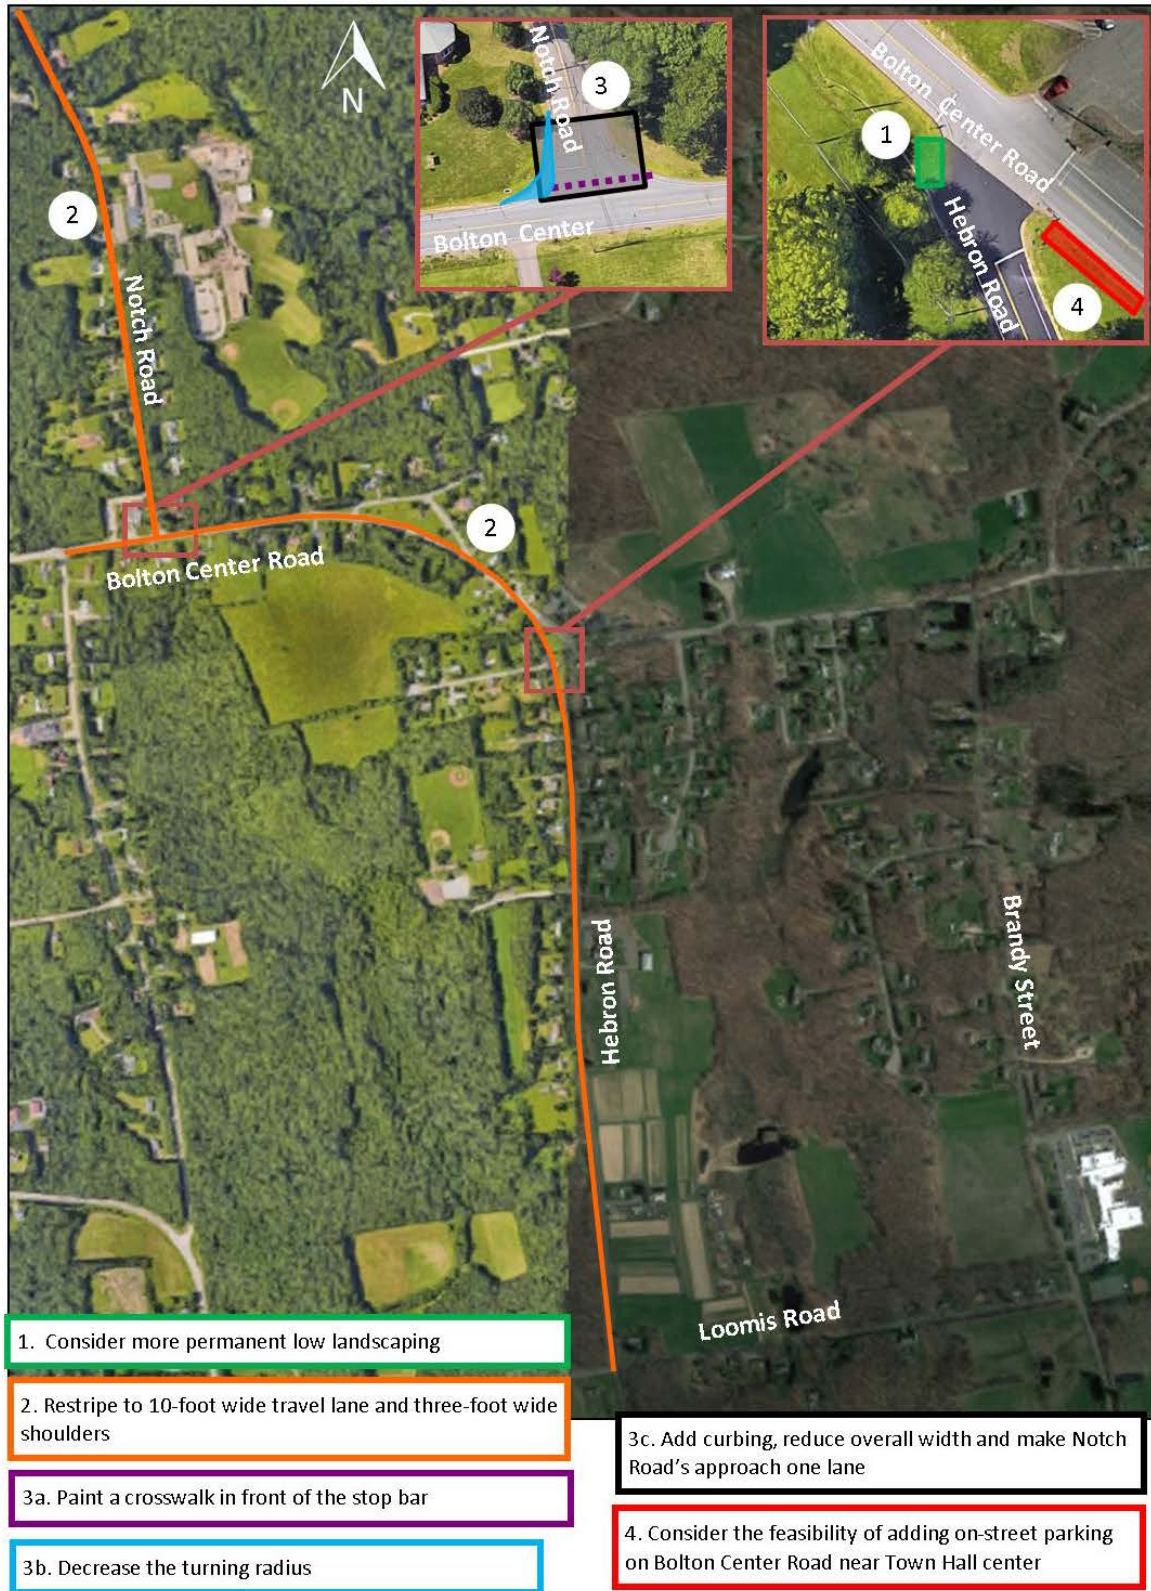
Figure 21. Medium Term Recommendations

Figure 21 depicts some of the recommendations.

1. If the temporary streetscaping on the southwest corner of the intersection of Hebron Road and Bolton Center Road is successful consider implementing more permanent low landscaping.
2. Restripe the following roads within the study area to 10-foot travel lanes and three-foot shoulders where possible:
 - a. Hebron Road;
 - b. Bolton Center Road where Route 85 turns right near the Fire House;
 - c. Notch Road.
3. At the Notch Road intersection with Bolton Center Road:
 - a. Paint a crosswalk in front of the stop bar.
 - b. Decrease the turning radius.
 - c. Add curbing to tighten intersection, reduce overall width and make Notch Road's approach one lane.
4. After evaluation of possible effects on the Green, consider the feasibility of adding on-street parking on Bolton Center Road near Town Hall center as a passive traffic calming measure.

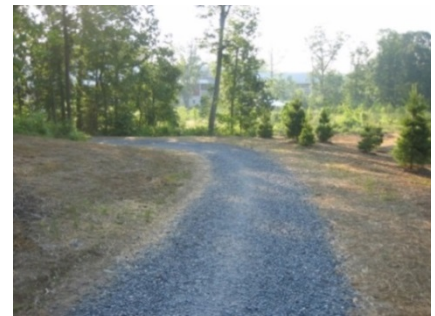
Figure 22. Gravel Path

2. Evaluate the possibility of replacing the stop controlled intersection of Bolton Center Road and Hebron Road with a roundabout.
3. Construct gravel paths (Figure 22) to complete connections between popular town destinations. Pass a town policy that states that residents do not need to maintain the path in front of their property and that the Town will not maintain the path during the winter.
