Bozrah

Fitchville Road (Route 608) – Road Safety Audit

August 30, 2016

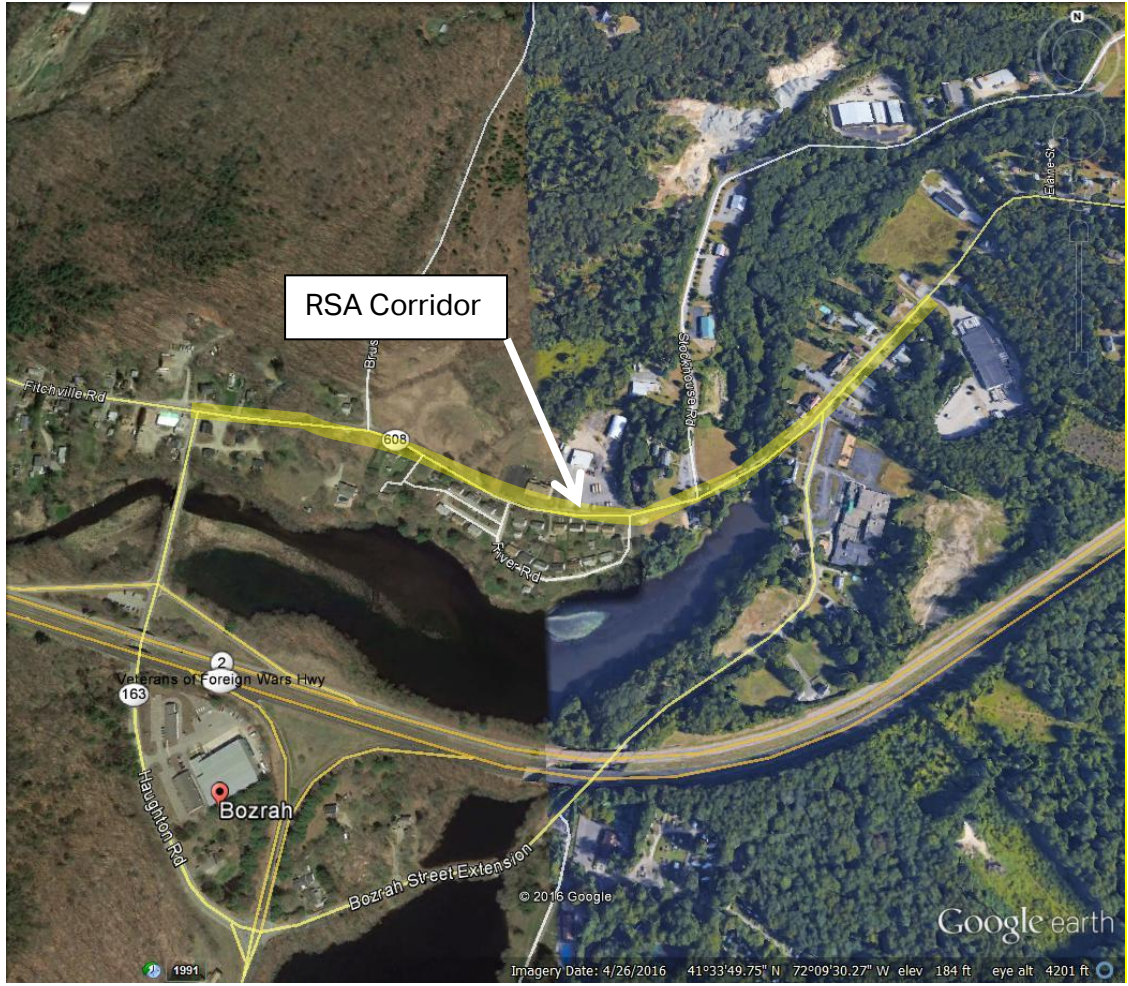
Figure 1. Fitchville Road (State Route 608), Bozrah

The RSA site is the section of Fitchville Road (State Route 608) between Haughton Road (State Route 163) and the post office at 181 Fitchville Road (Figure 1). The Average Daily Traffic (ADT) on Fitchville Road near the Haughton Road intersection is 2,700 vehicles per day (vpd). Fitchville Road consists of a single 11-foot wide lane in each direction, separated by a double yellow center line. There are striped shoulders on each side of the road, with widths that vary from one foot to over four feet.

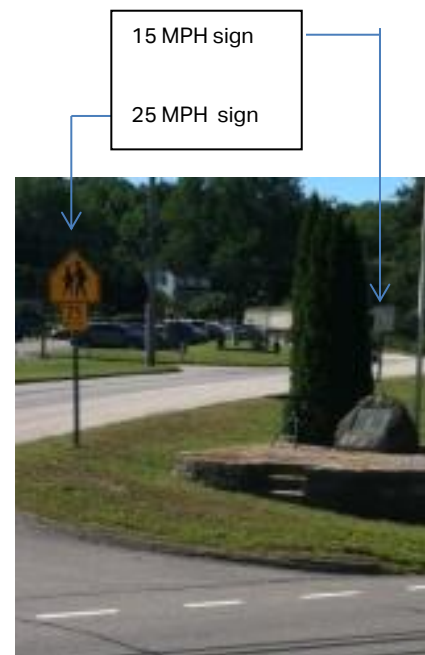
Figure 5. Conflicting Speed Limit Signage

- There is conflicting speed limit signage on Bozrah Street Extension (**Error! Not a valid bookmark self-reference.**).
- The existing alignment of the intersection is awkward with Bozrah Street Extension meeting Fitchville Road at a severe skewed angle.
 - The stop sign and stop bar are not aligned currently, likely due to the skew alignment.

8. Town to request CTDOT to replace faded signs with new retro-reflective signs and to provide pedestrian advance warning signs for the crosswalk west of Bozrah Street Extension.

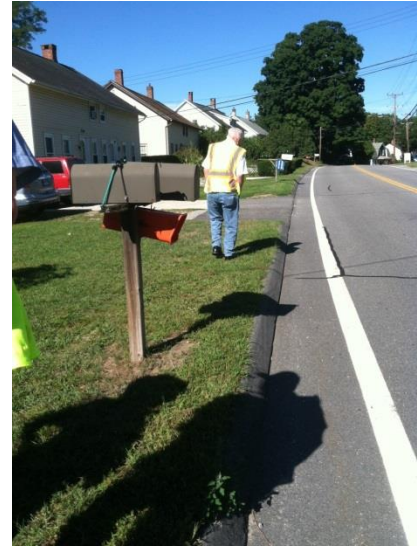
Figure 6. Mailboxes in Conflict with Future Sidewalk

- There are mailboxes within the area where a sidewalk is proposed that will need to be addressed through coordination with the postal service (Figure 6).

- Evaluate the needs for different crossing treatments for pedestrian safety based on sight distance and other constraints.
 - Coordinate the locations of mailboxes with the post office.

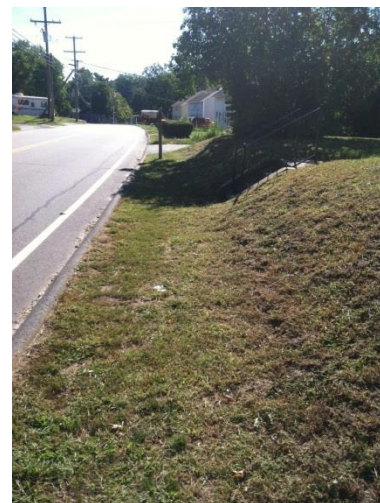
Figure 7. Flat Area across from Fire Department

- All catch basin grates appeared to be bicycle friendly.
- The pavement on Fitchville Road appears to be in good condition.
- The flat section at the bottom of the slope across from the Fire Department is approximately five to six feet wide. This could indicate where the state right-of-way ends (Figure 7).

6. Town to coordinate with CTDOT to research the right-of-way boundaries along Fitchville Road.
7. Town to coordinate with CTDOT to investigate the cause of the sinkhole that is on the north side of Fitchville Road just west of the bridge.

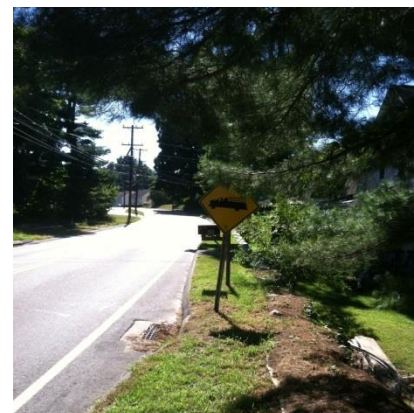
Figure 8. Older Signs Lacking Retro-Reflectivity

- At 305 Fitchville Road there is an existing culvert crossing that may need to be addressed if a sidewalk conflicts with the culvert end.
- Several of the signs on Fitchville Road appear to be old and are lacking retro-reflectivity (Figure 8).

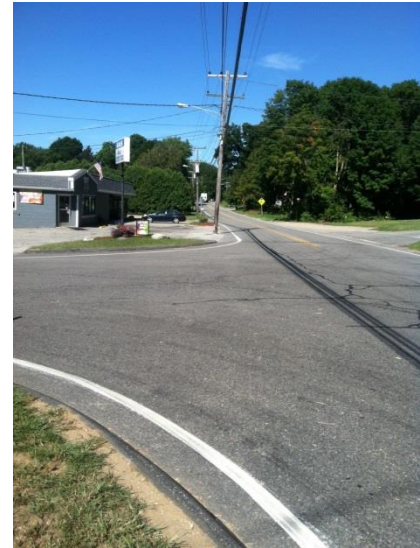
Figure 9. Houghton Road/Fitchville Road Intersection

- State right-of-way appears to be sufficient for a sidewalk based on the locations of utility poles and driveway aprons but should be investigated.
- A new pedestrian crossing at the Houghton Road/Fitchville Road intersection would be long due to the large curb radii (Figure 9).
- There are no pavement markings on Stockhouse Road.
- The distance between the wall at 213 Fitchville Road and the curb is approximately 15 feet, which would provide adequate space for a sidewalk.
- Several catch basins in the vicinity of the Fire Department are restricted by debris that has collected in their grates (Figure 10).
- In some areas, utility wires are in close proximity to tree branches.
- Three pedestrians were observed walking along the shoulder and in the grass on Fitchville Road.
- A group of three cyclists were observed on Fitchville Road traveling eastbound.

- Consider new street lighting in coordination with new sidewalk.
 - Coordinate with CTDOT to consider a flashing traffic beacon at Fitchville Road/Houghton Road to increase driver awareness.

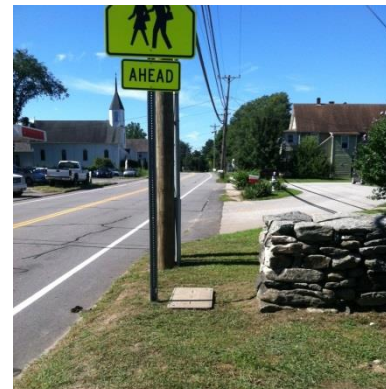
Figure 12. Stone Wall Pinch Point

- There is a pinch point at 185 Fitchville Road where a proposed sidewalk could be in conflict with a stone wall, utility pole and electric vault (Figure 12).

- Reconstruct the sidewalk in front of the Fitchville Rest Home (187 Fitchville Road) with a curb.
 - Relocate the existing electrical vault at the end of the stone wall at 185 Fitchville Road to alleviate the pinch point.

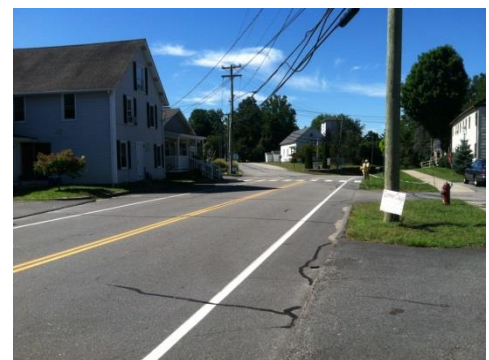
Figure 13. Skewed Intersection

- The Fitchville Road intersection with Bozrah Street Extension is awkward and difficult to navigate for all users (Figure 13). There are short-term (pavement markings) and longer term measures that can be considered to improve operations and safety.
- Consider a new sidewalk on the south side of Bozrah Street Extension at the school.
- The stone wall on the south side Fitchville Road at the church is deteriorating. The Town will need to contact CTDOT to request a structural evaluation.
- A crosswalk across Haughton Road would be long due to the large curb radii needed to accommodate truck traffic through the intersection. A flashing beacon for traffic can be considered.

1. Add striping to the Bozrah Street Extension intersection with Fitchville Road to channel vehicles to the correct locations. Relocate stop bar.

2. Evaluate long term improvements to the Bozrah Street Extension/Fitchville Road intersection such as installation of a mountable/flush median island (Figure 18) or revised geometry such as a standard T-intersection alignment.

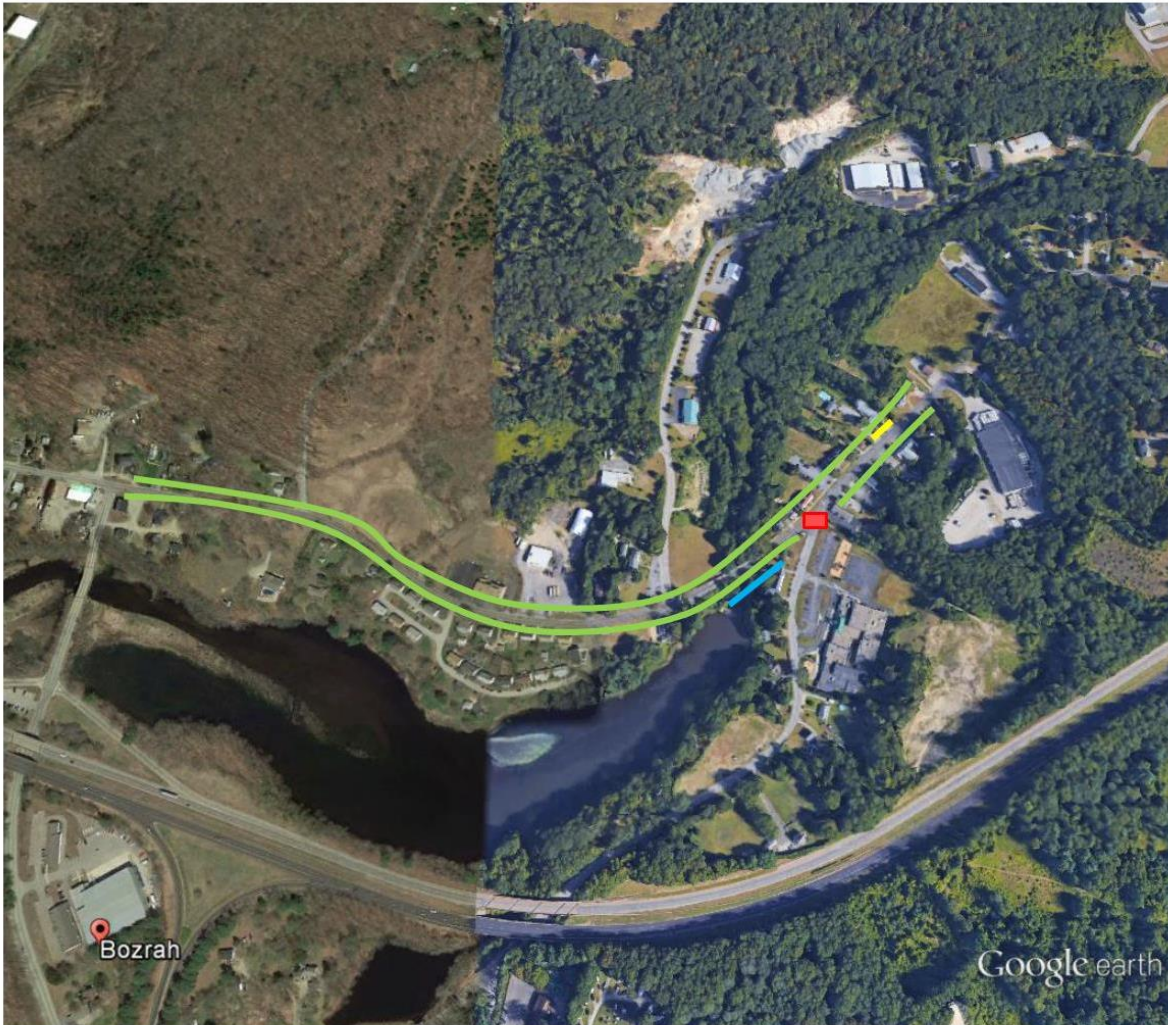
Figure 15. Short Term Recommendations

Clear and Grub (#2)

Add Striping (#1)

Replace worn-out signs and add advance pedestrian warning signs (#8)

Evaluate the structural condition of existing stone retaining wall (#11)

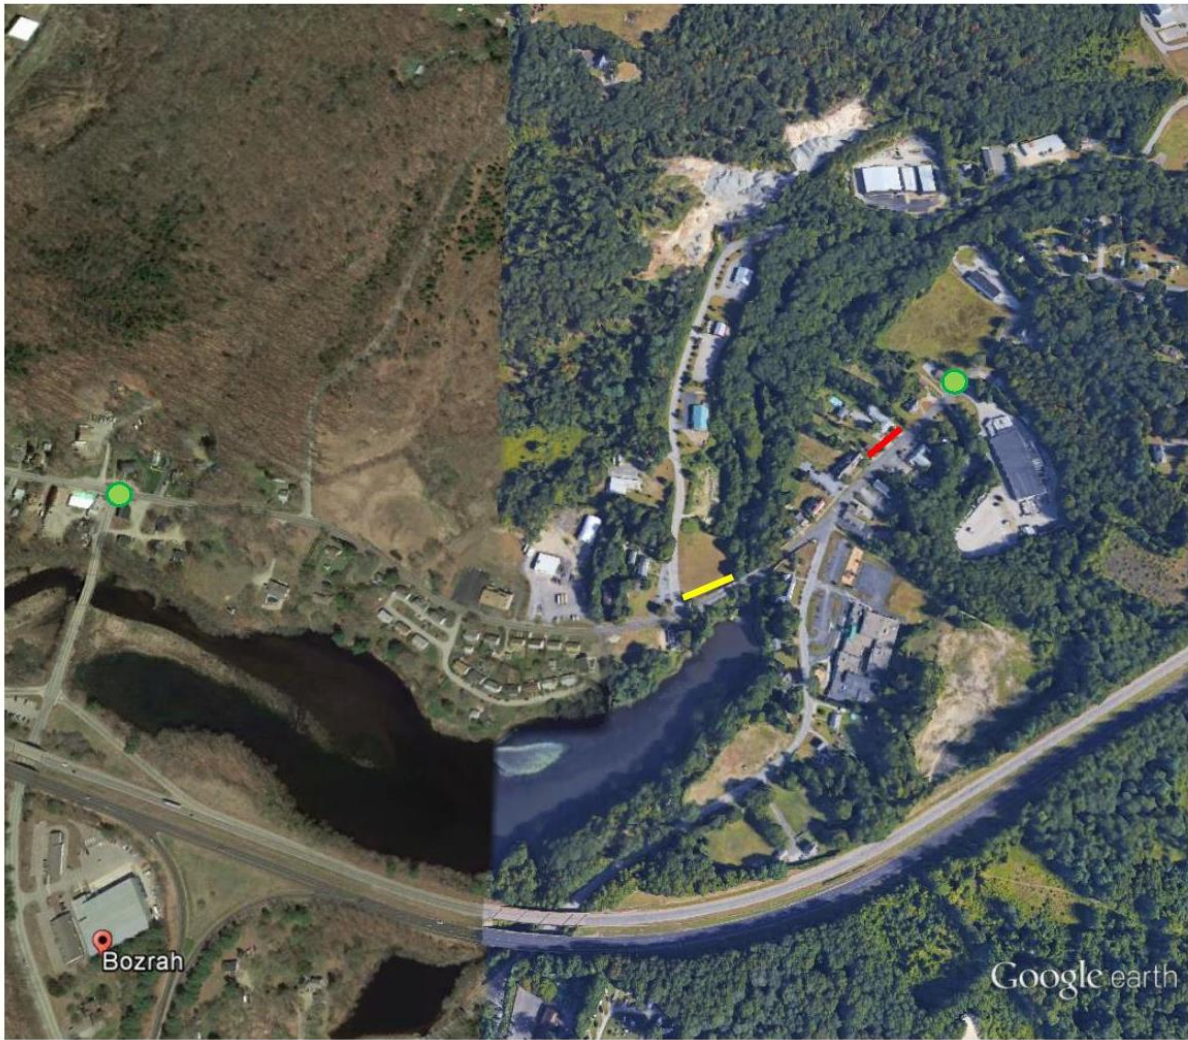
Figure 17. Medium Term Recommendations

Replace existing fence (#1)

Consider adding sidewalk ramps and tactile warning strips (#2)

Consider adding village center gateway signs (#3)

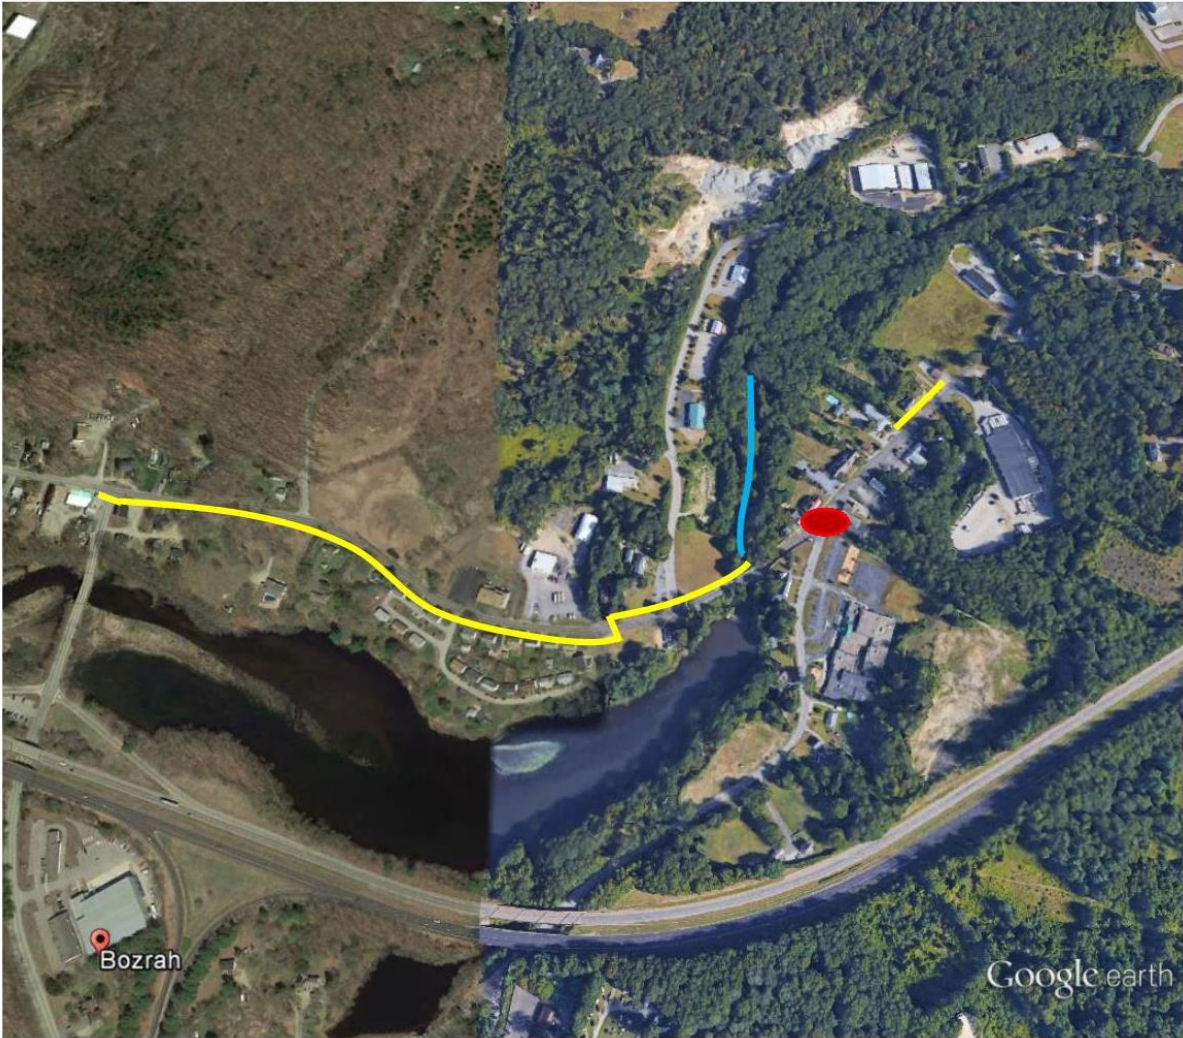
Figure 19. Long Term Recommendations

Construct new concrete sidewalk and crosswalks (#1)

Evaluate long term intersection improvements (#2)

Plan to extend Yantic River walkway (#3)
