Burlington

George Washington Turnpike – Road Safety Audit

April - 2016

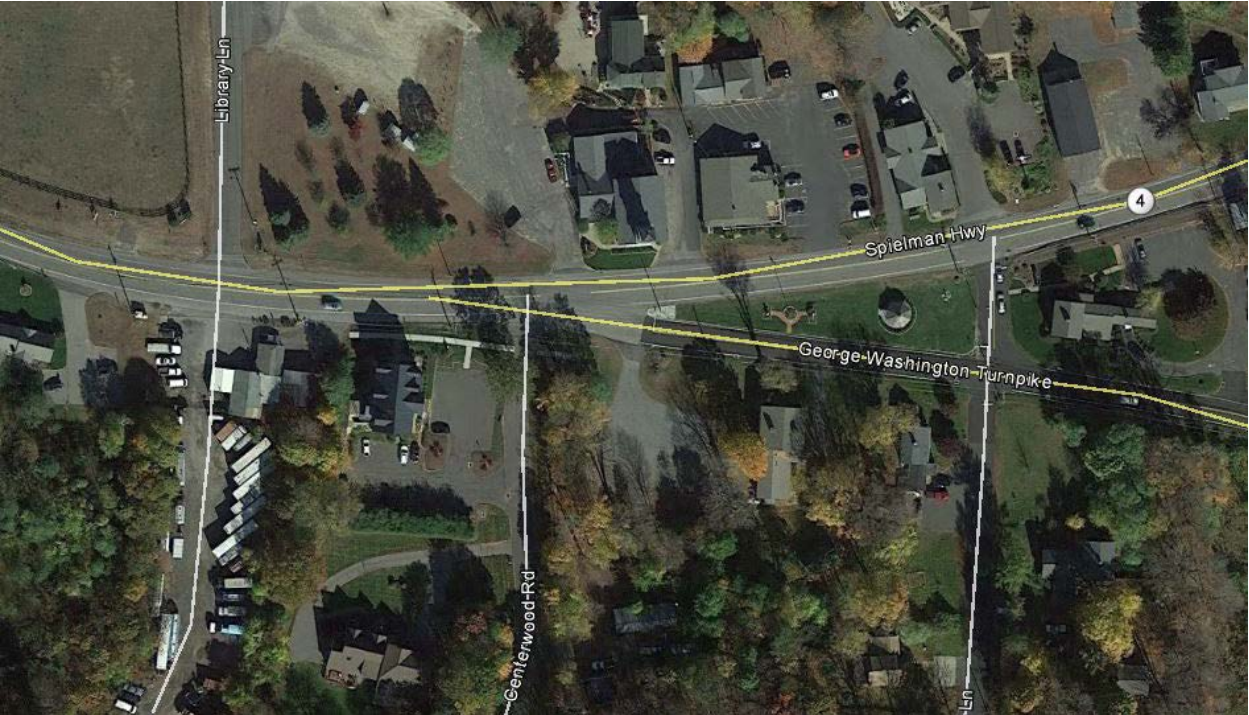
Figure 1. George Washington Turnpike at Route 4

The site is the intersection of George Washington Turnpike and Route 4 in the Town of Burlington (Figure 1). Located between these two roads is Burlington's Town Green, which is used for local events. There are no crosswalks or bicycle facilities in this area. Route 4 is a Principal Arterial and provides an east-west connection between Hartford and western Connecticut (Figure 3). As a result, this route is often used by commuters heading to the Hartford area. The Average Daily Traffic (ADT) on Route 4 near the George Washington Turnpike intersection is approximately 11,900.

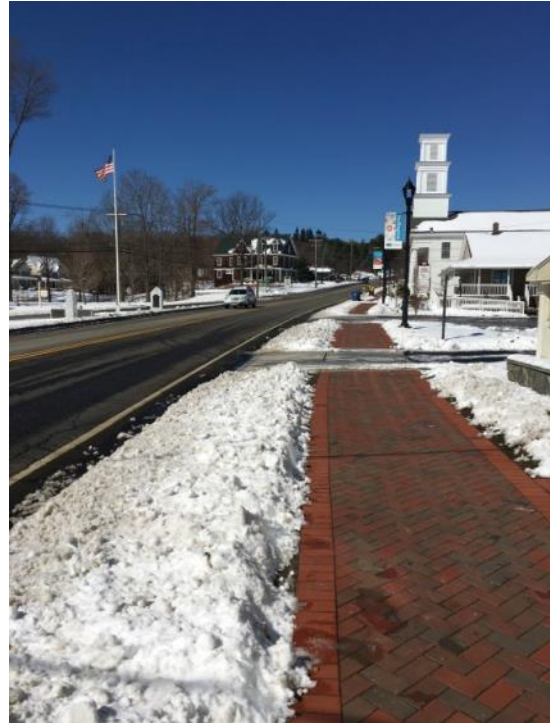
Figure 5. Recently installed sidewalk on Route 4

There is a brick sidewalk on the north side of Route 4 that was recently installed as part of the town’s streetscape initiative. The sidewalk is generally six (6) feet in width and has a snow shelf, or grass buffer, from the roadway traffic. An inventory of existing conditions of the intersection can be found in Table 3.

A number of best practices have already been applied to this area of Burlington. To improve pedestrian amenities, Burlington installed a sidewalk on the north side of Route 4 as part of a streetscape improvement project (Figure 6).

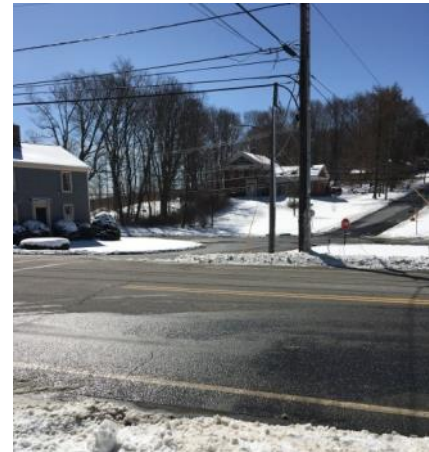
Figure 6. Visibility reduced by location of utility poles

- Vehicles were observed traveling at high speeds on Route 4.
- Utility poles restrict sight distance on Route 4 at George Washington Turnpike and Savarese Lane (Figure 7).

1. There is a lack of signage in Burlington to alert vehicles they are entering the town center area.
2. The sharp grade and location of utilities contribute to poor visibility at the Savarese Lane and George Washington Turnpike intersections at Route 4.

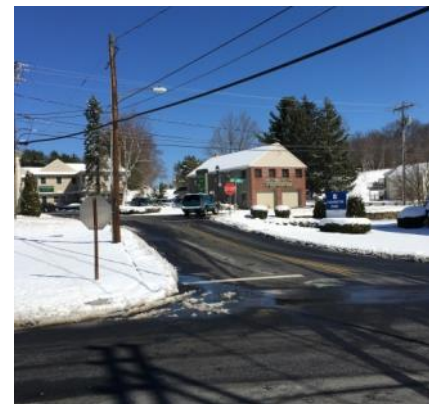
Figure 7. Short storage length on Savarese Lane

- Short storage length on Savarese Lane between Route 4 and George Washington Turnpike (Figure 8).
- The community served by Centerwood Road has another access option.

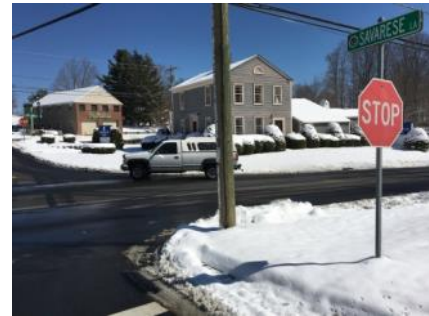
Figure 9. Westbound traffic does not stop on Savarese lane at George Washington Turnpike

- No "Intersection Ahead" signs on Route 4 westbound approaching Savarese Lane.
- The westbound approach on George Washington Turnpike at Savarese Lane is not controlled, but the other three intersection approaches are Stop controlled. This creates driver confusion as to who has the right of way.

3. The westbound approach at the George Washington Turnpike and Savarese Lane intersection is not controlled (Figure 10). The other three approaches do not have any signs indicating that this intersection is only a 3-way stop.

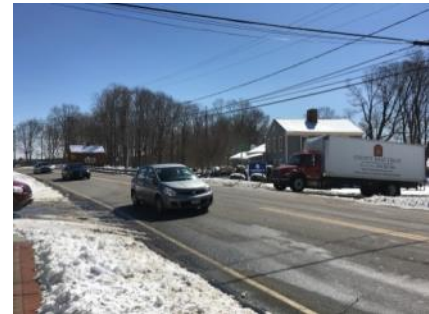
Figure 10. Narrow shoulders on Route 4

4. There are no pedestrian crosswalks along Route 4.
5. There are no bike facilities in the area and the existing shoulder width on Route 4 is narrow (Figure 11).

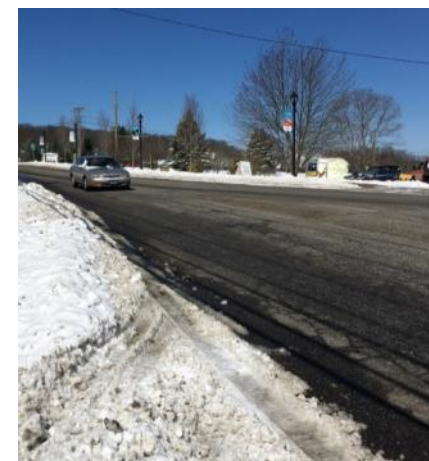
Figure 11. Route 4 and George Washington Turnpike intersection

- There are no pavement markings at the intersection of George Washington Turnpike and Route 4 to guide motorists. The current alignment encourages high speeds for motorists making a right turn from Route 4 eastbound onto George Washington Turnpike.

7. The configuration of the George Washington Turnpike and Route 4 intersection encourages motorists to travel at fast speeds. Due to the angle, the intersection feels more like a highway exit ramp (Figure 12). The Centerwood Road northbound approach to this intersection complicates turning movements and creates added confusion for motorists.
