COMMUNITY
connectivity program

Westminster Road (Route 14) between Canterbury Road
(Route 169) and Lisbon Road – Road Safety Audit

June 15, 2016

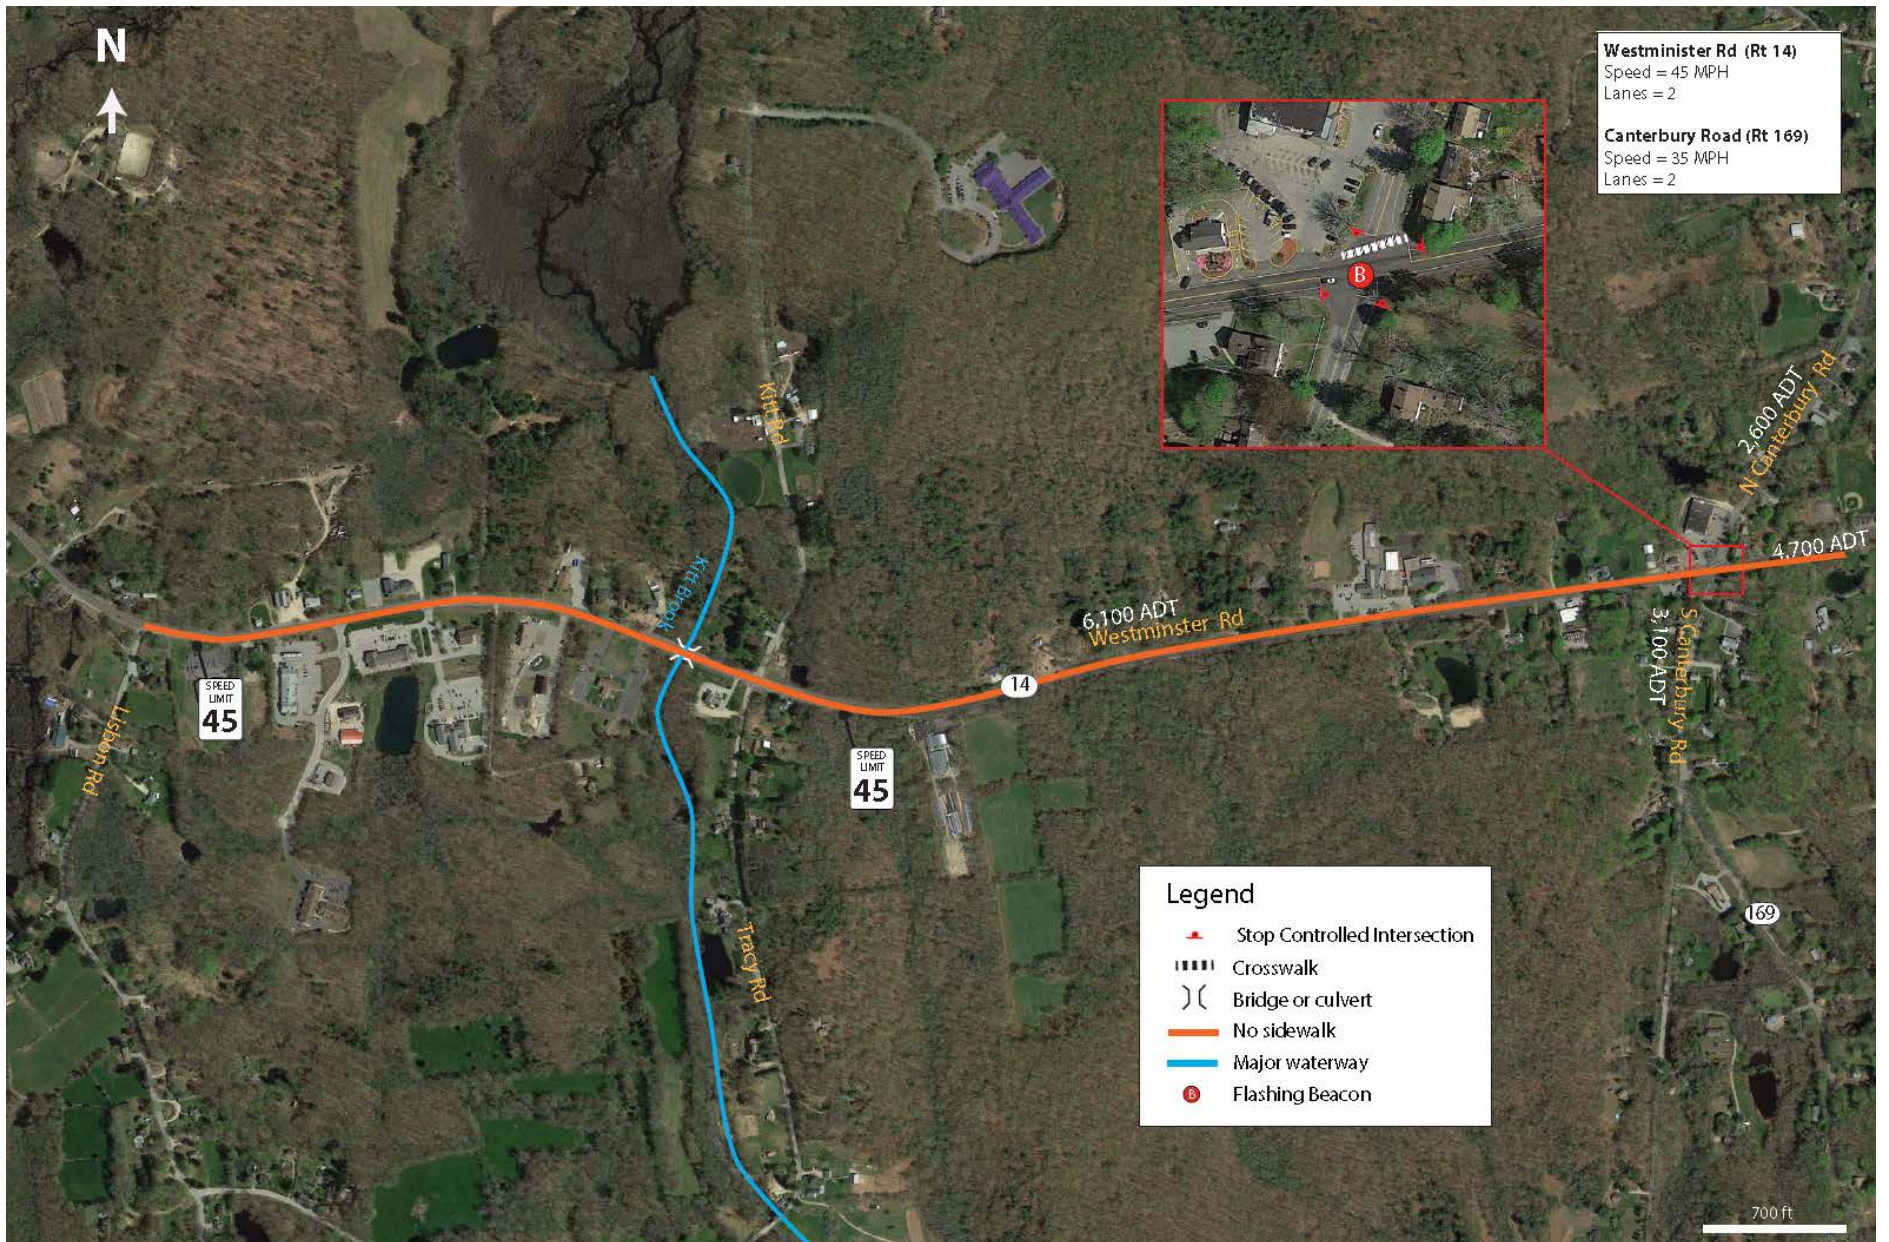
Route 14 is a Major Collector roadway with wide shoulders throughout most of its length and a single travel lane (12-12.5 feet wide) in each direction. While predominantly rural, the corridor has focused areas of commercial and municipal activity, such as the Prudence Crandall Museum located on the southwest corner of the intersection of Routes 14/169. There are no sidewalks along Route 14 for the entirety of the audit area. The posted speed limit on Route 14 in the study area is 45 MPH. The audit portion of the corridor includes three general areas of focus due to land use activity and traffic safety concerns. These are the intersection of Route 14/Route 169; Dr. Helen Baldwin Middle School; and the Cumberland Farms/Canterbury Plains shopping center.

Figure 4. Route 14 Roadway Geometrics and Average Daily Traffic (ADT)

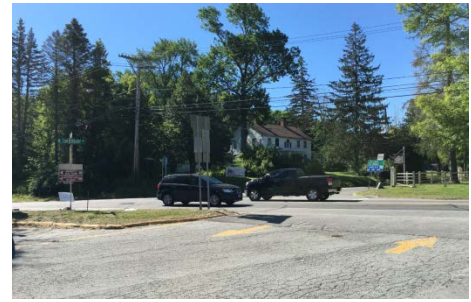
- The driveway to the grocery store on Route 14 is very close to the intersection, which leads to driver confusion and turning conflicts. It is difficult to make a left turn out of the driveway onto Route 14 (Figure 5).

Figure 5. View From Grocery Driveway on Route 14 Facing Southwest

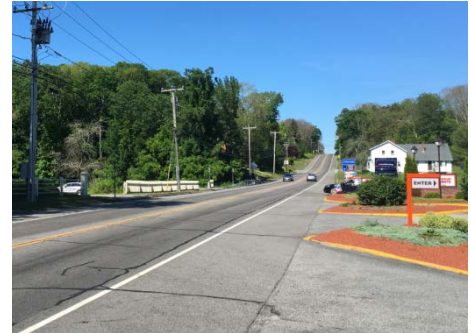
- There are multiple closely-spaced driveways in close proximity to the intersection, leading to turning conflicts and driver confusion (Figure 6).
- The existing crosswalk does not have a handicap ramp on either side (Figure 7). ADA compliant updates would include handicap ramps and tactile warning strips. The crosswalk serves pedestrians from the adjacent ball fields.

Figure 6. Multiple Driveways Facing West on Route 14.

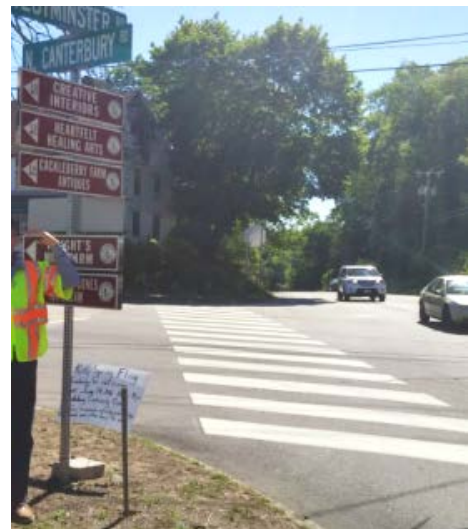
- Destination signs on the northwest corner of Routes 14/169 are mounted lower than seven feet which is hazardous for pedestrians (Figure 7).
- There are sight line issues for vehicles at the all-way stop due to both the geometry of the intersection and obstructions created by wayfinding signage (Figure 7). This results in drivers edging out into the intersection.

Figure 7. Existing Crosswalk Without Ramp on Route 169

- b. Raise height of directional signs at the Route14/Route 169 intersection and relocate to improve sight line issues.
 - c. Install reflective vertical strip on stop sign posts at driveways and cross-streets along Route 14 for improved driver awareness.
 - d. Replace and relocate worn "Do Not Enter Sign" at Middle School exit driveway. Add "One-Way" signs and "Intersection Ahead" signs. Add stop signs and bars at the exit driveways.
 - e. Add "Intersection Ahead" warning sign on eastbound Route 14 approaching the Cumberland Farms driveway from the west.
3. Pavement Marking Improvements:
- a. Repaint stop bar on Knollwood Drive so that it is closer to the road.
 - b. Stripe separate left and right turn lanes at the Middle School exit driveway.

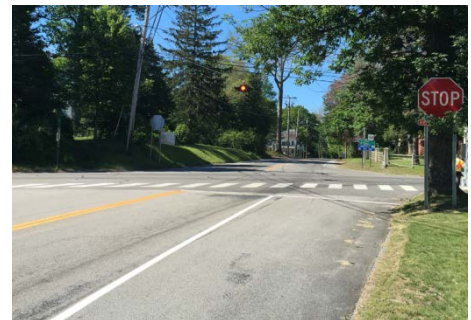
- Shoulders on eastbound Route 14 and southbound Route 169 are very wide and vehicles use them as a right turn lanes at the intersection.

Figure 8. Example of Wide Shoulder Southbound on Route 169 Used as Right-turn Lane at the Intersection

This increases conflicts and exacerbates confusion between vehicles and pedestrians as it is not clear who has the right of way at multi-lane all-way stop controlled intersections (Figure 8).

- Vegetation and trees obscure signage in the area (Figure 8).

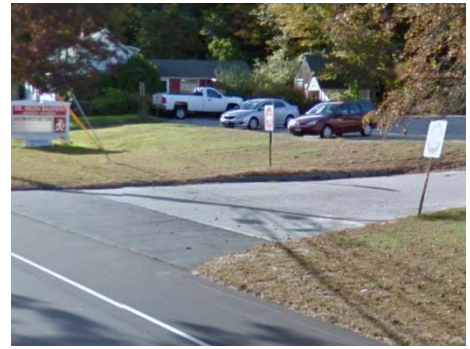
- “Do Not Enter” signs at the western Middle School driveway are not visible until drivers are already entering the driveway (Figure 9). One of the two signs is considerably worn (Figure 11).
- There is no sidewalk in front of the school (Figure 9, Figure 10).
- There are no left/right lane markings on the western Middle School driveway.
- There is only one warning sign per direction alerting drivers of the Middle School. There is no designated School Zone.
- The Middle School is located on the crest of a hill which creates sight line issues at the driveways and for vehicles traveling along Route 14 (Figure 10, Figure 12). This condition is exacerbated by the high speeds along Route 14.

Figure 9. “Do Not Enter” Signs Set Too Far Back at Middle School Exit Driveway

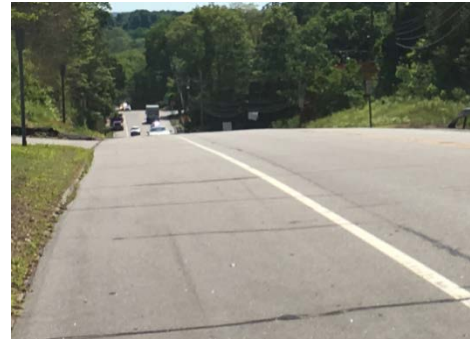
Figure 10. Sightline Constraints From Middle School Exit Driveway Looking East on Route14

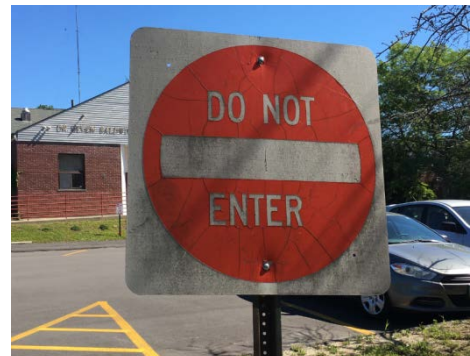
Figure 11. Faded Sign Wear at Middle School Exit Driveway

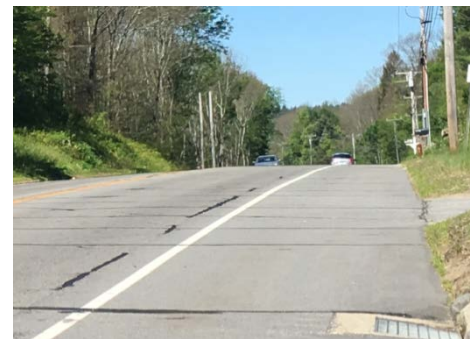
Figure 12. Sightline Constraints From Exit Driveway Looking West

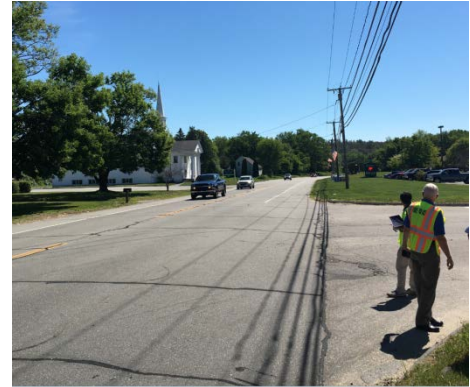
- There are no sidewalks for pedestrians walking between the various land uses (Figure 13).
- Pedestrian activity is focused on the south side of the roadway, in front of the shopping centers. Travel between shopping centers is common; however, pedestrians generally stay on the south side of the road and do not need to cross to the north side.
- The shopping center is along a straight section of Route 14 at the bottom of two hills, so vehicles enter the area at high speed and do not slow down.
- There are sight line constraints exiting Cumberland Farms due to the curve of Route 14 west of the driveway. This makes it difficult to exit the driveway, especially when vehicles are speeding on Route 14 (Figure 14).
- Vertical reflective strips have been installed on stop-sign posts, but not at all approaches (Figure 15).

Figure 13. Lack of Sidewalks on Route 14 at Canterbury Plains Shopping Center

- b. Provide new sidewalk between the Middle School and Dunkin Donuts, on the north side of Route 14.
 - c. Provide new sidewalk in front of shopping center area, on the south side of Route 14, connecting the three shopping plazas.

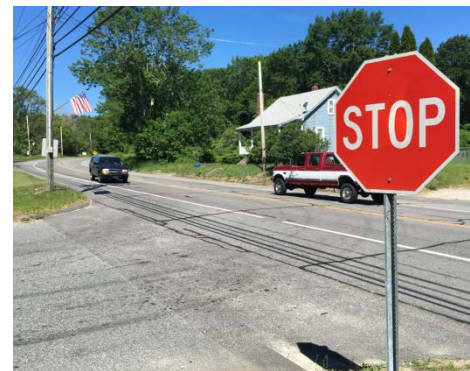
Figure 14. Sightline Constrains Looking at Route 14 West From Cumberland Farms Driveway

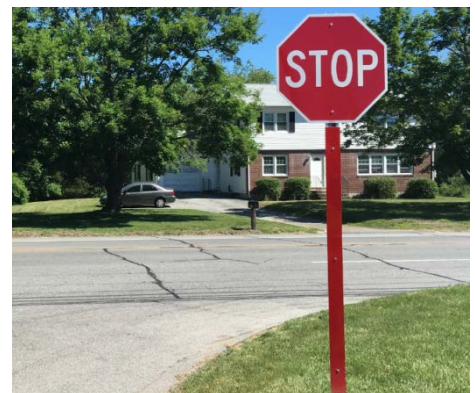
Figure 15. Reflective Sign Post on Knollwood Drive
