# Cheshire

Jarvis Street from Farmington Canal Linear Trail westerly to Guinevere Ridge – Road Safety Audit July 26, 2016

OFFICE OF INTERMODAL PLANNING BUREAU OF POLICY AND PLANNING CONNECTICUT DEPARTMENT OF TRANSPORTATION

With assistance from AECOM Transportation Planning Group

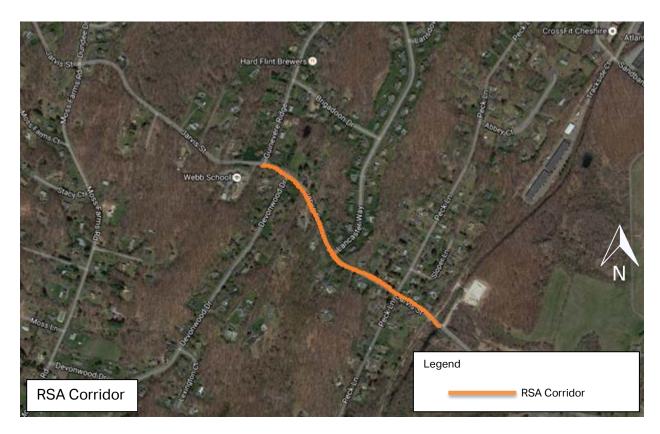
Figure 1. Jarvis Street, Cheshire

The RSA site is the section of Jarvis Street between Guinevere Ridge to the west and the Linear Trail to the east (Figure 1). Figure 2 shows the study corridor in a regional context. The Average Daily Traffic (ADT) on Jarvis Street near the Guinevere Ridge intersection is 1,700 vehicles per day (vpd). Jarvis Street consists of a single lane in each direction, separated by a double yellow center line. There are no shoulders on the road.

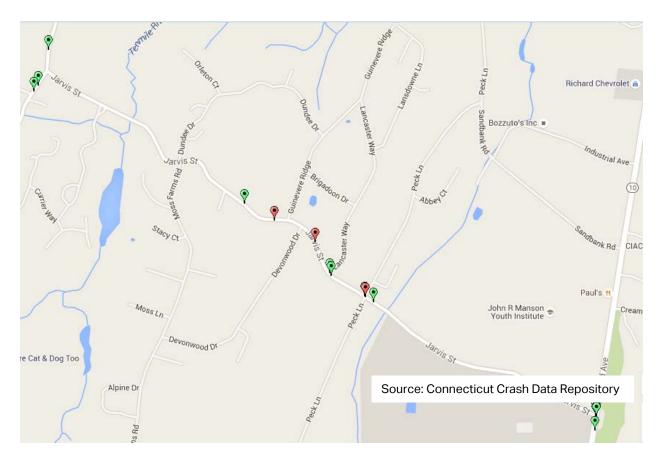
Figure 3. Crashes that Occurred in 2015 (Connecticut Crash Data Repository)

As noted above, traffic volumes are relatively low along the Jarvis Street corridor. Jarvis Street provides a connection between Highland Avenue (Route 10) on the east and Marion Road on the west and direct access to the Linear Trail. Although the crash history in this area is relatively low, there were two accidents involving injuries between 2012 and 2014 (Table 1 and Table 2). Figure 3 displays crashes that occurred in this area during 2015.

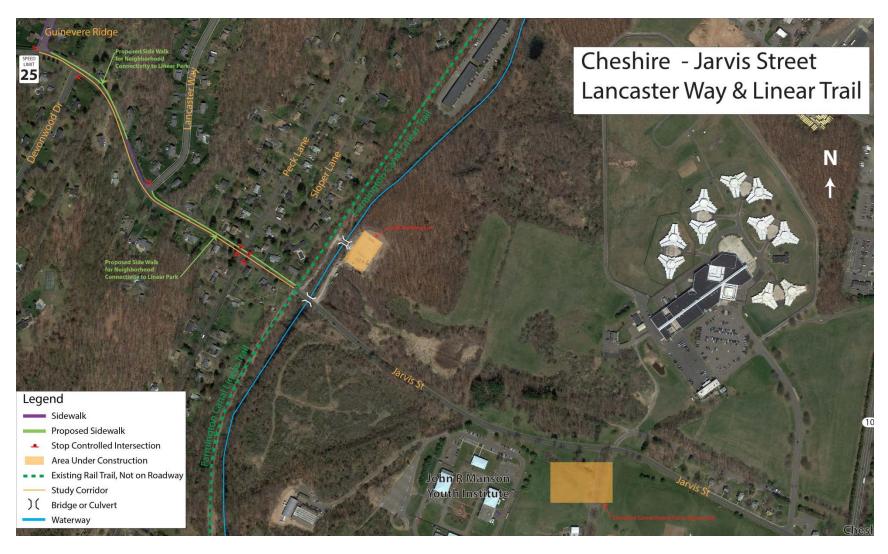
**Figure 4. Jarvis Street Road Geometrics**

Figure 4 and Table 3 below show the roadway geometrics for the Jarvis Street corridor.

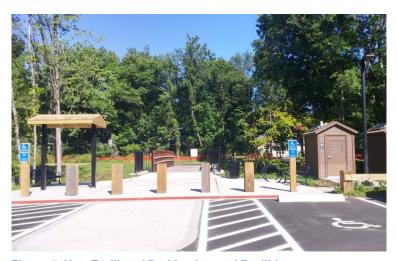
Figure 5. New Trailhead Parking Lot and Facilities

The Town of Cheshire has recently completed construction of the Farmington Canal Linear Trail through town to a northerly terminus at Jarvis Street, where they have placed a new parking lot. The parking lot has handicap facilities complete with ramps with pedestrian detectable warning strips. In addition, the parking lot is equipped with bike racks, trash receptacles, benches, kiosk and rest rooms. A pedestrian bridge was also built over the river to connect the parking lot to the Linear Trail (Figure 5). The Linear Trail is expected to be extended north to the southern border of Plainville and south to I-95 in New Haven.

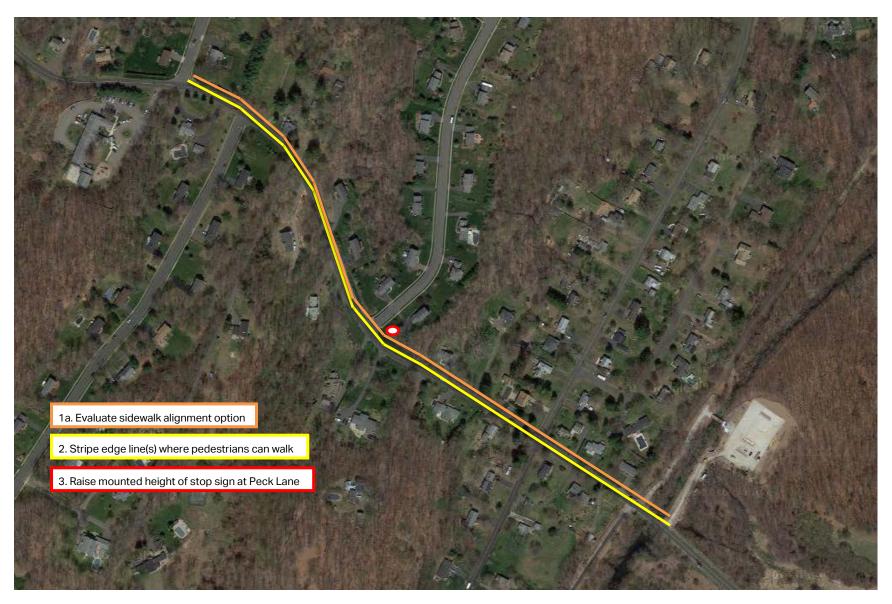
**Figure 14. Short Term Recommendations**

Figure 14 depicts these recommendations.

- Address the following during preliminary planning for the sidewalk project on Jarvis Street:
  - a) Perform a route land survey
  - b) Evaluate sidewalk alignment options and consider alternating between the south and north side of Jarvis Street. Avoiding utilities and slopes where possible to reduce the cost of the project.
  - c) Contact residents who may be affected by a new sidewalk on Jarvis Street.
- 2. Stripe edge line(s) and narrow lane width on Jarvis Street to lower traffic speed and provide accommodation for pedestrians and bicyclists.
- 3. Raise mounted height of stop signs at Peck Lane to 7 feet (standard height).
- 4. Pursue alternate funding options. Cheshire has capital funds for sidewalks that can be used for funding match.
- 5. Contact COG regarding project priority status.

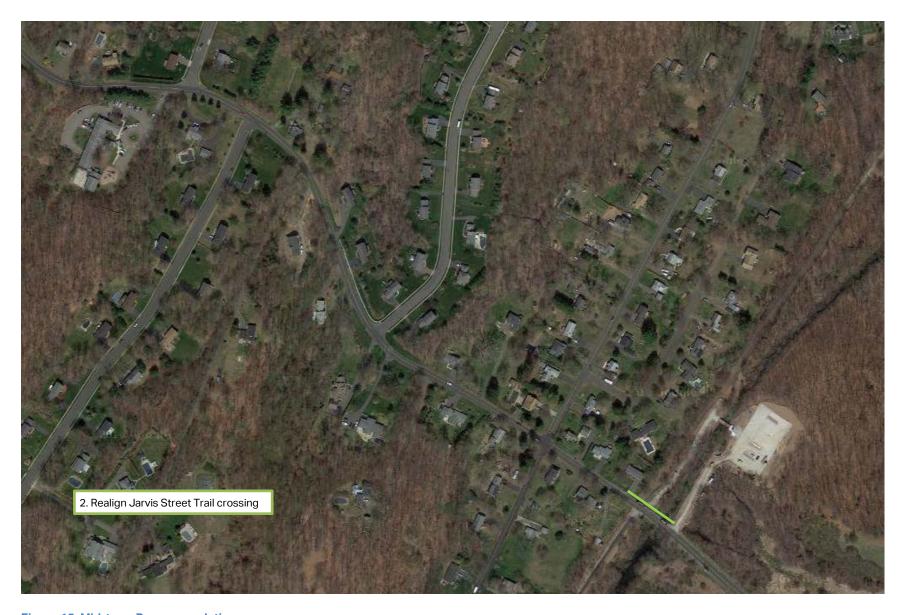
**Figure 15. Mid-term Recommendations**

Figure 15 depicts these recommendations.

- 1. Hold a public meeting and provide a visual representation of plan to help gain community support.
- 2. The Town plans to realign the Jarvis Street trail crossing near the trail head parking lot in order to provide a more direct crossing<sup>1</sup>.

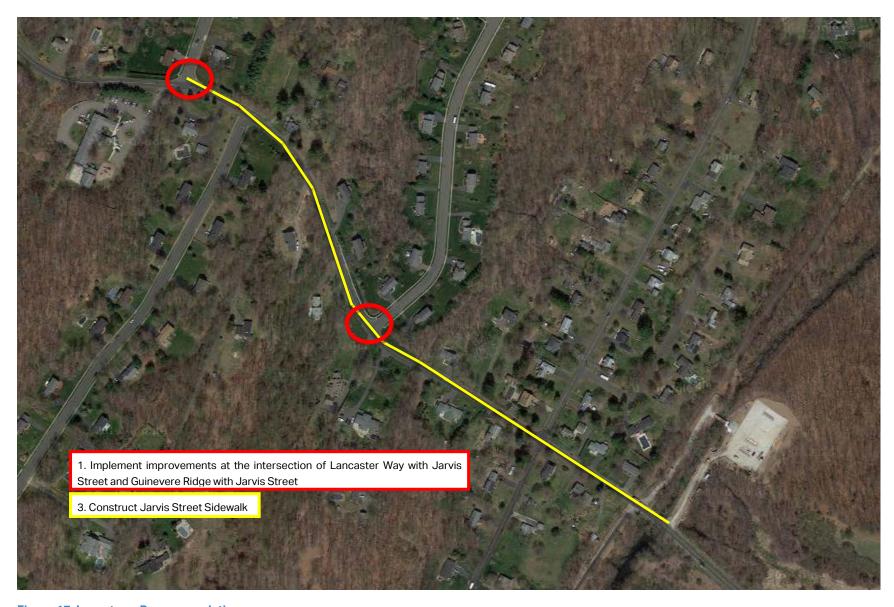
Figure 17. Long-term Recommendations

Figure 17 depicts some of these recommendations.

- 1. Implement the following improvements at the intersection of Lancaster Way with Jarvis Street and Guinevere Ridge with Jarvis Street:
  - a. Tighten the turn radius.
  - b. Realign ramps so that they direct pedestrians in front of the stop bar.
  - c. Install detectable warning strips on ramps to current ADA standard (Figure 16).
  - d. Upgrade ADA ramps.
- 2. Finalize the Jarvis Street sidewalk design.
  - a. Relocate utility poles and catch basins where the sidewalk is to be installed.
- 3. Construct the Jarvis Street sidewalk.
- 4. Review the Town ordinance prohibiting bikers on sidewalks for this section of sidewalk due to the residential nature and high traffic speeds on Jarvis Street.
