COMMUNITY
connectivity program

Cornwall

Route 7 and Route 4 Intersection

June 21, 2016

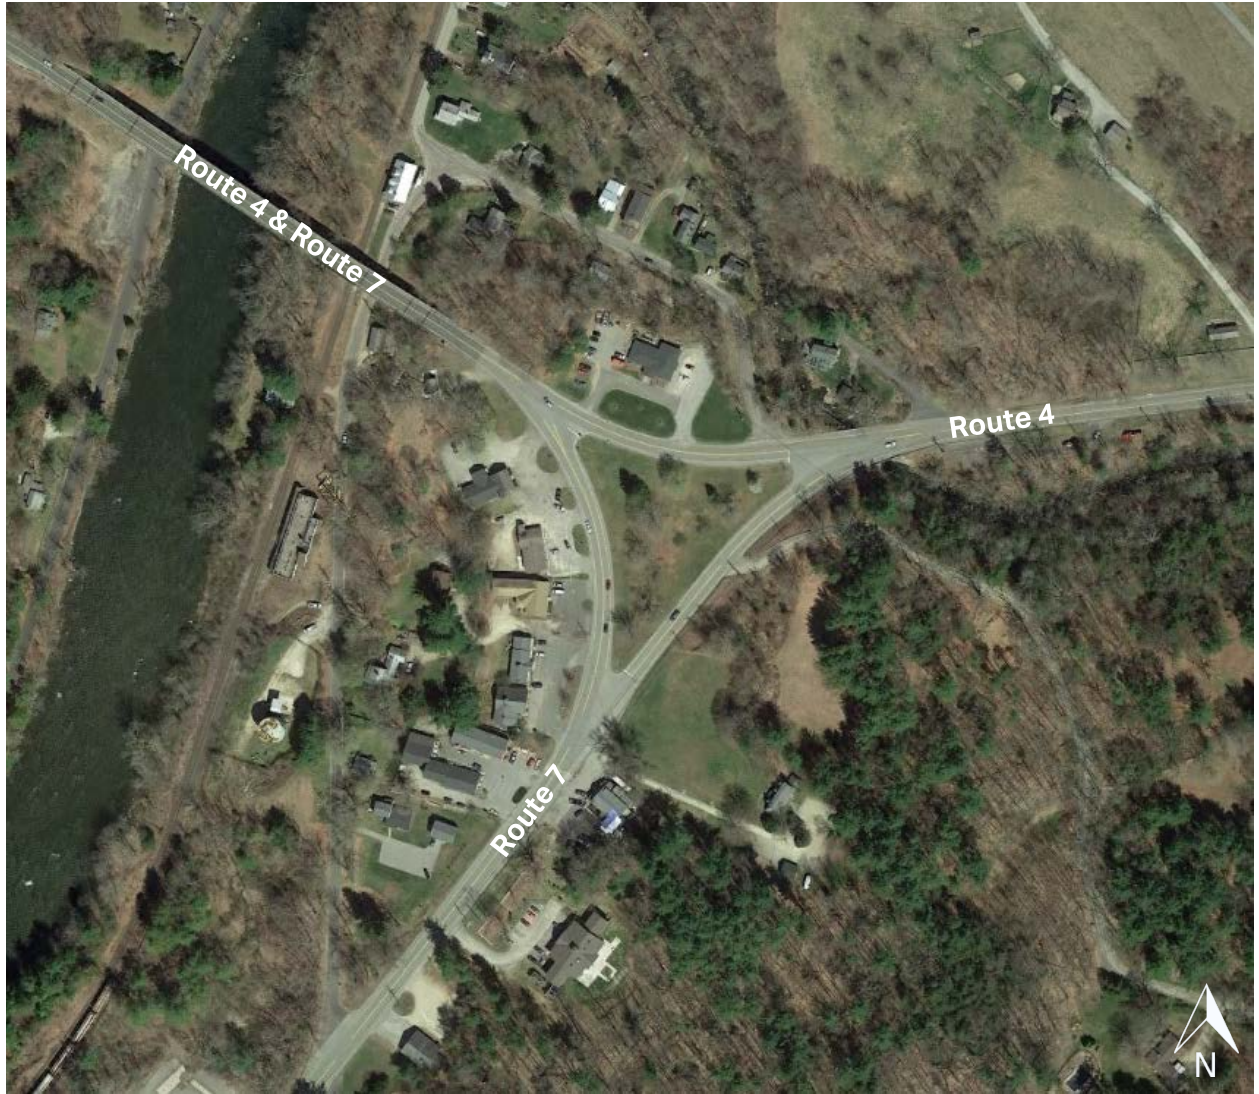
Figure 1. Route 4 and Route 7

The site consists of the Route 4 and Route 7 intersection which forms a triangular section used as the town green in the center of Town of Cornwall (Figure 1). Cornwall submitted an application identifying these two routes as in need of improved pedestrian connections. There are currently no sidewalks on either of these routes. Route 4 is a Minor Arterial and provides an east-west connection in western Connecticut (Figure 2). Route 7 is also a Minor Arterial but provides primarily a north-south connection through Cornwall and western Connecticut. As a result, these routes are often used by commuters and commercial truck traffic. The Average Daily Traffic (ADT) on Route 4 is 1,500 vehicles per day (vpd) and the ADT on Route 7 ranges from 2,600 and 3,400 vpd.

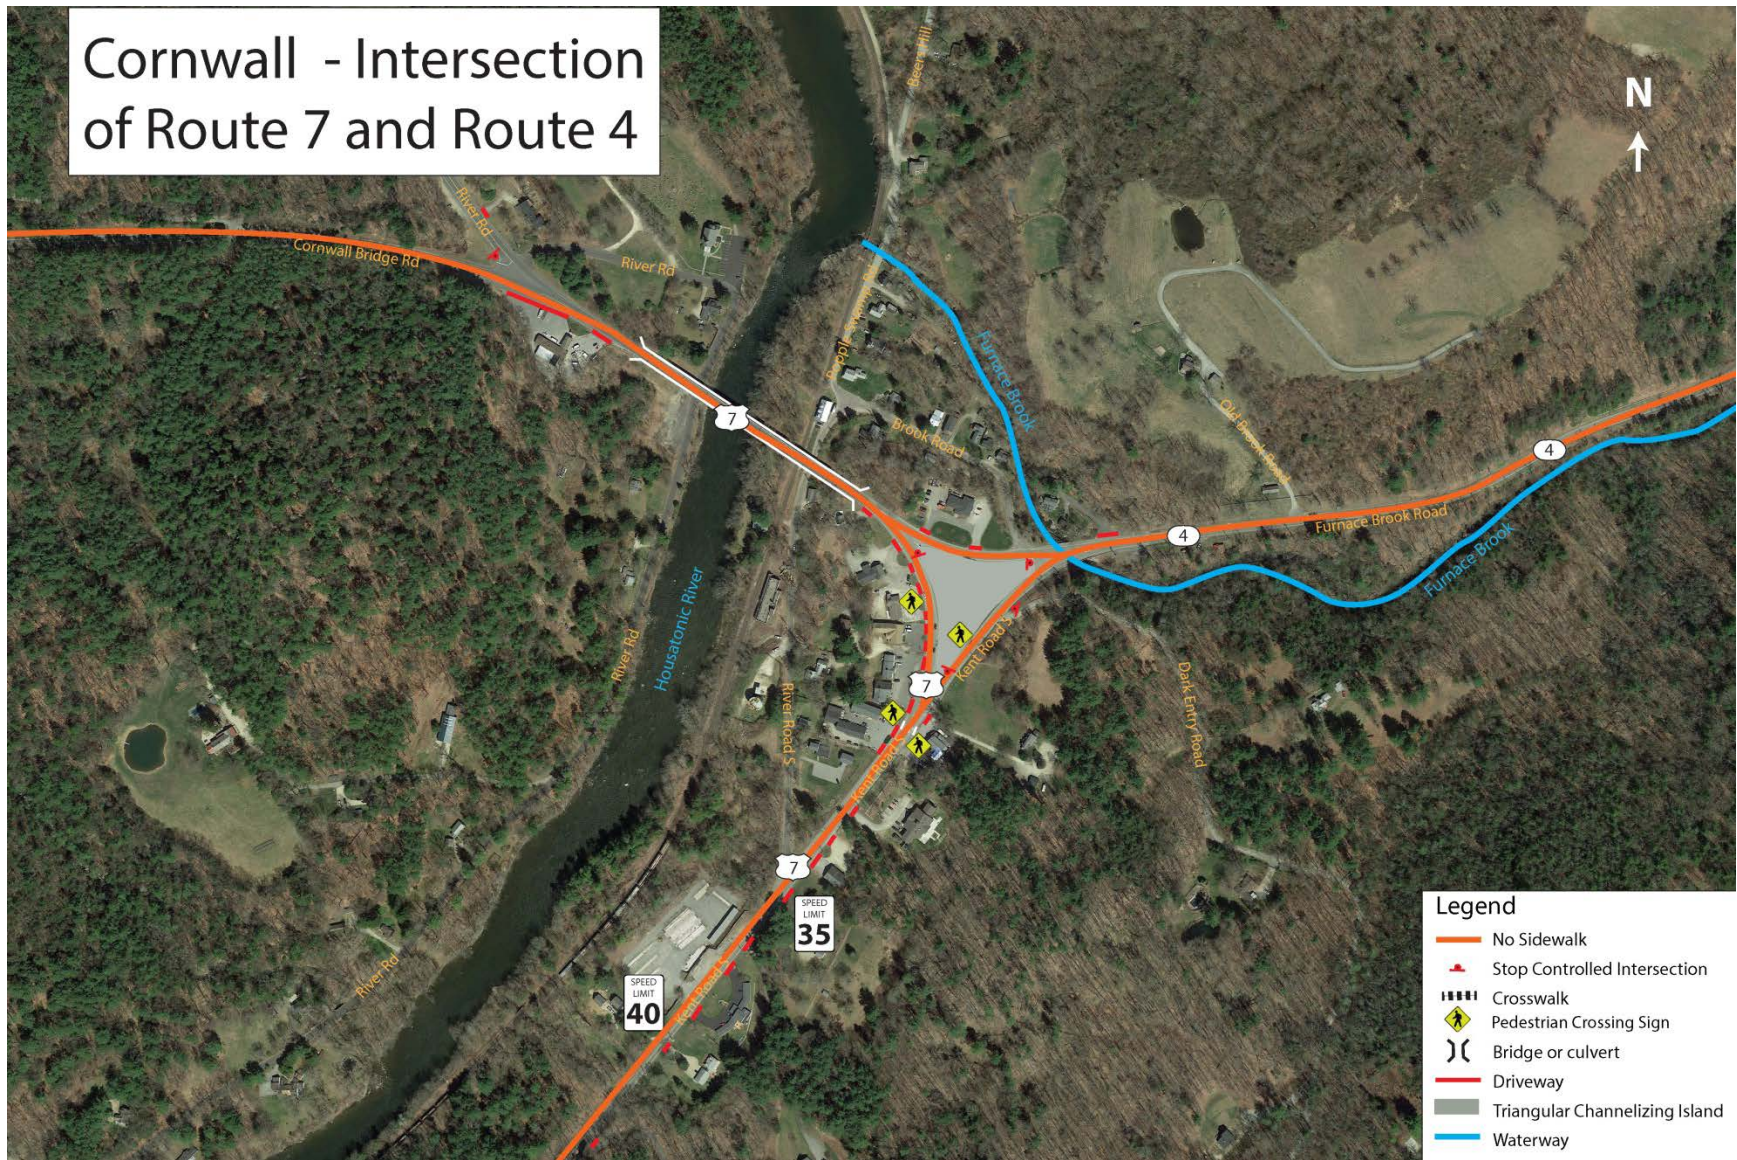
Figure 4.Route 4 and Route 7 area road geometrics

Route 4 is a state owned and maintained facility and runs in a relatively east-west direction through the center of Cornwall. Through the town center, Route 4 has one eastbound and one westbound travel lane. There are no sidewalks on Route 4 in this area.

Route 7 is also a state owned and maintained facility and runs in a relatively north-south direction through the center of Cornwall. Through the town center, Route 7 has one northbound and one southbound travel lane. There are no sidewalks on Route 7 in this area.

Roadway geometrics for the two routes are shown in Figure 4 and an inventory of existing conditions of the area can be found in Table 3.

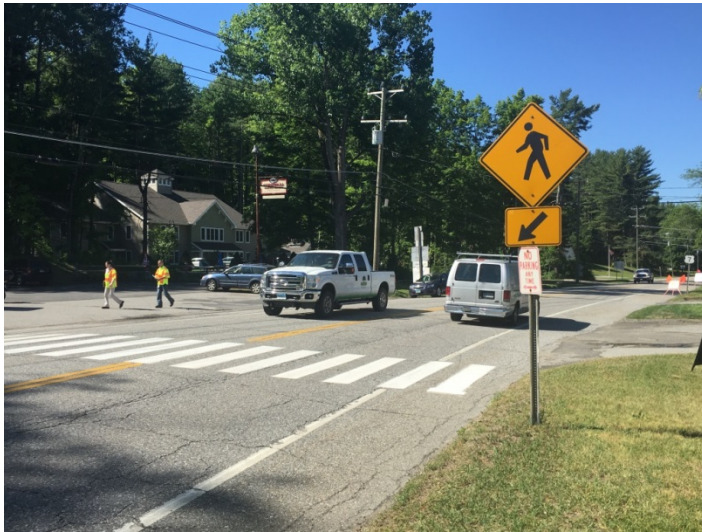
Figure 5. Crosswalk on Route 7

A number of best practices have already been applied to this area of Cornwall. At the pedestrian crosswalk on Route 7 near the Cornwall Country, Cornwall installed pedestrian crosswalk warning signs (Figure 5). On Route 7, near the Cornwall Package Store, the town installed a radar speed control sign (Figure 6) to encourage motorists to obey the 35 mph posted speed limit.

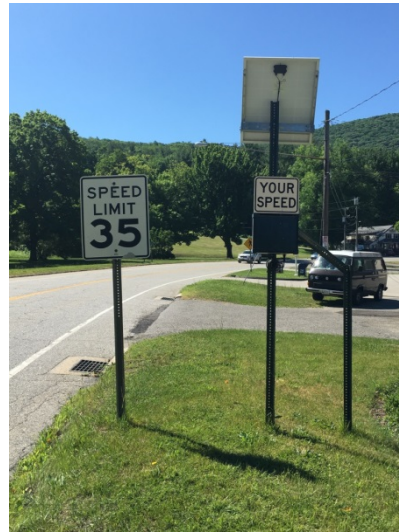
Figure 6. Solarized Radar Speed Control Sign

- A solarized radar speed control sign is located on Route 7 east of the Cornwall Bridge (in front of the package store).
- Motorists traveling westbound on Route 4 are on a downhill slope (Figure 9). This may contribute to faster speeds when entering the village center area.

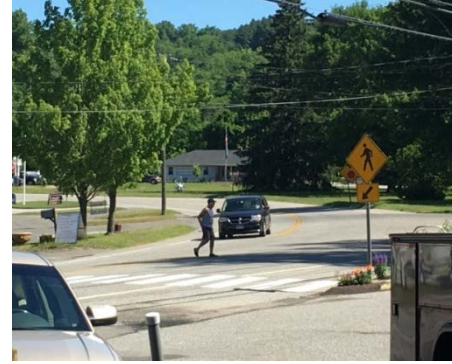
Figure 7. Pedestrian Crossing Route 7

- Passing traffic on Route 7 did not stop for pedestrians waiting to cross the road at the crosswalk.
- There are no sidewalks. Pedestrians must travel along roadway or parking lots.

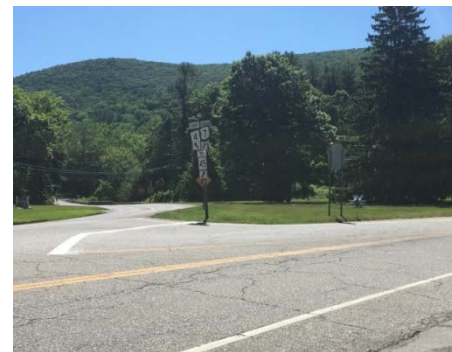
Figure 8. Stop Bar Located Far Past Stop Sign

- At the intersection of Route 4 and Route 7 nearest the Cornwall Bridge, the stop bar on Route 7 is located far past the stop sign (Figure 8).
- During the audit, the owner of the package store indicated that he sees many vehicles driving straight through the stop sign northbound on Route 7. He also indicated that speeding is the biggest issue.

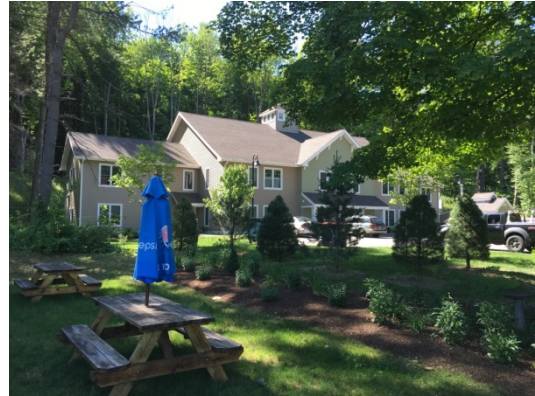
Figure 10. Senior Housing Complex

1. There are few facilities on Route 7 and Route 4 for pedestrians and cyclists. This is primarily an issue for Route 7 as most of the town's businesses are located here.
2. Existing pedestrian activity comes from the residents at the senior housing complex (Figure 10) and the hotel on Route 7.
3. Advanced warning signs for the pedestrian crosswalk are only located southbound on Route 7. There are no warning signs for motorists traveling northbound into the Town Center area.
4. Motorists waiting for a parking spot at the Cornwall Corner Market sometimes queue on Route 7, causing congestion.
5. There are several driveways/curb cuts on Route 7 for the local businesses. These entrances contribute to additional turning movement conflicts for motorists.
6. The Route 4 and Route 7 intersection controls and roadway geometry may be confusing for motorists who are unfamiliar with the area.

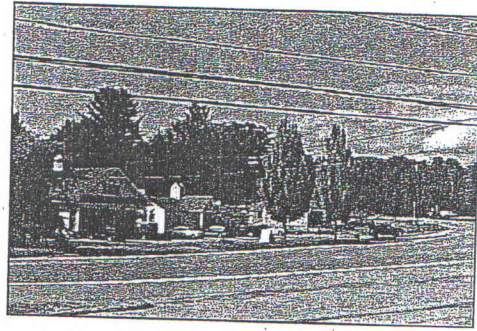
Existing Development

compared with a more suburban strip development arterial. The Average Daily Traffic (ADT) is 3,400 vehicles on Route 7 and 1,500 on Route 4 as compared to 15,000 to 20,000 on a typical suburban arterial. There are numerous and often poorly defined access points into retail and service establishments.

Parking is generally located in the front setback between the road and the building. There are no sidewalks, which combined with the speed of traffic discourages pedestrian circulation. In effect, from a built environment perspective, Cornwall Bridge does not function as a village center. Traces of a village center character remain in the vicinity of the rail station on the river, but there is no physical or functional relationship between the modern day Cornwall Bridge and the historic area.
