Coventry

Main Street, Daly Road to Town Hall – Road Safety Audit

June 30, 2016

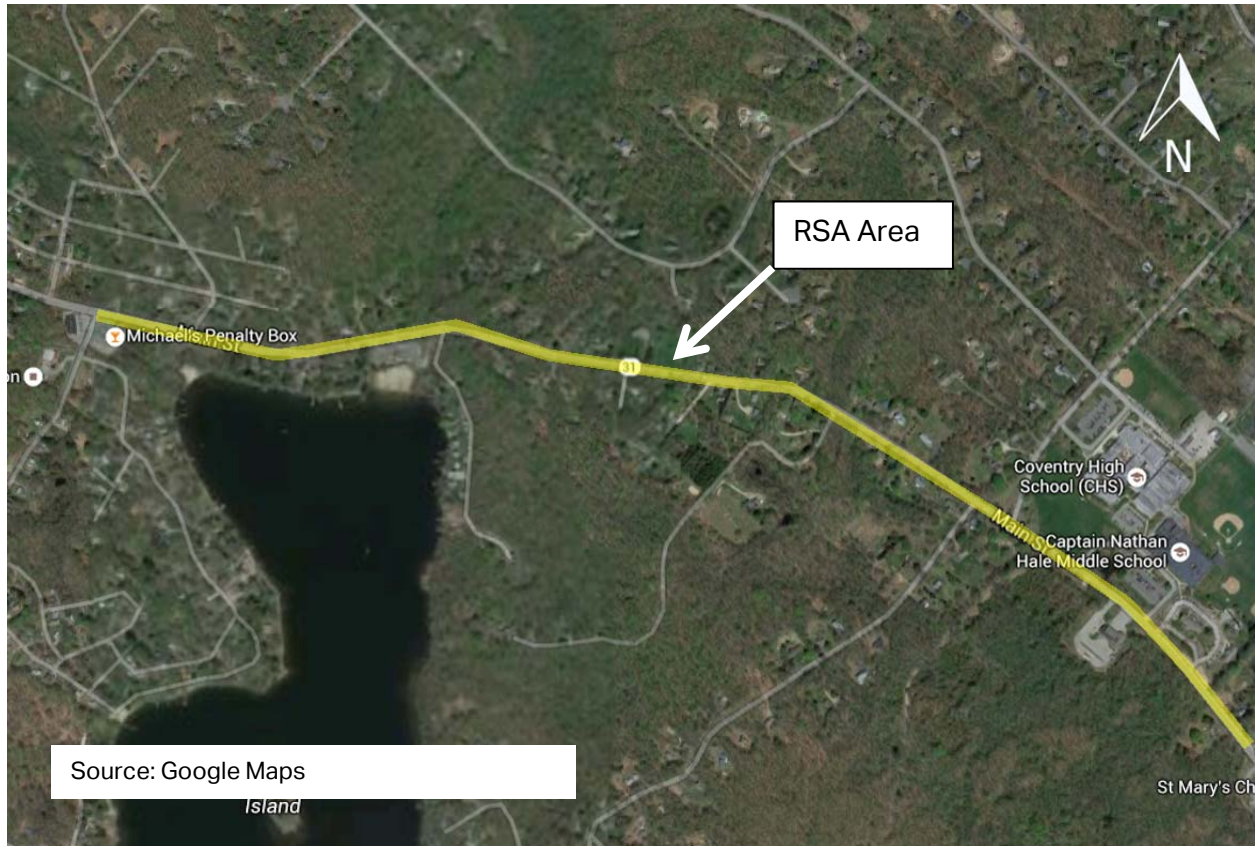
Figure 1. Main Street, Coventry

The site is the segment of Main Street (Route 31) between Daly Road and the Municipal Complex in the Town of Coventry (Figure 1). The Main Street Average Daily Traffic (ADT) is 8,200 vehicles per day (vpd). These are significant volumes of traffic for a rural state highway to process. Figure 2 shows the regional context of the study area.

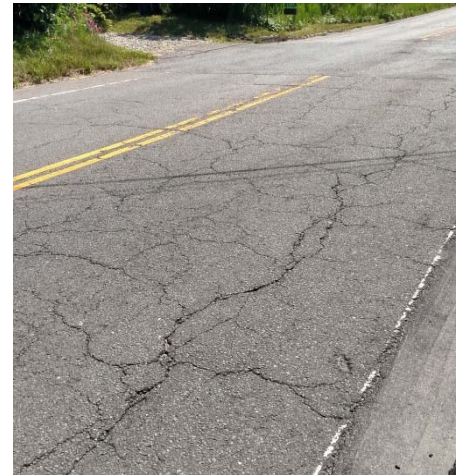
Figure 5. Poor Roadway Condition on Route 31

- The building at the corner of Daly Road and Route 31 is mostly vacant and for sale. It has potential to be redeveloped as a destination for residents.
- There are approximately 90 residences on Daly Road.
- Daly Road does not have any sidewalks.
- The intersection of Route 31/Daly Road has a flashing yellow beacon for Route 31 (both directions) and flashing red for Daly Road.
- The roadway width for Daily Road is 32 feet near the Route 31 intersection.
- Vehicles on Route 31 appear to be exceeding the posted limit of 35 mph.
- Route 31 travel lanes average 12 feet wide. The shoulders range from less than 1 foot up to over 6 feet in certain locations but average 3 feet.
- Route 31 pavement condition is poor; the road has several cracks and heaves in the winter due to frost (Figure 5).
- The shoulder striping is faded, particularly along the south side of Route 31.

- There are several traffic signs which are blocked by vegetation. CTDOT is responsible for tree trimming and mowing along Route 31.
- The roadway is in poor condition and in need of repaving and possible full depth reconstruction. It is not currently on the state's VIP list for paving.

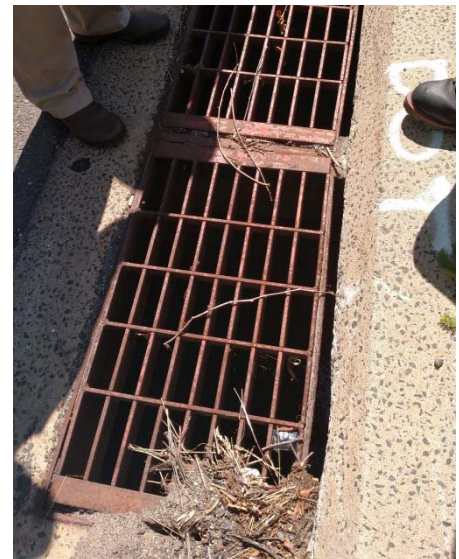
Figure 6. Non-bicycle Friendly Catch Basin Grates

- There are a variety of catch basin grate styles, approximately half are the older non-bike friendly type (Figure 6).
- Overhanging branches block many of the traffic control signs along Route 31 (Figure 7).

1. Replace non bicycle friendly catch basins (Figure 22).
2. CTDOT to repave Route 31 with possible full depth reconstruction and consider:
 - a. Restripe 11 foot travel lanes and wider shoulder lanes
 - b. Install centerline rumble strips (Figure 23).
 - c. Widen the roadway to provide consistent shoulder widths.
3. Request CTDOT perform a signal warrant study for the intersection of Route 31 and Ripley Hill Road and evaluate the potential for a roundabout.
4. Request CTDOT evaluate the need for passing zones on Route 31 in the study area.

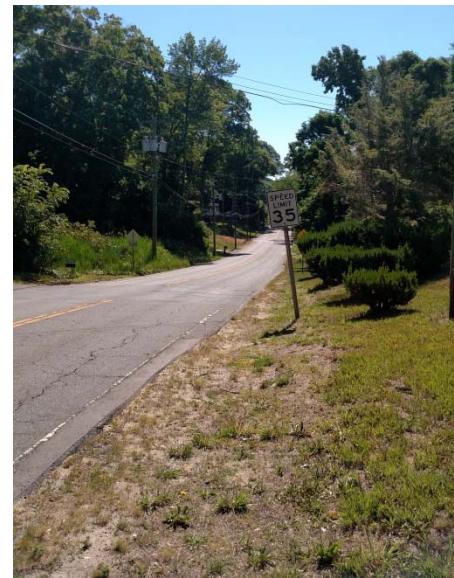
Figure 8. South Side of Route 31

- The utility poles are along the north side of the road (Route 31) until Hemlock Point Drive where they switch to the south side of the road.
- The south side of Route 31 would better accommodate a sidewalk, there is a better side shelf and minimal slope issues (Figure 8).

- A new sidewalk would be better suited on the south side of Route 31. If asphalt sidewalks were used a bio barrier would need to be installed to minimize cracking due to vegetation growth.

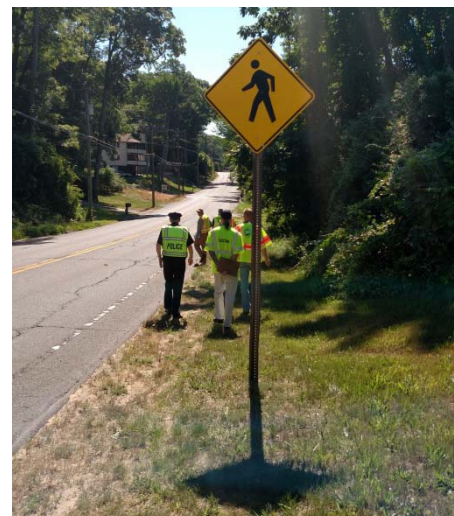
Figure 9. Pedestrian Signage MUTCD sign 11-2

- The pedestrian signs approaching Lisicke Beach are not informative to motorists (Figure 9). Each direction has three signs (MUTCD sign 11-2), with

the last sign having "END" under it. There are no beginning signs.

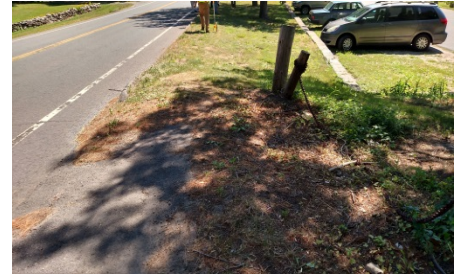
Figure 10. Curb cut Easement to Lisicke Beach must be Maintained

- The curb cut easement for boat access to Lisicke beach must be maintained (Figure 10).
- There are several mature trees just west of the Lisicke Beach entrance that may have to be removed to install a new sidewalk.

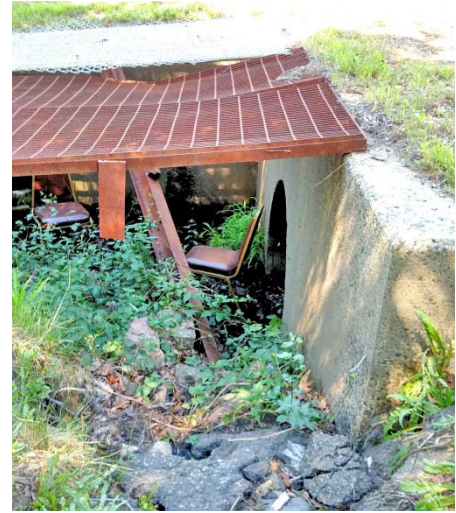
Figure 11. Civil War Canal Pit Area

- The "Civil War Canal" pit area is unsafe. Drainage issues from the road have resulted in the collapse of the steel beam holding the grates up. The head wall to the culvert is in poor condition. Both the culvert under the road and the culvert leading to Wangumbaug Lake need to be cleaned out. The water is not filtered or cleaned before entering the lake (Figure 11).

- The corridor does not have a consistent width, the shoulders vary greatly.
- The crosswalk on Route 31 at Ripley Hill Road is being moved to the other side as part of the Safe Routes to School improvements.
- The “Civil War Canal” drainage pit on the south side of Route 31 near Lisicke beach is failing and is an attractive nuisance.

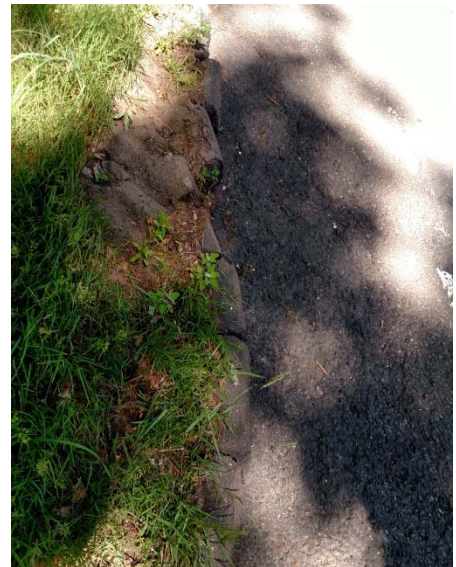
Figure 12. Broken Curbing at Winterberry Lane

- In the vicinity of Winterberry Lane the curbing is broken in several places (Figure 12).
- The soil is several inches below the backside of the curb at several locations along Route 31 between Cheney Lane and Hemlock Point Drive (Figure 13).

- c. Mowing of recovery area
- 9. Repair broken curbing along Route 31.
- 10. Town to create a plan for pedestrians and bicycles that can be included in the plan of Conservation and Development

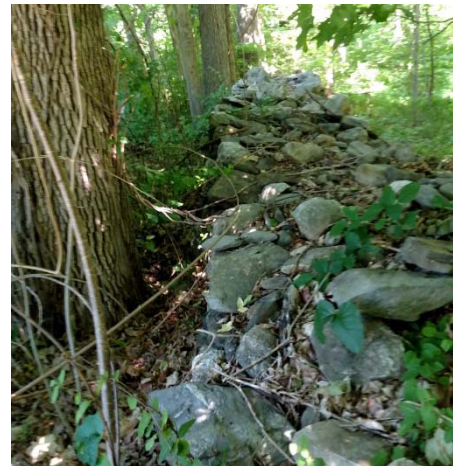
Figure 14. Old Tolland Turnpike Rockwall

- Old Tolland Turnpike formerly continued onto Route 31. The town still owns the right-of-way and all concrete has been removed. Trees and vegetation have begun to take over the area and growth is approximately 10 years old. There are rock walls that mark the roadway boundary (Figure 14). This area connects to several neighborhoods to the north. Repurposing the right-of-way as a trail would require maintenance and a mid-block crosswalk to connect to the proposed sidewalk. Mid-block crosswalks on state highways are not desirable by CTDOT. This crossing may also lack proper sight distance.

- 12. Maintain the vegetation on the closed section of Old Tolland Turnpike.
- 13. Repair curb where reveal is 2 inches or greater.
- 14. Request to CTDOT that a school zone be established in front of the middle school.

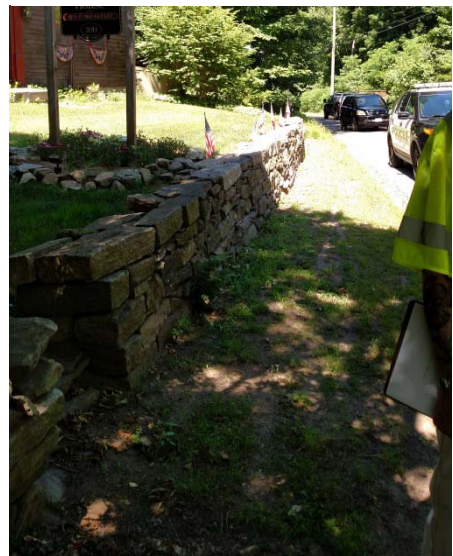
Figure 15. Narrow Right-of-Way at Rust House

- There are illegal signs in the right-of-way in front of the Daniel Rust House.
- The right-of-way in front of the Daniel Rust House is narrow. To install a new sidewalk the rock wall may need to be moved and rebuilt (Figure 15).

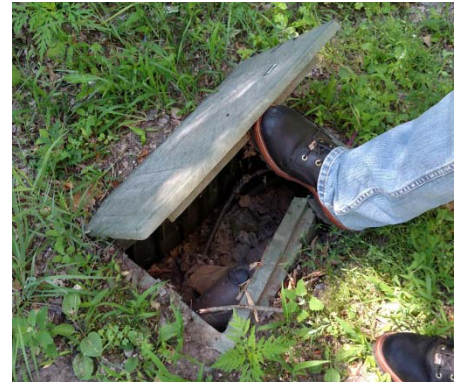
Figure 16. Broken Hand Hole

- The hand hole for telephone at the corner of Birch Bend Road is broken (Figure 16).
- Just east of the Daniel Rust House there are slope issues on both sides of the road. This is a result of previous construction which lowered the road. Retaining walls and landscaped fences may be needed if a sidewalk is installed.

1. Town to contact telephone provider to repair the broken telephone handhole at the corner of Route 31/Birch Bend Road.
2. Town to work with landowners to remove illegal signs (Figure 17).
3. Town to establish policies that inform the community that biking is allowed on sidewalks. Current state legislation allows biking on sidewalks unless the town states otherwise.
4. Town with CTDOT to discuss the “Civil War Canal” pit area and roles and responsibilities for repairing and improving it.
5. State to replace outdated signs with the current standards that are retroreflective (Figure 18).
6. Install “Share the Road” signs (Figure 19).
7. Contact Eversource to clear the vegetation off the utility poles and wires.
8. Contact CTDOT to perform routine maintenance on Route 31 of the following:
 - a. Clean out catch basins
 - b. Trim trees (Figure 20)
