COMMUNITY
connectivity program

Cromwell

Main Street (Route 99) between Sunset Drive and Geer Street; Geer Street between Main Street and Woodside Road; and Court Street between Main Street and Woodside Road – Road Safety Audit

September 6, 2016

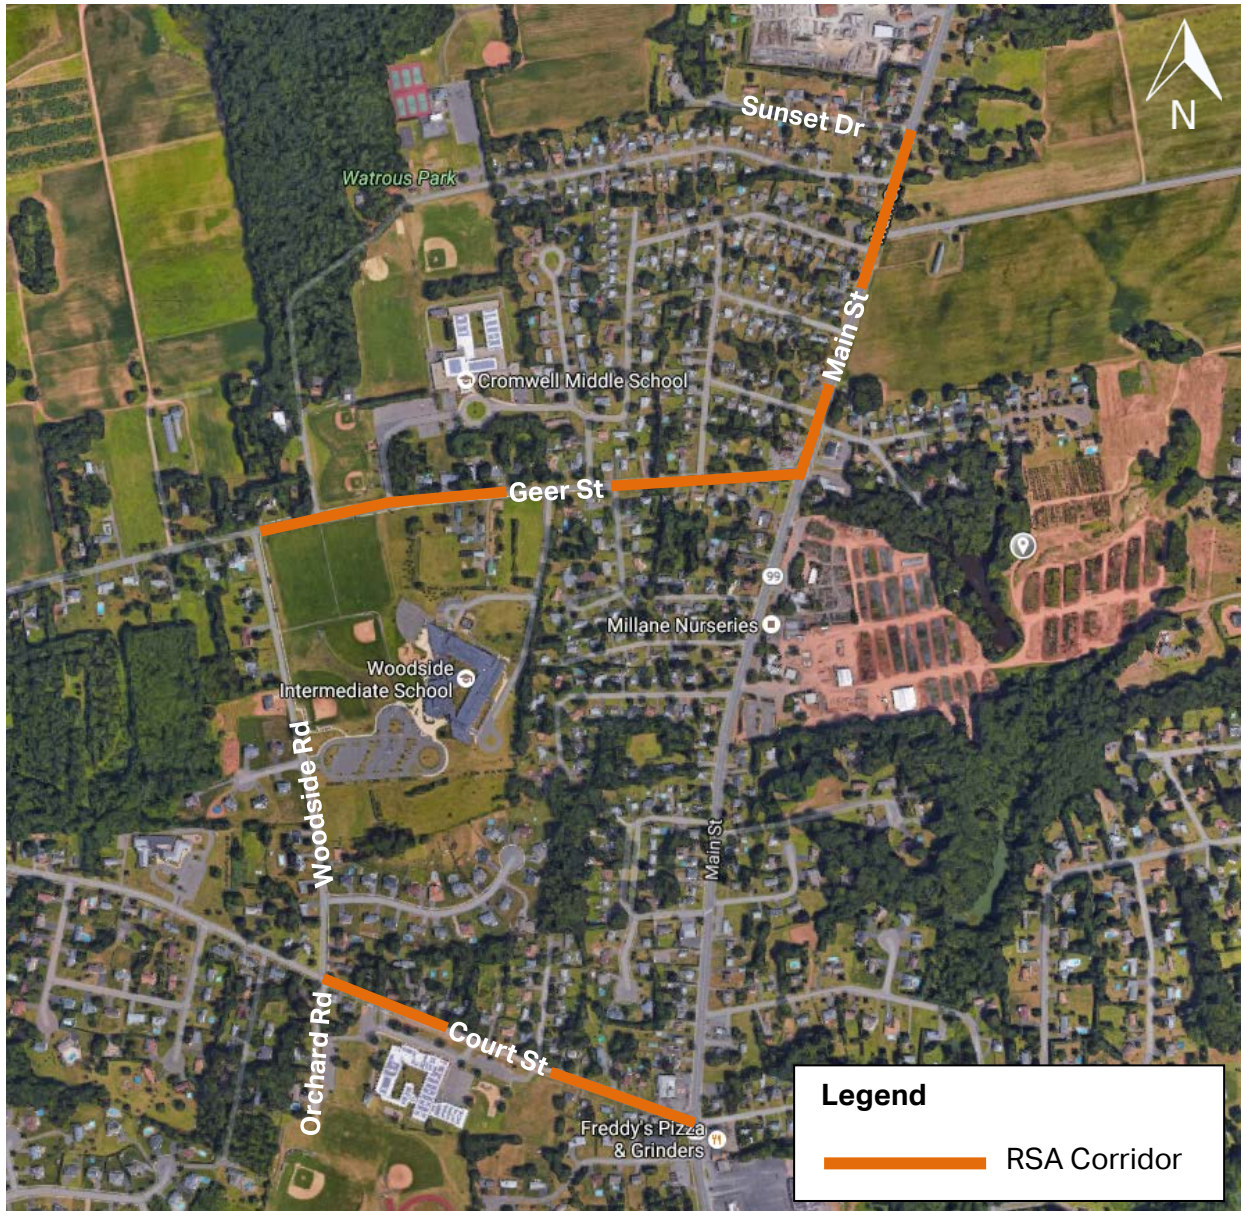
Figure 1. Main Street, Court Street, Geer Street, Cromwell

The RSA site is the section of Main Street between Sunset Drive and Geer Street; Geer Street between Main Street and Woodside Road; and Court Street between Main Street and Woodside Road (Figure 1). The Average Daily Traffic (ADT) on Main Street is between 6,900 vehicles per day (vpd) near the intersection with Geer Street and 8,100 vpd near the intersection with Court Street. Geer Street has an ADT of 1,900 vpd, while Court Street has an ADT of 3,700 vpd. All intersections throughout the study area are controlled by stop signs, except the intersection of Main Street/Court Street/Eastwood Road which is controlled by a traffic signal. Main Street contains driveways serving retail and commercial businesses, adding complexity to walking and bicycling maneuvers through the area. Figure 2 shows the regional context of the study area.

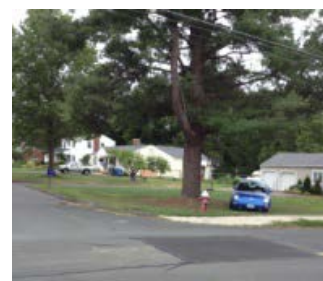
Figure 8. Sidewalk on south side of Geer Street ends at Briadon Drive

- The crosswalk signs at Raymond Place are retroreflective but are lower than minimum requirement of seven feet. The sign on south side is leaning.
- The sidewalk on south side ends at Briadon Drive. There are no detectable warning strips at the handicap ramp (Figure 8).

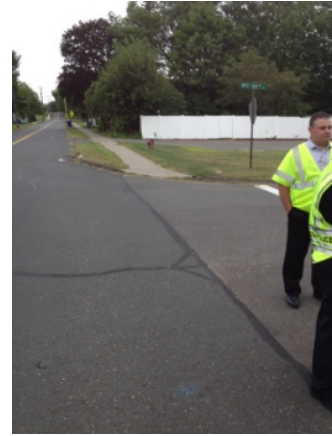
Figure 9. Intersection of West Tract Road and Geer Street

- At West Tract Road there is no crosswalk or detectable warning strips at the handicap ramps (Figure 9).
- There are utility poles and private driveways on the south side of Geer Street near Main Street which may present challenges to constructing a new sidewalk (Figure 10).
- The catch basins on Geer Street are bicycle friendly.
- There are no shoulders lines on Geer Street,

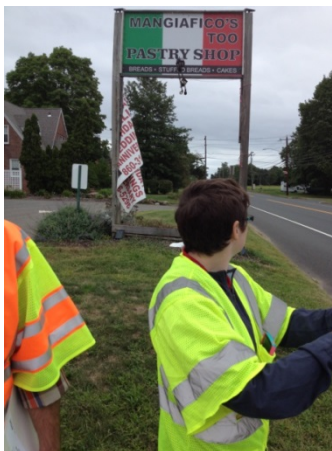
Figure 12. Business on northwest corner of Main Street/Geer Street looking north

- There is no crosswalk across Geer Street, but there is one across Main Street. On the east side there is no ramp and the crosswalk ends at a utility pole. On the west side there is a ramp but no tactile warning strip.

- The stop bar on Geer Street is set back far from the intersection.

11. The Town is to repair the fence protecting the catch basin on the southwest corner of the Court Street/Main Street intersection.
12. The Town will coordinate with CTDOT regarding moving the stop bar at Geer Street closer to the intersection (Main Street).

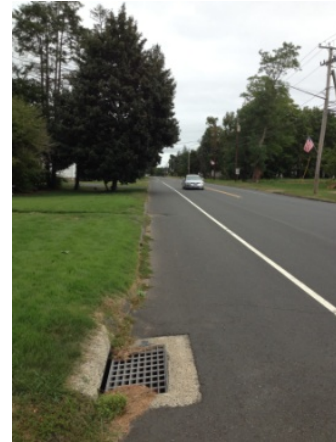
Figure 13. West side of Main Street north of Geer Street looking north

- There appear to be no major constraints to constructing a sidewalk on the west side of Main Street (Figure 13). Neighborhood monument structures may need to be relocated.
- The crosswalk at Goodrich Avenue has no handicap ramps and no crosswalk or advance crossing signs. The need to keep this crosswalk was questioned. During the TPC golf tournament a police officer is stationed at this location.
- The northbound travel lane is 11.5 feet wide, and southbound is 13 feet wide. The shoulders are seven to eight feet wide.
- The catch basin grates are not bicycle friendly (Figure 14).

1. Develop a plan and alignment and coordinate with the CTDOT for a new sidewalk on the west side of Main Street between Geer Street and Sunset Drive

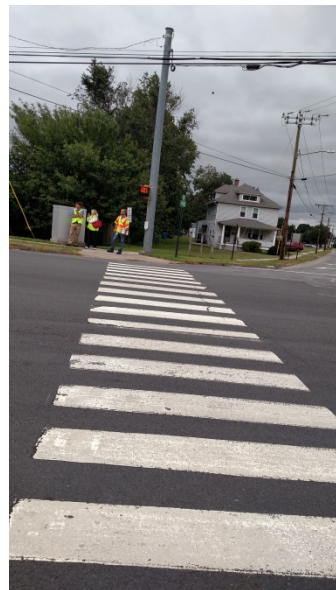
Figure 15. Main Street crosswalk

- The Court Street approach has one shared left-through lane and one exclusive right-turn lane. All other approaches have single lanes.
- There is a crosswalk (54 feet long) on the south leg of Main Street with pedestrian signal heads and pushbuttons provided on each end (Figure 15). The push buttons and placards are different on either side. The pedestrian signal heads are different styles and neither is countdown or audible.
- The pedestrian signal phase is exclusive.

- The time measured to cross Main Street with the pedestrian signal was approximately 20 seconds total, 12 of these seconds were the flashing hand indication. This time does not appear to be adequate to cross Main Street (54-foot long crosswalk).
- There are handicap ramps on the southwest and northwest corners only and no detectable warning strips (Figure 16). There is no crosswalk across Court Street.
- There is a fence/barrier, which is falling down, that protects a catch basin on the southwest corner of the intersection.

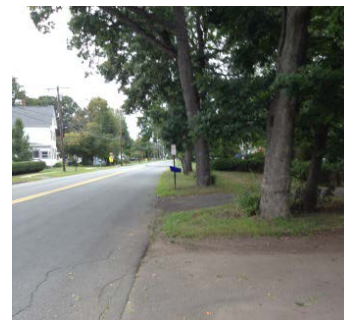
Figure 17. Trees in right of way on north side of Court Street at #32

- The Town would like to construct a new sidewalk on the north side of Court Street. There is an existing sidewalk on the south side of Court Street. It is four feet wide with a 10 foot wide buffer/snow shelf.
- Court Street is 30 feet wide and does not have shoulder lines.
- The crosswalks across the school entrances/exits do not have tactile warning strips on the ramps.
- The north side of Court Street is flat but the following minor constraints to constructing a sidewalk were noted:
 - Utility pole at #4 Court Street.
 - Water and gas lines run along the north side of Court Street.
 - Trees at #32 Court Street (Figure 17).
 - Fire hydrant at #16 and #30 Court Street.

2. Construct a new sidewalk on the north side of Court Street between Main Street and Woodside Road

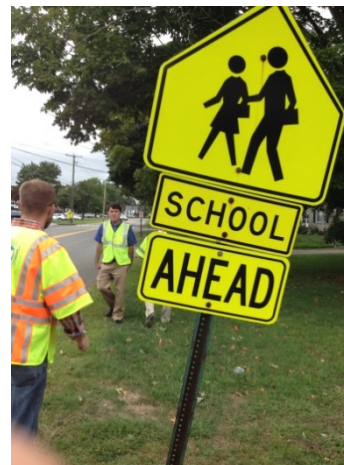
Figure 18. Tilted school crossing ahead sign on westbound Court Street west of Court Place

- Mail boxes.
- There is a leaning school crossing ahead sign facing westbound Court Street east of Court Place (Figure 18).
- There are no handicap ramps at the crosswalk across Court Street at Court Place (Figure 19).

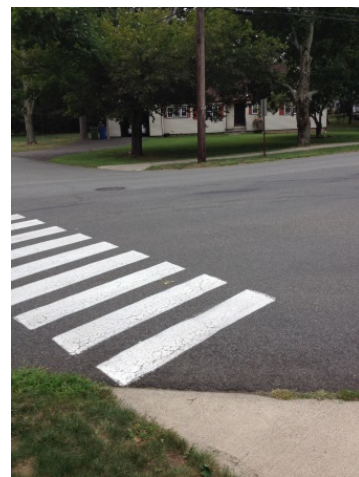
Figure 20. Northeast corner of Court Street and Woodside Road

- There is one crosswalk on the east leg of Court Street at Woodside Road and Orchard Road. There are handicap ramps on both ends of the crosswalk and on the southwest corner. There are no detectable warning strips (Figure 20).
- The pedestrian crosswalk signs and the stop sign on the Orchard Road approach are below seven feet high.
- The Town places a Yield to Pedestrians bollard at the crosswalk during the school year.
- The four-way intersection has stop control on the Woodside Road and Orchard Road approaches. The Town has considered making the intersection all-way stop controlled, but after evaluation determined the current two-way stop control provides the best operation.
