DEEP RIVER ROAD SAFETY AUDIT

ROUTE 154: MAIN STREET AND
UNION STREET TO SPRING STREET

OCTOBER 2022

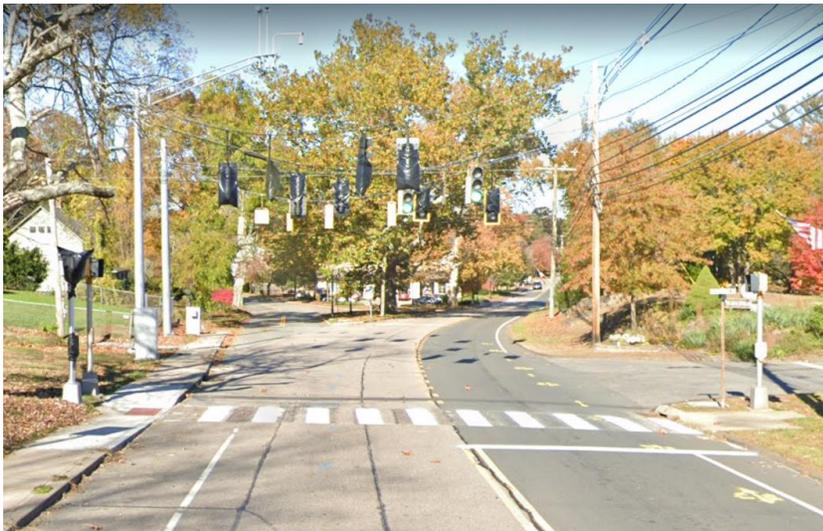
Exhibit 5: Intersection of Main Street, Union Street, and Southworth Street

Signal upgrades at the intersection of Route 154 (Main Street), Union Street and Southworth Street were completed in Spring 2022. Replacements of the signals, crosswalk indicators and pedestrian actuator buttons in addition to overhead video vehicle detection were installed as part of this work effort. Exhibit 5 shows the newly painted crosswalk and signal equipment.

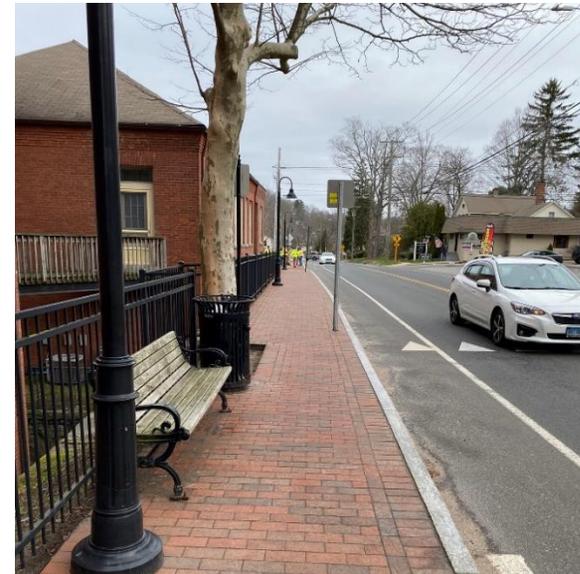
Exhibit 6: Streetscape design along Main Street

Brick sidewalks were installed along Main Street at various stages over the past 15 years. This work included the installation of pedestrian scale light posts that run throughout the downtown. Exhibit 6 displays Deep River's Main Street.

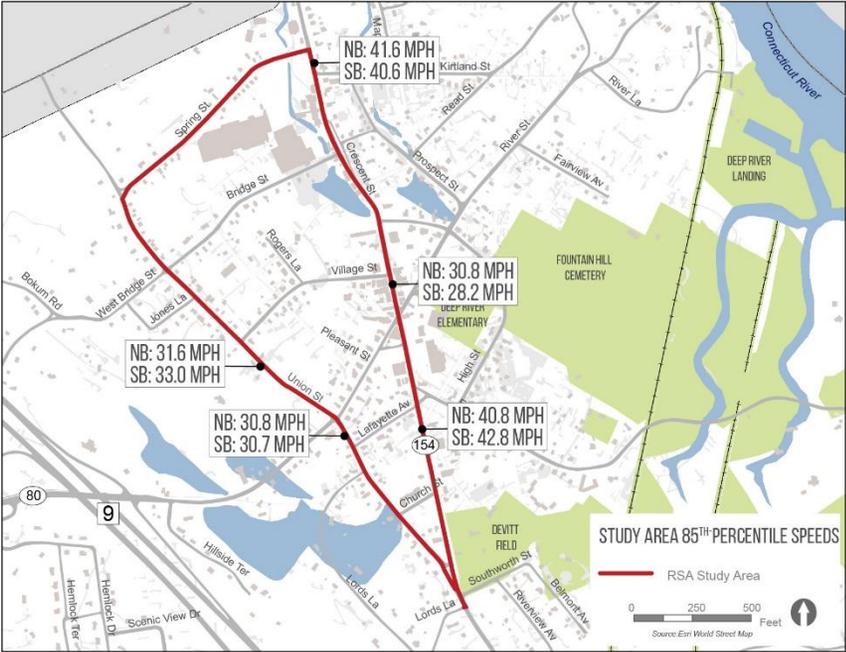
Exhibit 8: Study Area Observed 85th-Percentile Speeds

Exhibit 8 shows the observed 85th-percentile speeds at various locations in the study area. 85th percentile speeds range from 28.2 MPH on Route 154 (Main Street) in the southbound direction approaching Route 80 (Elm Street) and as high as 42.8 MPH on Route 154 (Main Street) in the southbound direction south of Lafayette Avenue.

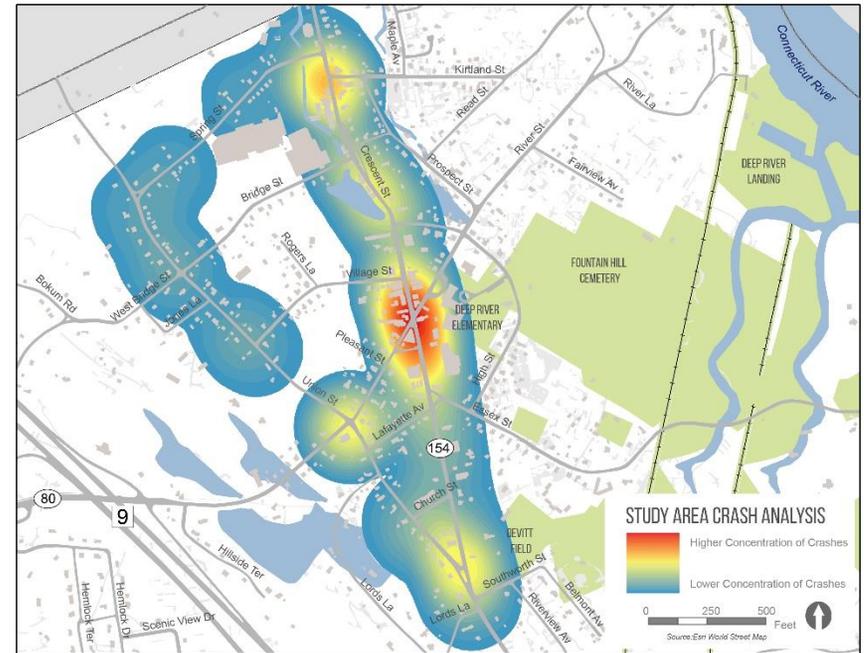
Exhibit 10: Study Area Crash Heatmap

Crashes: Based on data retrieved from the Connecticut Crash Data Repository (CTCDR) for the five-year period between January 2016 through December 2020, there were a total of 75 crashes in the Deep River RSA study area. Crashes were concentrated in the vicinities of the Route 154 (Main Street) / Route 80 (Elm Street) intersection in the commercial area, the intersection of Route 154 (Main Street) at Kirtland Street, the four-way intersection of Route 80 (Elm Street) and Union Street, and the signalized intersection of Route 154 (Main Street), Union Street, and Southworth Street. Exhibit 9 displays the study area crash summary and Exhibit 10 displays a study area crash heatmap.

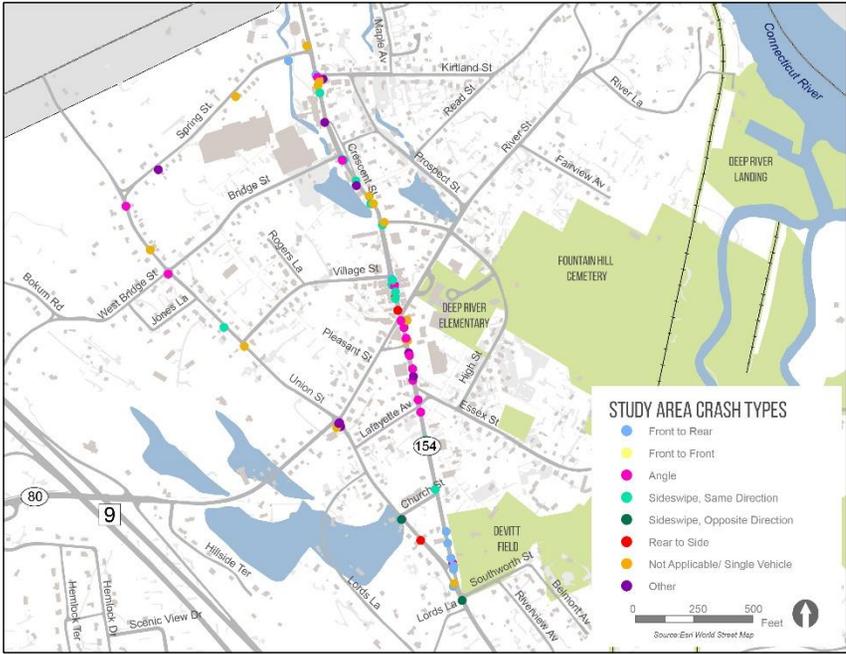
Exhibit 12: Crashes by Type

Crashes by Type: The majority of crashes are angle crashes, single vehicle crashes or a sideswipe same direction crash. Single vehicle crashes are indicative of crashes where motorists veered off the road, ran into a guardrail, etc. The “rear-end” crashes are common in areas of stopped traffic such as an approach to an intersection, commercial area, or in areas with many driveways. Other types of crashes including angle crashes and sideswipe crashes are common in areas with ingress and egress movements such as business areas. Exhibit 11 and Exhibit 12 display the location and breakdown of crashes by type in the corridor.

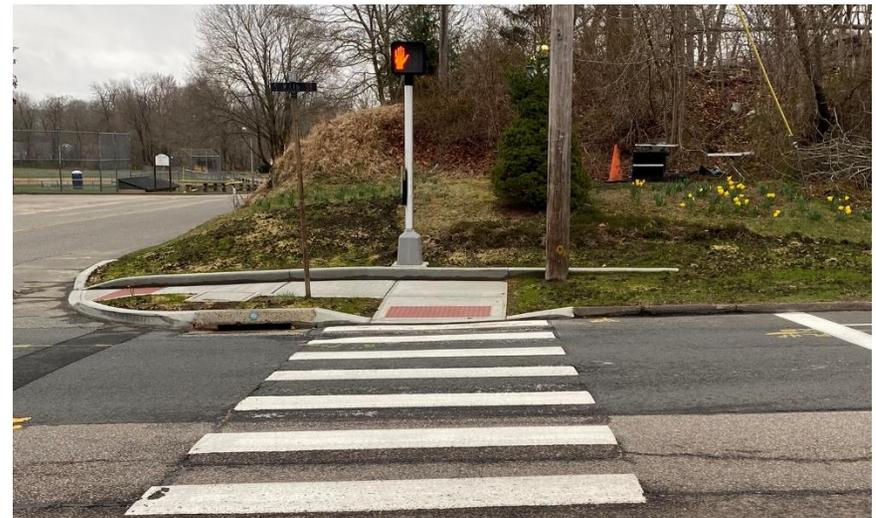
- People often cross Route 154 at the north end of Devitt Field to access the ball fields and playground. There is no crossing at this location and it does not seem to be a safe location for a crosswalk due to the proximity to the intersection.
- There is a crosswalk missing on the Union Street approach to the intersection. Exhibit 19 displays this location.
- Speeding is in issue in this location. Speed limit is 40 mph south of the intersection and quickly slows to 30 mph to the north of this intersection.

Exhibit 18: Crosswalk on Route 154 south of Southworth Street

The recommendations at this intersection are two-fold: first, to provide safer pedestrians connections between Devitt Field and the existing sidewalks on Route 154 (Main Street), and second, to explore additional redesign options at this intersection which can enhance this intersection's role as a gateway for motorists entering the village center from the south.

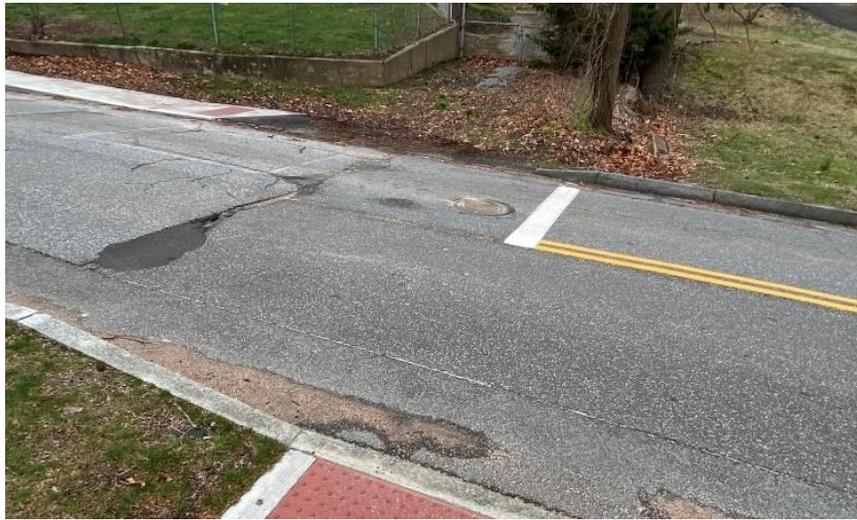
Exhibit 19: Missing crosswalk at Union Street

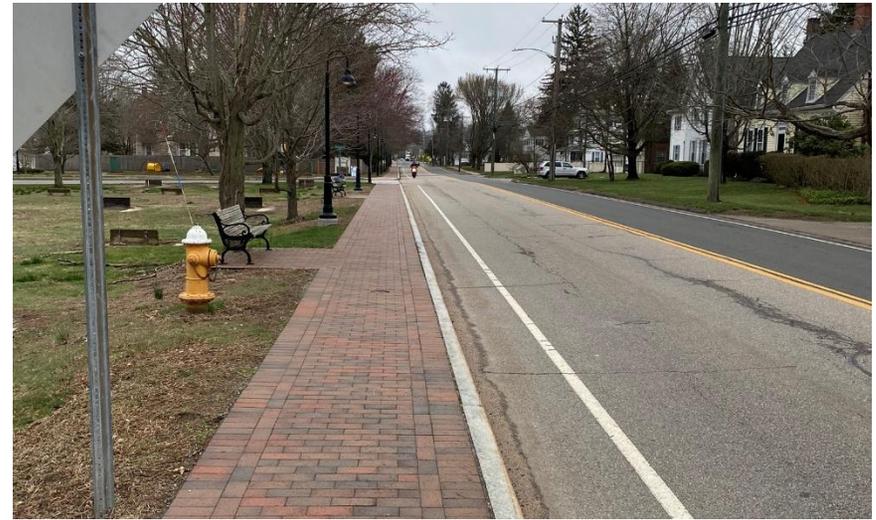
Exhibit 20: Main Street near Church Street. View looking north.

- Speeding is an issue in this area.
- This area is very busy with events during warmer months. The church green space hosts a horseshoe league on Mondays and Thursday evenings, while the Deep River Historical Society also hosts events such as weddings. People often park along Church Street and cross at this location without a crosswalk. See Exhibit 20.

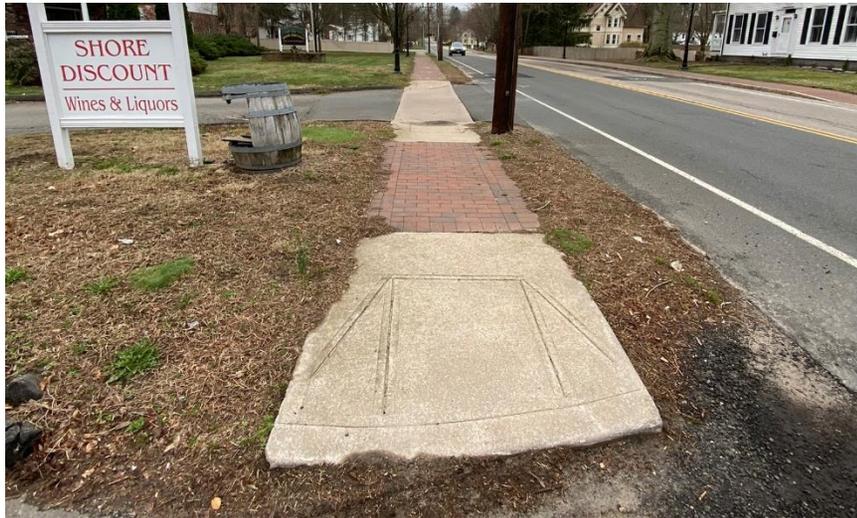
- Pedestrians often cross Main Street at this location, but there is currently no crosswalk.
- The entrance/exit driveway to 211 Main Street (Shore Discount Liquors) causes confusion. See Exhibit 21 for a view of the driveway.
- Vehicle speeds are an issue at this location.
- Representatives from the inn noted that delivery trucks in this area often drive over a raised manhole in the road at this location. This results in a loud noise for visitors at the inn. CTDOT personnel observed this location in 2019 and did not notice any unusual traffic noise and found that paving joint was within CTDOT tolerances.
- Sidewalk lacking in front of Riverwind Inn.

Exhibit 21: Driveway to 211 Main Street (Shore Discount Liquors)

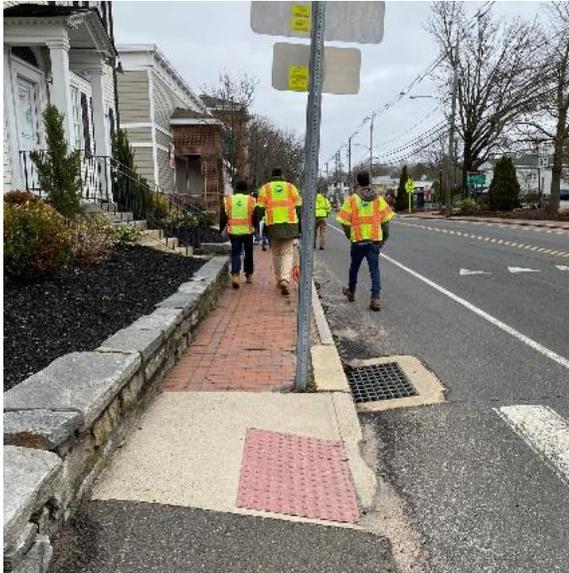
Exhibit 23: Signage in the sidewalk causing an obstruction on Main Street

- Participants felt that Route 154 (Main Street) had too much signage in this area. Participants noted that due to the number of signs, signage is not effective for drivers. The amount of signage also takes away from the visual character of the area and sometimes causes obstructions in the sidewalk.
- Exhibit 23 shows a location in the study area with a sign installed which is narrowing the sidewalk width.
- Eversource installed additional cobra head lighting in the commercial area, but the area is lacking pedestrian scale lighting.
- Entrance to 193 Main Street (Adams Market) is busy in this area.

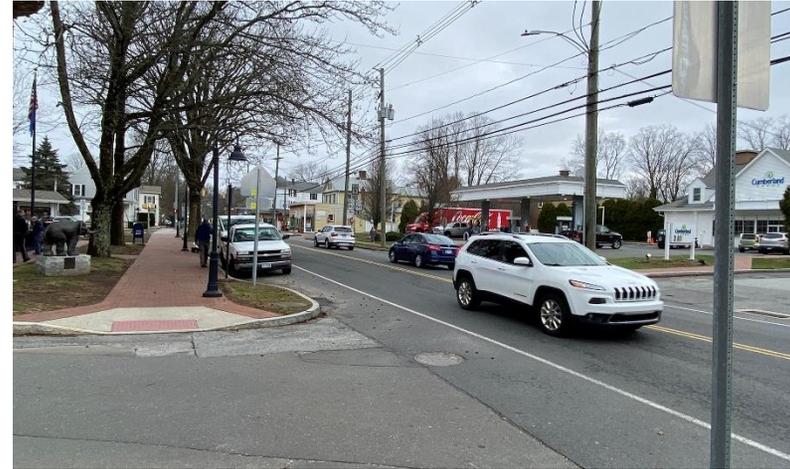
Exhibit 24: View of Route 154 looking north toward Cumberland Farms and Route 80 (Elm Street) Intersection

- Very busy area between Essex Street and the intersection with Route 80 (Elm Street). There is a lot of turning movements into and out of the businesses in this area. See Exhibit 24 for a photo of this area.
- Many drivers do not yield to pedestrians at crosswalk on Route 154 (Main Street) between Adams Grocery Store and Walgreens Pharmacy. This could be a suitable location to install a raised crosswalk.
- 9 – Town Transit stops at this location, is a busy pick-up and drop-off location.

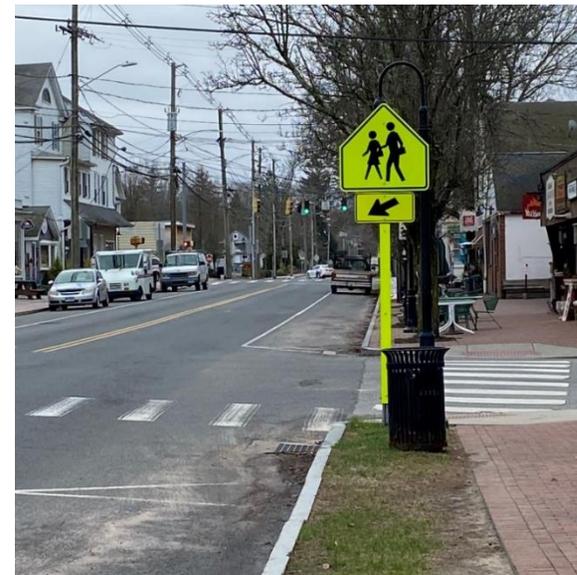
- This is one of the busiest pedestrian crossing locations in Town.
- Parking is striped closely to crosswalk which makes it difficult to see pedestrians waiting to cross as their view is occluded by parked vehicles. Current design does not meet state law prohibiting parking within 25-feet of crosswalks or intersections.
- Additionally lighting or a raised crosswalk should be considered at this location.
- The crosswalk is missing a curb ramp on the eastern side
- See Exhibit 27 for a photo of the crosswalk.

Exhibit 27: Crossing on Main Street and Village Street

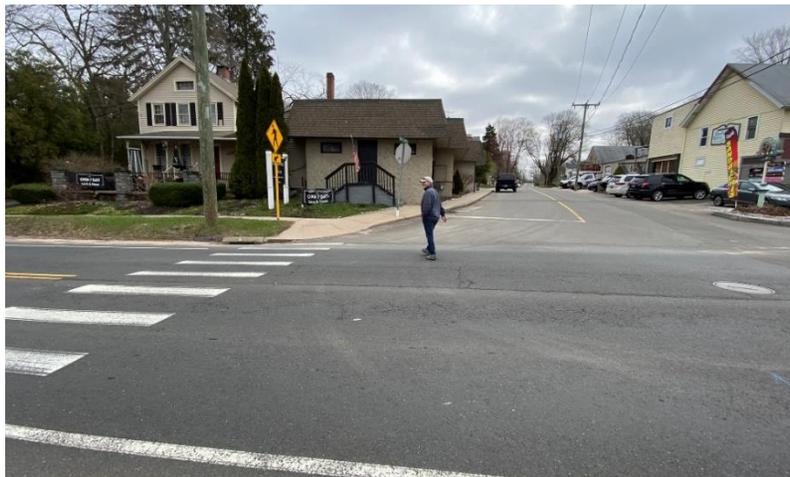
Exhibit 28: Intersection of Main Street and Kirtland Street

- Many residents of Piano Works utilize the on-street parking.
- Intersection with Kirtland Street has seen several vehicle crashes. See Exhibit 28 for a photograph of this location.
- Speeding is an issue at this location.
- Drivers often do not yield to pedestrians in this location.
- There is no crosswalk across Kirtland Street.
- On-street parking in the northbound direction in the area of Bridge Street can be difficult to see and to access parked vehicles
- The parking lot to 83 Main Street (EmJay's) creates poor delineation in the roadway and does not provide pedestrian accommodation
- Signage on the northeast corner should be evaluated to ensure it does not pose a sightline obstruction for exiting traffic from Kirtland Street.

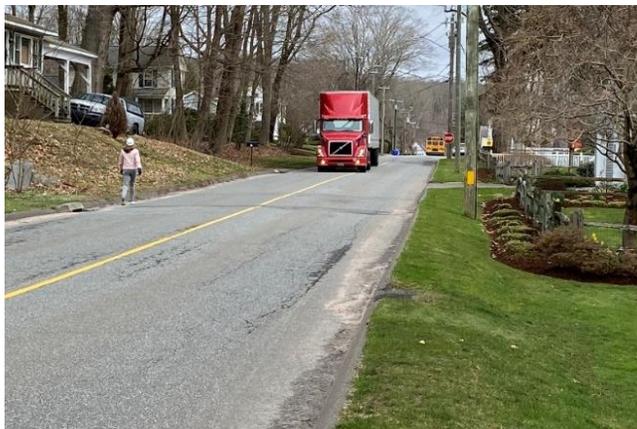
Exhibit 30: Lack of Sidewalk on Union Street

- Sidewalk missing on Union Street between Village Street and Route 80 (Elm Street), see Exhibit 30.
- A significant wetland exists to the north of Route 80 (Elm Street).

- 1) Consider sidewalks on the west side of Union Street
- 2) Continue sidewalks on south side of Route 80 (Elm Street) between Union Street and Hemlock Drive

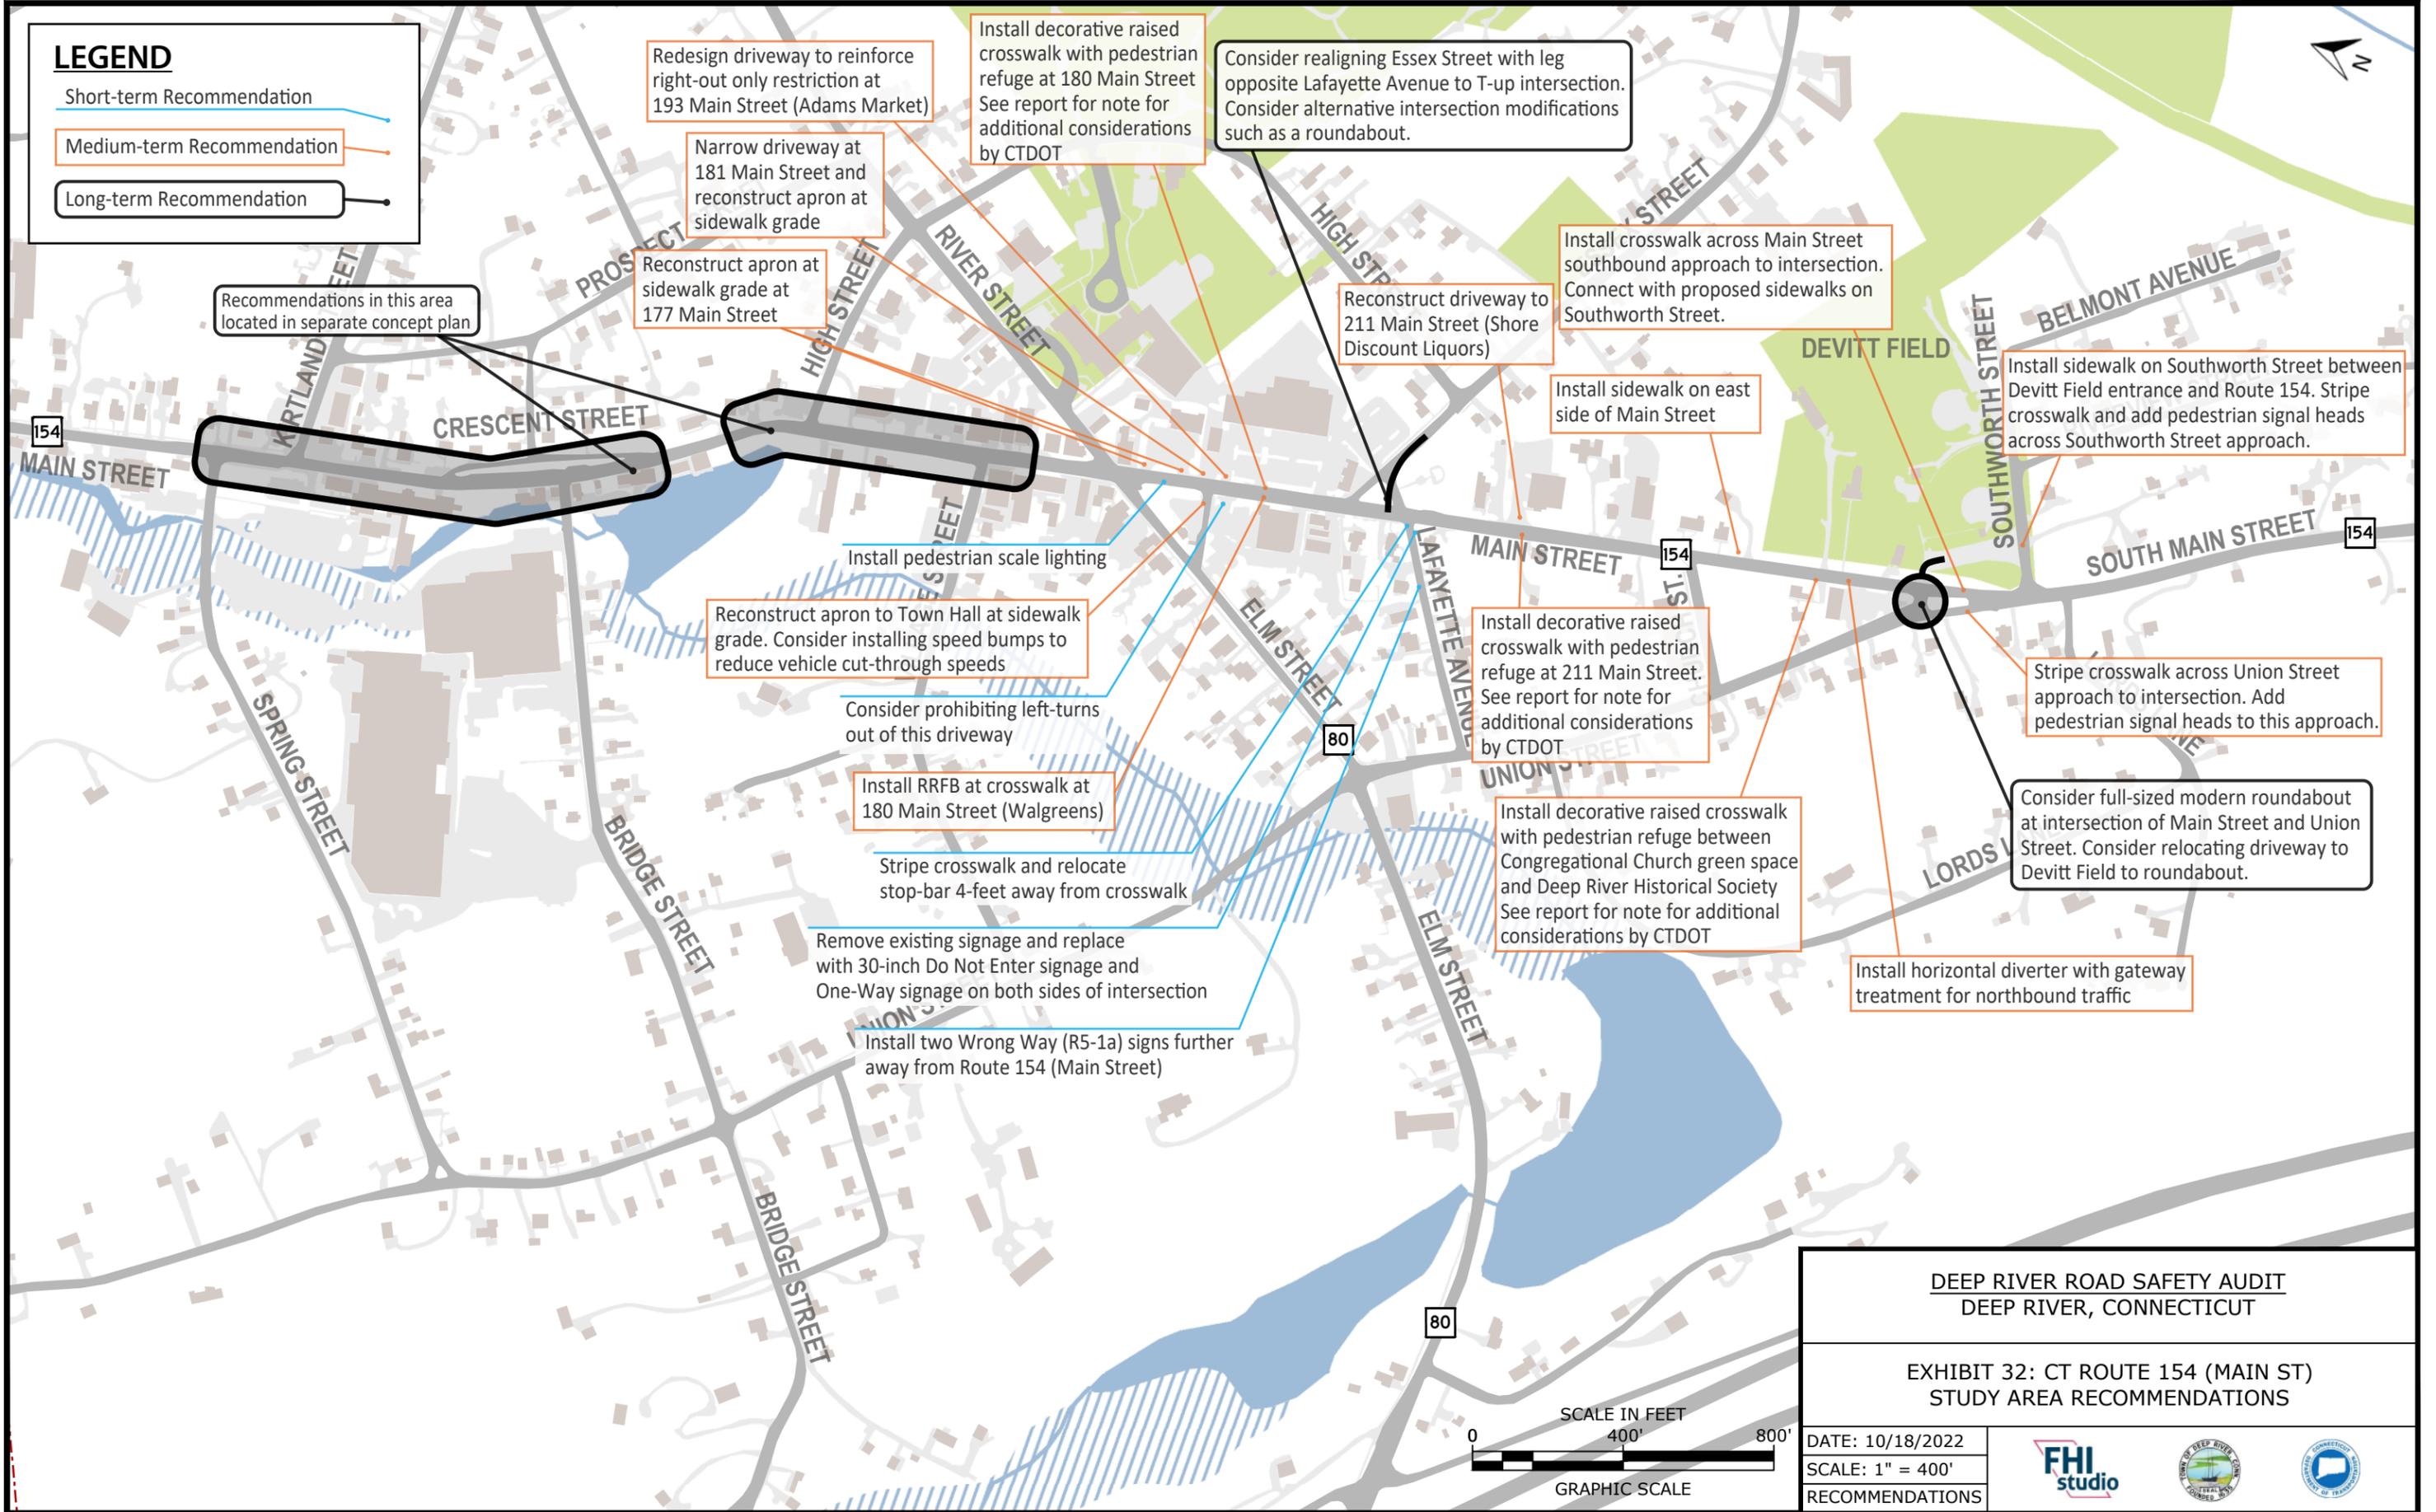
**EXHIBIT 32: CT ROUTE 154 (MAIN ST)
STUDY AREA RECOMMENDATIONS**

Redesign driveway to reinforce right-out only restriction at 193 Main Street (Adams Market)

Remove existing signage and replace with 30-inch Do Not Enter signage and One-Way signage on both sides of intersection

Exhibit 32 and Exhibit 33 display the recommendations of the overall study area on a map. Exhibit 32 includes recommendations on Route 154 (Main Street) while Exhibit 33 shows recommendations for Spring Street and Union Street. Further detail is provided in the sections below, while Exhibit 45 and Exhibit 46 provided conceptual graphics of Route 154 (Main Street) between Route 80 (Elm Street) and High Street, and Route 154 (Main Street) between Bridge Street and Kirtland Street areas respectively.

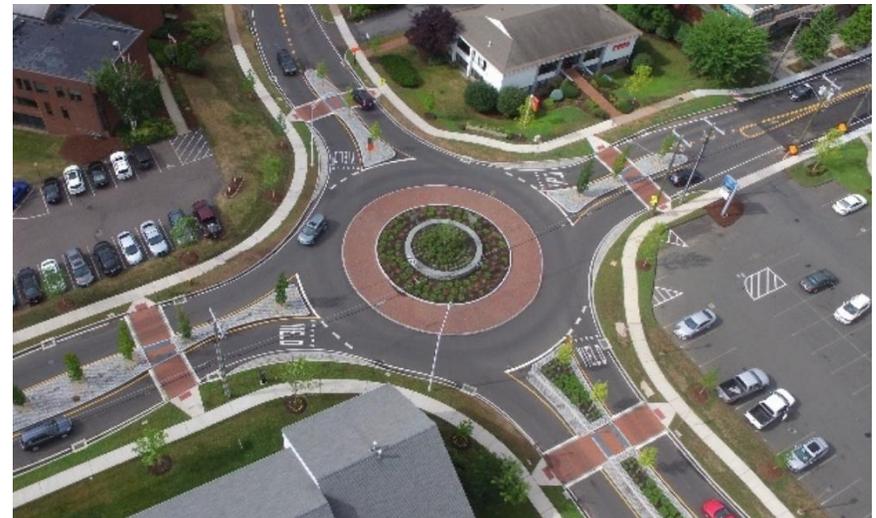
Exhibit 34: A modern roundabout in Glastonbury, CT serves a safer intersection control compared to a conventional signalized intersection¹ but also reduces vehicle travel speeds and serves as a gateway for motorists entering the town center. (Source: FHI Studio)

¹Roundabouts overall have been found to have a 78% reduction in crashes resulting in fatality or injury compared to signalized intersections. This is based

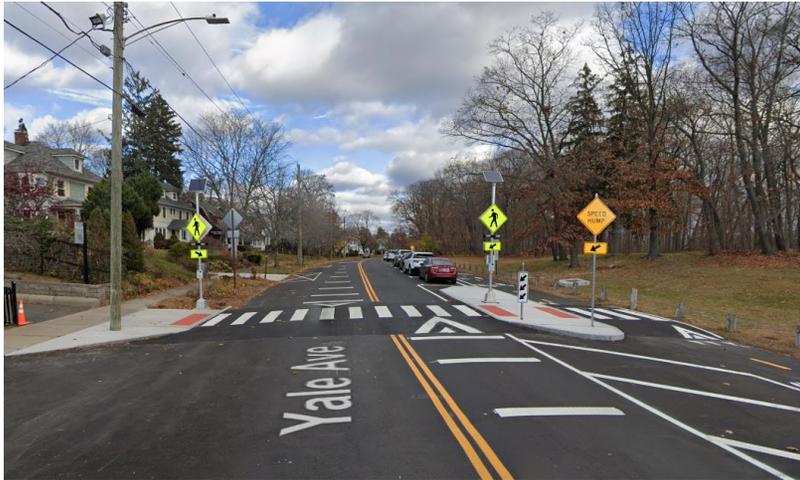
Exhibit 38: Raised crosswalk in New Haven, CT on Yale Avenue (Source: Google Maps Streetview)

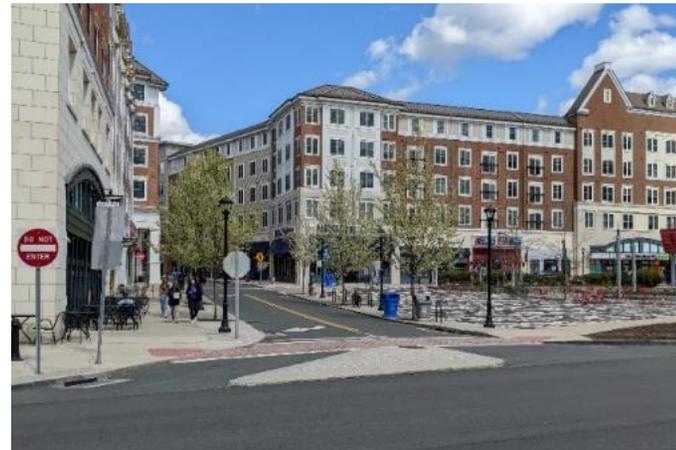
Exhibit 42: A right-out design restriction in Storrs, CT designed to not permit left-turns out. (Source: FHI Studio)

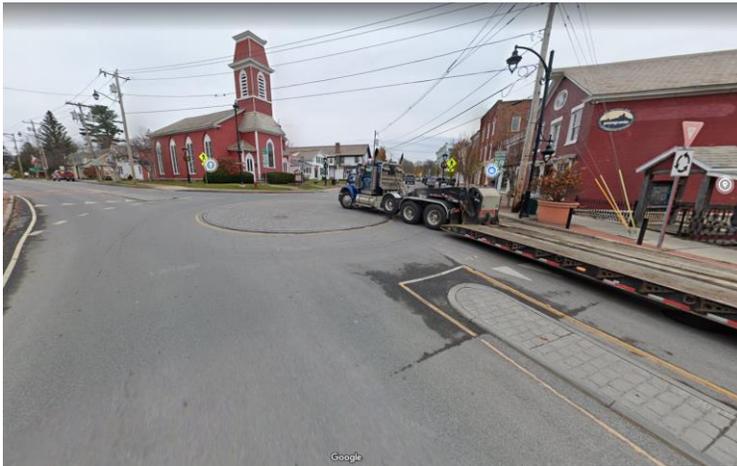
Exhibit 43: Example of a mini-roundabout in Manchester, VT with a diameter of 65-feet. Note the decorative, mountable center island to allow large vehicle movements. (Source: Google Maps Streetview)

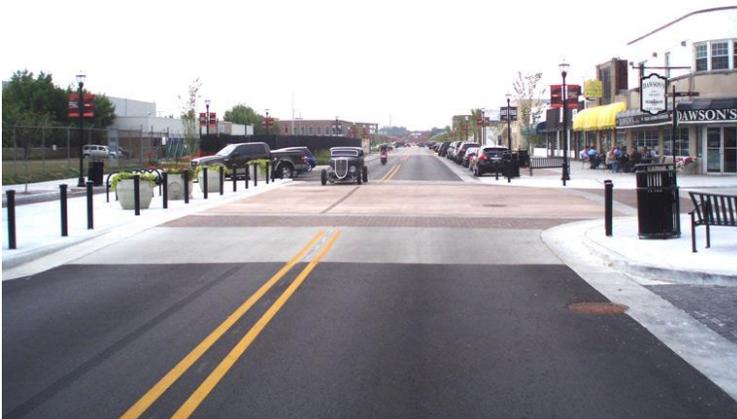
Exhibit 44: A raised intersection with decorative materials (Source: ABAAT.org)

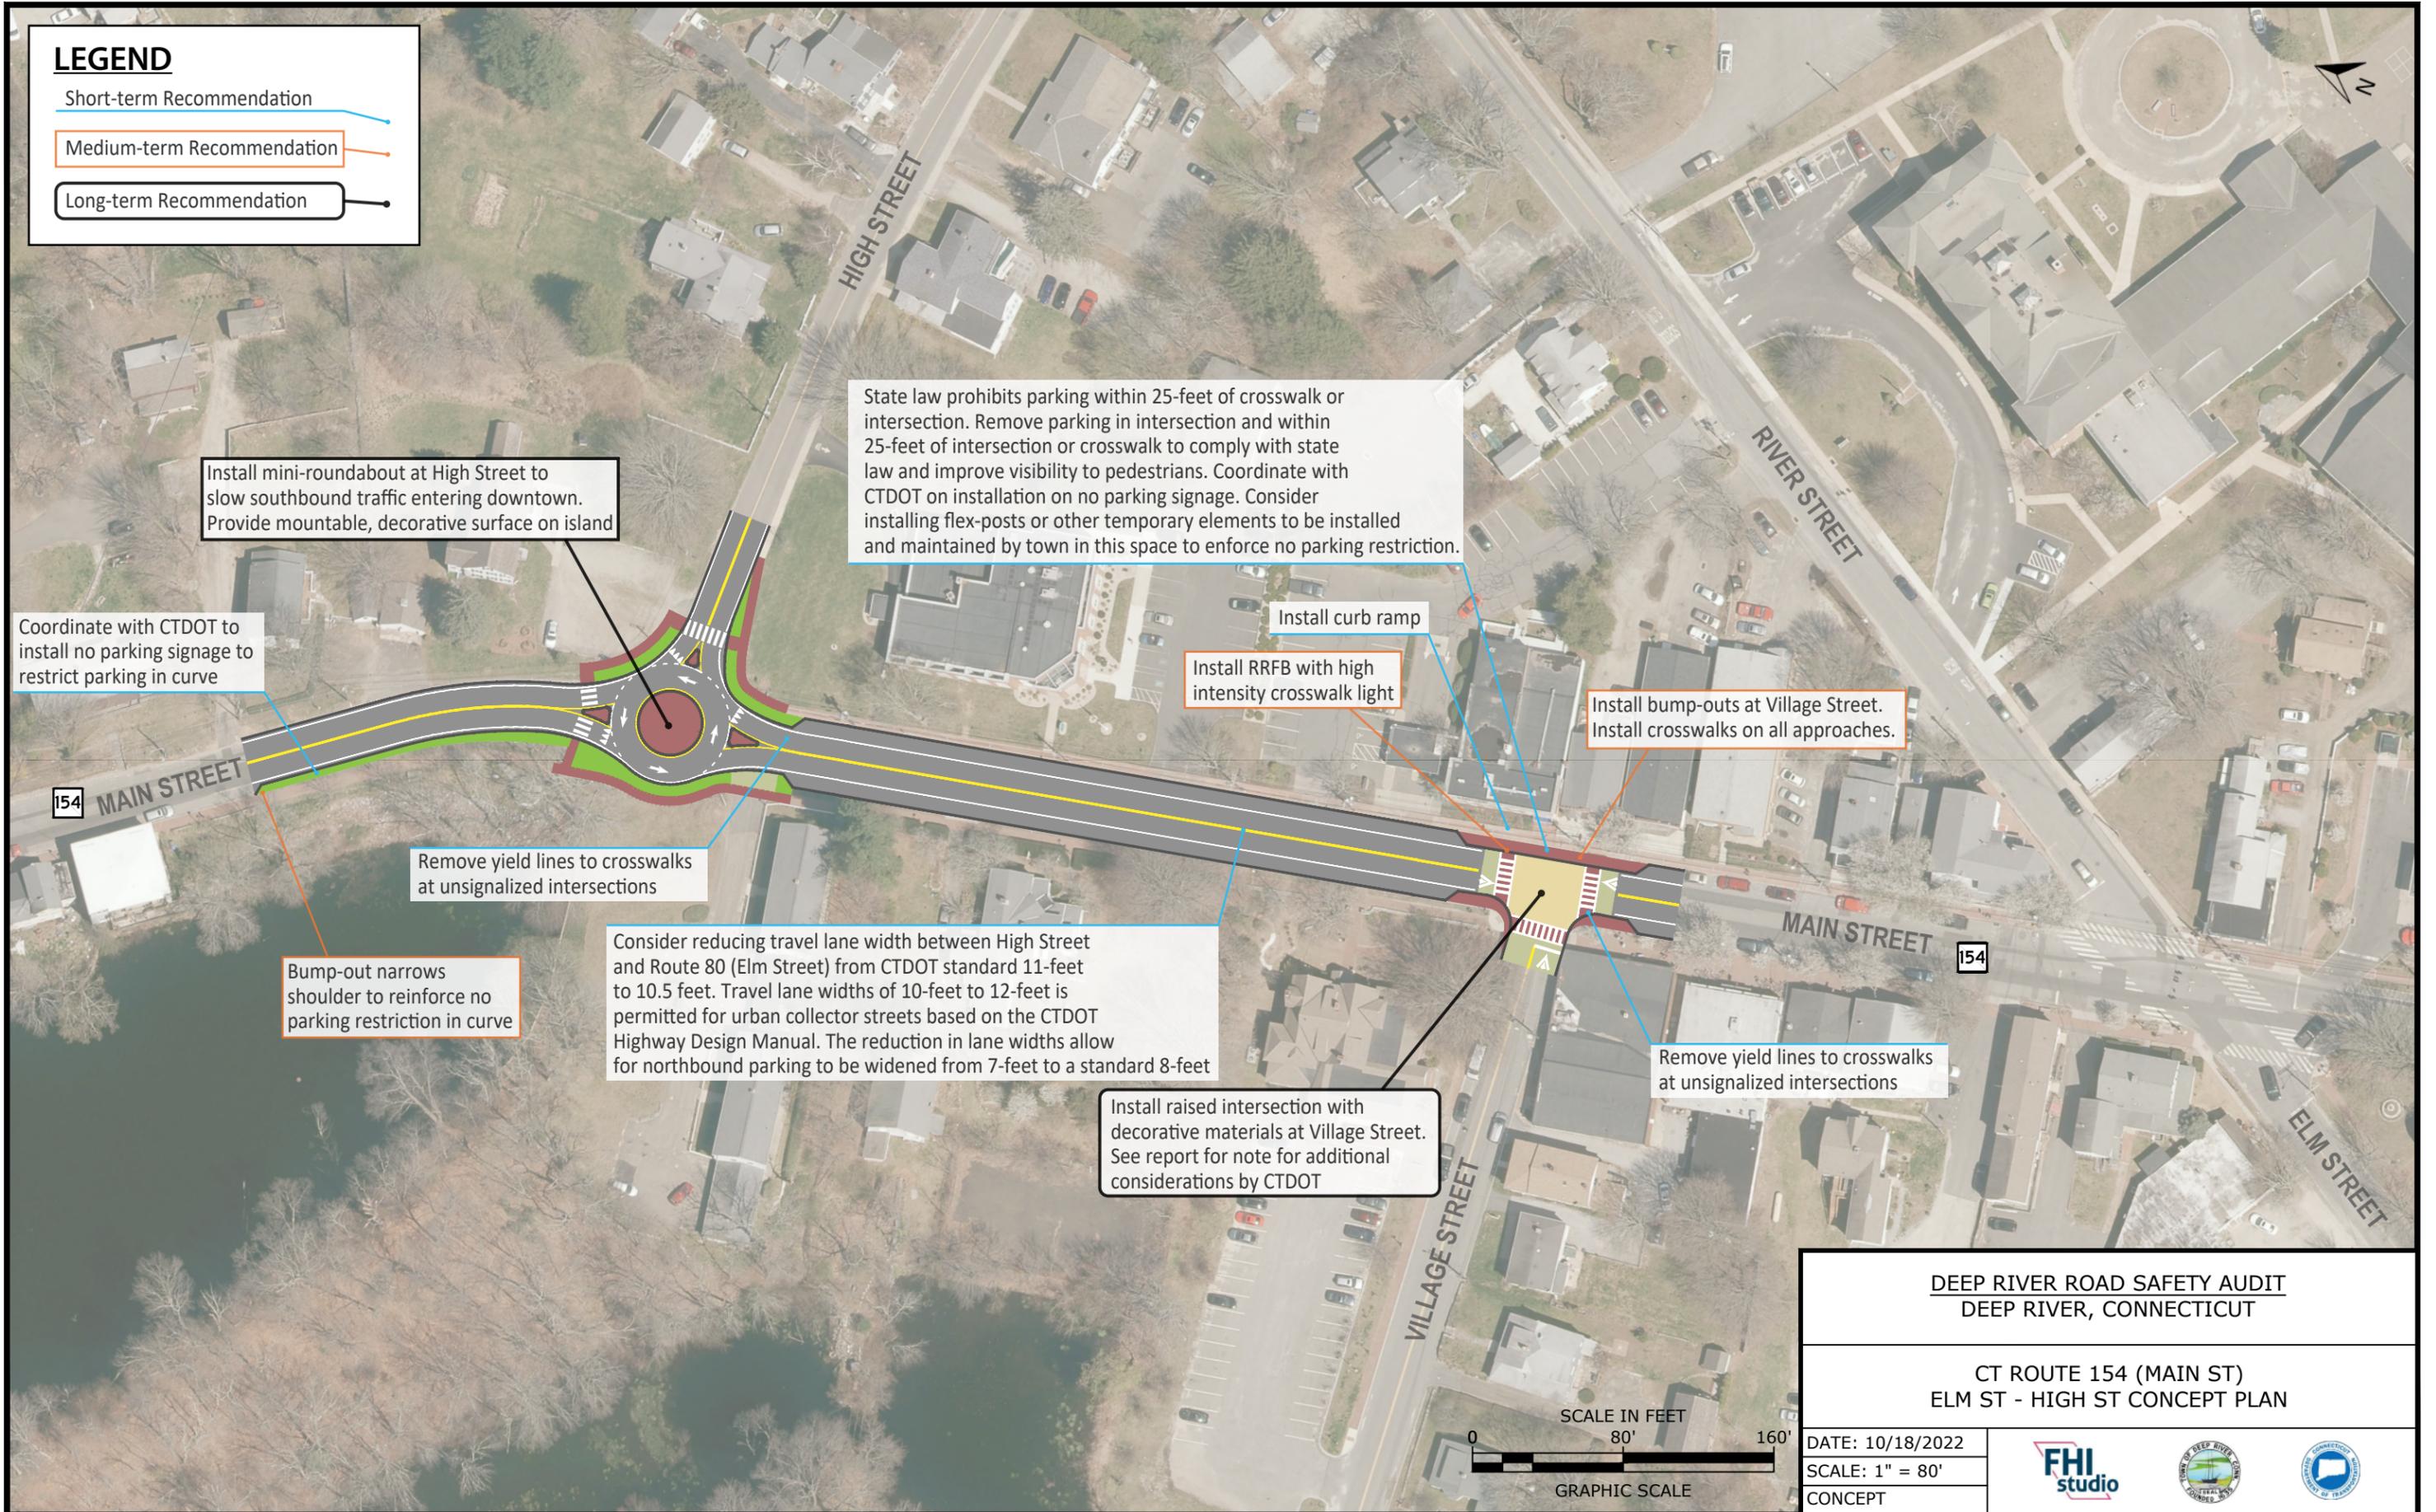
Install mini-roundabout at High Street to slow southbound traffic entering downtown. Provide mountable, decorative surface on island

Exhibit 45 depicts these recommendations as a conceptual plan.

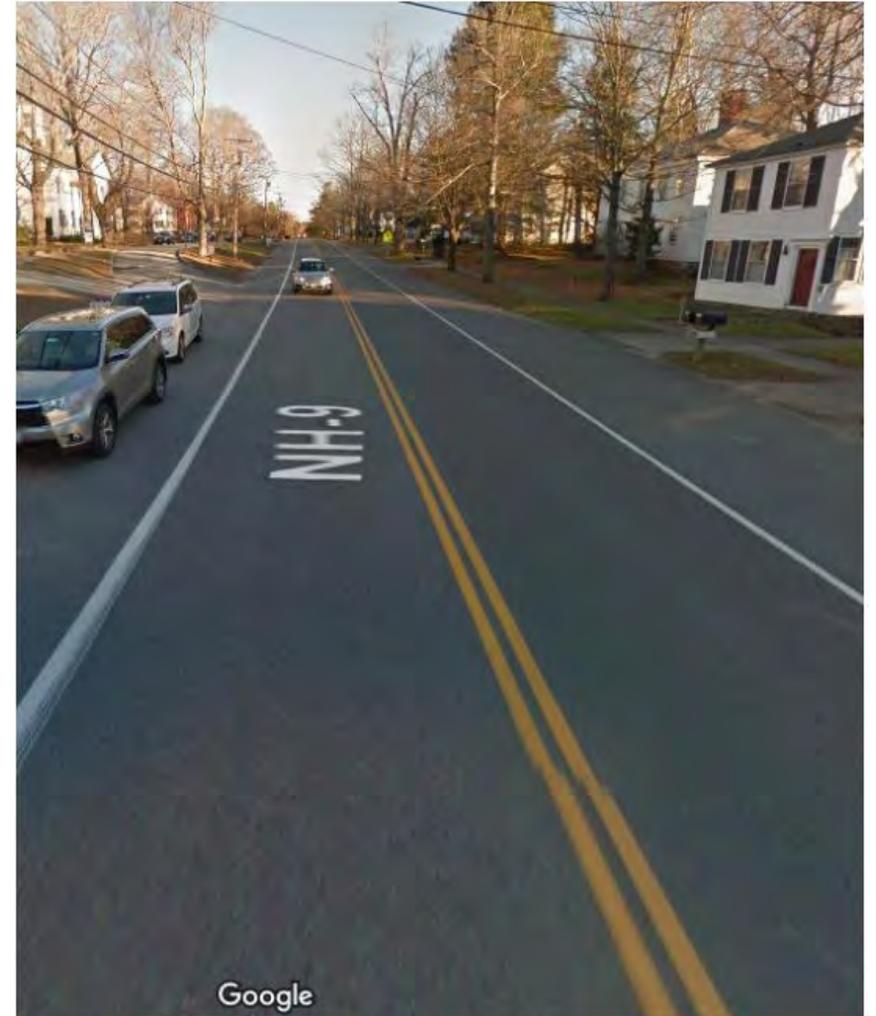
A 10-ft lane installed in Hopkinton, NH

- Standard CTDOT lane width is 11 feet
- Narrow lane width (as low as 9 feet) can promote slower speeds and provide space for other purposes
- Narrower width may be appropriate in areas with limited daily traffic and truck traffic

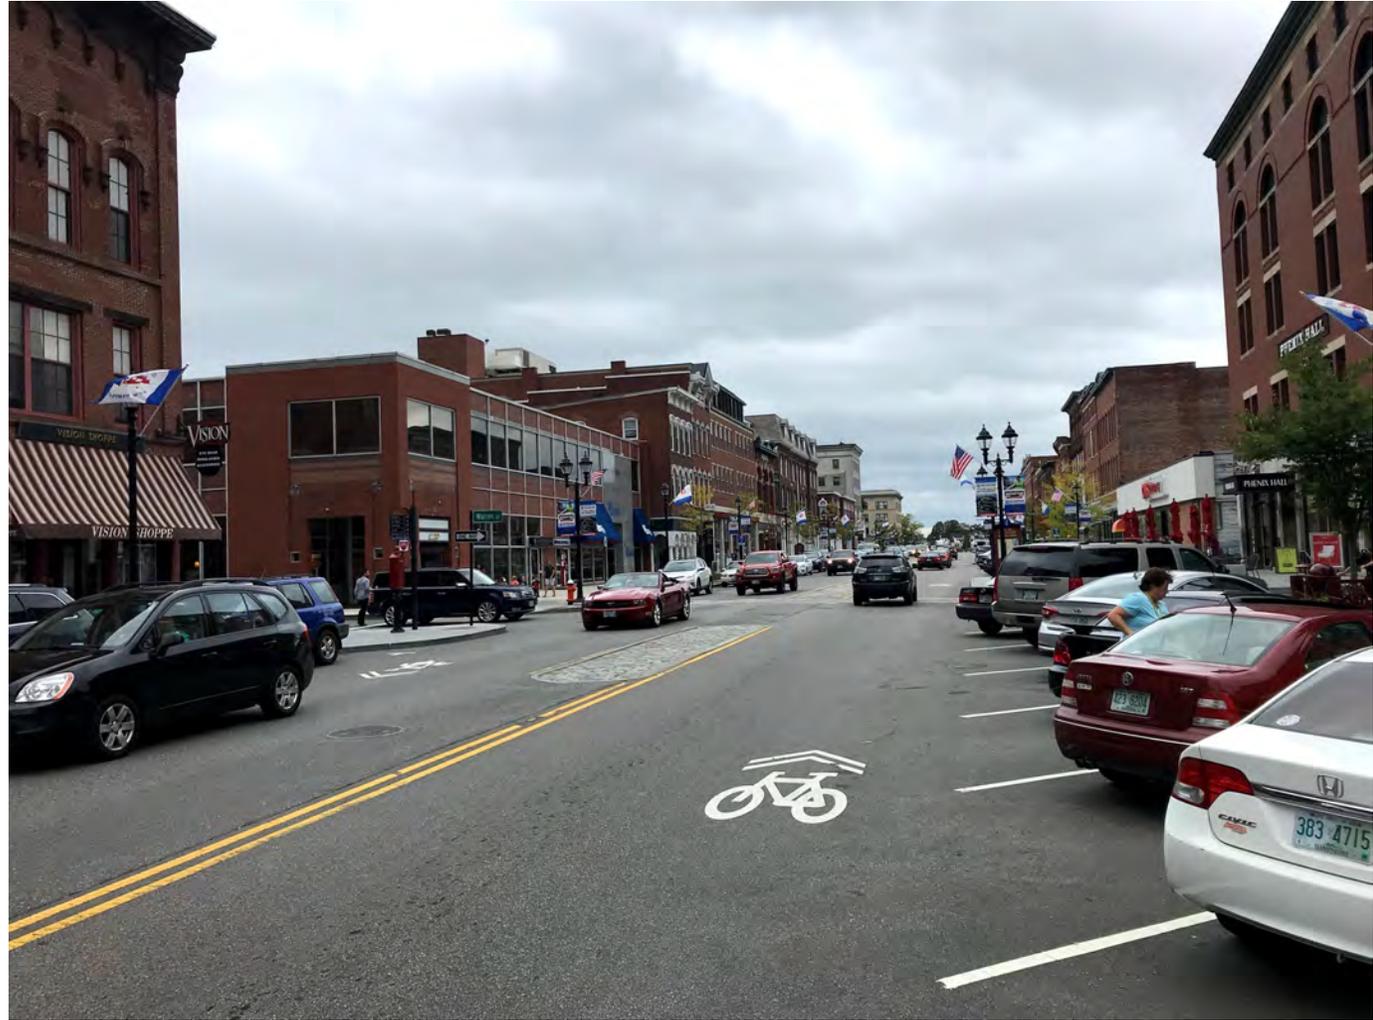
Bike Sharrow in Concord, NH

- Bike sharrow markings in lane can alert motorists to presence of bicyclists in roadway
- Sharrows likely appropriate based on vehicular volumes near beach and target speeds in this area

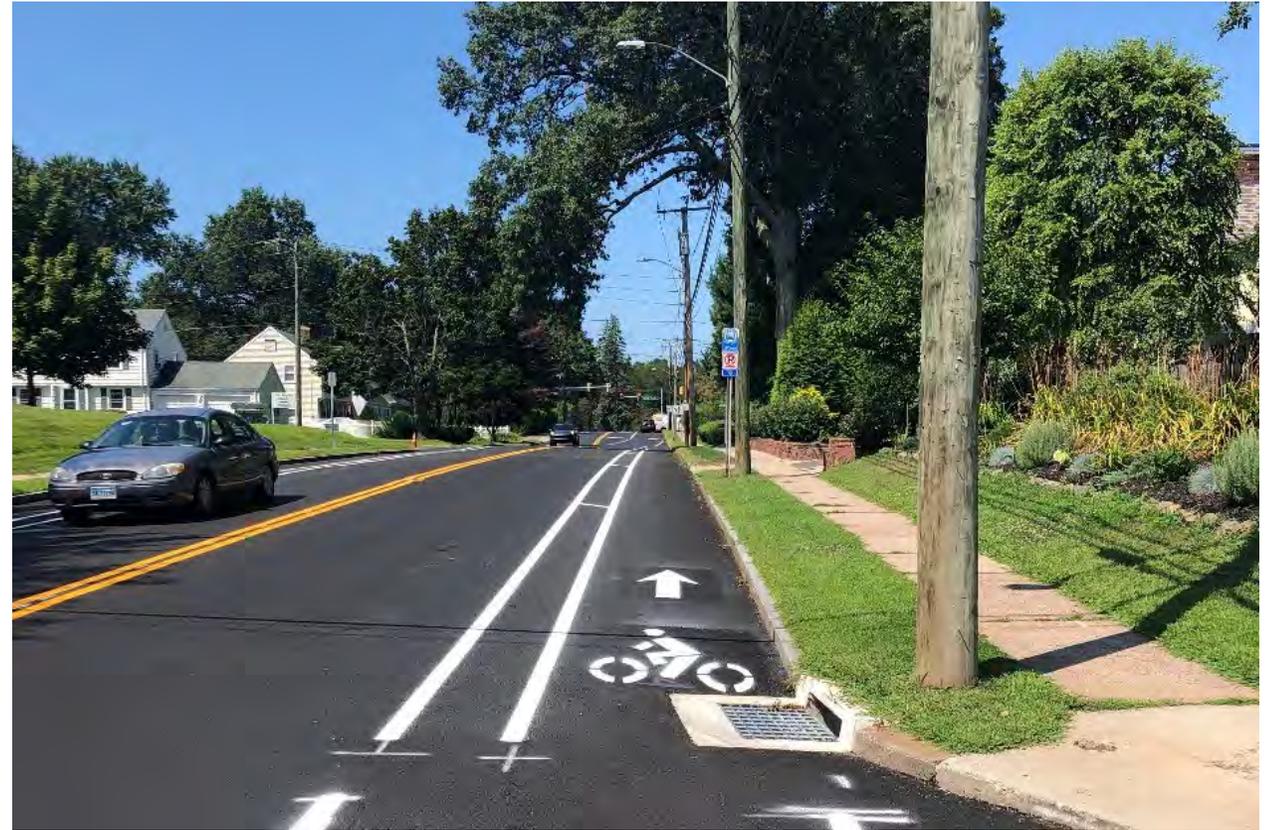
Buffered Bike Lane in West Hartford, CT

- Bike lanes and other bike facilities can provide comfortable bike travel in ROW
- A buffer can also be striped to reinforce separation from motorists

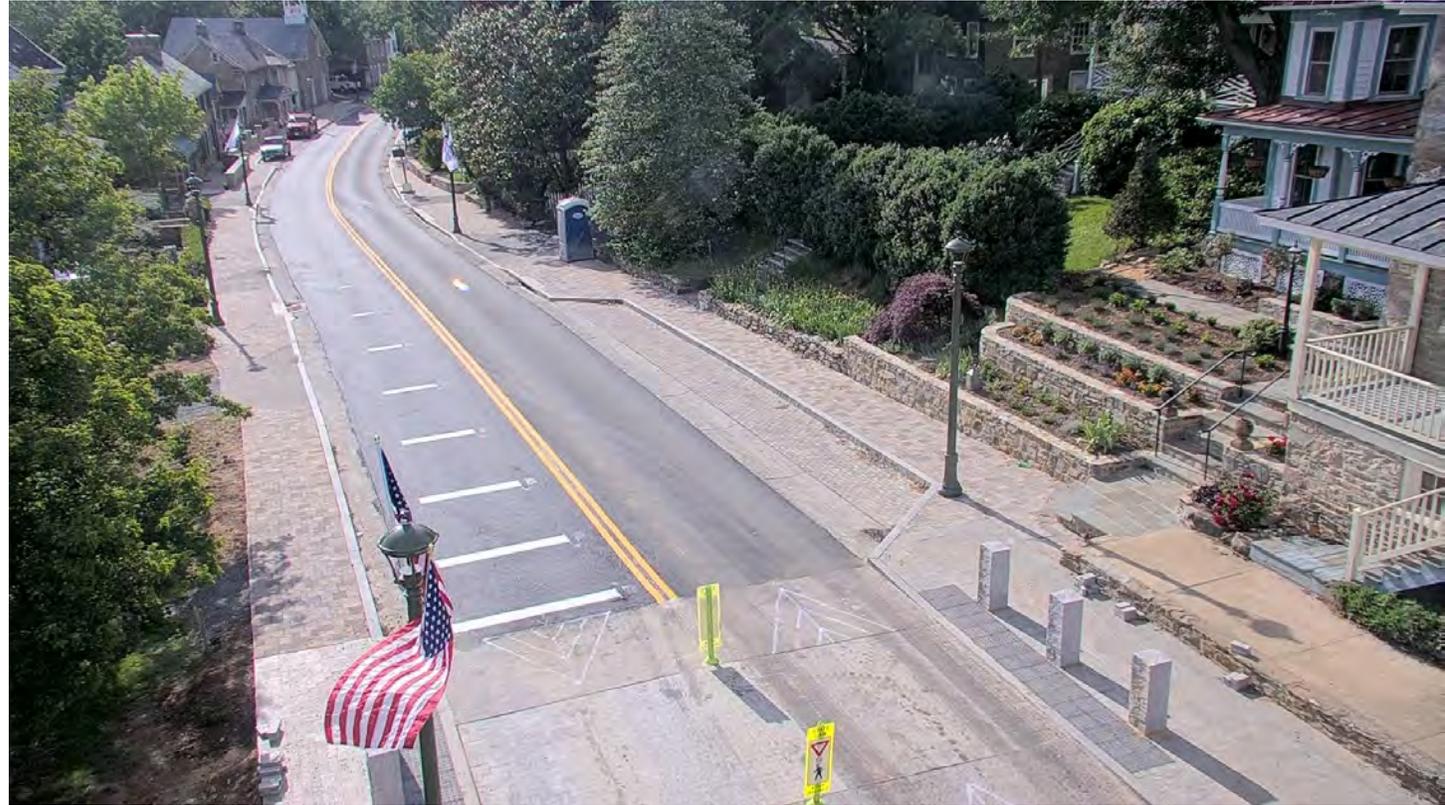
- Improves pedestrian safety by causing motorist speeds to decrease at the crossing.
- Typically between 3 and 6 inches above street level. It is common for a raised crosswalk to be level with the street curb.
 - Height increases the visibility of a pedestrian in a crosswalk to a motorist.
