DEEP RIVER ROAD SAFETY AUDIT

ROUTE 154: MAIN STREET AND
UNION STREET TO SPRING STREET

OCTOBER 2022

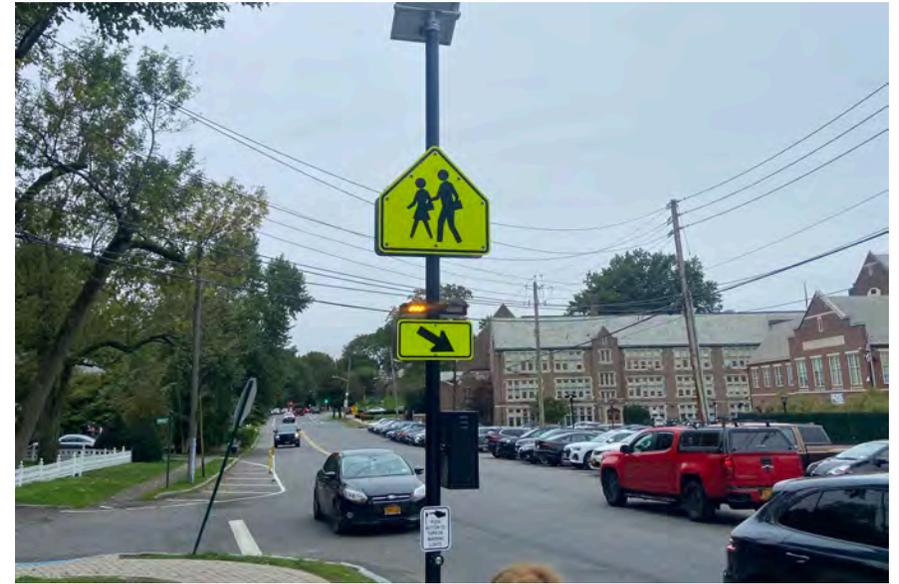
- RRFB
 - Rectangular Rapid Flashing Beacon
 - Provides enhanced visibility of crosswalks, but is **not** a regulatory signal

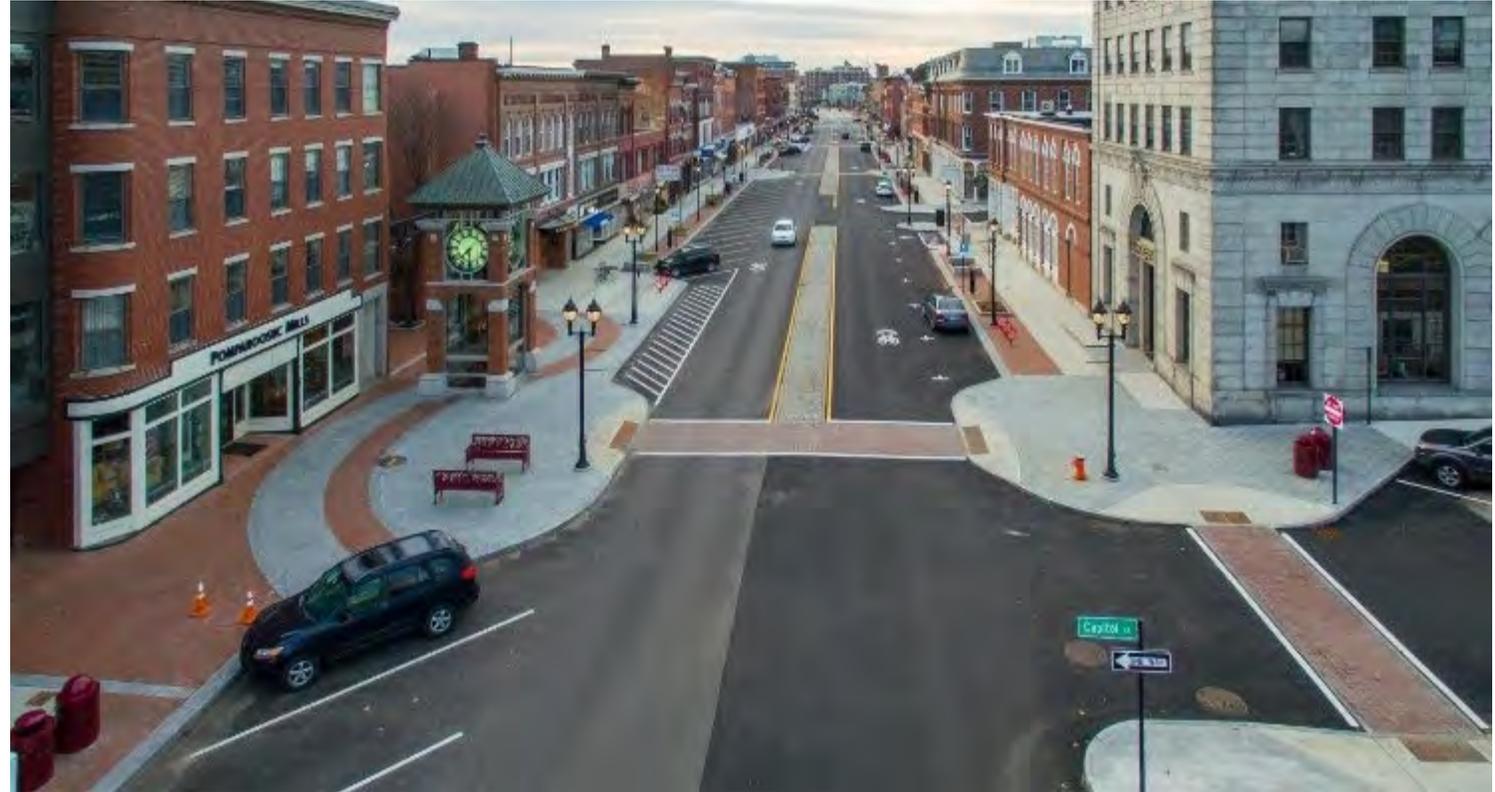
- A curb extension is a horizontal extension of the sidewalk into the street resulting in a narrower roadway and a shorter crosswalks.
- Slows automobile turning speeds, shortens pedestrian crossing distance, and increases pedestrian visibility

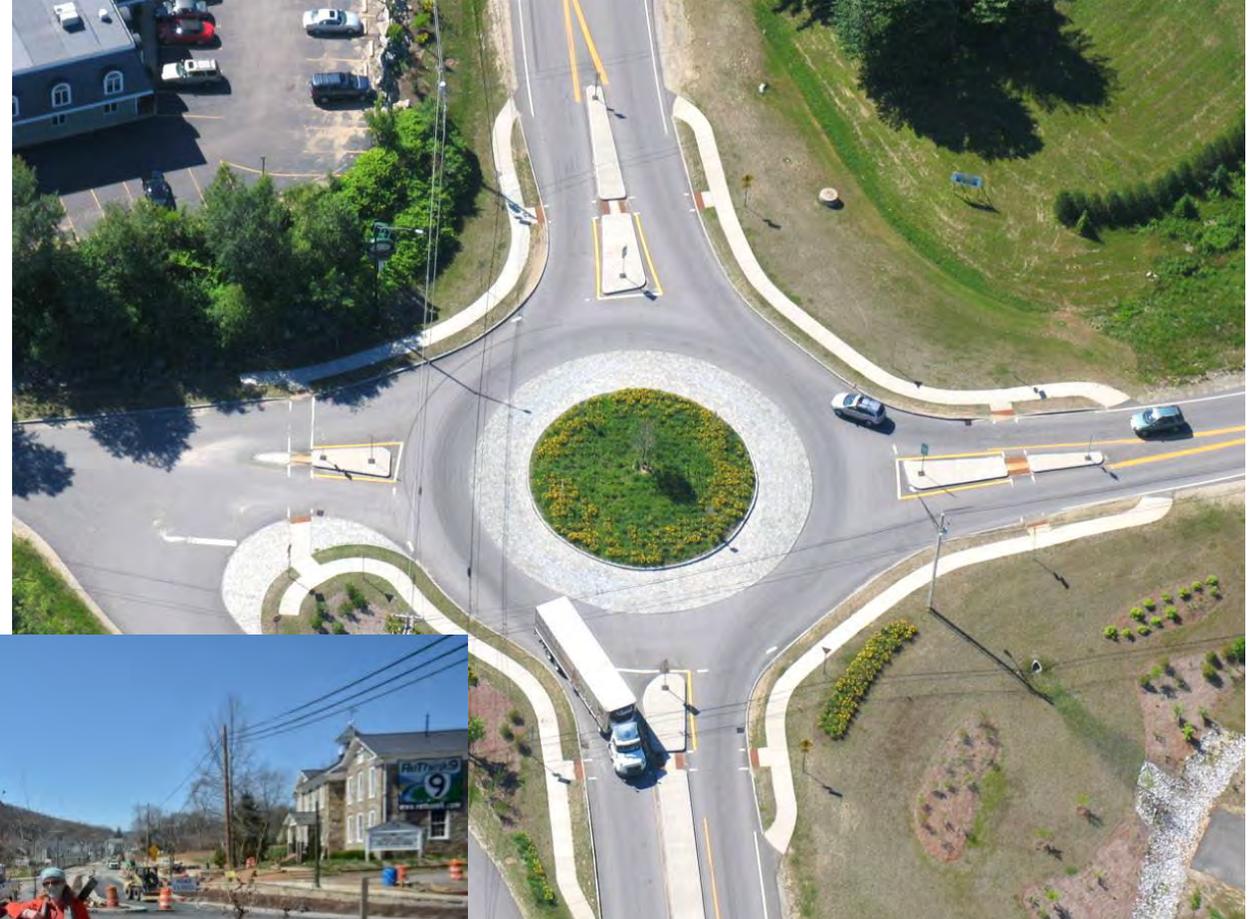
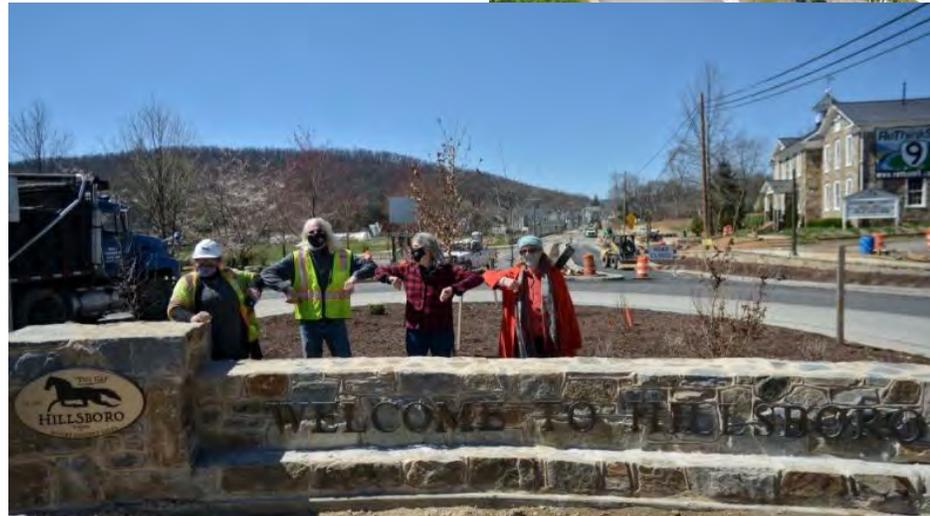
- Slows traffic by requiring horizontal deflection for entering vehicles
- Modern roundabout requires entering vehicles to yield to circulating traffic
- Roundabout provides opportunity for greenspace or gateway signage
- Roundabouts reduce vehicles speeding to make green lights etc.

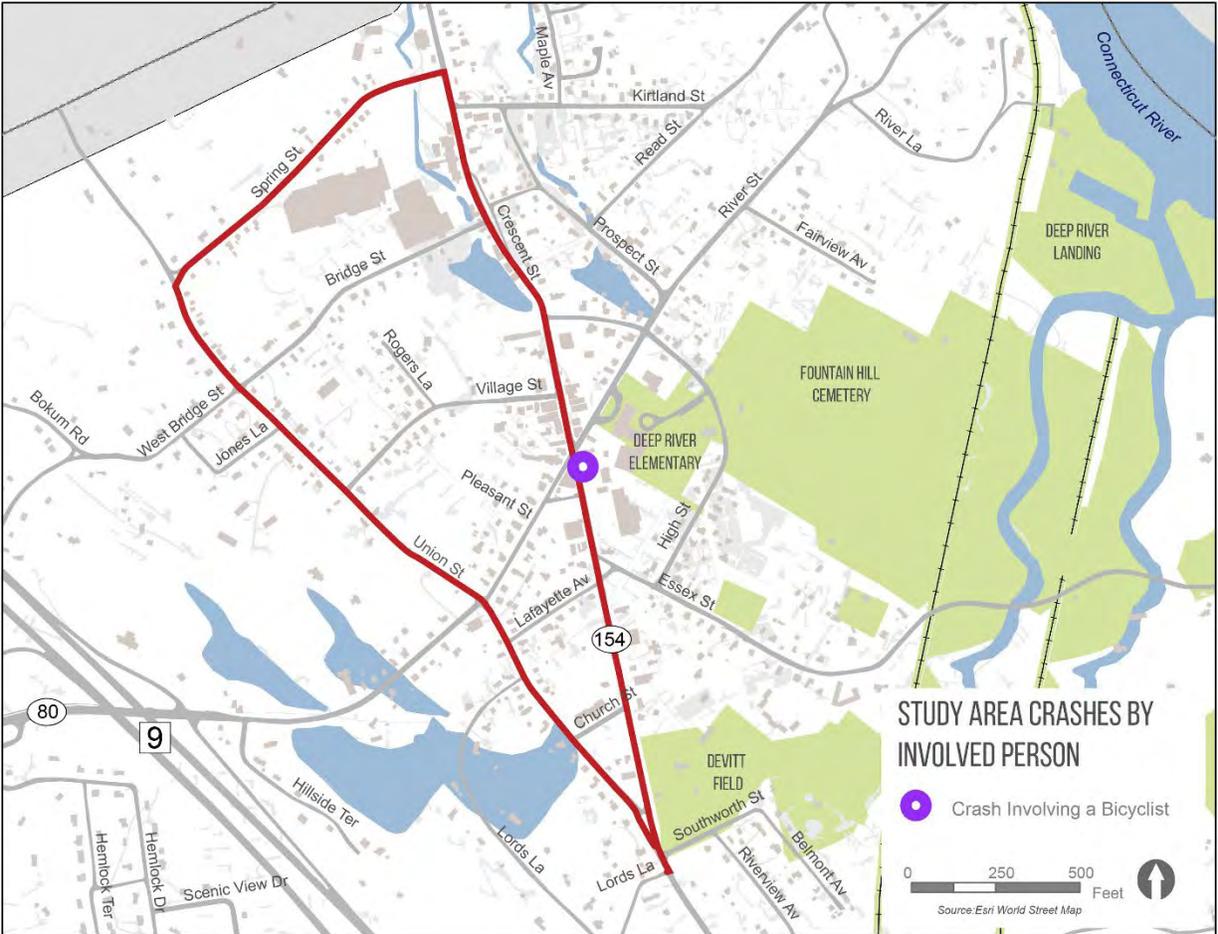
Deep River Road Safety Audit Crash Summary - Crashes by Involved Person

- There was 1 crash involving a bicyclist in the Study Area (2017).
- There were no crashes involving pedestrians

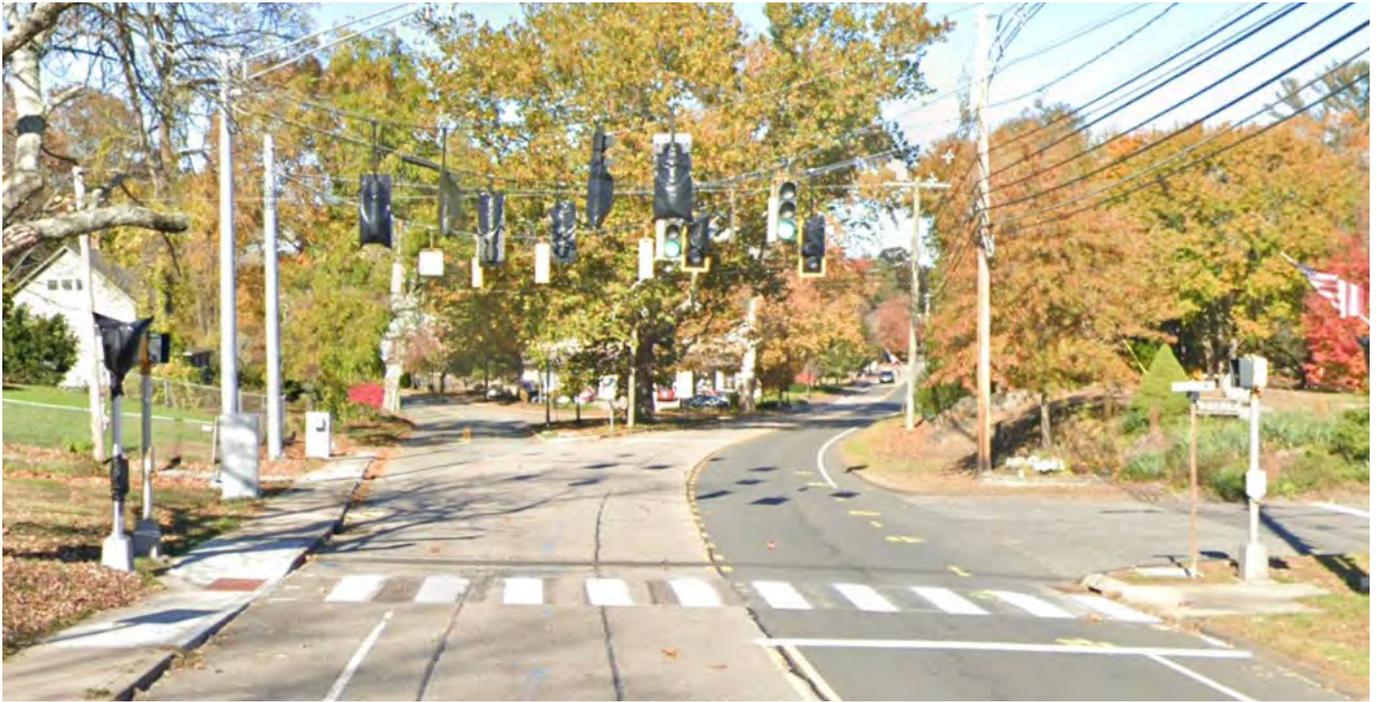
- Intersection signal upgrades to the Route 154/ Union Street/ Southworth Street Intersection.
- Streetscape and pedestrian scale lighting along Route 154.

*Intersection upgrade work to the signalized intersection at Route 154, Union Street, and Southworth Street.
Image Credit: Google Street view*
