COMMUNITY
connectivity program

Derby Greenway – Rail Station – Road Safety Audit

April 12, 2017

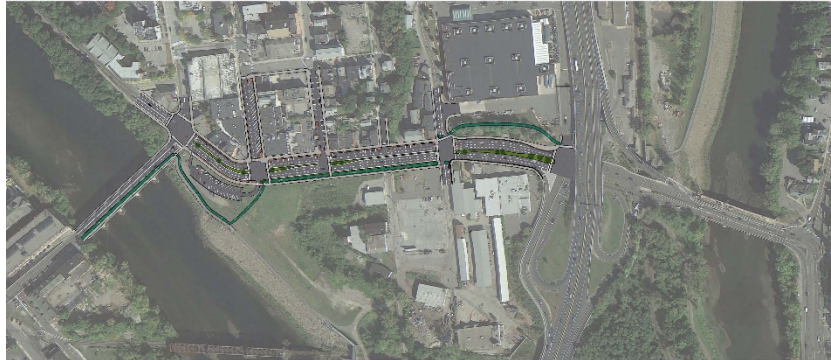
Figure 5: Route 34 Widening Project

Route 34 (Main Street) through downtown Derby will be widened and reconstructed as part of a federal/state project, as shown in Figure 5. Preliminary design is complete, but is under review for coordinating design elements with the proposed redevelopment of land south of Route 34. As part of the project, a bi-directional bicycle path (10 feet wide) and a pedestrian plaza are included along the south side of road. The

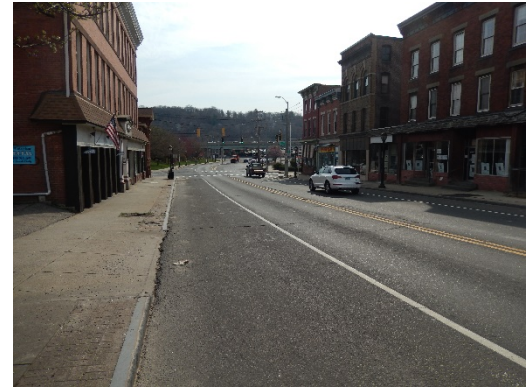
Figure 7: Main Street west of Route 8

- This corridor is congested due to the location of the Route 8 interchange at the center of the Route 34 corridor.
- Sidewalks run along the north and south sides of Main Street to the west side of Route 8 entrance and exit ramps (Figure 7). The sidewalk continues on the north side, crosses the Route 8 northbound on ramp and continues across the Bridge exclusively on the north side. Pedestrians can connect to the Derby Greenway prior to the bridge crossing, using an access road that currently has construction materials and vehicles.

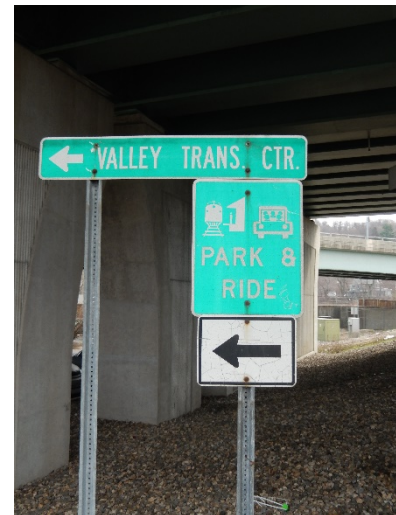
Figure 8: Current Wayfinding Signs

- The lack of pedestrian crossing signals throughout corridor and safe amenities over the Atwater Bridge are a concern.
- Lack of wayfinding signs, especially for the train station needs to be addressed (Figure 8).

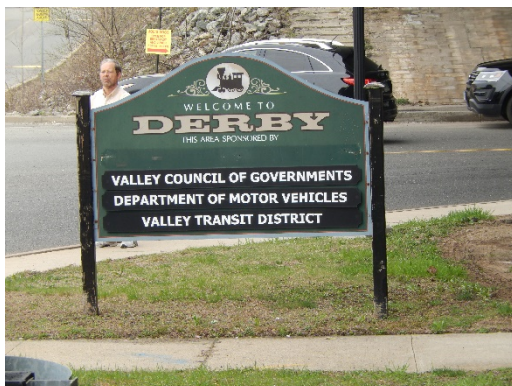
Figure 9: Entrance to Train Station and DMV

- The Town attendees stressed the importance of linking the new development to the train station and the Greenway (Figure 9). The Town made clear that it is imperative for the Town's long term plans to increase non-motorized mobility and connectivity through this corridor.

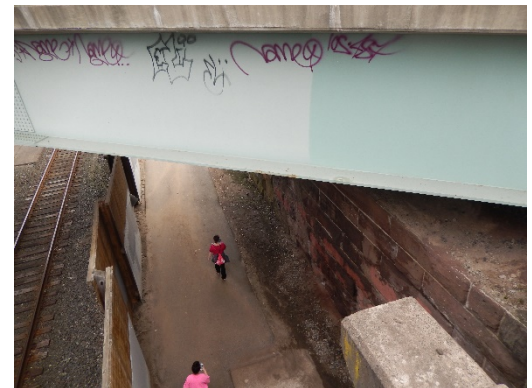
Figure 11: Derby Greenway under Route 8 on-ramp

- This is a segment of the Naugatuck River Greenway.
- This Derby section is a two mile long paved path that passes under route 34 at the Route 8 Interchange within the study area (Figure 11).
- Average weekly usage along the Greenway is 12,000 persons according to Naugatuck Valley Council of Governments findings in 2015.

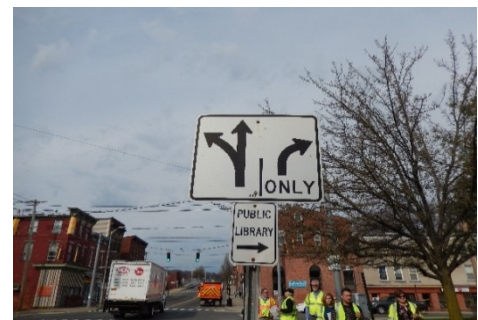
Figure 13: Signage along westbound Route 34

- The current alignment of CT-34 westbound, west of CT-8, with two lanes of through traffic reducing to one and an exclusive right turn lane causes driver confusion and contributes to side-swipe crashes. In addition, on-street parking is permitted west of this point in the downtown area. This lane reduction and permitted on-street parking causes driver confusion and traps vehicles in the right turn only lane without warning. There are two regulatory signs but they are insufficient to warn drivers of the changing lane patterns.

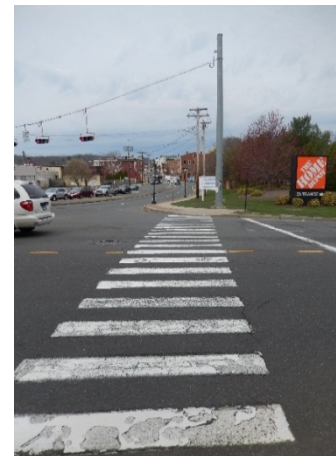
Figure 12: Crosswalk at Home Depot Entrance

- Four way signalized intersection.
- There are crosswalks on all four legs of the intersection; they are in fair condition.
- There are pedestrian pushbuttons to call vehicle phases.

- There are ramps at each corner but they do not have the ADA required tactile warning strips.
- The sidewalks are in good condition; they average six feet in width with asphalt curbing and no buffer.

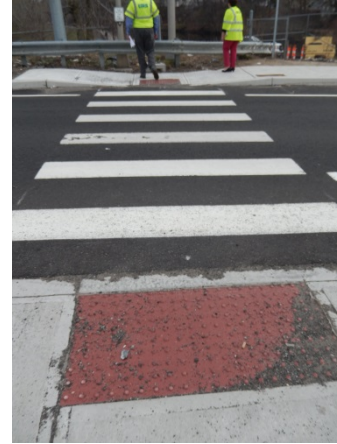
Figure 14: Pedestrian button location is not accessible

- There is a crosswalk located on the north leg of Ausonio Drive. There is no pedestrian phase or signal associated with this crossing. There is a pushbutton to actuate the vehicle phase on the northwest corner and on the controller cabinet on the southwest corner. The button on the controller is placed behind a guiderail. There is no button on the northeast corner (Figure 14).
- The driveway to the Home Depot is located on Ausonio Drive.
- The Metro-North Train station and DMV Photo License Center Office are located adjacent to the Northeast corner of this intersection (Figure 15).
- There are two post mounted auxiliary signals for the channelized right turn onto the southbound ramp. It is unclear as to whether right turns are allowed on red, since the indications are so far into the turn. Some drivers wait, while others do not.

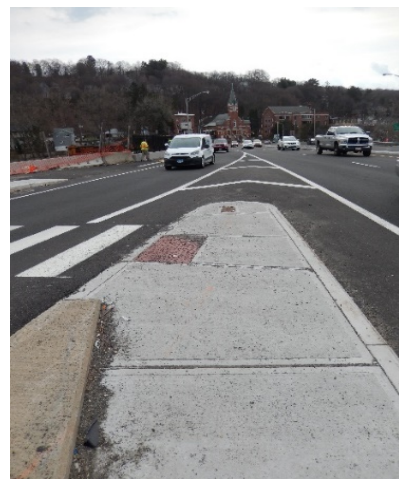
Figure 16: View of westbound traffic on bridge and entering Route 8

- There is a four foot wide sidewalk continuing along the north side of the bridge with no buffer. Pedestrians are very exposed to dense vehicular traffic.
- The pedestrian connection forces pedestrians to cross the entrance to the on-ramp for northbound Route 8 (Figure 16).
- The pedestrian signal is not presently functioning on the south side of the crosswalk and the push button is mislocated, facing north towards the on-ramp, not the sidewalk. Pedestrians must step into oncoming ramp traffic to activate the signal which stops oncoming vehicles in theory. Our team witnessed several vehicles proceeding through on red without pause. This signal is presently being

upgraded, and may have improved visibility and functionality when completed.

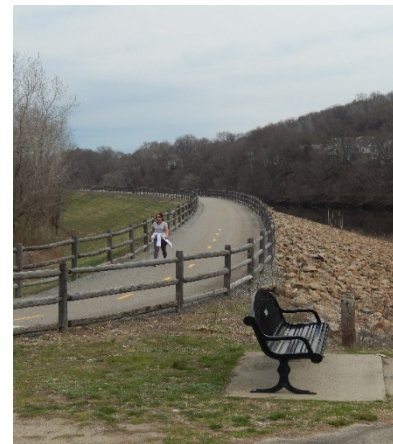
Figure 17: Derby Greenway

- This two mile long paved pathway runs in a north south direction adjacent to the Naugatuck River (Figure 17). It runs under Route 34 and the Route 8 North on-ramp, and continues north along the river. There is one access point Main Street from the north side of Atwater Bridge.
- There is no direct connection from the Greenway to the Train Station. The railroad tracks are between the facilities.

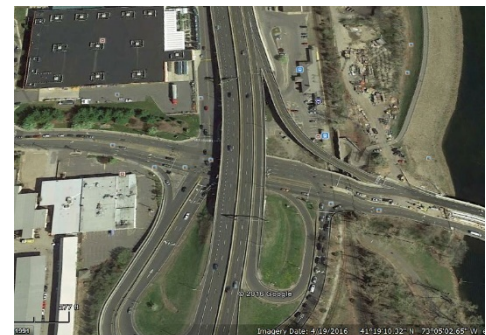
Figure 18: Route 34 Aerial View

- The current alignment of Route 34 causes driver confusion (Figure 18). Some lane striping should be redesigned. In other areas better signage might suffice to increase driver awareness of changing lane patterns.
- The Route 8 southbound on-ramp configuration could be lengthened.
- Corridor needs wayfinding signs.
- Congestion in this study area is due to the geometry of the interchange.
- Due to congestion the town could consider alternative interchange designs, such as diverging

diamond interchange, Texas turn or single point interchange (this was done on Exit 48 of the Merritt Parkway near Milford Mall.)

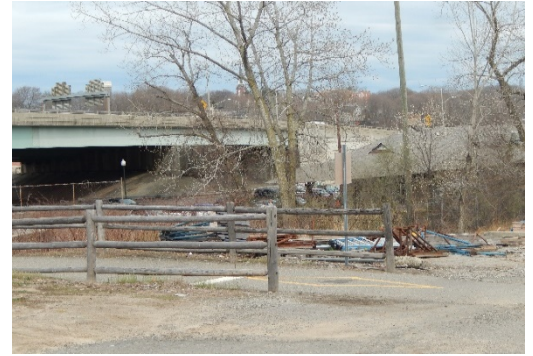
Figure 19: Greenway with Derby Train Station in background

- Include recommendations from this audit in the Route 34 widening project.
- Pedestrian bridge over railroad tracks is best option for connectivity between downtown, the train station and the greenway (Figure 19).
- Town would like the State to change center lane of Route 8 southbound off ramp through lane designation to through/right turn. That would reflect the current traffic patterns since drivers ignore the exclusive through lane for the center lane.
- Car storage is the issue through the entire interchange area.
- On the southwest corner of the Route 34 Route 8 interchange, the former Lifetouch building is designated to be the gateway for the downtown revitalization (Figure 20).

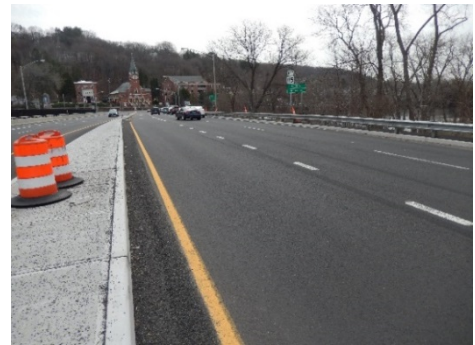
Figure 26: Route 34 eastbound over Atwater Bridge

- The alignment of travel lanes on Route 34 eastbound over the Atwater Bridge causes cars to jockey for position in the right lane. The current configuration forces the middle lane drivers into an exclusive left turn lane at intersection of CT-115 and CT- 34.

1. Town to coordinate with CTDOT to install pedestrian countdown signals at Route 34 and Ausonio Drive (Figure 24).
2. Town to coordinate with CTDOT to provide pedestrians crossing the Route 8 on-ramp with a protective barrier (Figure 25).
3. Town to coordinate with CTDOT to realign the travel lanes on the eastbound section of Route 34 over the Atwater Bridge before placement of final epoxy (Figure 26). This modification is needed to guide drivers from the two through lanes at to Route 8 northbound off-ramp to the more frequently used right turning lanes. This would be more conducive to the current flow of traffic. A capacity analysis would need to be performed and a request to the Office of the State Traffic Administration (OSTA) would be needed.
