COMMUNITY
connectivity program

Ellington

Route 83 – Road Safety Audit

October 27, 2016

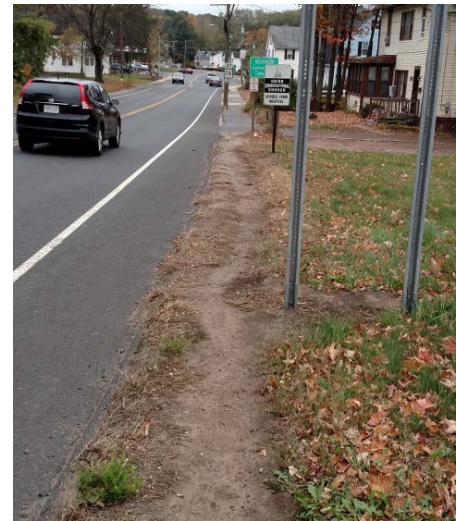
Figure 5. Goat Path Leading From Sidewalk

- There are brook crossings by Kloter Farms, Johnny Appleseed, and the Barn Yard.
- The sidewalk in Vernon ends at the town line, there are goat paths leading from it on the Ellington side (Figure 5).

12. Investigate the Middle Butcher Road stop bar location and the possible need for a no turn on red.
13. Finalize the design plans for the sidewalk including where to connect the west side with the east side by the Vernon town line.

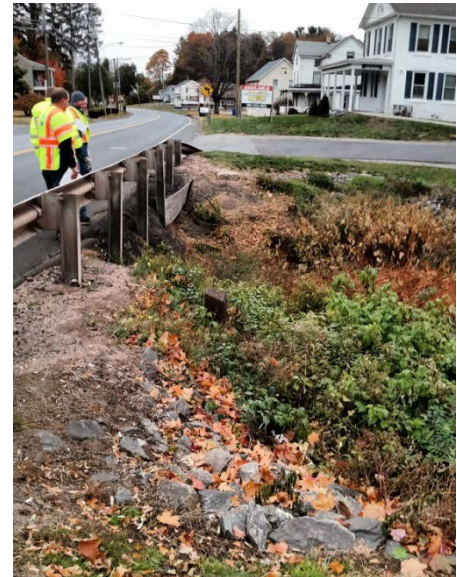
Figure 6. Retention Pond Requiring Pedestrian Bridge

- By Ellington Printery there is a culvert and on the east side with a retention pond. This will require a

bridge to cross. The roadway is beginning to deteriorate around the guide rail for the culvert. (Figure 6)

1. Install sidewalk along the east side of Route 83.
 - a. Install pedestrian bridges or culverts where needed over brooks.
2. Extend sidewalk from Kloter Farms to Route 83.

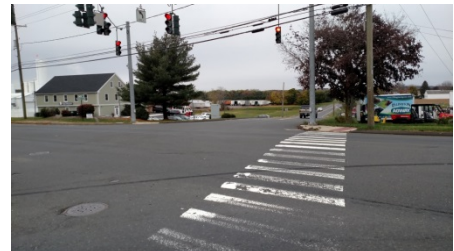
Figure 7. Intersection of Route 83 and Middle Butcher Road

- At the intersection of Middle Butcher Road and Route 83 there are pedestrian ramps on all but the southeast corner. There are tactile warning strips in the northern corners at the crosswalk. The ramp in the northeast corner is steep and most likely not ADA complaint. (Figure 7)

- This intersection has a concurrent pedestrian phase with a "Push button for green light" to call the side street to allow the crossing of Route 83. There are push buttons at all corners except the southeast.

- There are no pedestrian signal heads.
 - The crosswalk is faded.
- Along Middle Butcher Road, just past the driveway for Ed's Automotive, there is a bush which has grown blocking clear access to the sidewalk (Figure 8).

1. Conduct a drainage study for the culvert at Johnny Appleseed.
2. Install a crosswalk at Lower Butcher Road and install a ramp on the northeast corner. This will require relocating a catch basin.
3. Restripe with 11 foot travel lanes. The Town to coordinate with CTDOT to incorporate on next Vendor in Place (VIP) repaving project.
4. Update signals to be ADA accessible with ramps, tactile warning strips (Figure 16), proper grading, audible and tactile push button (Figure 17), and pedestrian signal heads with countdown (Figure 15).
5. Obtain easements and right-of-way required to install sidewalk.

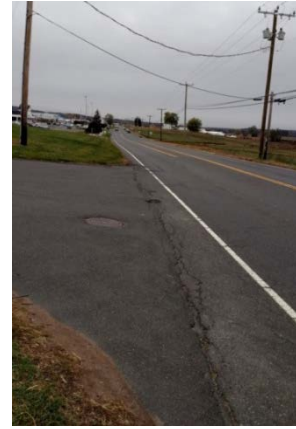
Figure 9. Flat Roadway With Room for Sidewalk

- Between Charter Road and Johnny Appleseed Farm it is relatively flat and has sufficient space for a sidewalk (Figure 9). The road then drops off sharply on the west side and there are numerous trees and slope issues on the east side. As the road gets closer to the Mountain Road signal, the grade becomes steeper on the east side (Figure 10). A three foot snow shelf and five foot sidewalk would most likely require a retaining wall.

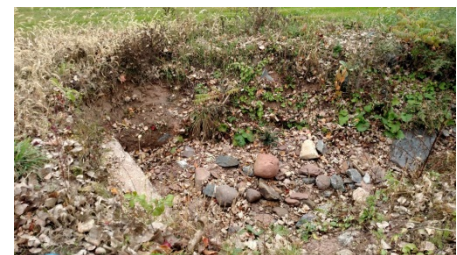
Figure 11. Culvert Which is Easily Clogged

- Just north of Johnny Appleseed Farm, there is a culvert which gets clogged easily because of the small pipe size (Figure 11).
- At the signalized intersection of Mountain Road and Route 83 there is a crosswalk at the northern leg of Route 83 but it does not connect to a sidewalk. On both sides it ends at the guide rail. (Figure 12).

- A sidewalk would require easements, right-of-way, and tree removal in certain locations.
- The culvert at Johnny Appleseed needs a drainage study and the pipe size addressed. It has clogged several times. If new pipes are needed they could be extended out far enough that a pedestrian bridge would not be needed.

1. The Town to coordinate with CTDOT to get roads swept to keep them accessible.
2. The Town to coordinate with CTDOT to inspect and maintain the culverts.

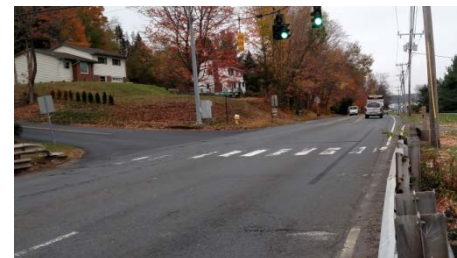
Figure 12. Mountain Road Intersection

- This intersection has concurrent pedestrian phasing using "Push button for green light" to call the side street to allow the crossing of Route 83. There are push buttons in the northwest corner and southeast corner. The button in the northwest corner is placed behind the guide rail. It was observed that the push button was not operational at the time of the audit.
- There are no pedestrian signal heads.
- The crosswalk is faded

5. Repaint all crosswalks. The Town to coordinate with CTDOT to incorporate on next Vendor in Place (VIP) repaving project.
6. Replace existing signs with newer retroreflective ones.

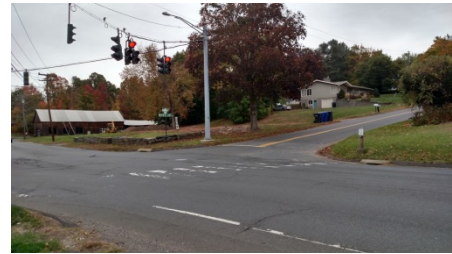
Figure 13. Main Street Intersection

- Marsh Brook crosses just past the Mountain Road intersection. A bridge would be required to place a sidewalk here.
- At the signalized intersection of Main Street and Route 83 there is a crosswalk on the southern leg of Route 83 but it does not connect to sidewalk nor have ramps (Figure 13).

- This intersection has concurrent pedestrian phasing using "Push button for green light" to call the side street to allow the crossing of Route 83. There are push buttons on the southwest corner and southeast corner.
- There are no pedestrian signal heads.
- The crosswalk is faded.

- The sidewalk on Main Street ends 350 feet short of the intersection.
- Sand and dirt have begun to build up in the shoulder and debris is in and on the catch basins.

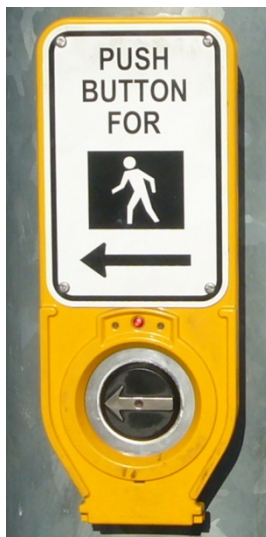
Figure 17. Pedestrian Pushbutton

- The town does have a sidewalk plan with GIS maps of all sidewalks. It conducts repairs that are requested.
- None of the signals have pedestrian phases or crossings. All pedestrian pushbuttons call for the side street green.

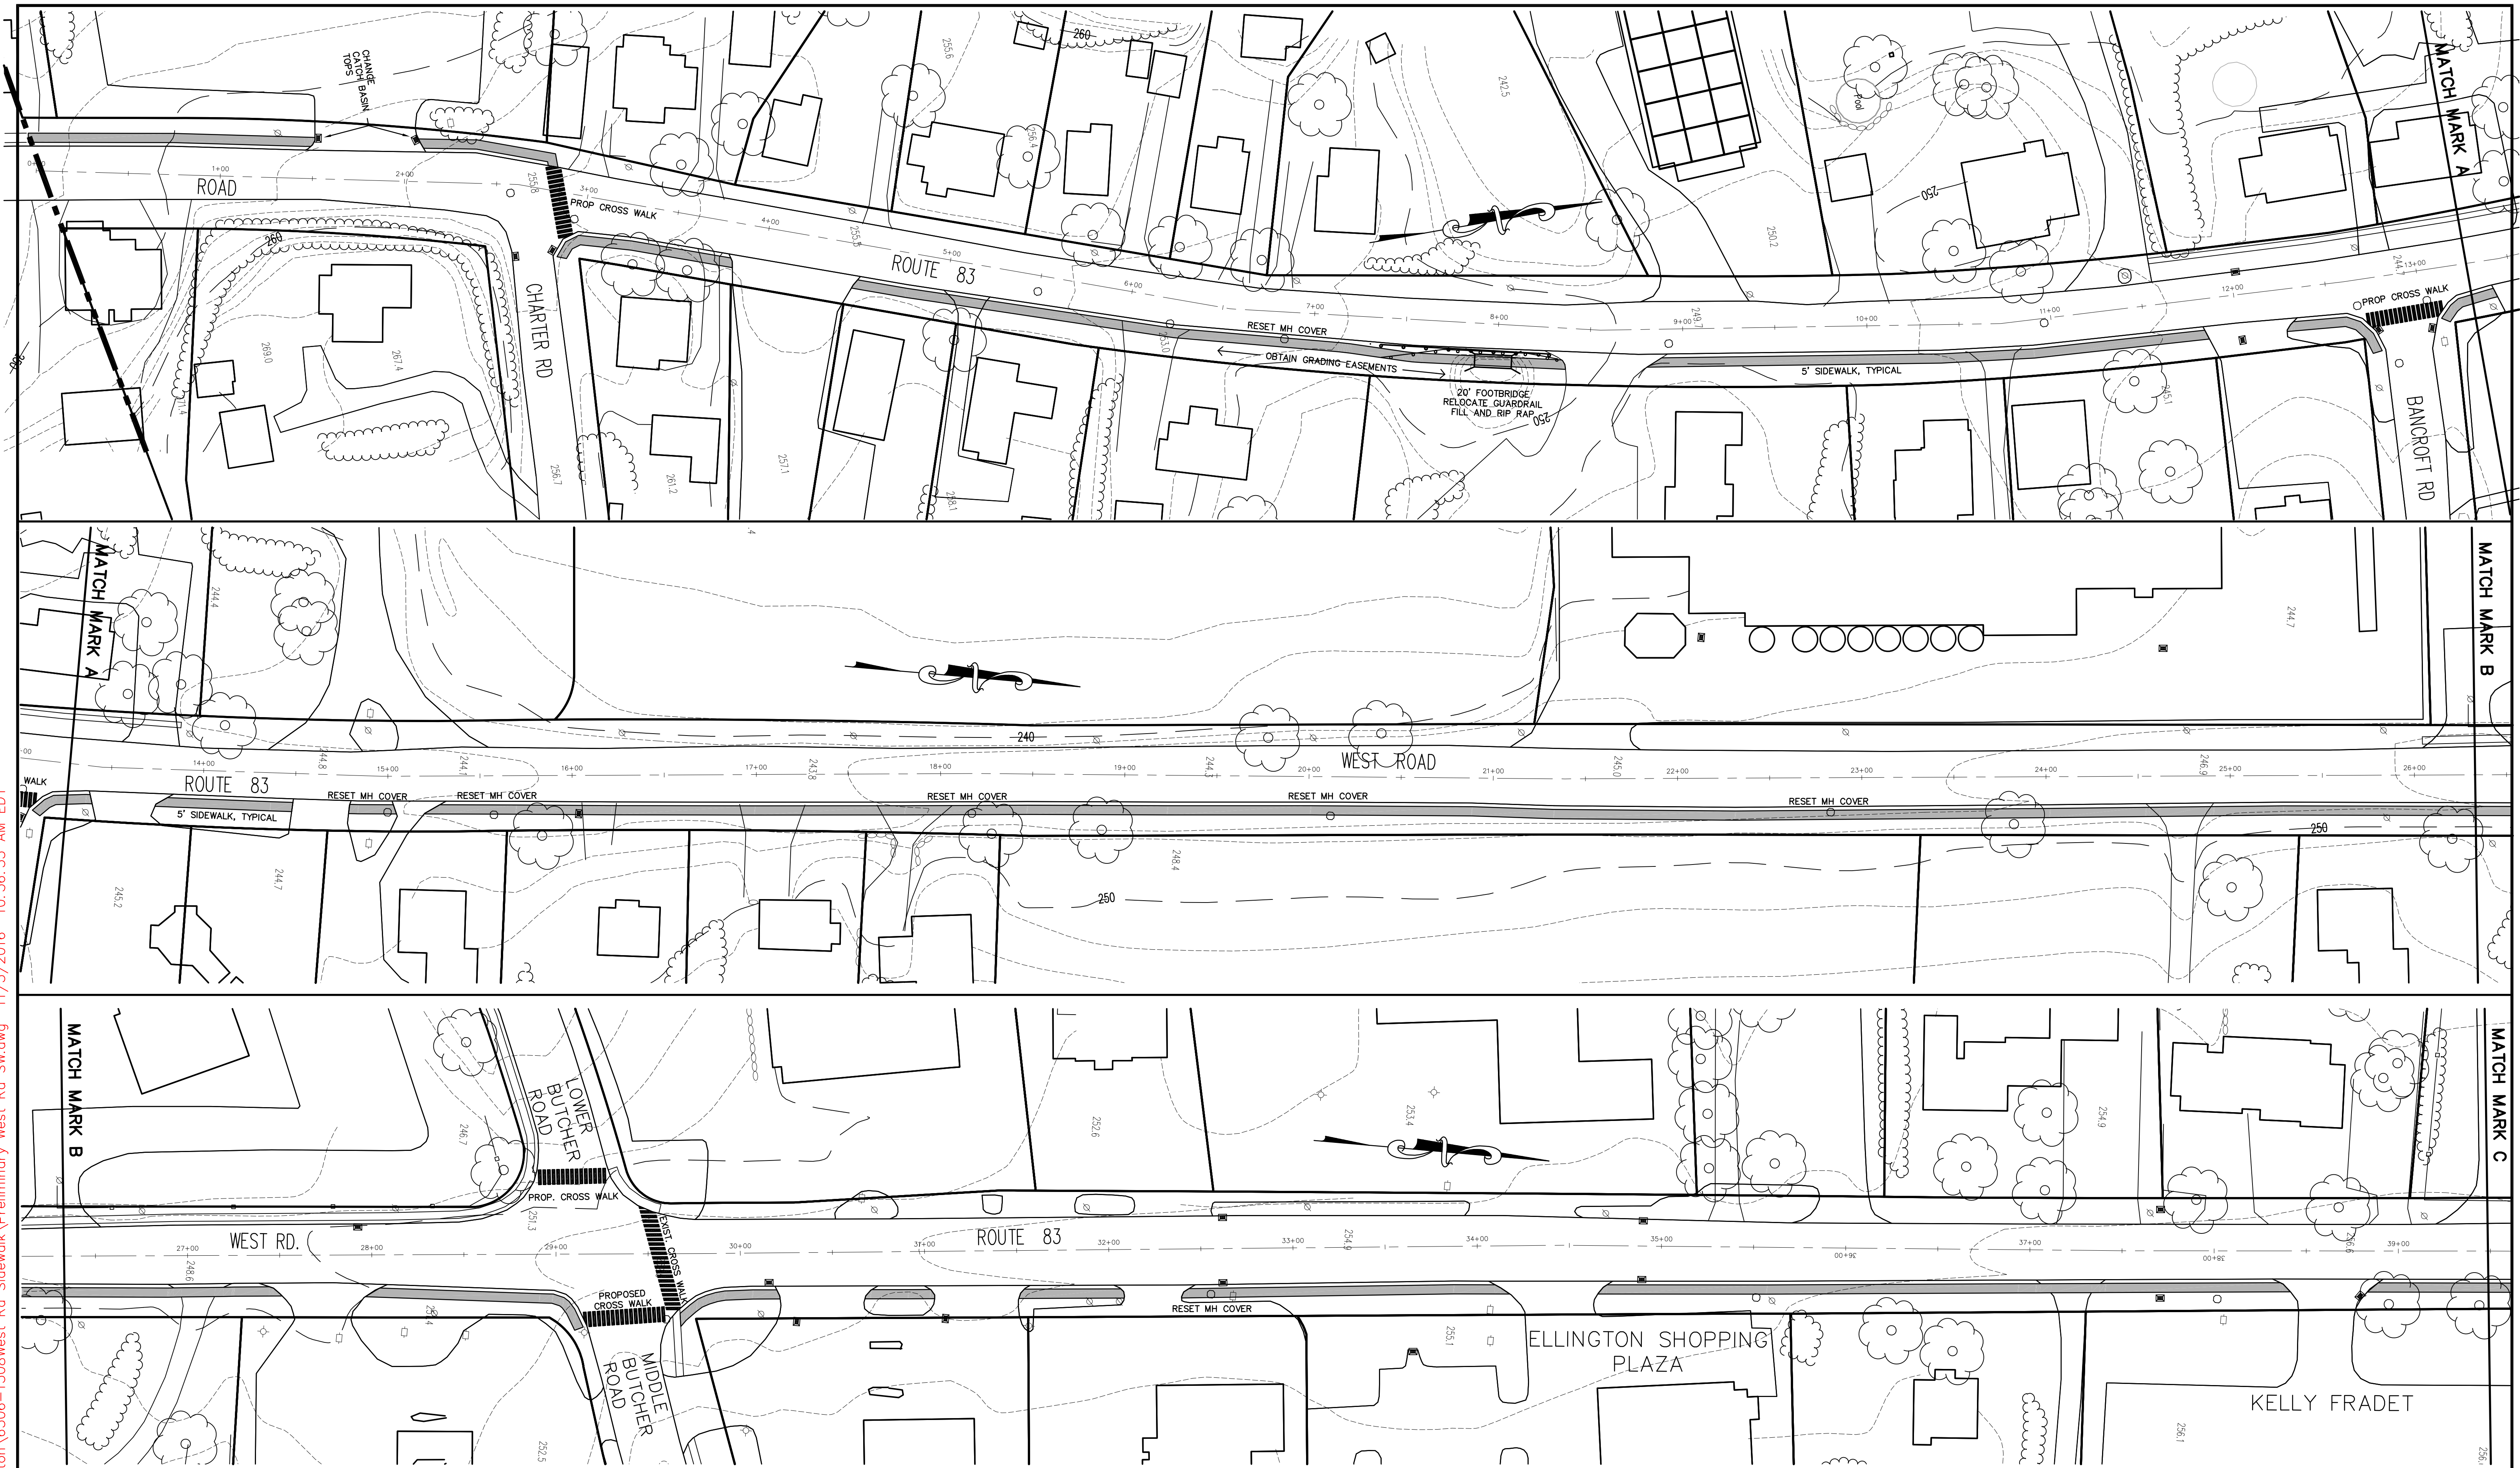
NOTE:
PROPOSED SIDEWALKS SHOWN SHADED

PLAN
SCALE 1" = 40'
