COMMUNITY
connectivity program

Enfield

Enfield Street Corridor

June 29, 2016

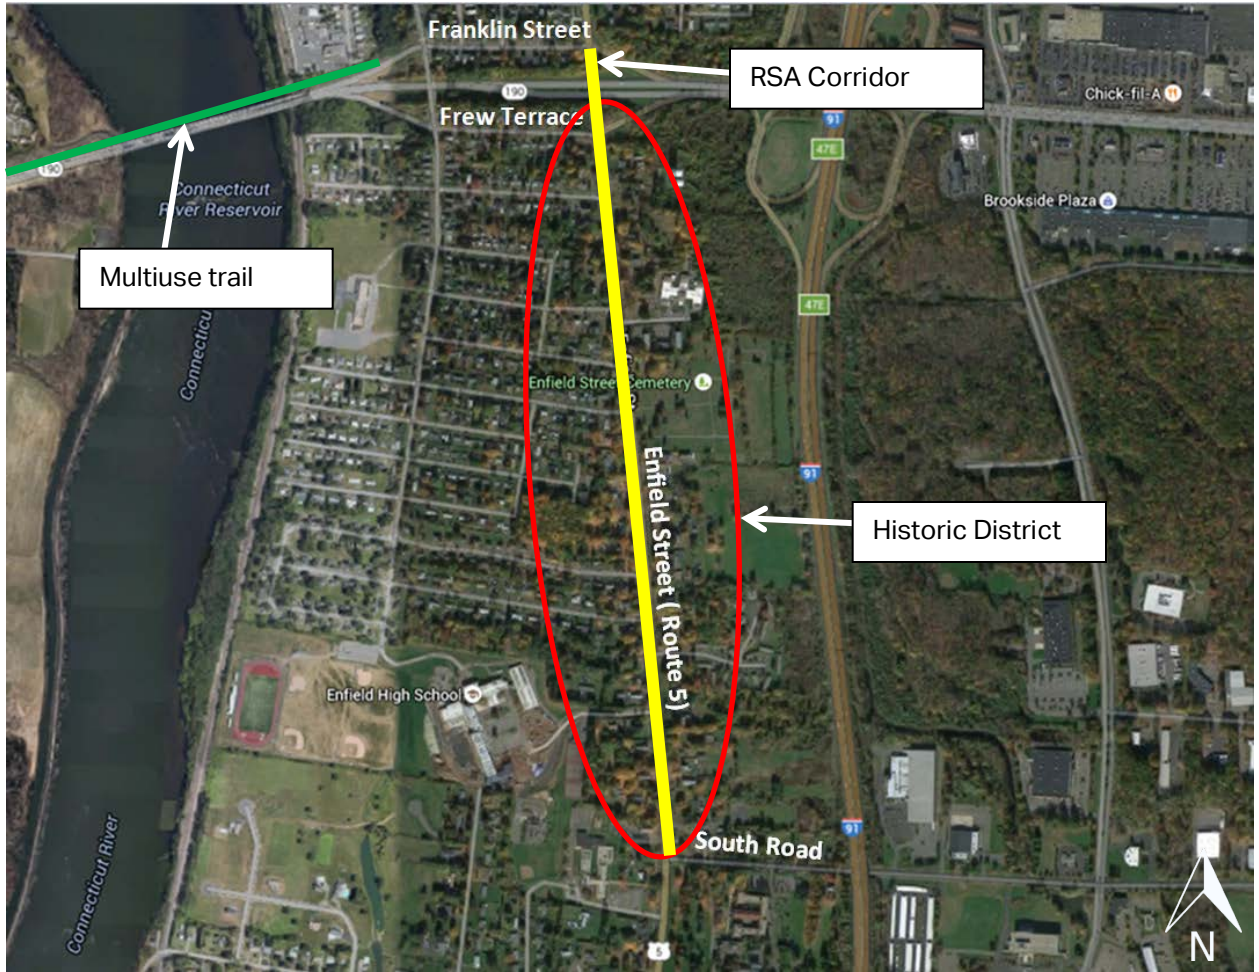
Figure 1. Route 5 between Franklin Street and South Road

The site consists of a one-mile corridor on Route 5 between Franklin Street and South Road in the Town of Enfield (Figure 1). Enfield submitted an application identifying Route 5 as in need of improved bike route connections. There are currently sidewalks on the west side of Route 5, most of which are separated by a wide grass buffer. Route 5 is a Principal Arterial and provides a north-south connection throughout Enfield and central Connecticut (Figure 2). In this part of Enfield, Route 5 runs parallel with I-91. As a result, this route is often used as a bypass for motorists travelling between the Hartford and Springfield area. The Average Daily Traffic (ADT) on Route 5 ranges from 11,900 at Franklin Street, 10,300 at Frew Terrace and 12,200 near South Road.

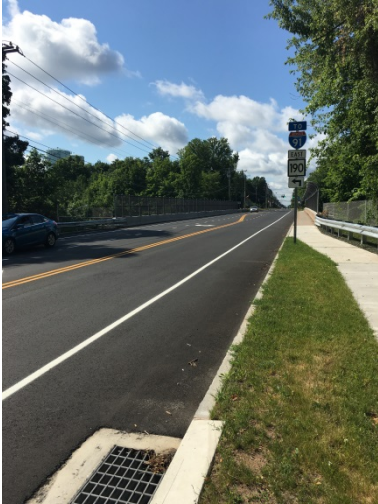
Figure 5. Wide Shoulders

A number of best practices have already been applied to this area of Enfield. When Route 5 was repaved, the roadway was striped to include 5 foot shoulders (Figure 5) that can be used as a bike lane. Along this corridor in the historic district of Enfield, the sidewalks are separated from the roadway by a wide grass buffer (Figure 6). The crosswalks at the intersection of Route 5 and Franklin Street have been updated and include ramps, detectable warning strips (Figure 7) and newer pushbuttons and signal heads.

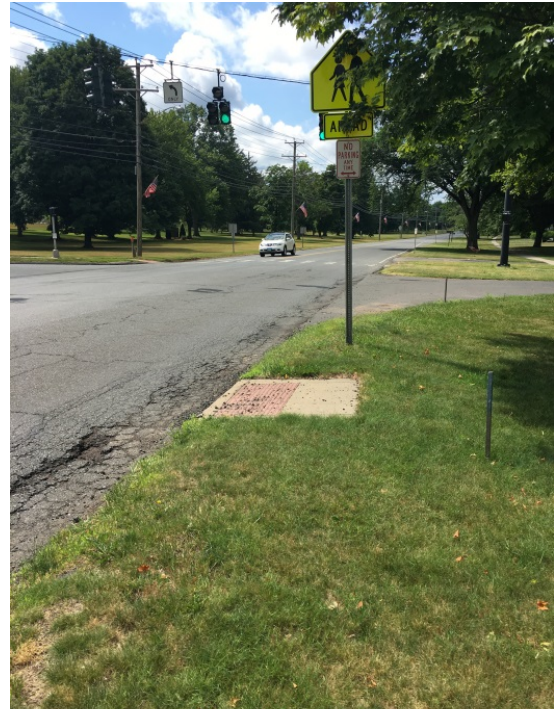
Figure 8. Ramp Not Connected to Sidewalk

- On Franklin Street there is on-street parking and sidewalks on both sides of the road.
- At the intersection with South Road, sidewalks are not connected to the crosswalk ramps (Figure 8). This is not compliant with ADA standards.

- 1) Construct sidewalks to complete gaps between the existing sidewalk and crosswalk ramps (Figure 23).
- 2) In areas of Route 5 where the roadway is narrow and there is no room to expand shoulder, consider paving a path on the grass buffer area to use as a bike path (Figure 24).

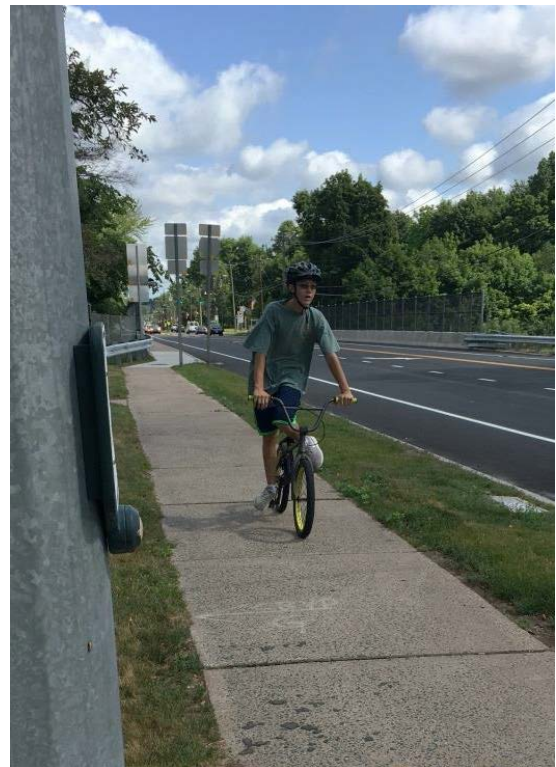
Figure 9. Cyclist on Sidewalk

- Cyclists were observed riding in both the roadway shoulder and on the sidewalks (Figure 9).
- Some crosswalks are worn and should be repainted.
- Some sections of sidewalks throughout the corridor are in need of repairs.

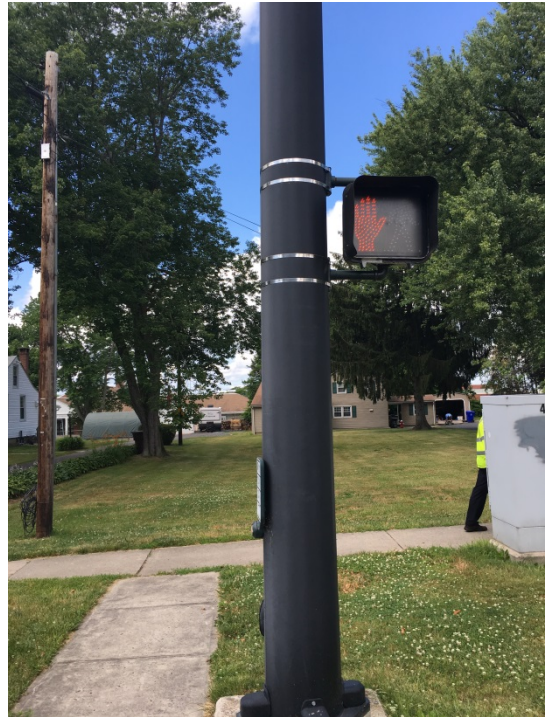
Figure 10. Crosswalk Signal

- The advanced crosswalk warning sign on Route 5 near South Road is partially blocked by vegetation.
- Pedestrian crosswalk signals (Figure 10) do not have countdowns and the timings are not compliant with new ADA standards.

- c) Pedestrian signal heads with countdowns (Figure 28).

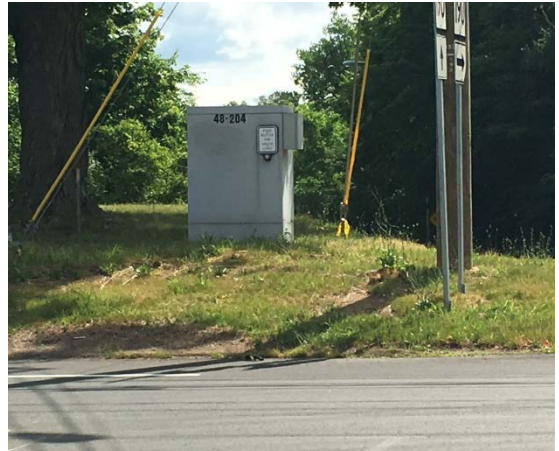
Figure 11. Pushbutton Located on Utility Box

1. Enfield would like to extend the bike routes into other towns in the future.
2. Some crosswalks are not ADA compliant. Upgrades to the crosswalks throughout the corridor are inconsistent. In some areas, the crosswalk ramps are not connected to sidewalks. Some pushbuttons are located in areas that are inaccessible to pedestrians with disabilities (Figure 11). This may result in a challenging environment for pedestrians to navigate.

- 5) Upgrade all crosswalks to be ADA compliant including:
 - a) Ramps and detectable warning strips (Figure 27).
 - b) Pushbuttons in accessible locations.

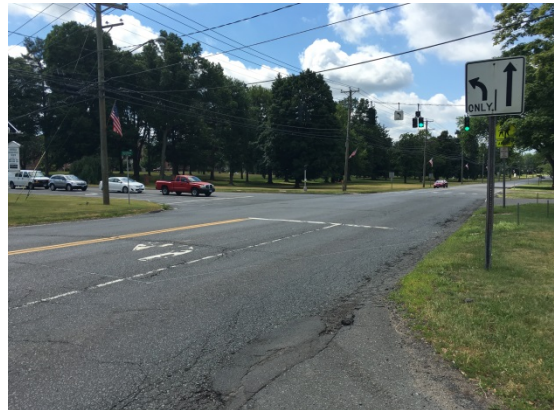
Figure 12. Shoulder Area is Not Defined by Striping

3. On the newly paved section of Route 5, the shoulder areas are striped to approximately 5 feet wide. Further south on Route 5, in the areas that were not re-paved, the shoulders are very narrow or not defined by striping (Figure 12).

- 1) Clear overgrown vegetation blocking signs, such as the pedestrian sign on the southbound side of Route 5 at the South Road intersection (Figure 15).
- 2) Along the sidewalks, trim tree branches near the crosswalks to improve visibility of pedestrians.
- 3) Paint faded crosswalks (Figure 16).
- 4) Repair any damaged sections of sidewalks (Figure 17).
- 5) Raise signs to standard height to improve visibility (Figure 18).
- 6) Stripe shoulders on Route 5 (Figure 19).

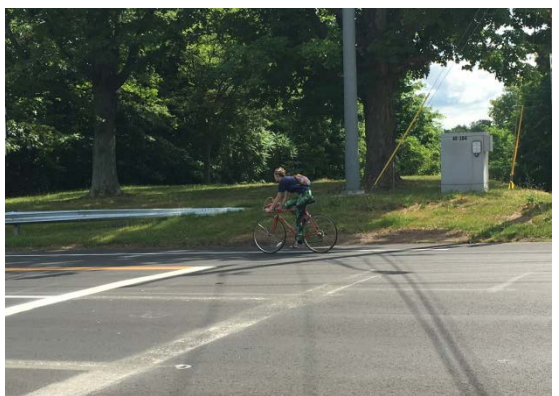
Figure 13. Cyclist Using Shoulder Area on Route 5

4. There are no sidewalk ordinances in Enfield restricting cyclists from using the sidewalks. As a result, cyclists use both the roadway (Figure 13) and the sidewalks to navigate through the corridor. However, Enfield would prefer to keep cyclists separate from the pedestrians on the sidewalks.

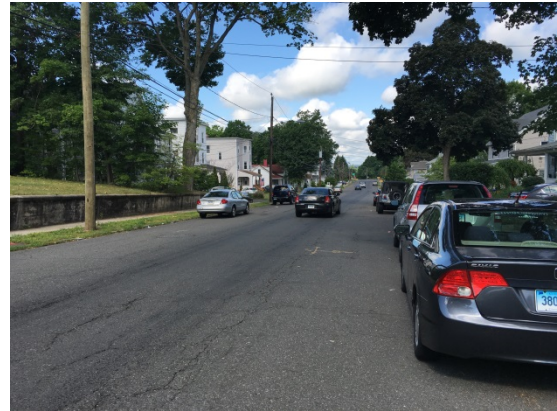
Figure 14. Franklin Street

7. Constructing a multi-use path on Franklin Street (Figure 14) to connect to the existing path on Route 190 is not feasible at this time. During the winter months, maintenance could be a challenge as clearing a multi-use path would not be the town's highest priority. Bike lanes in the roadway would be more feasible.

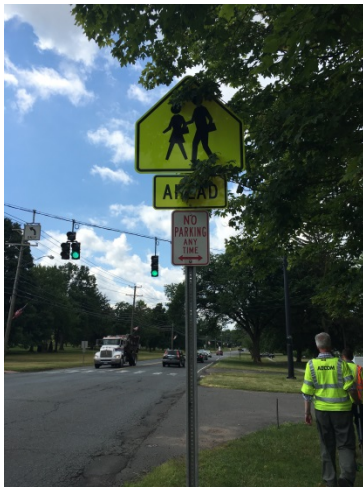
Figure 15. Trim Areas with Overgrown Vegetation

5. Vegetation needs to be trimmed to improve sign and pedestrian visibility. Some of the trees on the sidewalks near the local street crosswalks could be trimmed to improve visibility.

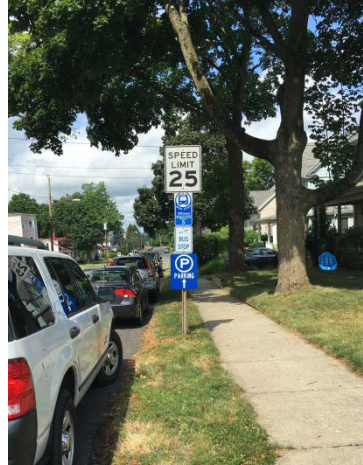
Figure 18. Raise Signs to Standard Height

- Signs on Franklin Street are low to the ground and do not meet standards.
- South of Frew Terrace, the sidewalk on the southbound side of Route 5 is separated from the roadway by a wide grass buffer.
