COMMUNITY
connectivity program

White's Woods Road from South Lake Street to
Mattatuck Trail at the Morris Town Line – Road Safety
Audit

November 8, 2016

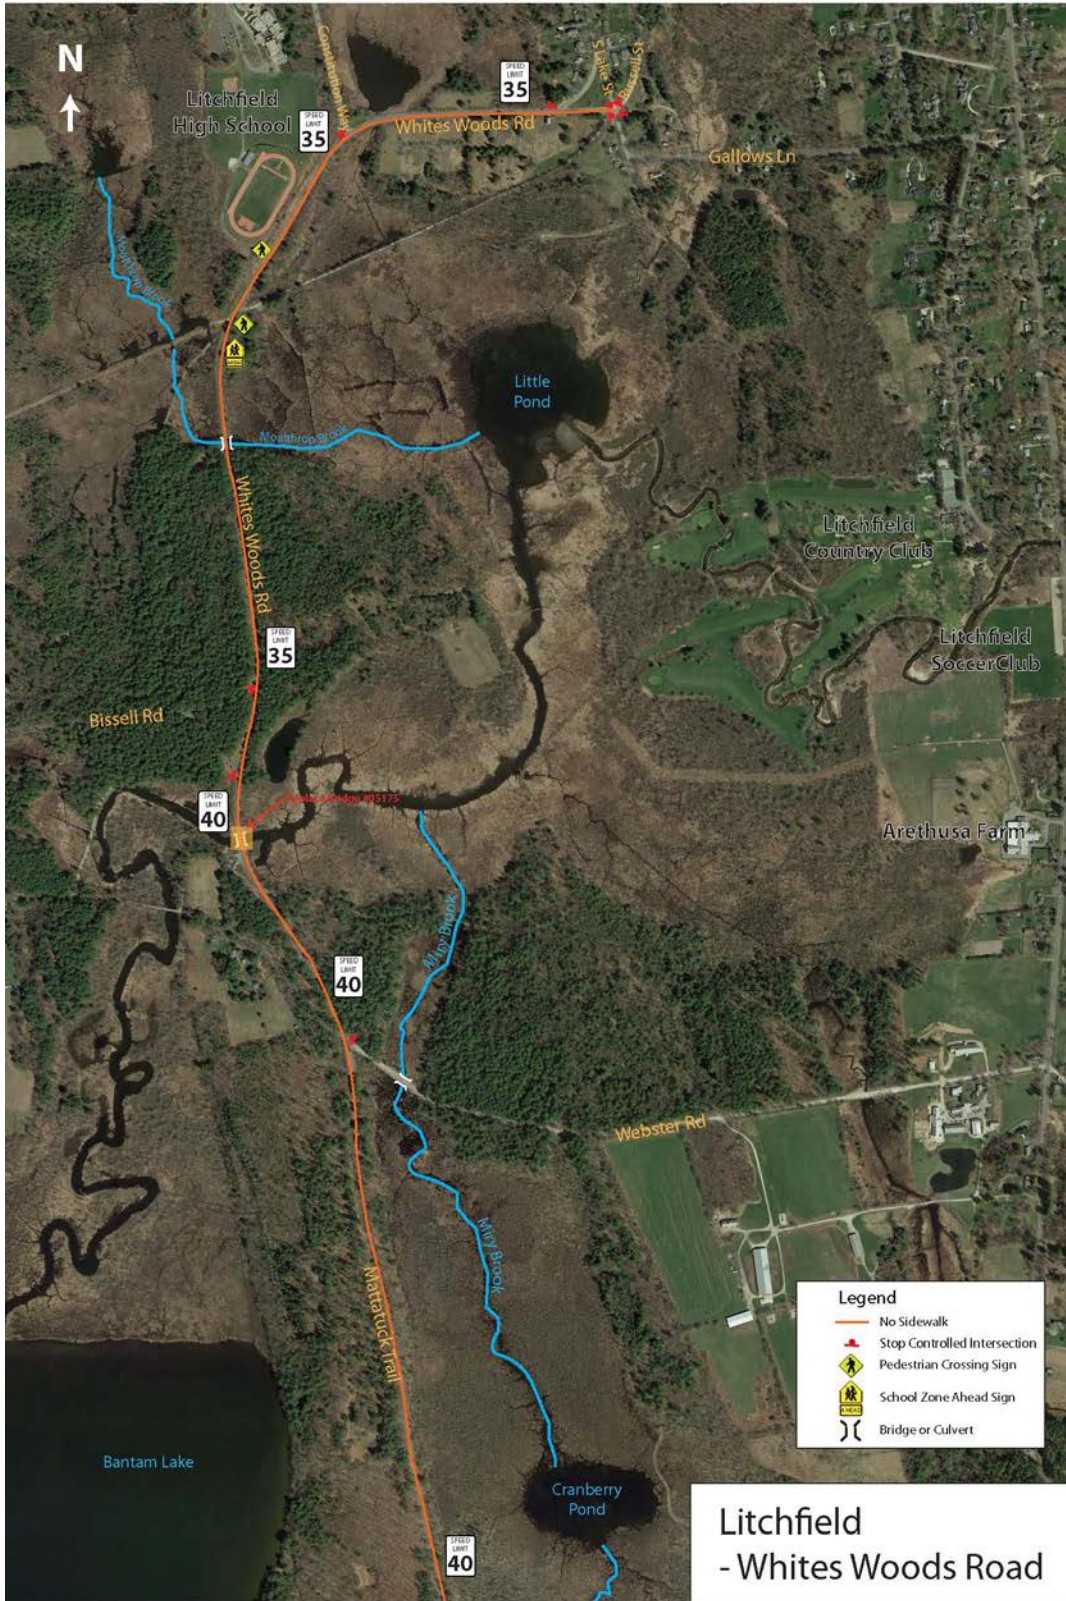
Figure 4. White's Woods Road and Mattatuck Trail Road Geometrics

Figure 4 and Table 3 summarize roadway geometrics for the study area.

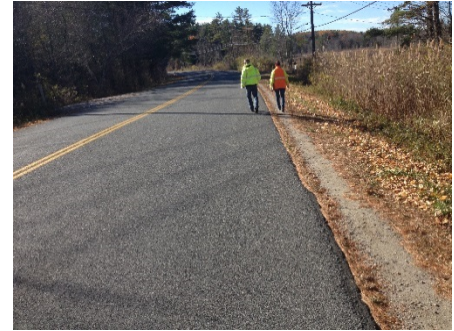
Figure 5: Looking north on White's Woods Road toward Greenway crossing

- The northbound travel lane is 14.5 feet wide and the southbound lane is 16 feet wide. There is a narrow gravel recovery area on both sides. (Figure 5).
- There are advance pedestrian crossing signs in both directions that are newer and appear to meet retro-reflectivity standards.
- There is no crosswalk and no pedestrian crossing signs where the Greenway actually crosses White's Woods Road (Figure 6).
- There are no street lights near the crossing.
- The sight distance was measured as approximately 270 feet for vehicles traveling northbound on White's Woods Road approaching the Greenway crossing. The sight distance is restricted by a vertical curve. The available stopping sight distance is adequate for approximately 35 mph.
- There is no centerline or shoulder striping on White's Woods Road.

2. Town to borrow a portable speed trailer from the Town of Morris for use on White's Woods Road (Figure 15).
3. Town to stripe a crosswalk at the Greenway crossing on White's Woods Road with reflective paint or thermo-plastic/inlay tape. Install new retro-reflective pedestrian crossing signs and arrow plaques. See Medium-term measures below.

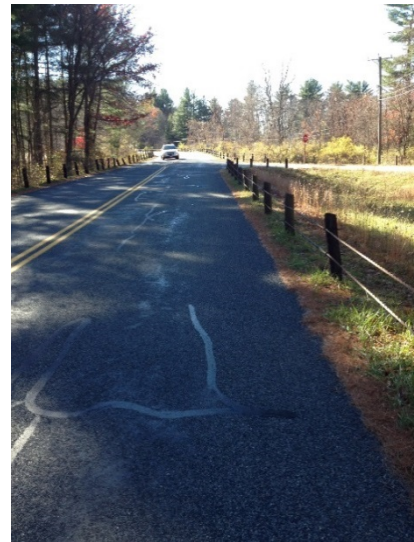
Figure 7: White's Woods Road looking south at Bissell Road (south)

- The northbound travel lane is 12 feet wide and the southbound lane is 14 feet wide.
- There is a post and cable guide rail on both sides of White's Woods Road at the Bissell Road (south) intersection (Figure 7).

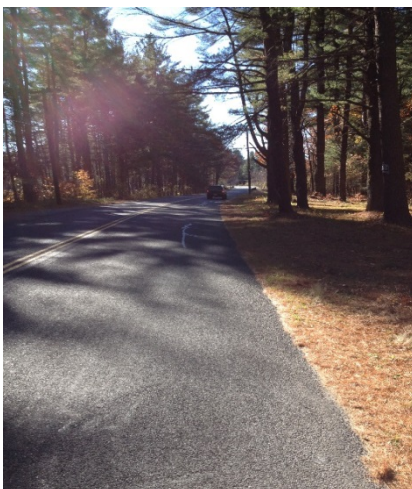
Figure 8: Looking southbound on White's Woods Road near Bissell Road (North)

- The sight distance was measured as approximately 375 feet for vehicles traveling southbound on White's Woods Road approaching Bissell Road (north). The sight distance is restricted by White Pine trees on the west side of the road.

- White Pine trees also block the sight distance for vehicles exiting Bissell Road (north) and looking south on White's Woods Road (Figure 8).
- Bissell Road (north) is approximately 26 feet wide.

5. Town to evaluate alternatives for a new configuration and alignment at the intersection of White's Woods Road and Bissell Road (north and south). Alternatives should be developed that would eliminate one of the two T-intersections or consolidate the two Bissell Road segments into a single roadway. The goals of a new alignment would be to improve safety for all users, slow traffic speed, reduce the amount of impervious pavement, and potentially provide an additional parking area. Alternatives may include a roundabout, a one-way pair, and consolidating the existing north and south segments into a single conventional T-intersection. The Town should coordinate with the White Foundation which owns property adjacent to the intersection and within the intersection.

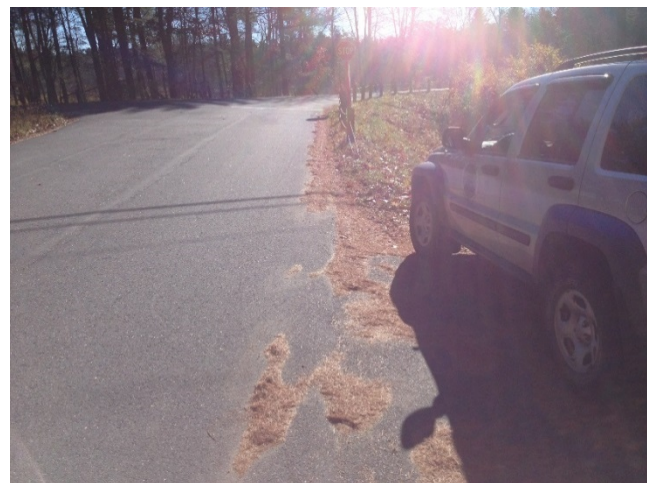
Figure 9: Bissell Road (north) approach to White's Woods Road

- There are stop signs and stop bars on both Bissell Road approaches to White's Woods Road (Figure 9).
- There is no centerline or shoulder striping on White's Woods Road.

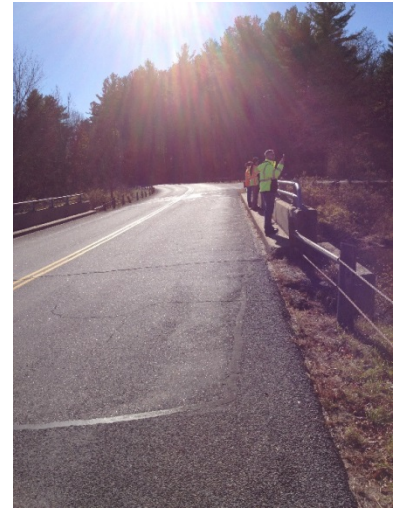
Figure 10: Bridge on White's Woods Road looking south

- The bridge has 15-foot wide travel lanes in each direction and a 2-foot wide safety walk on each side (Figure 10).
- There are steep slopes and wetlands on both sides of the bridge that may restrict options for providing a new pathway on either side.
- There is post and cable guide rail on both sides south of the bridge.

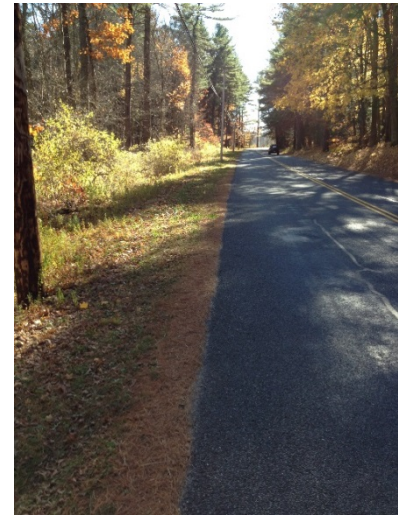
Figure 11: White's Woods Road looking south, south of bridge

- The northbound travel lane is 13.5 feet wide and the southbound lane is 15 feet wide.
- The posted speed limit is 40 mph in both directions south of the bridge.
- There are no speed advisory signs.
- South of the bridge the utility poles cross from the west side of White's Woods Road to the east side.
- The east side of White's Woods Road appears to have fewer constraints than the west side, which has steep slope (Figure 11).

3. Town to repair damaged guiderail on the southeast corner at the intersection of White's Woods Road and Webster Road.
4. Town to develop concept plans for a new pedestrian pathway between Bissell Road and Webster Road. A preliminary alignment may have the pathway on the west side of White's Woods Road from Bissell Road to and including the bridge, and then shifting to the east side south of the bridge and continuing to Webster Road. Materials for the pathway may include stone dust or crushed stone.

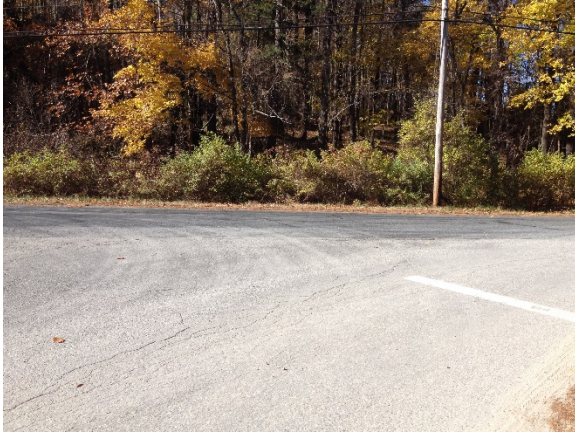
Figure 12: Webster Road approach to White's Woods Road

- Webster Road intersects White's Woods Road on the east side as a T-intersection.
- There is a new stop sign with a vertical reflective strip on the pole, but no stop bar.
- Webster Road is wide where it intersects White's Woods Road, with wide corner radii on the both corners (Figure 12).
- Town staff indicated there have been crashes at this intersection.
- There is damaged guide rail on the southeast corner (Figure 13).

4. Town to stripe a stop bar on the Webster Road approach to White's Woods Road. The stop bar should be located near the intersection with White's Woods Road.

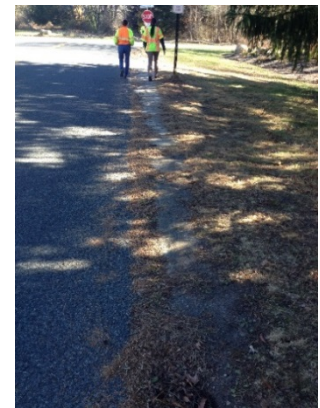
Figure 14: White's Woods Road looking northbound at intersection with South Lake Street and Russell Street

- On-street and off-street parking is prohibited in the vicinity of the intersection and the Greenway trailhead. As a result, Greenway users who drive must park further away, such as on Russell Street.
- The cemetery is located on the east side of White's Woods Road.
- There is a worn path on the east side of the road indicating pedestrian activity (Figure 14).

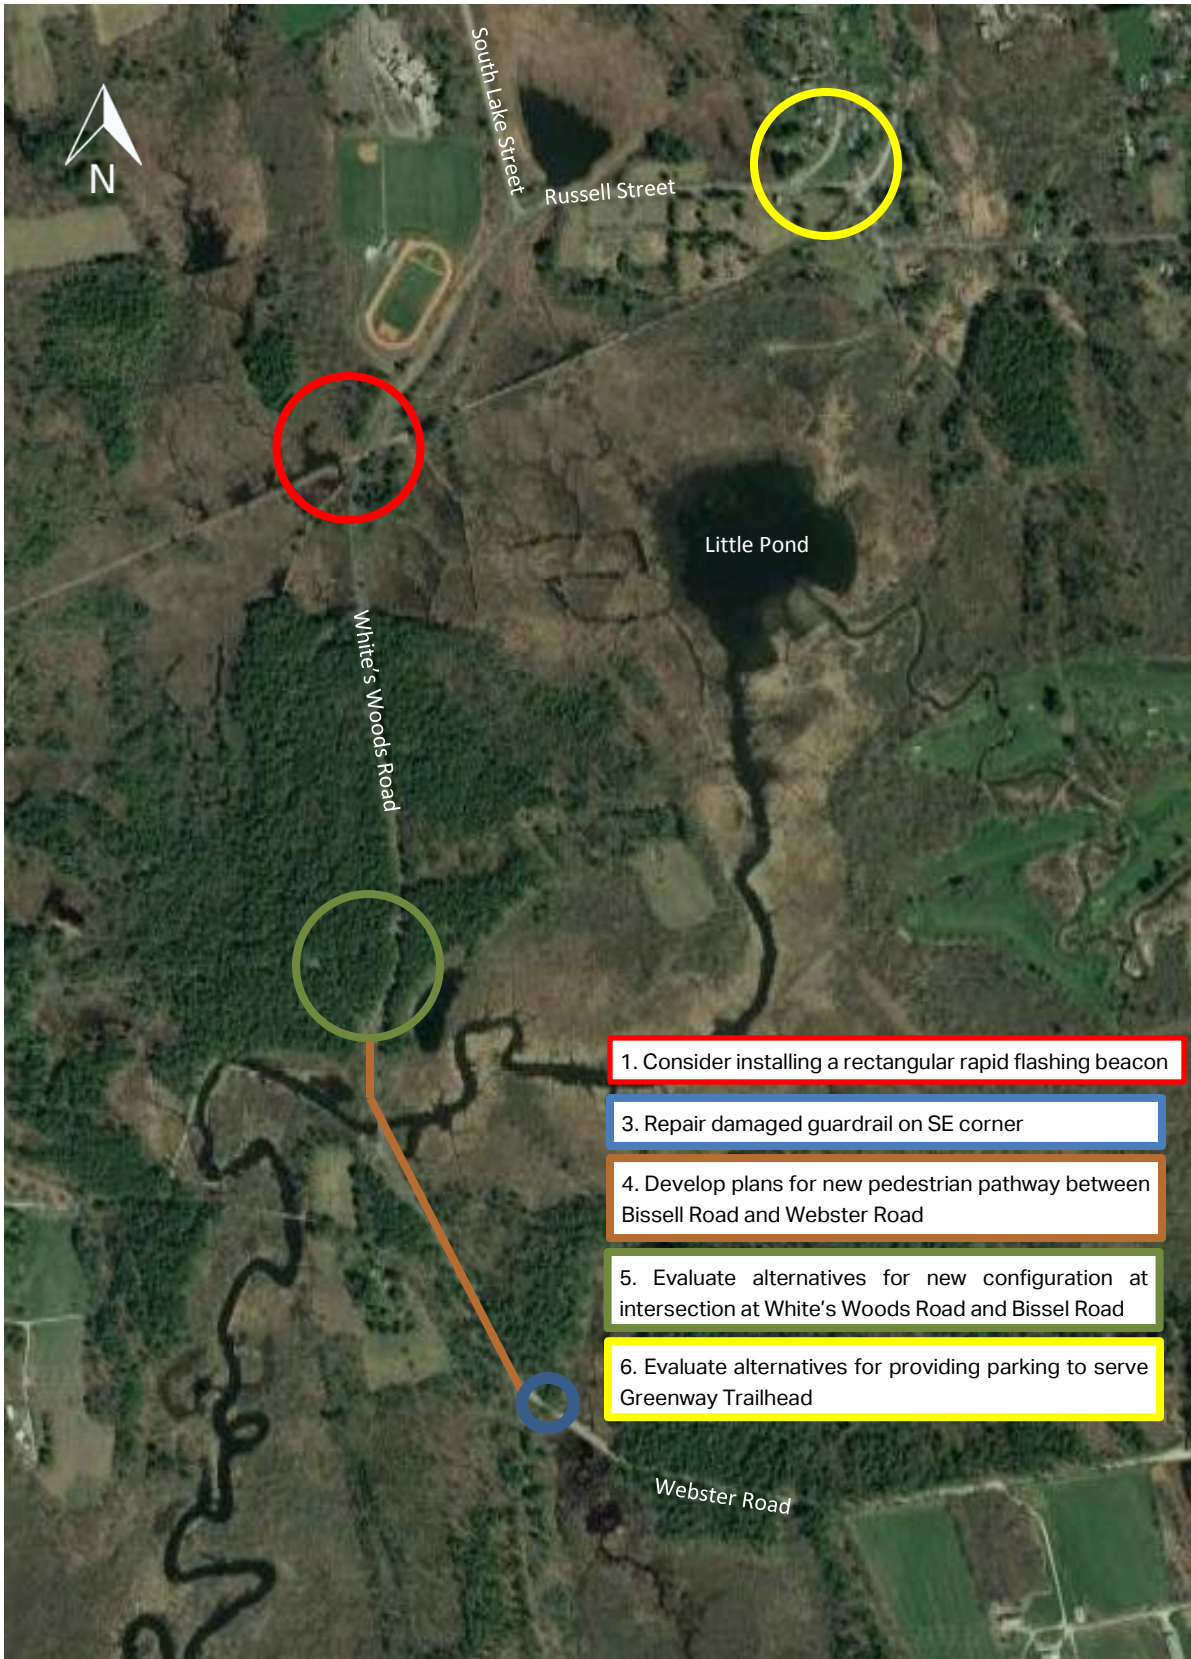
Figure 18: Medium-Term Recommendations

Figure 18 depicts these recommendations.

1. Town to consider installing a rectangular rapid flashing beacon or other similar device at the Greenway crossing on White's Woods Road. This type of device may be needed due to limited sight distance and high travel speed (Figure 17).

2. Town to consider providing street lighting at critical spot locations on White's Woods Road where pedestrians cross, such as the Greenway crossing and Little Pond Boardwalk trail.
