Mansfield

Middle Turnpike (Route 44) and Storrs Road (Route 195) –
Road Safety Audit

September 29, 2016

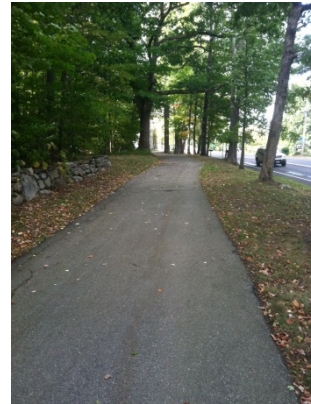
Figure 5. Bituminous multi-use path

- The bituminous multi-use path west of the intersection is 10-feet wide (Figure 5).
- There are overgrown trees and brush blocking some of the signs on the trail.

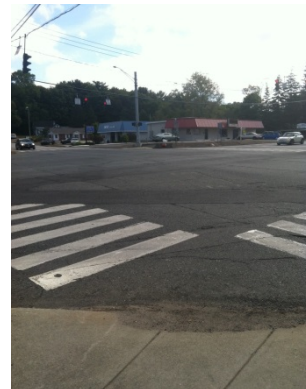
Figure 6. Deteriorating pavement

- The pavement condition at the intersection is deteriorating (Figure 6).
- Route 44 was measured as having a 4-foot eastbound shoulder, 12-foot eastbound lane, 11-foot eastbound turn lane, 12-foot westbound lane, 6-foot westbound shoulder.

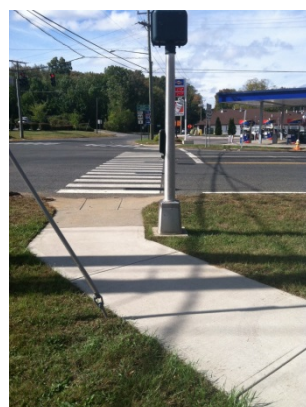
Figure 7. Long crosswalk, no detectable warning strips

- West side: 75 feet.
 - South side: 122 feet.
 - East side: 53 feet.
 - North side: 85 feet (Figure 7).

- The pedestrian signal phase is approximately 30 seconds, which does not appear adequate for crossing at the longest crosswalk.
- There are no detectable warning strips on the sidewalk ramps at the intersection (Figure 7).

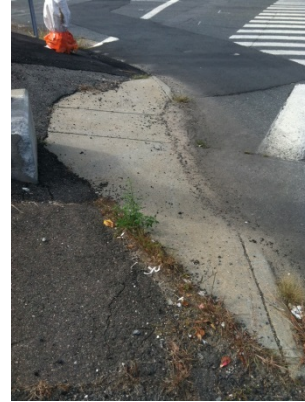
Figure 8. Steep sidewalk ramp

- Some sidewalk ramps at the intersection are very steep and do not meet ADA requirements (Figure 8).
- The pedestrian push buttons are not Accessible Pedestrian Signals (APS) and are not ADA compliant.

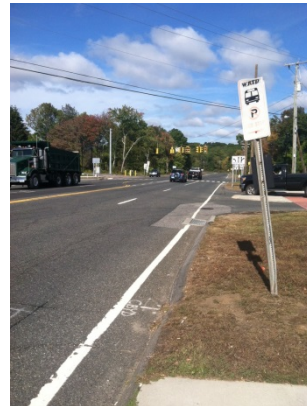
Figure 9. Bus stop sign in poor condition

- Bus stop signs are in poor condition and with low retro-reflectivity (Figure 9).
- Several signs need to be adjusted to provide a 7-foot minimum clearance.

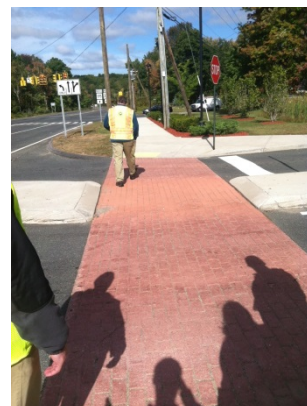
Figure 10. Mis-aligned sidewalk ramp

- The sidewalk ramp at Cumberland Farms is not aligned correctly (Figure 10).
- Trucks are not able to navigate the existing curb radius at one of the entrances to Cumberland Farms (Figure 11).

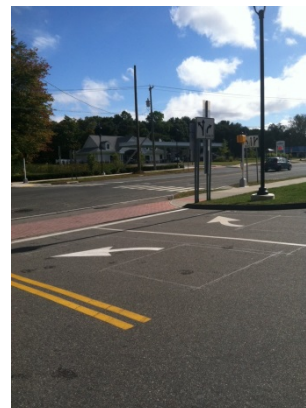
Figure 12. Painted arrows and sign not matching

- The painted arrows in the eastbound driveway at the Route 320 intersection do not match the mounted sign. Additionally, the placement of the sign makes it difficult for drivers to see it due to its orientation and the direction drivers approach the intersection (Figure 12).

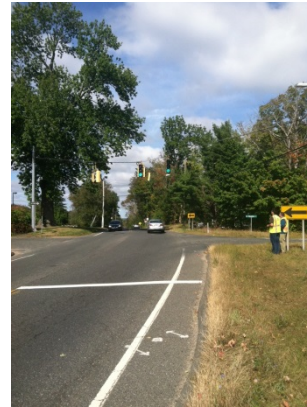
Figure 13. Signs lacking retro-reflectivity

- Some signs are in poor condition and some signs are fading (Figure 13).
- Trimming of some of the trees and bushes around the intersection is needed for utility maintenance and to improve sight lines (Figure 14).

2. Town to coordinate with the CTDOT to replace signs that are faded and lack retro-reflectivity.
3. Town to coordinate with the CTDOT to add additional One-Direction Large Arrow (W1-6) warning signs in the southbound direction at the Route 195/Moulton Road intersection (Figure 23).

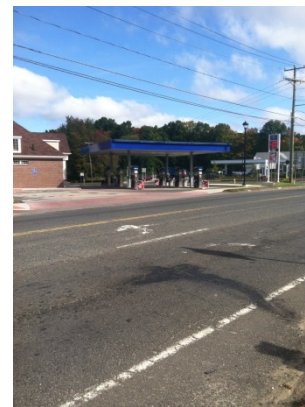
Figure 16. Faded pavement markings

- Detectable warning strips are missing from sidewalk ramps.
- The intersection needs to be re-striped to refresh faded markings (Figure 16).
- Some of the signage is old and in poor condition and should be updated.

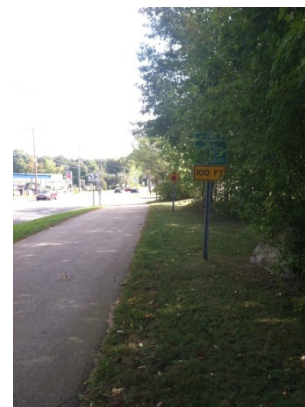
Figure 17. Multi-use path signs obstructed by branches

- Trimming of trees and bushes is needed around some of the multi-use path signage (Figure 17).
- There is a painted bike symbol in the shoulder of Route 44 westbound. It may be useful to add signage at the intersection directing bikers and pedestrians to the multi-use path.

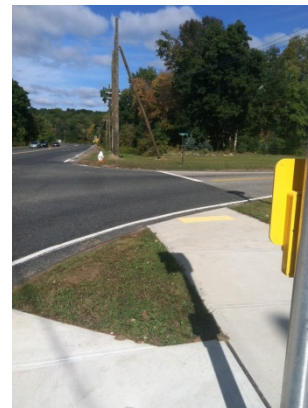
Figure 19. No receiving ramp on Route 320 north side

- There is no receiving ramp on the north side of Route 320 at the intersection of Route 320 and Route 195 (Figure 19).
- The pavement marking arrows exiting the parking lot at the Route 320 intersection need to be revised.
 - The lane use sign could be hung from the span wire to be more visible.

10. Town to coordinate with the CTDOT to provide a receiving handicap ramp on the northeast corner of Route 195 and Route 320 intersection.

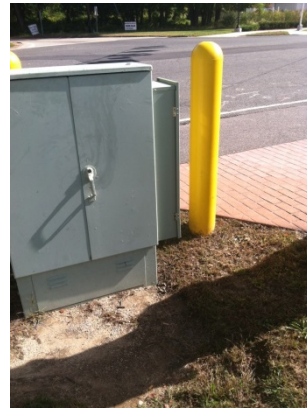
Figure 20
Telecommunications boxes adjacent to Dunkin Donuts sidewalk

- The crosswalk at the driveway does not have a sidewalk ramp at the northwest corner. There are currently two communication cabinets at that location protected by bollards. The town stated that there are plans to relocate these cabinets in the future and provide an ADA accessible sidewalk ramp.

- After telecommunications cabinets are relocated a ramp can be constructed at the northwest corner of Dunkin Donuts/Sunoco gas station driveway (Figure 20).
- Several signs need to be adjusted to provide a 7-foot minimum clearance.

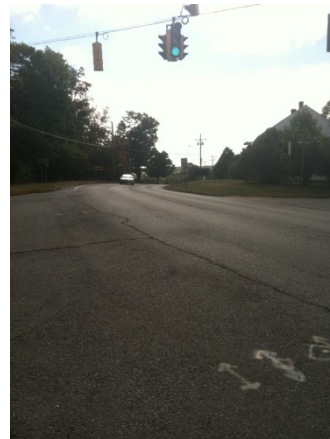
Figure 21. Sight distance looking south from north side of Moulton Rd. intersection

- The roadway geometry of Route 195 creates poor sightlines for vehicles approaching the intersection from Moulton Road and Tower Loop Road.
- There are not enough One-Direction Large Arrow (W1-6) warning signs for the horizontal curve in the southbound direction.

- Pavement markings at the intersection are faded.
- Some signs at the intersection have faded and lost retro-reflectivity over time.
- Adding "No Turn on Red" signs should be considered due to the sightline constraints.
