COMMUNITY
connectivity program

Straits Turnpike (Route 63) from Woodside Avenue to
Country Club Road – Road Safety Audit

November 15, 2016

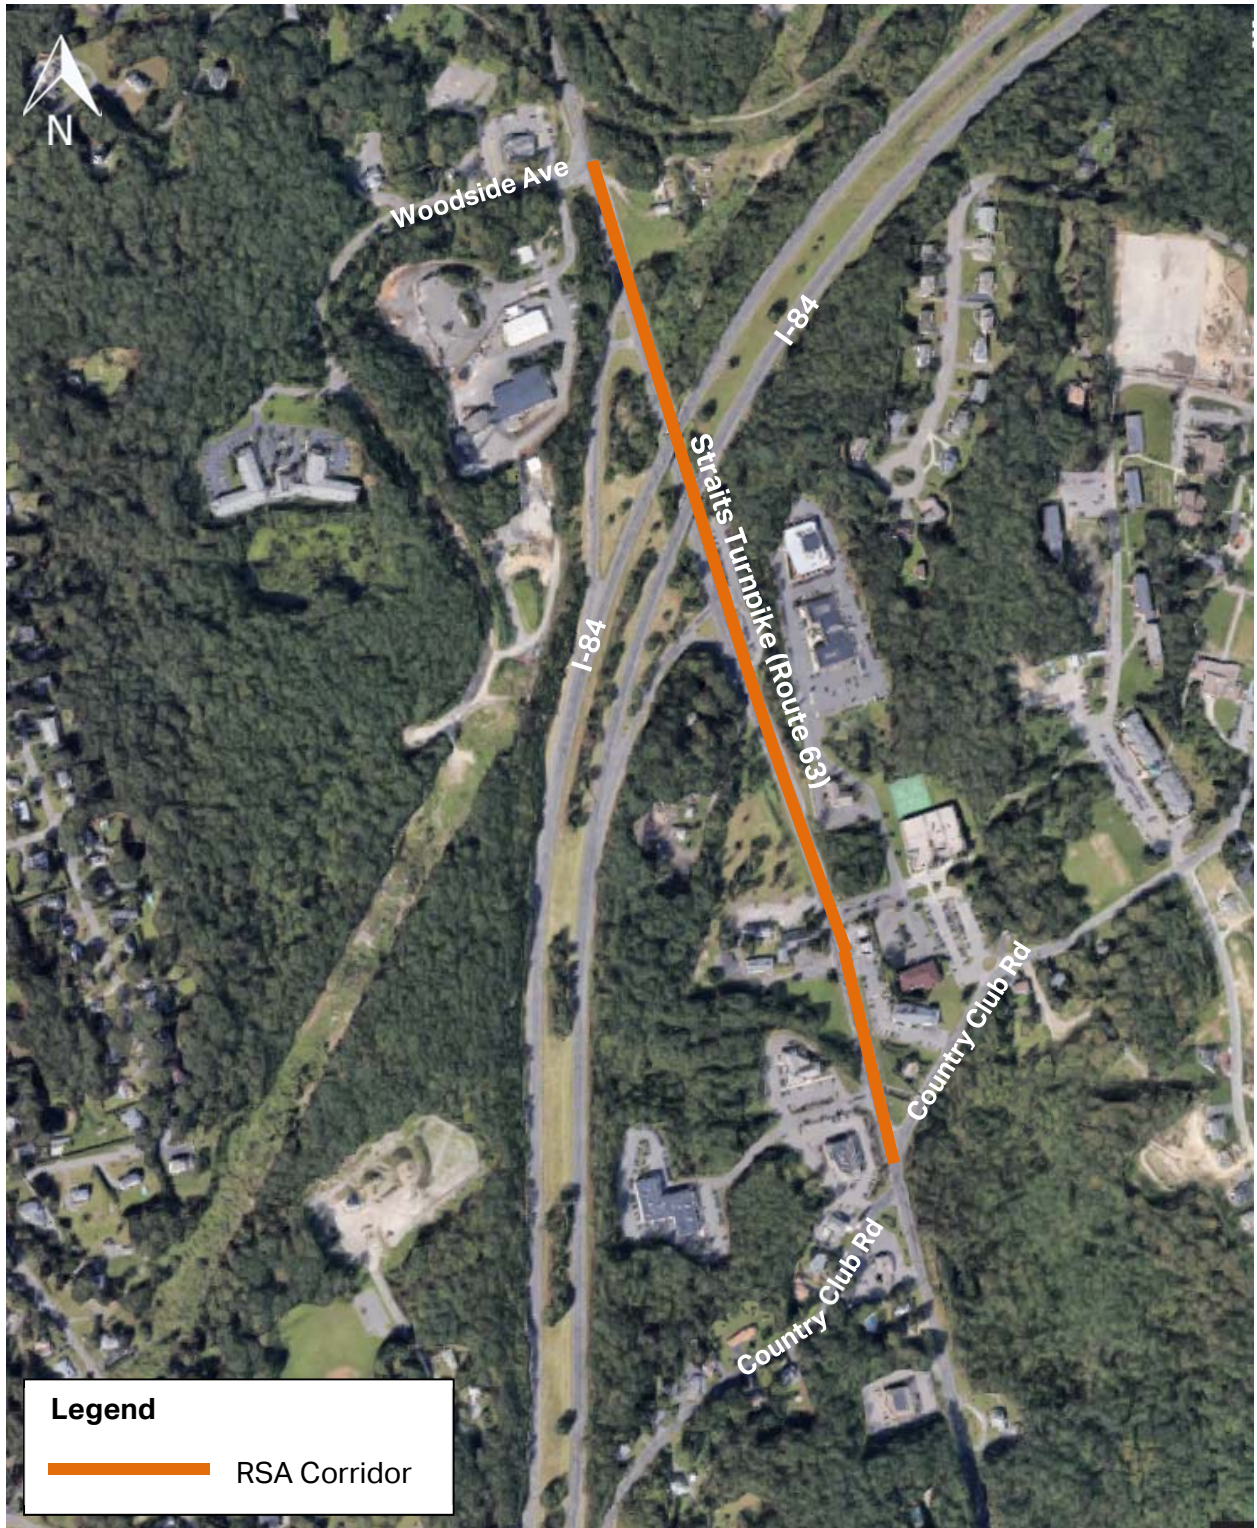
Figure 1. Straits Turnpike (Route 63), Middlebury

The RSA site is the section of Straits Turnpike between Woodside Avenue to the north and Country Club Road to the south (Figure 1). Figure 2 shows the study corridor in a regional context. Route 63 is classified as a Minor Arterial. The Average Daily Traffic (ADT) on Straits Turnpike is 12,100 vehicles per day (vpd) near the Country Club Road intersection, and 13,600 vpd near the intersection of Woodside Avenue. Route 63 consists of a single lane in each direction, with a double yellow center line with shoulders on both sides of the roadway. South of Country Club Road, passing is allowed in the southbound direction and then further south, it is allowed in both directions.

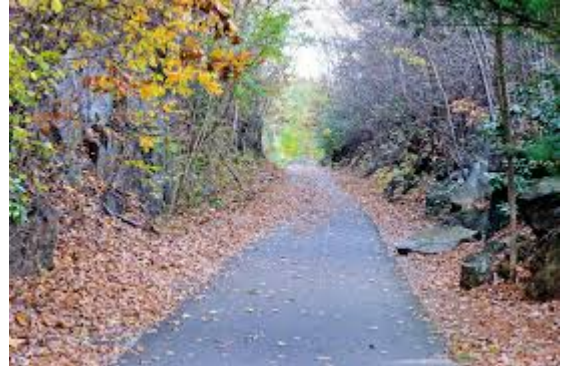
Figure 5: Middlebury Greenway

The Town of Middlebury has made efforts at improving the connectivity and vitality of the Route 63 corridor. The Town has successfully completed most of the Middlebury Greenway, a walking and biking trail converted from an old trolley bed that extends from east to west along Route 64 from Lake Quassapuag on the west side to the Route 63 and Woodside Avenue intersection on the east side of town. Currently the Greenway stretches 4.4 miles, but there is a missing section along Route 63 from Woodside Avenue to Hop Brook Recreation Area (see Figure 5).

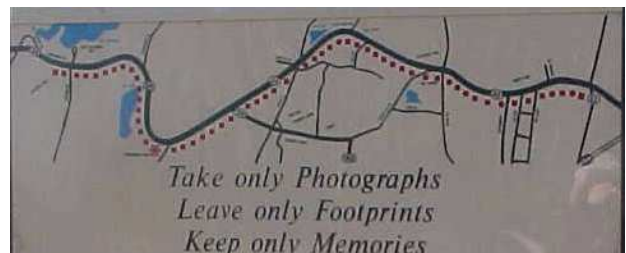
Figure 6: Middlebury Greenway map

- The land use along Route 63 is a mix of retail, commercial, residential and dedicated open space.
- The project area lies within the Hop Brook sub-basin of the Naugatuck River and the Hop Brook Lake Recreation Area, which is located along both sides of Route 63 within the project area. This area is owned and maintained by the Army Corp of Engineers and consists of about 249 acres. It protects sections of the Hop Brook and Wooster Brook.
- The Greenway is currently 4.4 miles long, from Lake Quassapuag on the west side to the Route 63 and Woodside Avenue intersection on the east side of town (Figure 6). The missing greenway section is along Route 63 from Woodside Road to Hop Brook Recreation Area.
- Memorial Drive may be considered for a

future extension of the Greenway.

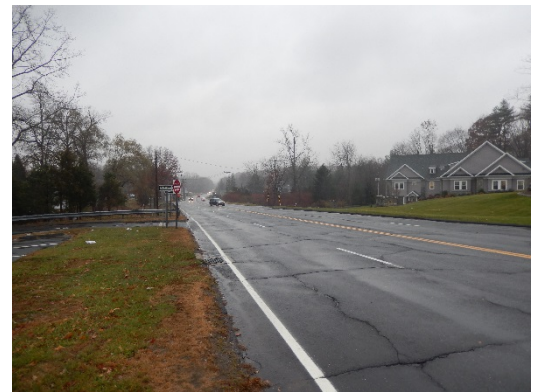
Figure 7: Route 63

- There are bituminous curbs with low reveal.
- Road pavement and striping are in fair to good condition on Route 63 (Figure 7).
- Police noted that speeding patterns along this corridor are congruent with other areas in town.

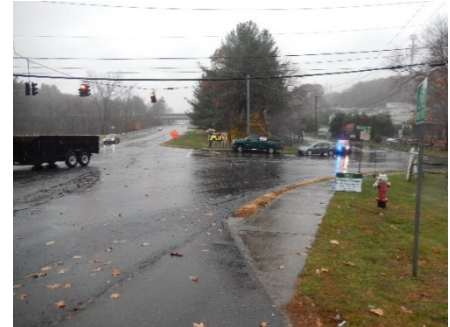
Figure 8: Route 63 and Woodside Avenue looking south.

- This is a three-way, T-intersection with Woodside Avenue forming the stem of the T on the west side of Route 63 (Figure 8).
- The popular restaurant Maggie McFly's is located on the northwest corner at this intersection.

- There are pedestrian pushbuttons on the northwest and southeast corners, but no pedestrian signal heads.
- There are no crosswalks or handicap ramps.
- There is a sidewalk on the east side that begins at the Greenway and extends on the north side of Woodside Avenue. It provides access via a crosswalk to a pathway on the south side of Woodside Avenue.

- Route 63, north of this intersection, has some vertical curvature and limited sight lines.
- There are no street lights in this area.

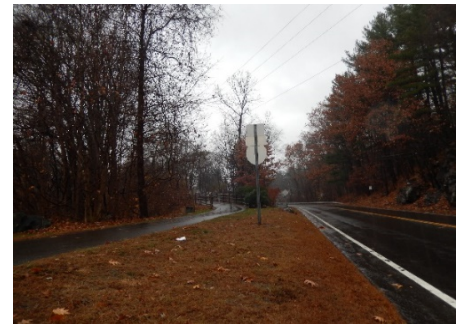
Figure 9: Middlebury Greenway Trail north of Woodside Avenue

- There are separate left- and right-turn lanes on the Woodside Avenue approach.
- The Greenway trail begins north of this intersection on the west side. This is where the trail extension to the south is anticipated to begin (Figure 9).

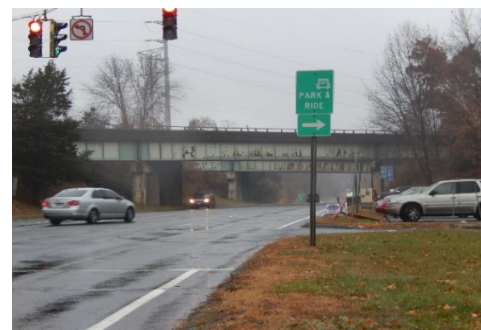
Figure 10: Route 63 and I-84 Exit 17 interchange

- This section of Route 63 is four lanes wide, with two northbound and two southbound lanes (Figure 10).
- There are narrow shoulders on each side of the road.
- The lanes measure 11-feet wide.
- The I-84 bridge abutments are obstacles to extending the Greenway on either side of Route

63 (Figure 10). They measure as follows:

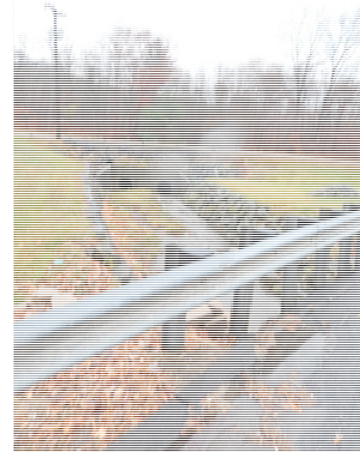
Figure 14: Culvert on east side of Route 63

- There are environmental constraints on both sides of Route 63 that are issues for developing a Greenway. North of the intersection there is a large culvert (Wooster Brook) on both sides of Route 63 and riprap on the east side. CTDOT will be replacing this culvert as a separate project (Figure 14). Both sides have steep slopes and embankments (Figure 15).

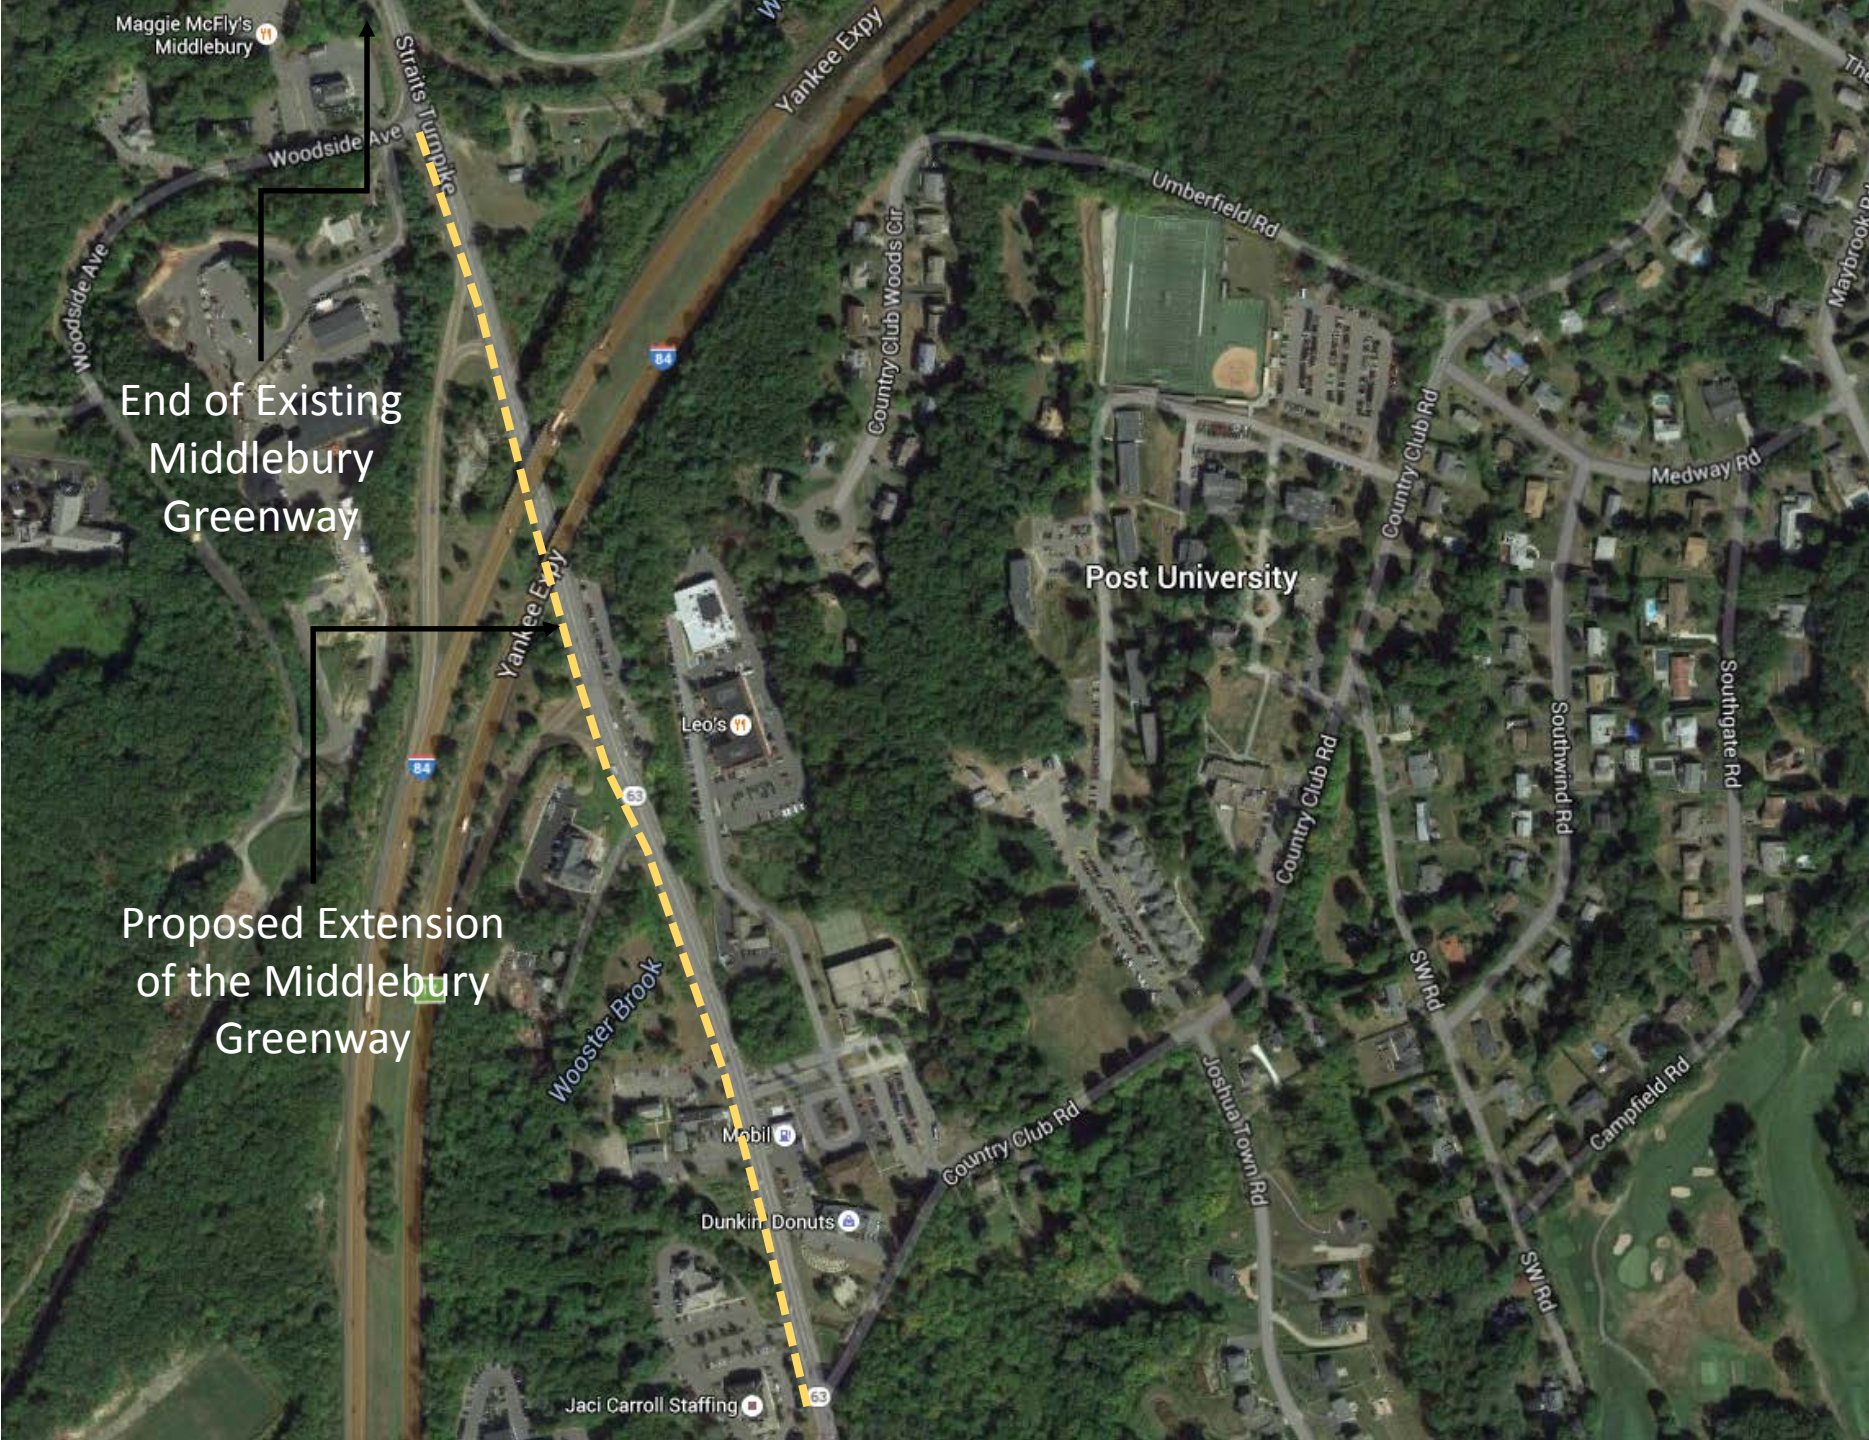
End of Existing Middlebury Greenway

Proposed Extension of the Middlebury Greenway

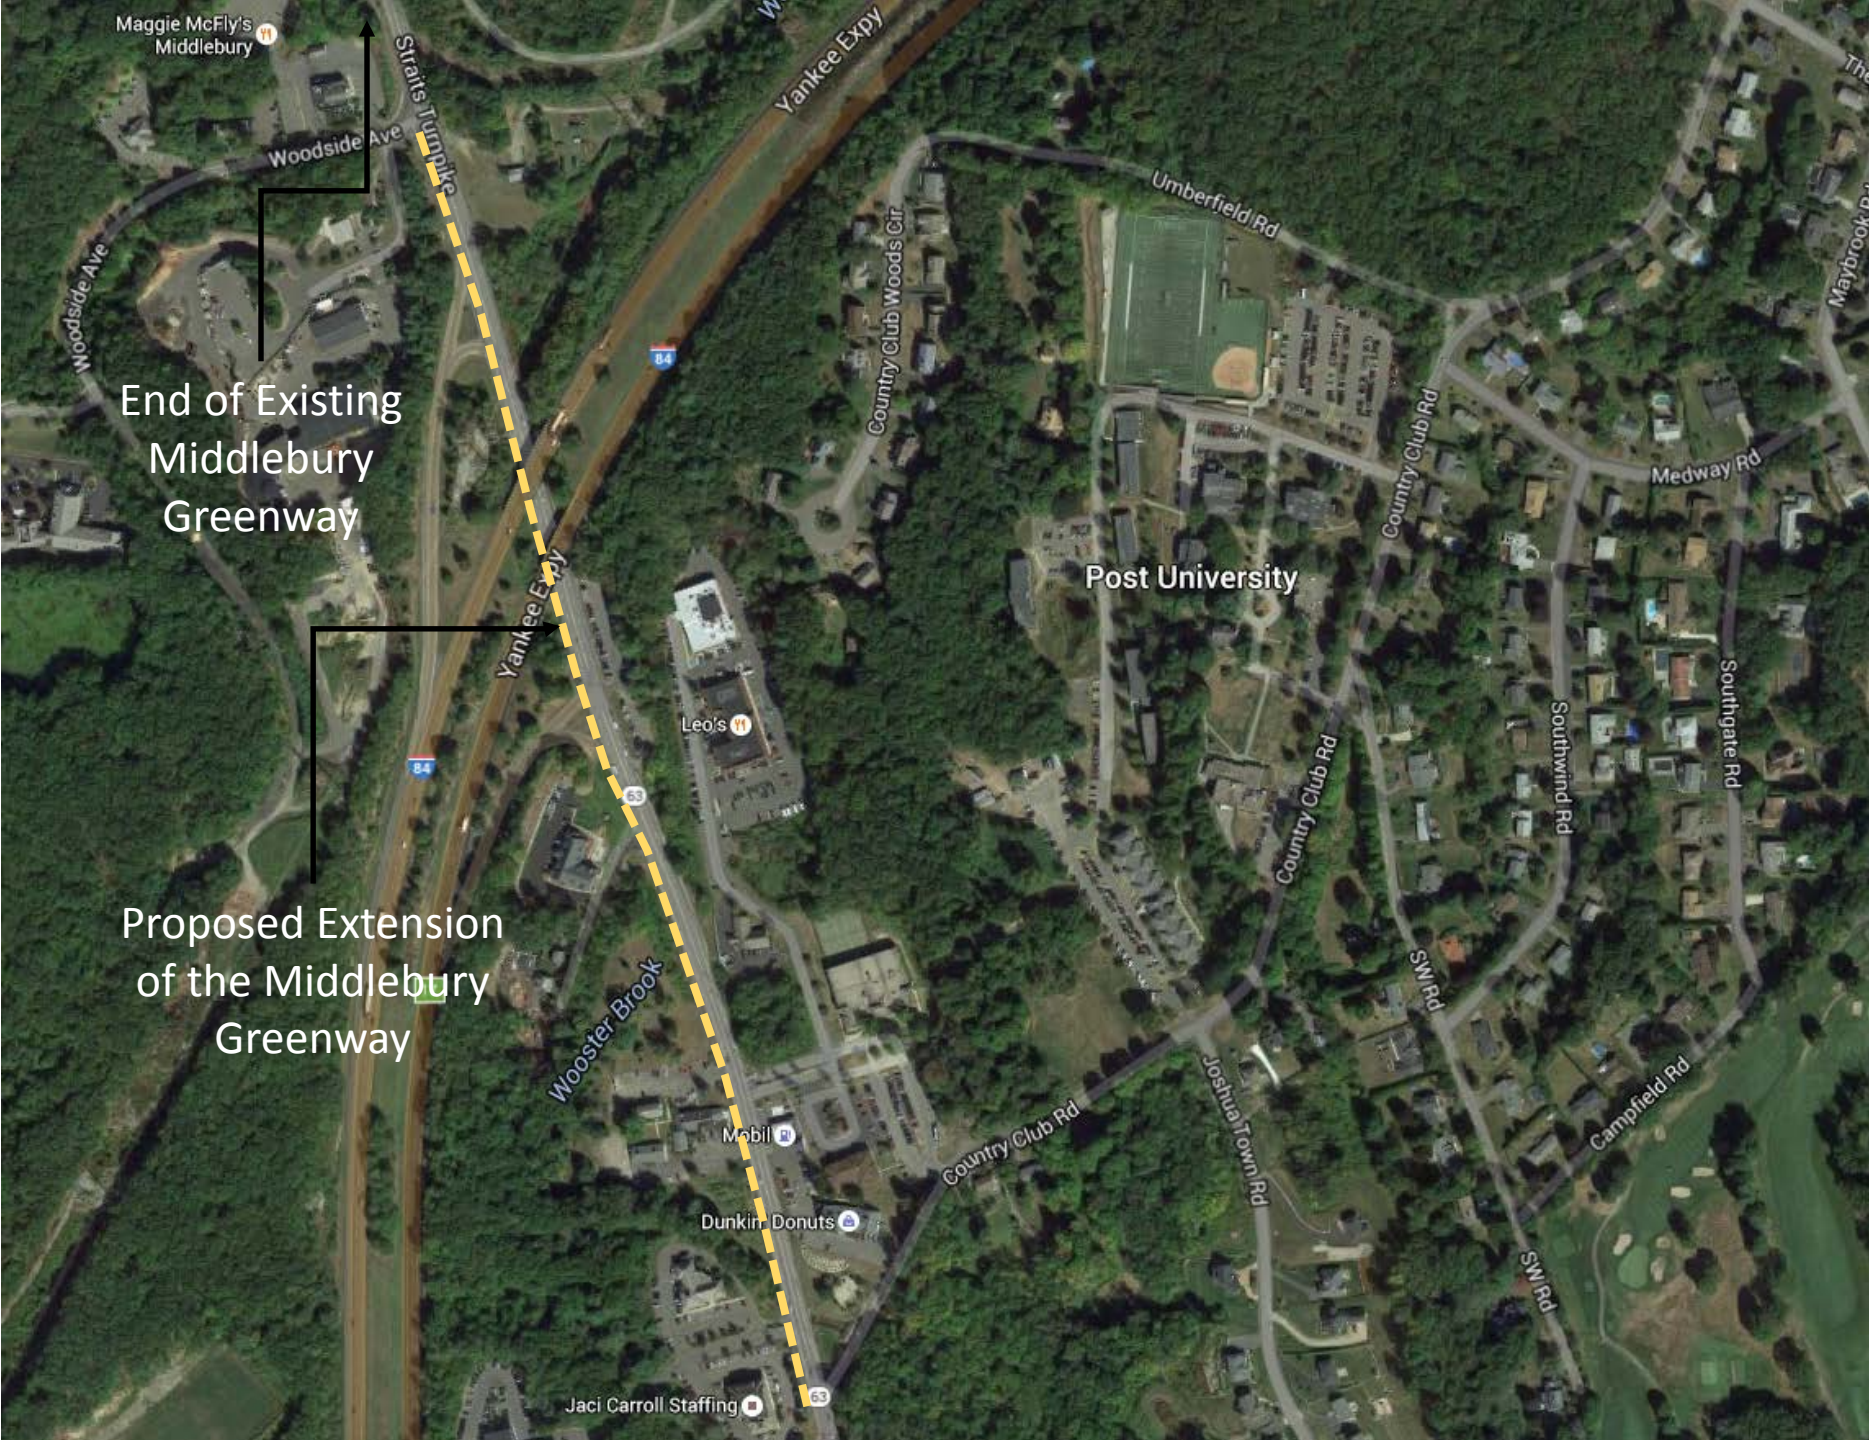
End of Existing Middlebury Greenway

Proposed Extension of the Middlebury Greenway
