COMMUNITY
connectivity program

Milford

Boston Post Road (Route 1), Cherry Street, River Street
and Broad Street – Road Safety Audit

July 14, 2016

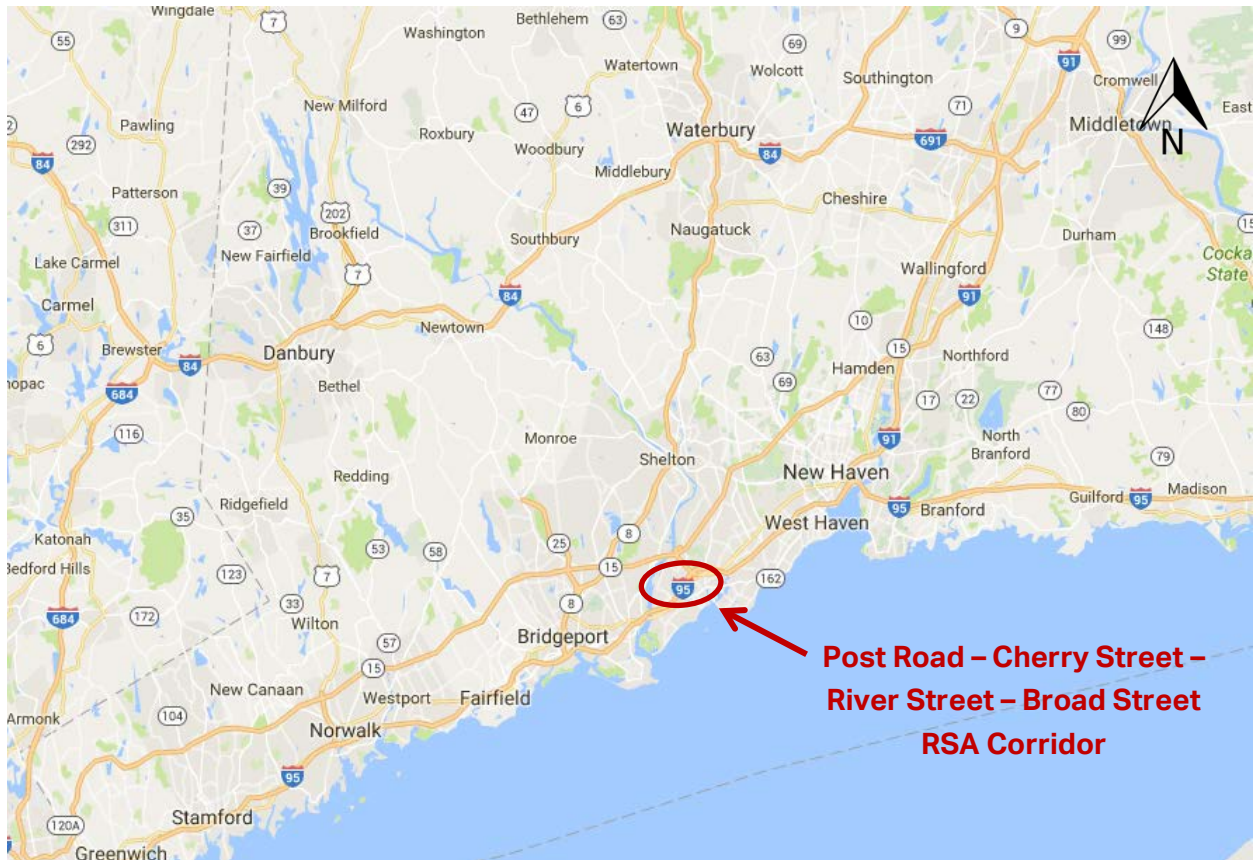
Figure 2. Study Area – Regional Context

Boston Post Road (US Route 1) is a State-owned and maintained facility and in general runs in a northeast/southwest direction through Milford connecting other communities in Connecticut such as Stratford, Orange and West Haven. Cherry Street is a City-owned road that runs between Boston Post Road and River Street in a northeast/southwest direction. River Street is a City-owned road and runs between Cherry Street and Broad Street in a north/south direction. Broad Street is a City-owned one-way pair, one traveling westbound and another traveling eastbound.

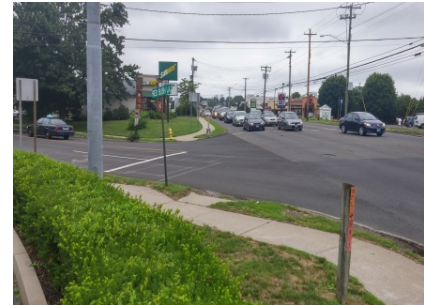
Figure 7. No Crosswalk and Non ADA Compliant

- There is only one crosswalk (long) that crosses the Roses Mill Road approach.
- There are no pedestrian signals.
- The two lanes on the Red Bush Lane approach are striped for a short distance before tapering into one lane.
- The Red Bush Lane approach has non-ADA compliant handicap ramps and no crosswalk (Figure 7).
- A "push button for green light" on a pedestal activates a green phase for the side streets so that pedestrians can cross Boston Post Road (Figure 8).
- Roses Mill Road and Red Bush Lane are not well aligned.
- Red Bush Road has an advance green signal phase. This may create confusion between vehicles on each side street regarding who has the right of way when both approaches have green signals.
- The vehicle loop detectors at this intersection are new.

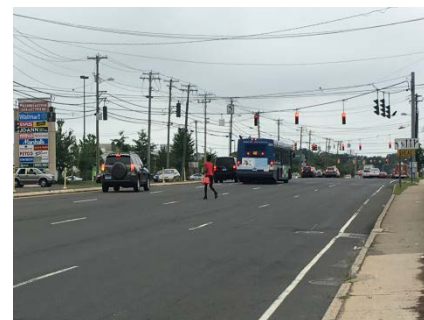
Figure 9. Pedestrian Crossing Mid-block

- Pedestrian activity:
 - One pedestrian alighted a bus and crossed all lanes of traffic on Boston Post Road (Figure 9).
 - Another pedestrian crossed at the intersection.

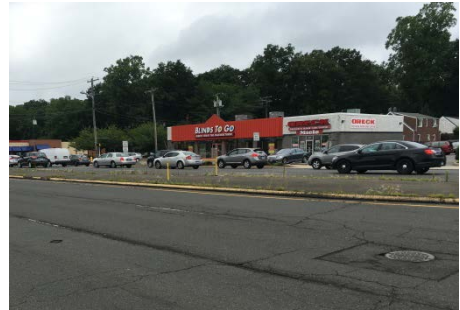
Figure 10. Wide Median

- The median is very wide in this location (Figure 10).
- There may be room on the Post Mall side for a multi-use bike and pedestrian path (Figure 11).
- Can low-level plants be added to the center median as a traffic calming measure? This could reduce the highway feel of Boston Post Road.
- The driveway to Starbucks is 24 feet wide.

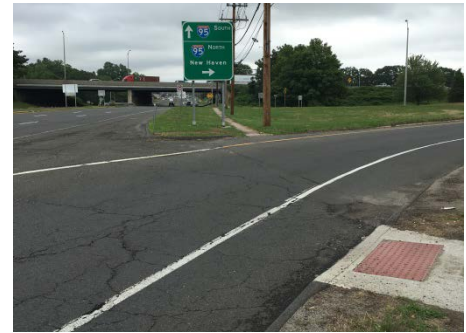
Figure 12. I-95 Ramp Crossing

The pedestrian crossing distances across I-95 on-and-off ramps are long and vary from 23 feet across I-95 southbound off-ramp to 49 feet across I-95 northbound on-ramp. There is a three-foot wide sidewalk between Home Acres Avenue and I-95 northbound on-ramp. The sidewalk continues between the I-95 ramps. However, there are no crosswalks at the I-95 ramps that provide connection with the Home Acres Avenue or the sidewalks between the ramps. There are no pedestrian crossing signs at the ramps. Shoulders on I-95 on-and-off ramps vary from two to nine feet. An inventory of existing conditions of the intersection can be found in Table 6.

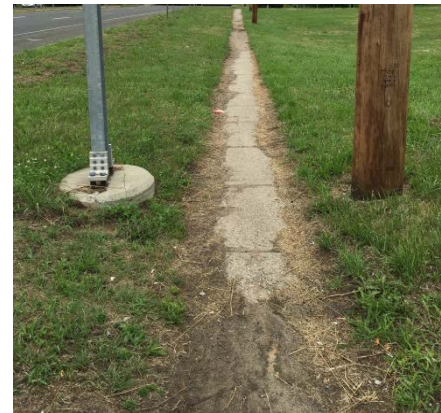
Figure 13. Sidewalk Between I-95 Ramps

- The stop bar on Home Acres Avenue westbound approach is set back 55 feet from the intersection.
- There are no crosswalks or pedestrian signs at the I-95 ramps (Figure 12).
- The pedestrian crossing distance across the I-95 northbound on-ramp is 49 feet.
 - The north corner of the on-ramp could be extended to occupy the shoulder striping which would reduce the pedestrian crossing distance to about 22 feet.
- The sidewalk between I-95 ramps is three feet wide. The sidewalk has room to be widened (Figure 13).

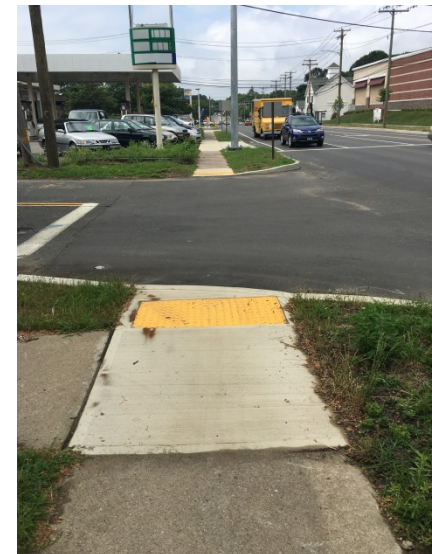
Figure 14. No Pedestrian Crosswalk and Signal at Corona Drive

- No pedestrian signals are provided on the side street approaches. There is no crosswalk at Corona Drive (Figure 14).
- The sidewalk continues across the ShopRite plaza driveway.
- There are ADA compliant ramps on three corners at this intersection.
- The previous Stop sign on the Corona Drive approach is still in place (Figure 15).
- The sidewalks are four feet wide at this development.

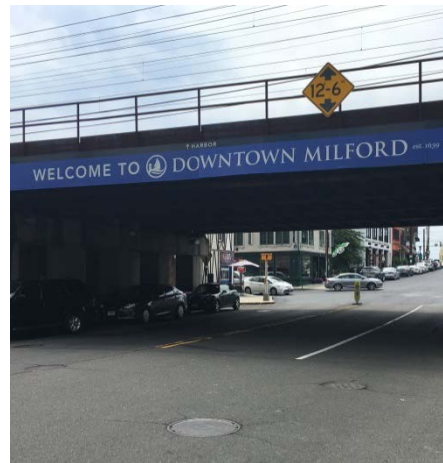
Figure 16. Downtown Gateway Signing

- There is on street parking on the east side of River Street.
- There is gateway signing to the Milford Downtown on the railroad bridge (Figure 16).
- River Street is one-way southbound south of the train station.
- Pedestrian amenities are provided on the sidewalk (Figure 17).
- There is a mid-block crosswalk on River Street north of Daniel Street.
- The sidewalks around Broad and River Streets are up to 12 feet wide. North of the railroad bridge on River Street the sidewalk is five feet wide.

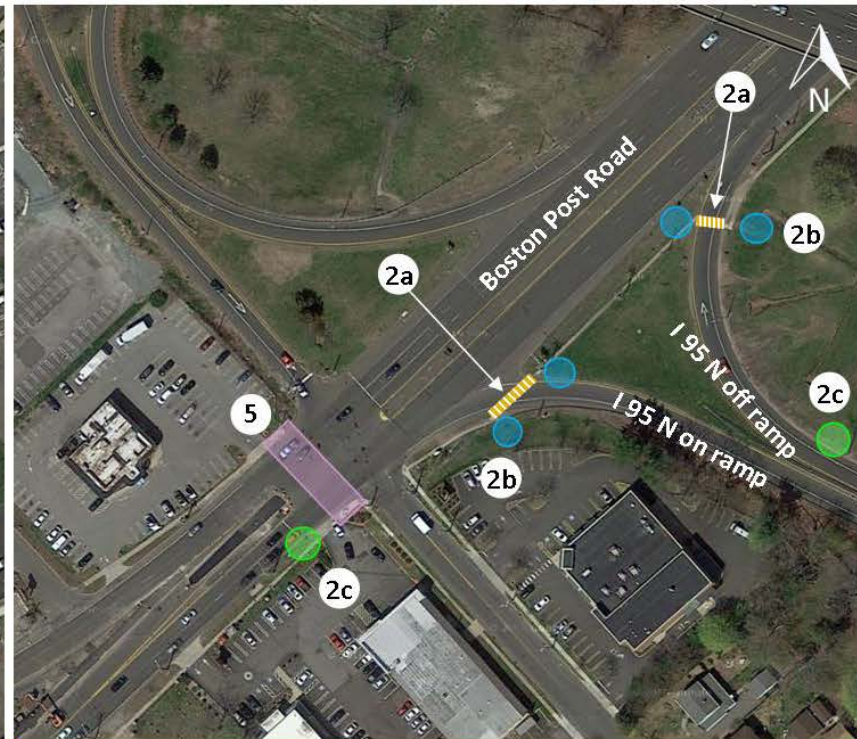
Figure 20. Short Term Recommendations Map 1

1a. Stripe white extension lines to help direct left turns

1b. Extend two lane striping for the Red Bush Lane approach

2a. Stripe Crosswalk

2b. Install pedestrian crosswalk signs

5. Stripe a crosswalk and analyze signal timing to provide adequate time for pedestrians to cross Boston Post Road.

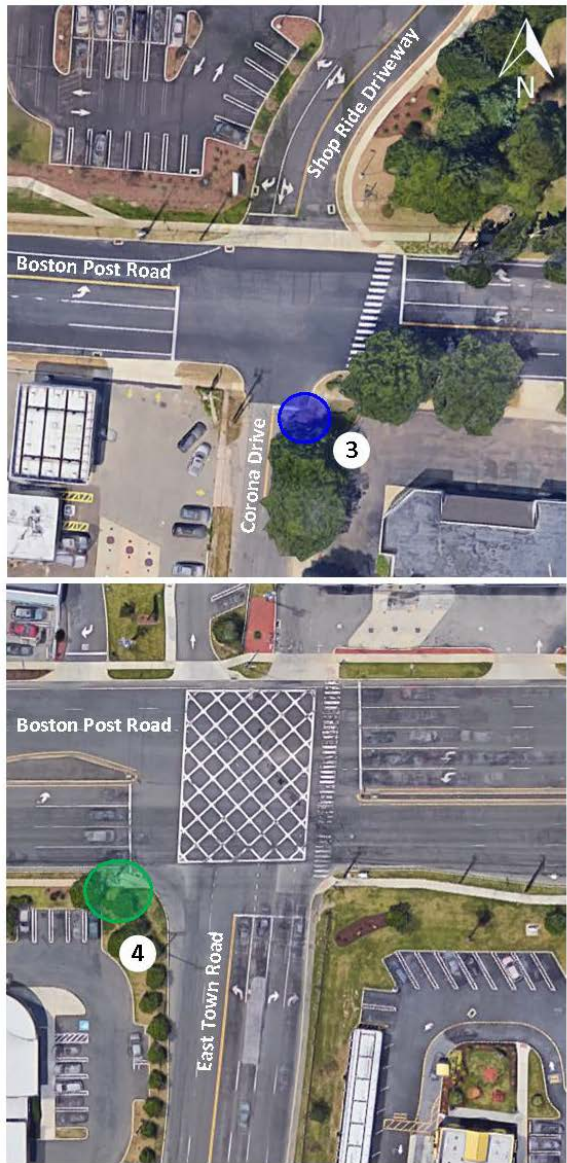
Figure 21. Short Term Recommendations Map 2

3. Remove the stop sign at the Corona Drive approach to the signalized intersection with Cherry Street

4. Evaluate removing the northbound CT Transit stop on Boston Post Road at East Town Road

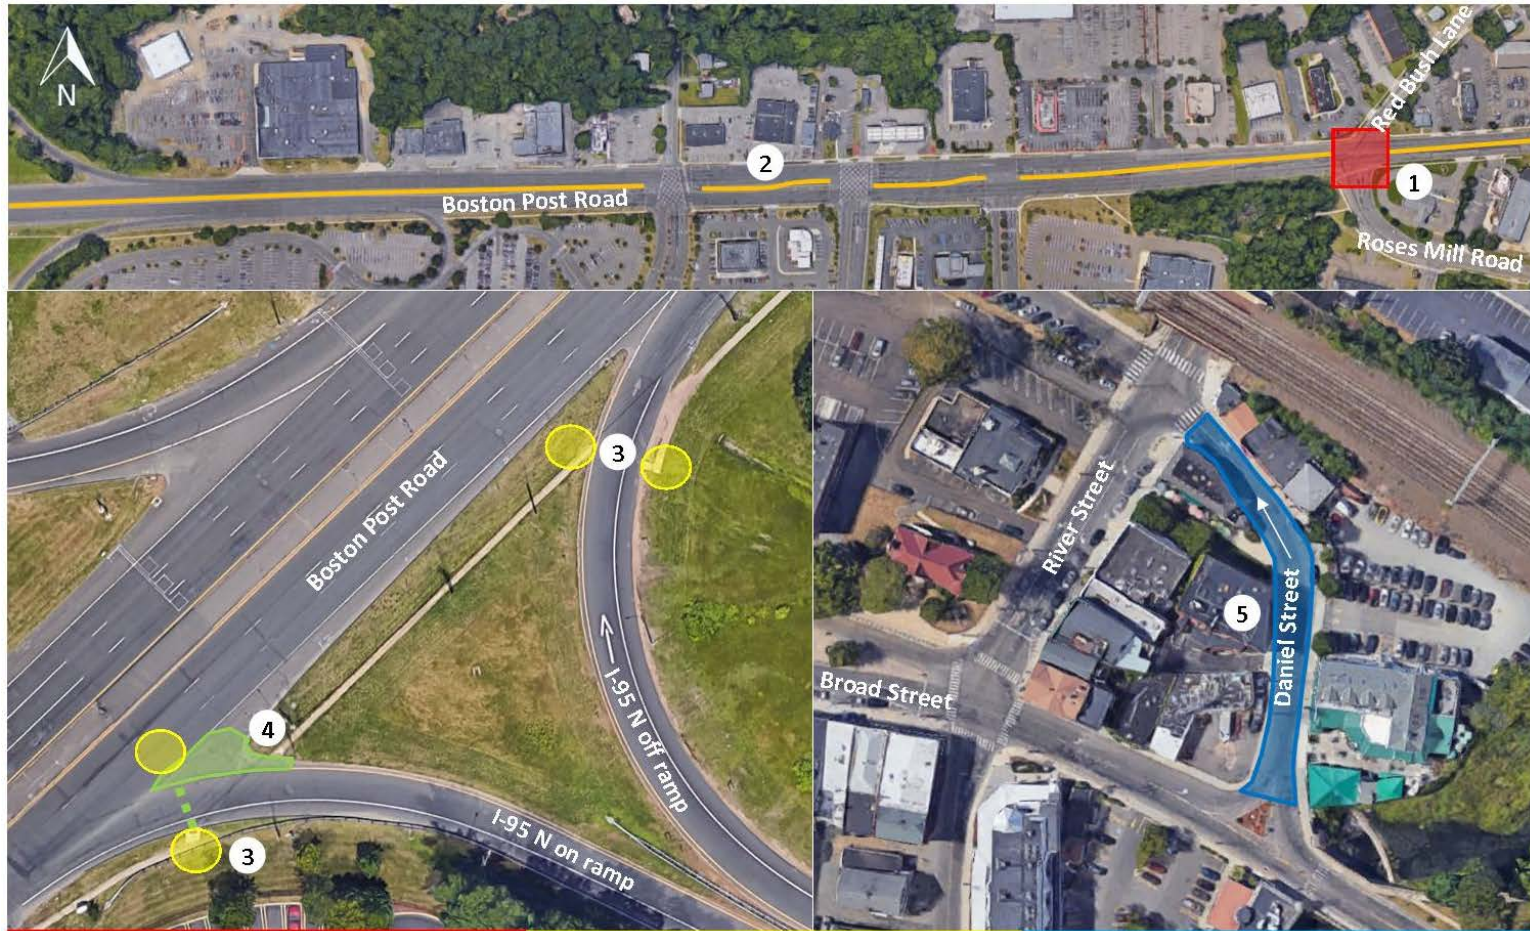
Figure 28. Long Term Recommendation Map

<p>1. Realign Roses Mill Road and Red Bush Lane's intersection with Boston Post Road</p>	<p>3. Install rectangular rapid flashing beacons at the I-95 ramp crossings</p>	<p>5. If the temporary one lane of travel on Daniel Street is successful, then consider installing permanent pavement markings and signing</p>
<p>2. Evaluate a dedicated cycle track in the center lane median of Boston Post Road</p>	<p>4. Extend the curb at the I-95 North on ramp crossing to shorten crossing distance</p>
