COMMUNITY
connectivity program

Norfolk Downtown– Road Safety Audit

April 4, 2017

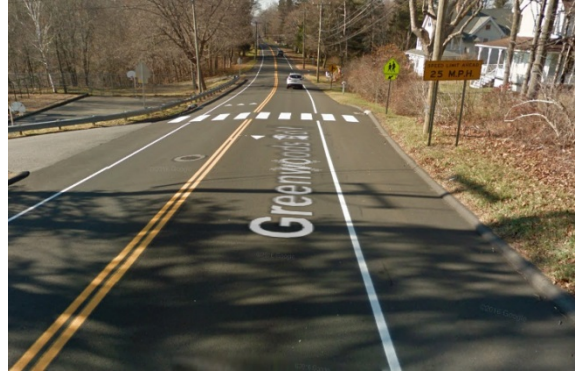
Figure 5: Greenwood Road East looking westbound in front of Botelle Elementary School

- There are two crosswalks in front of the school. Neither is connected to a sidewalk, and the south end of the westerly sidewalk faces a guiderail.
- Crosswalk signs with downward placards are located at each crosswalk in both directions. There are two advance “School Children ahead” signs in each direction approaching the crosswalks. The closest sign in each direction is 200 to 250 feet from the closest crosswalk, and is static. The farthest is 500 to 600 feet from the closest crosswalk and has non-actuated flashing yellow beacons (See Figure 21). There is a yellow “Speed Limit Ahead 25 MPH” sign for westbound traffic located between the two crosswalks (See Figure 5, previously).
- There is no 25 MPH School Zone signing.

10. Town to coordinate with CTDOT to evaluate installing "15-Minute Parking for Truck Delivery" signs on Greenwoods Road West near Station Place.
11. Town to coordinate with CTDOT to remove the two existing crosswalks on Greenwoods Road East at the Botelle School and replace with one new crosswalk located further south at the intersection with Beacon Lane. In addition, providing a School Zone with a 25 mph speed limit when school is in session should be evaluated.

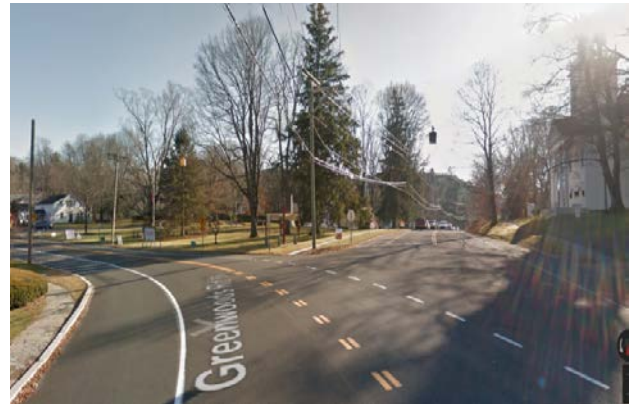
Figure 6: Looking east at intersection of Greenwood Road West/Greenwood Road East/Litchfield Road with two flashing beacons hanging from overhead span wires

- Traffic speeds are higher than 25 mph through the downtown area and conflicts with pedestrians are a concern.
- There have been suggestions to install a traffic signal at the intersection of Greenwood Road West (Routes 4 and 272)/Greenwood Road East (Route 44)/Litchfield Road (Route 272). This intersection currently is stop controlled with a flashing beacon, and has no crosswalks. It was noted that a State trooper was struck by a vehicle at this intersection approximately six years ago (See Figure 6).

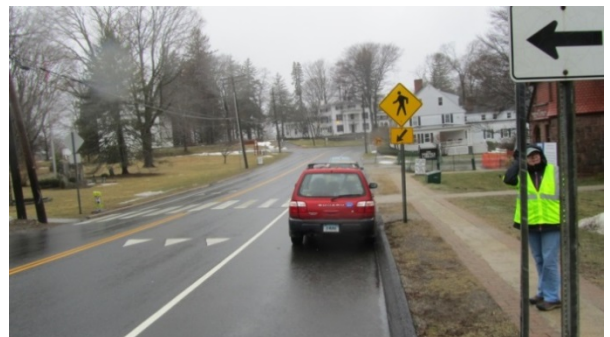
Figure 7: Crosswalk on Greenwood Road East looking west. Note pedestrian bollard on left side.

- The existing crosswalk on Greenwood Road East is a concern due to speeding traffic (See Figure 7). Traffic and large trucks approaching downtown from the east (westbound) descend a steep hill which begins to level out just east of Maple Avenue. Potential ideas to improve

visibility and safety at this location were discussed, including installing flashing beacons.

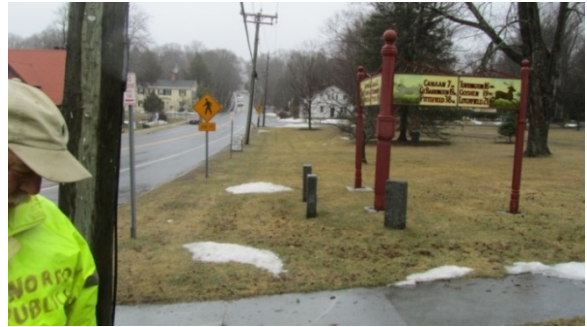
- One fatality recently occurred north of the downtown area. It was mentioned that the crash was a head-on collision with a delivery vehicle.
- The direction sign on the Village Green had been struck repeatedly in the past. As a result, the Town moved the sign further into the Green and installed granite bollards around it to protect it (See Figure 11). It has not been struck since these improvements were made.

Figure 11: Direction sign on the northwest corner of Norfolk Village Green with protective bollards

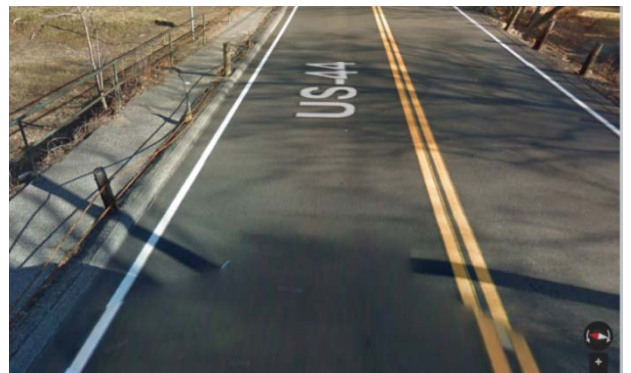
Figure 12: Damaged cable and wooden post guard rail on Greenwood Road East looking west, east of Maple Avenue

- On Greenwood Road East, east of Maple Avenue, there is old cable and wooden post guide rail on both sides of the road. It is in poor condition (See Figure 12).

12. Town to coordinate with CTDOT to replace the damaged cable and wooden post guide rail on Greenwoods Road East, east of Maple Avenue.

13. Coordinate with CTDOT to replace the damaged cable and wooden post guard rail on Greenwoods Road East, east of Maple Avenue.

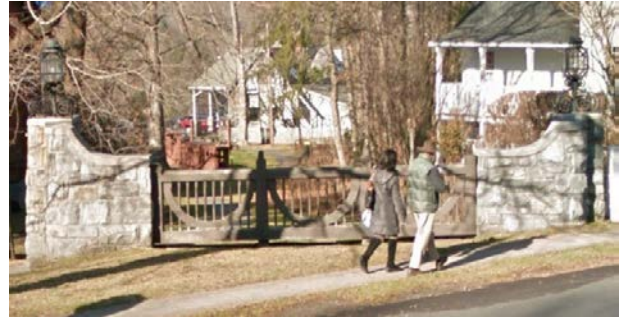
- There is an old train tunnel that runs underneath the intersection of Greenwood Road East/Maple Avenue. A decorative gate structure is located at this location (See Figure 13).

Figure 13: Decorative gate demarking old train tunnel near library on Maple Avenue north of Greenwood Road East

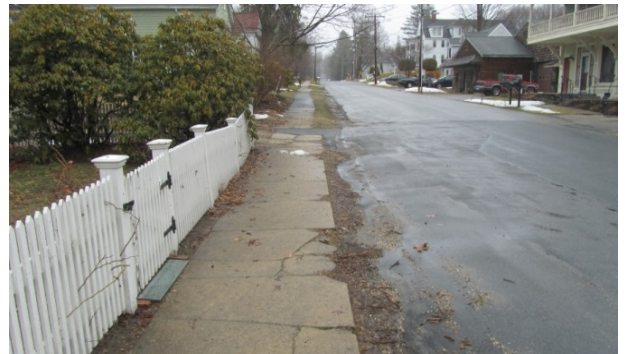
Figure 14: Sidewalk on the west side of Maple Avenue

- Sidewalk on west side is a patchwork of materials: brick lined concrete, concrete, bituminous, slate in poor-fair condition (See Figure 14). There is a new bituminous curb on the west side for a short segment, but this ends before Greenwood Road East.
- There is a bituminous sidewalk on the east side only along the frontage of the historic house on the corner.
- There is no crosswalk or handicap ramps at the intersection of Greenwood Road east and Maple Avenue (See Figure 15).
- Maple Avenue forms the stem of the T-intersection with Greenwood Road East and is controlled with a Stop sign and Stop Bar.

1. Town to repair/replace sidewalk on Maple Avenue and on Greenwoods Road East and West between the library and Station Place.
2. Coordinate with CTDOT to construct new sidewalk on Greenwoods Road West on the east side closer to the existing stone wall and remove existing sidewalk. Repair/replace curb.
3. CTDOT in coordination with the Town to install new crosswalks across Greenwoods Road West at Station Place (with Rectangular rapid flashing beacon or similar device) and Litchfield Road at Greenwoods Road west with a new sidewalk on the west side of Greenwoods Road West connecting the two new crosswalks.

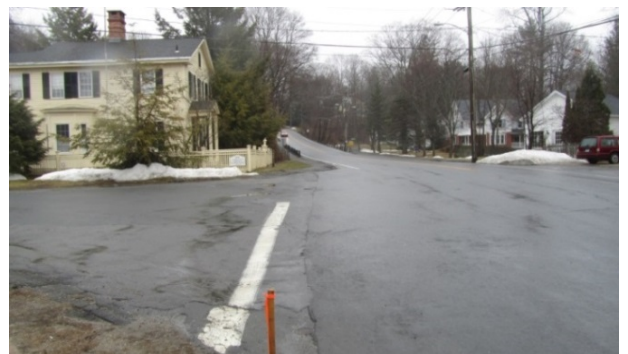
Figure 15: Looking east at Greenwood Road East Avenue at Maple Avenue

- The travel lanes are 11.5 feet wide, with a seven-foot eastbound shoulder and a 9-foot westbound shoulder to accommodate on-street parking. Parking is prohibited on the south (eastbound) side.

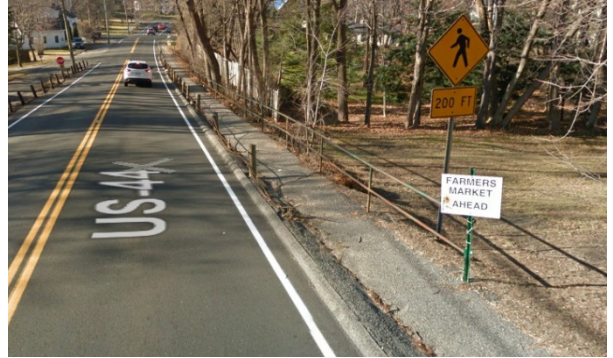
Figure 16: Advance pedestrian crosswalk sign on Greenwood Road East westbound approaching Maple Avenue

- There is a mid-block painted crosswalk in front of the library with pedestrian yield lines in each direction.
- There is a pedestrian sign and down arrow placard on each side of the crosswalk. The signs are the older yellow sign and do not meet retro-reflectivity standards.

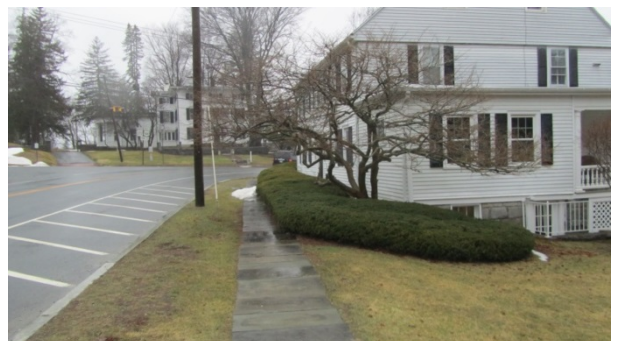
Figure 17: Greenwood Road east looking west at shrubs growing over slate sidewalk at #3 and diagonal striping to designate no parking

- West of the library driveway, the sidewalk is slate in poor condition, and is slightly narrower than four feet wide. The shrubs in front of the house on the corner (#3) overhang the sidewalk and reduce the effective sidewalk width (See Figure 17).

- Between the driveway for #3 Greenwood Road East and the curve to the west, on-street parking is prohibited on the north side (See Figure 17).
- The intersection of Greenwood Road West (Routes 4 and 272)/Greenwood

6. Town to trim shrubs overhanging the sidewalk on the corner of #3 Greenwoods Road East and West (or coordinate with owner).
7. Town to coordinate with CTDOT to move the 25 mph speed limit on Greenwoods Road West north of the curve closer to the roadway.

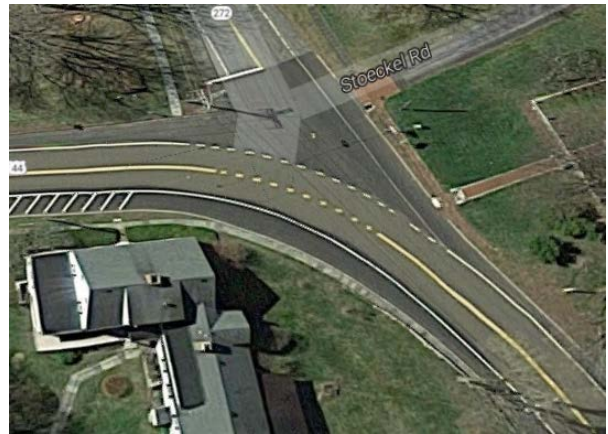
Figure 18: Looking south at intersection of Greenwood Road East and West with Litchfield Road

Road East (Route 44)/Litchfield Road (Route 272) has a flashing beacon mounted on span wire. There are no crosswalks at this intersection and the sight lines are restricted due to the curve and topography (See Figure 18).

5. Town to coordinate with CTDOT to replace the current intersection ahead signs on Greenwoods Road East and West approaching the curve with new retro-reflective signs.

3. Coordinate with CTDOT to replace the current "Intersection Ahead" signs on Greenwoods Road East and West approaching the curve with new retro-reflective signs.

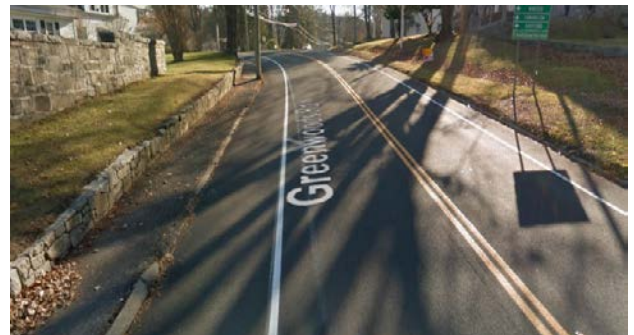
Figure 19: Greenwood Road West looking south with sidewalk and retaining wall on the left (east) side

- There is a 25 MPH speed limit sign for the northbound direction approaching Station Place that is set well to the right of the roadway.
- There is sidewalk on the east side that changes from slate to bituminous and ranges between 4.5 and 5 feet wide. The sidewalk is in poor to fair condition. There is low curb reveal and the curb is deteriorated. The curb is a combination of granite, concrete and bituminous. There is a retaining wall east of the sidewalk and there is a grass buffer between the sidewalk and a rock wall. The west side has a concrete curb, but no sidewalk (See Figure 19).

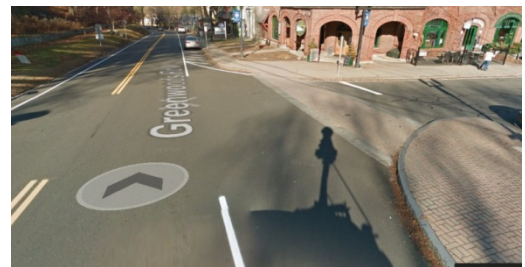
Figure 20: Intersection of Greenwood Road West and Station Place looking north

- The sight lines for motorists turning from Station Place westbound onto Greenwood Road West are limited due to the intersection geometrics and topography of Greenwood Road West. This situation is exacerbated by speeding vehicles, parked delivery trucks and vehicles parked along the east side of Greenwood Road West (typically for a concert at the Infinity Music Hall). (See Figure 20).

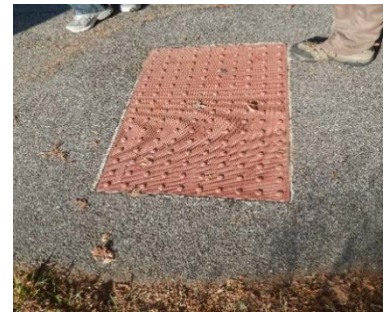
Figure 22: Detectable Warning Strip

3. Town to coordinate with CTDOT to install a new crosswalk, handicap ramps and detectable warning devices across Maple Avenue at Greenwoods Road East (See Figure 22).

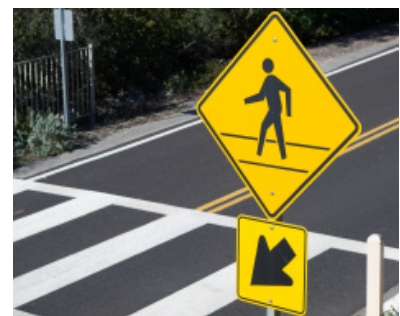
Figure 23: Pedestrian crossing sign

4. Town to coordinate with CTDOT to upgrade the pedestrian crosswalk signs and advance pedestrian signs with new retro-reflective signs at the crosswalk on Greenwoods Road East at the library (See Figure 23), and install tactile warning strips on the ramps.

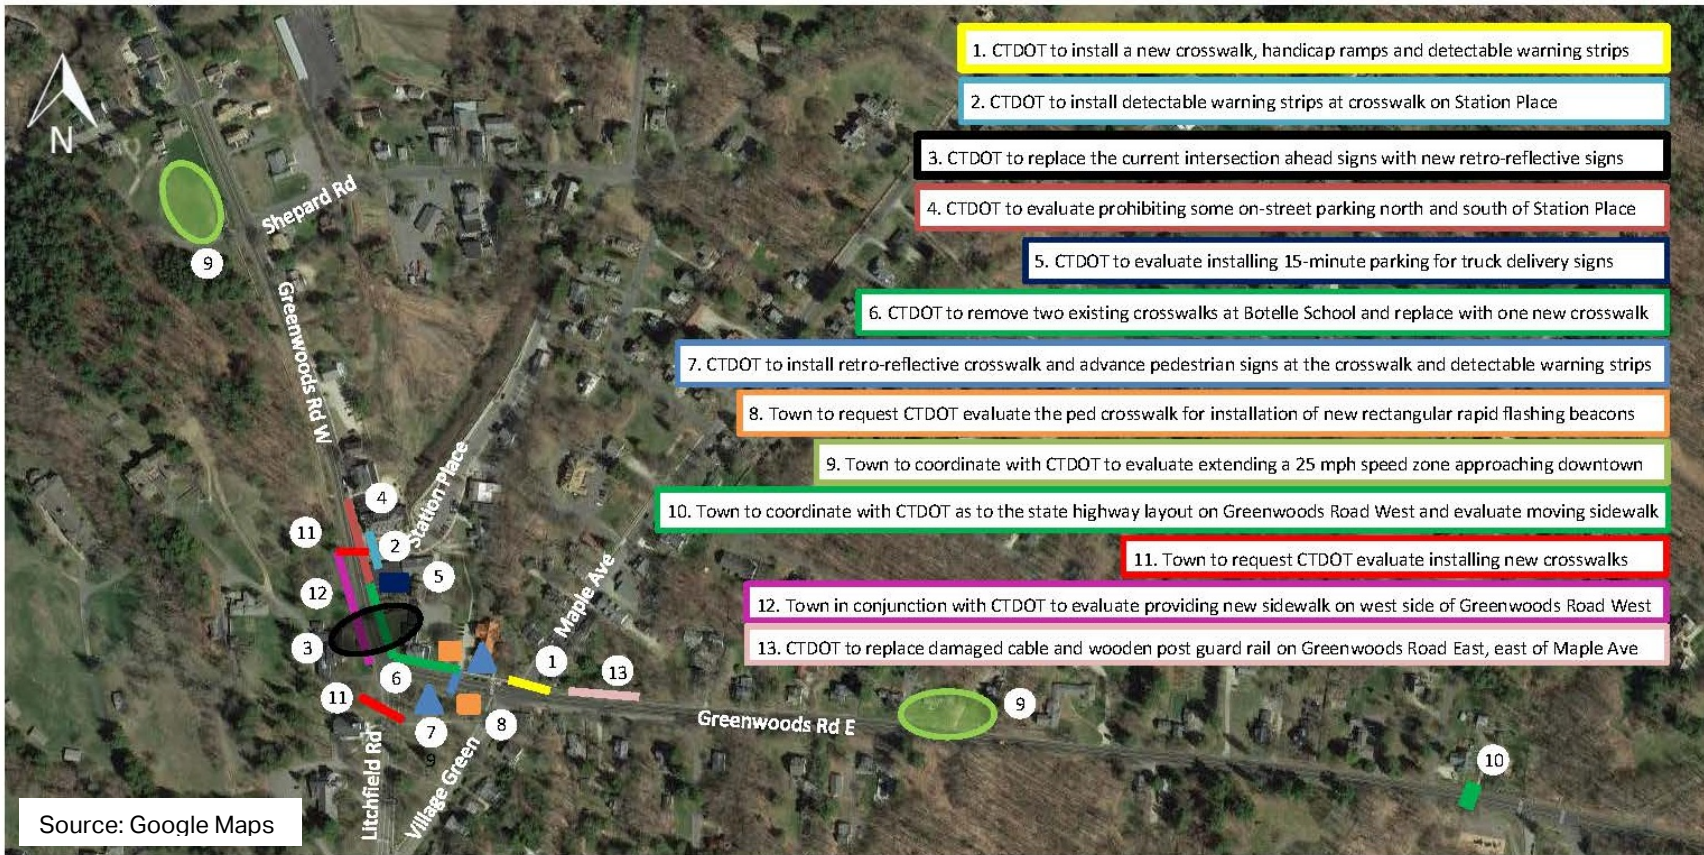
Figure 25: Medium Term Recommendations

Figure 25 depicts these recommendations.
