COMMUNITY
connectivity program

Norwalk

Calf Pasture Beach Road – Road Safety Audit
July 19, 2016

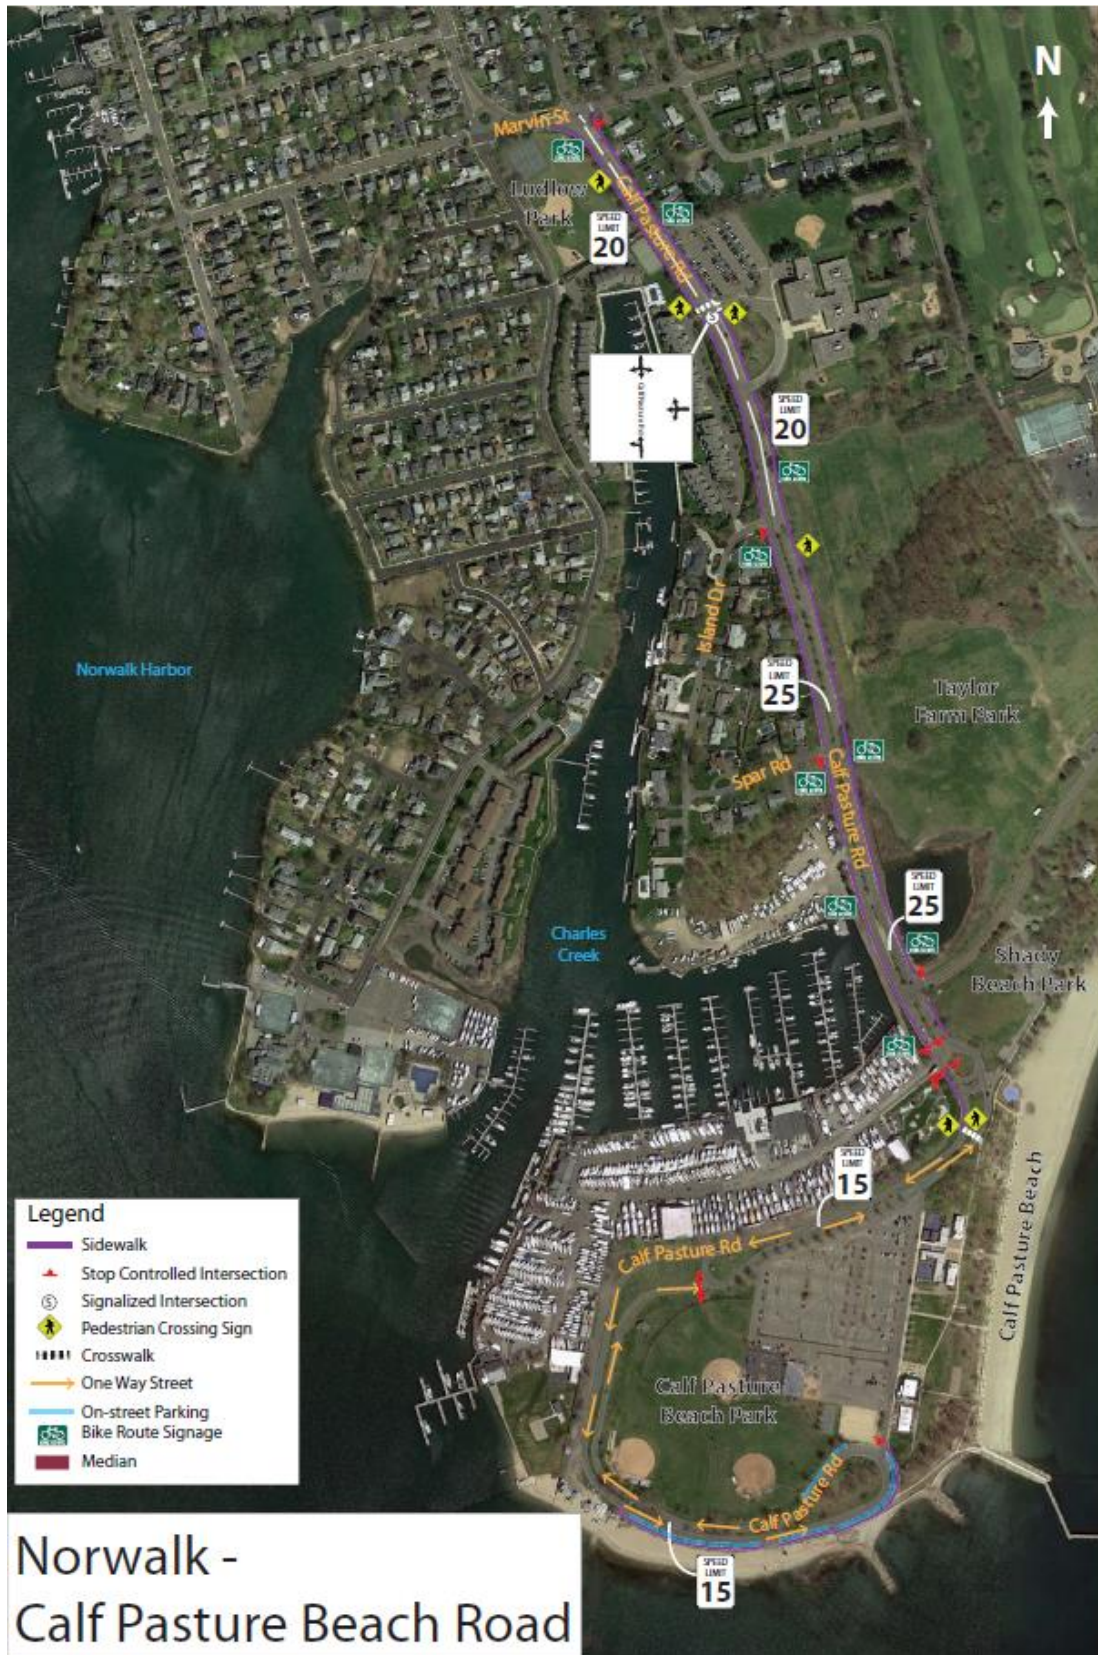
Figure 4. Calf Pasture Beach Road Geometrics

Figure 4 shows the study roadway features and geometry. Roadway geometric data is further described in Table 3. There are sidewalks on both sides of Calf Pasture Beach Road that are in fair to good condition. Many of the sidewalks have newly installed handicap accessible curb ramps. "Share the Road" signage for bicyclists is also provided throughout the length of the corridor.

Sidewalk widths along Calf Pasture Beach Road vary between the northern portion of the road and the southern section. The change in sidewalk type and width occurs at the Marvin Elementary School traffic signal. Along the northern portion of Calf Pasture Beach Road, between Marvin Street and the school exit, the sidewalks are four feet in width and have been recently paved with asphalt. There are also numerous utility poles obstructing the already narrow sidewalks in the northern section. South of the entrance, the sidewalk is between two and three feet in width and is a concrete surface that shows damage in various places.

There are many sections of Calf Pasture Beach Road that have breaks in the center median, to allow for U-turns. South of Island Drive, the large landscaped median obstructs the line-of sight for vehicles trying to make a U-turn. Along this stretch of Calf Pasture Beach Road,

there is a break in the median approximately every 300 feet, amounting to six breaks between Island Drive and the beach entrance. Of these, only two (Island Drive and Canfield Avenue) are providing side street access.

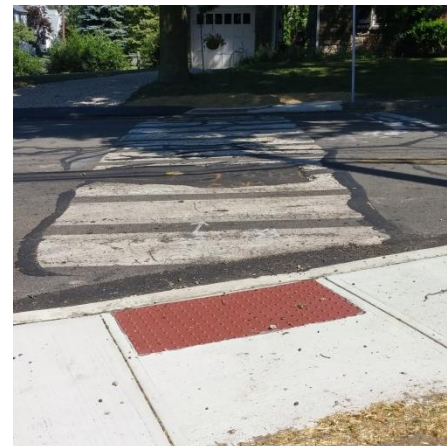
Figure 5. New Curb Ramps and Faded Crosswalk at Marvin St and Calf Pasture Beach Rd

- Only the westbound approach has a striped crosswalk. The paint on this crosswalk is in poor condition (Figure 5). There is no crosswalk for the Ludlow Manor approach. The Calf Pasture Beach Road and west Marvin Street approaches are missing crosswalks and ADA ramps.
- A channelizing island on the northbound approach was recently removed from the intersection.
- This intersection is large and vehicles, bikers and pedestrians may find it challenging to navigate (Figure 6).
- The southwest corner of the intersection has a large turn radius which may encourage vehicles to make the free right turn from Marvin Street onto Calf Pasture Beach Road at higher speeds.

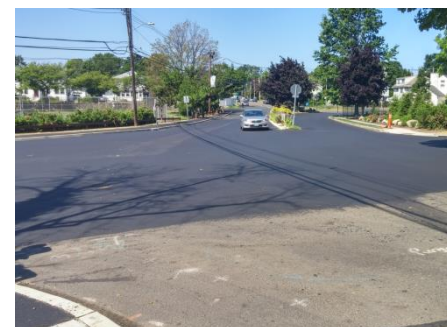
Figure 6. Calf Pasture Beach Road and Marvin St (Looking West)

- The stop sign for the westbound Marvin Street approach is partially blocked by branches on the property of 3 Marvin Street.
- Calf Pasture Beach Road is about 51 feet wide with 14 and 10 foot travel lanes and a 3 foot median.

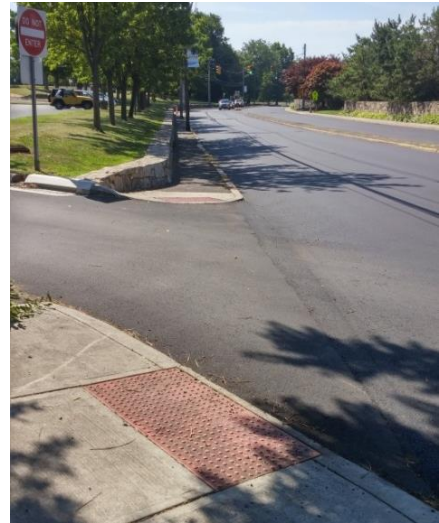
Figure 7. Curb Ramps at Elementary School Exit Driveway

- There is no crosswalk striped across the north exit to Marvin Elementary School (Figure 7).
- Utility poles are located in the middle of the sidewalk, obstructing the path for pedestrians (Figure 8).

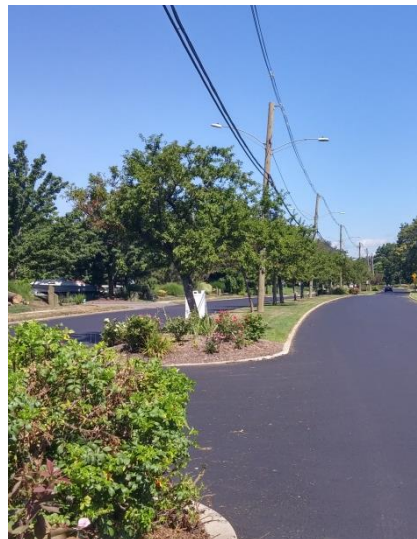
Figure 9. Landscaped Median With Turning Visibility Constraints

2. Curb cuts in the median on Calf Pasture Beach Road invite drivers to make left turns and unnecessary U turns with limited visibility. The limited visibility is caused by the trees and utility poles on the landscaped median.

5. Install curbs in order to fully block off the median curb cuts where vehicles make U turns and left turns. Curb cuts should be maintained at driveways and side streets. Relocate curb cuts to align with driveways better where they are close.

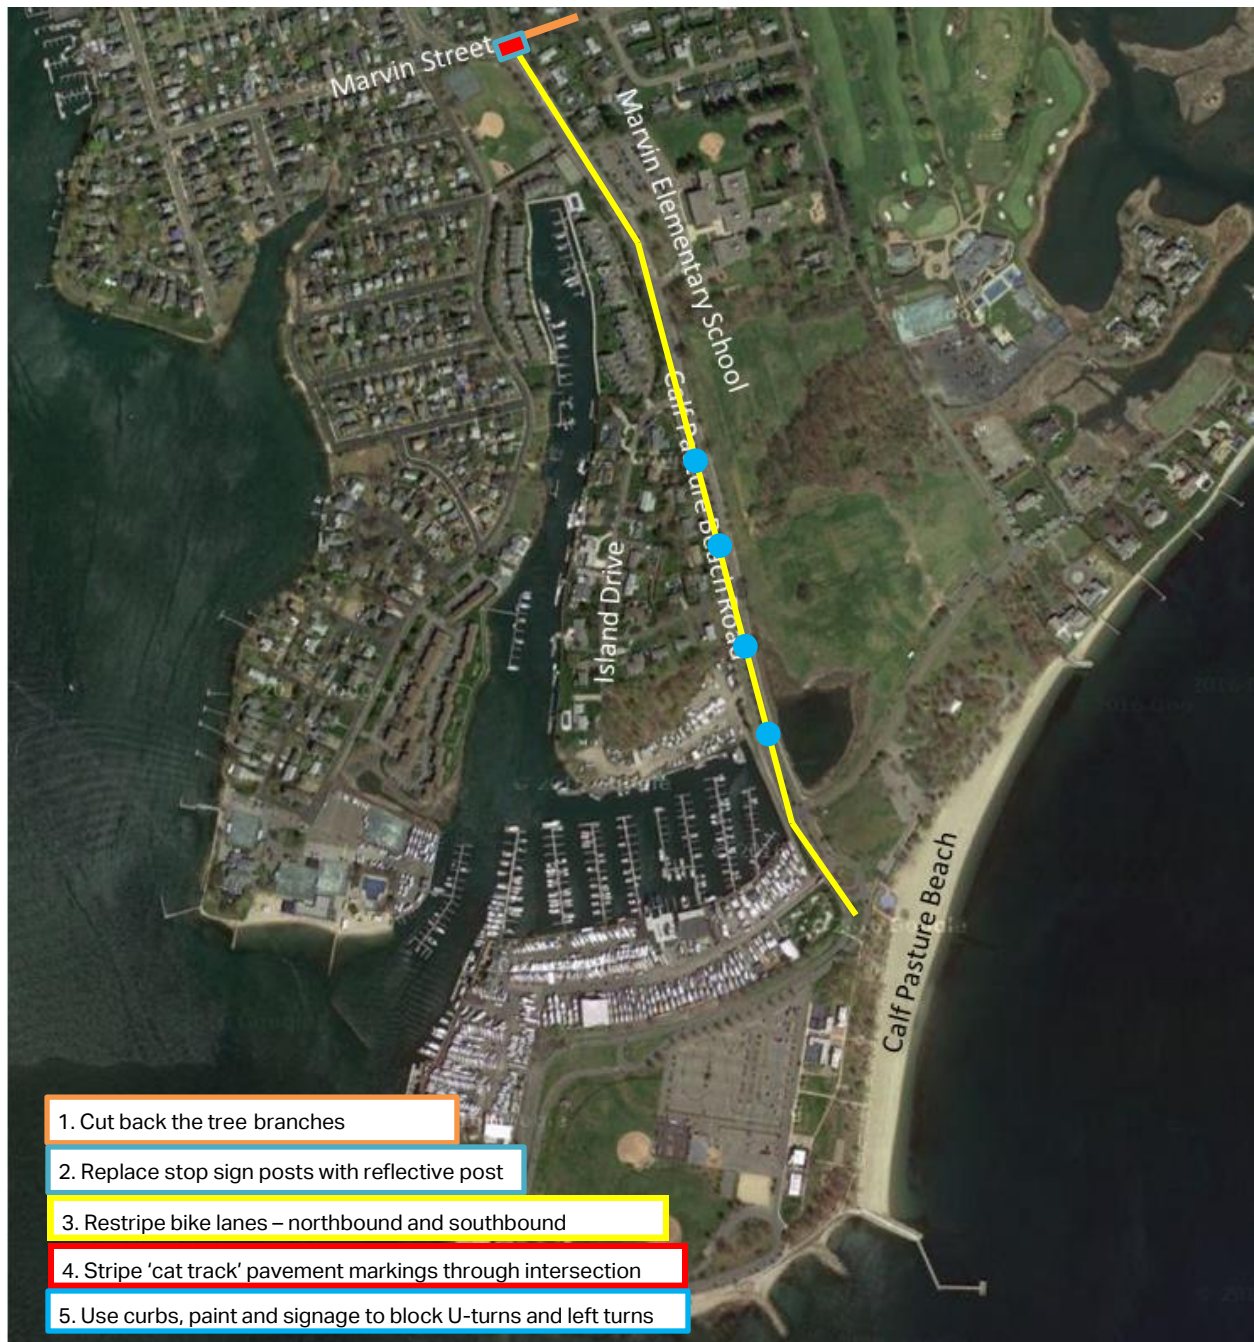
Figure 14. Short-Term Recommendations

Figure 14 depicts these recommendations.

1. Cut back the tree branches blocking the stop sign on the westbound Marvin Street approach at the intersection with Calf Pasture Beach Road.
2. Replace the stop sign post with a red reflective post so even if branches do not get maintained regularly the stop sign can be more visible to drivers. (Figure 11).
3. Stripe a bike lane on North and South bound Calf Pasture Beach Road with water based paint for

4. Stripe "cat" track pavement markings (white line extensions) to guide vehicles on the desired paths through the intersection of Calf Pasture Beach Road and Marvin Street. At minimum, a centerline cat track should be striped east to west along Marvin Street. (Figure 13).
5. Use paint and signage to block U turns and left turns at unwanted median curb cuts along the corridor. Curb cuts should be maintained at driveways and side streets.

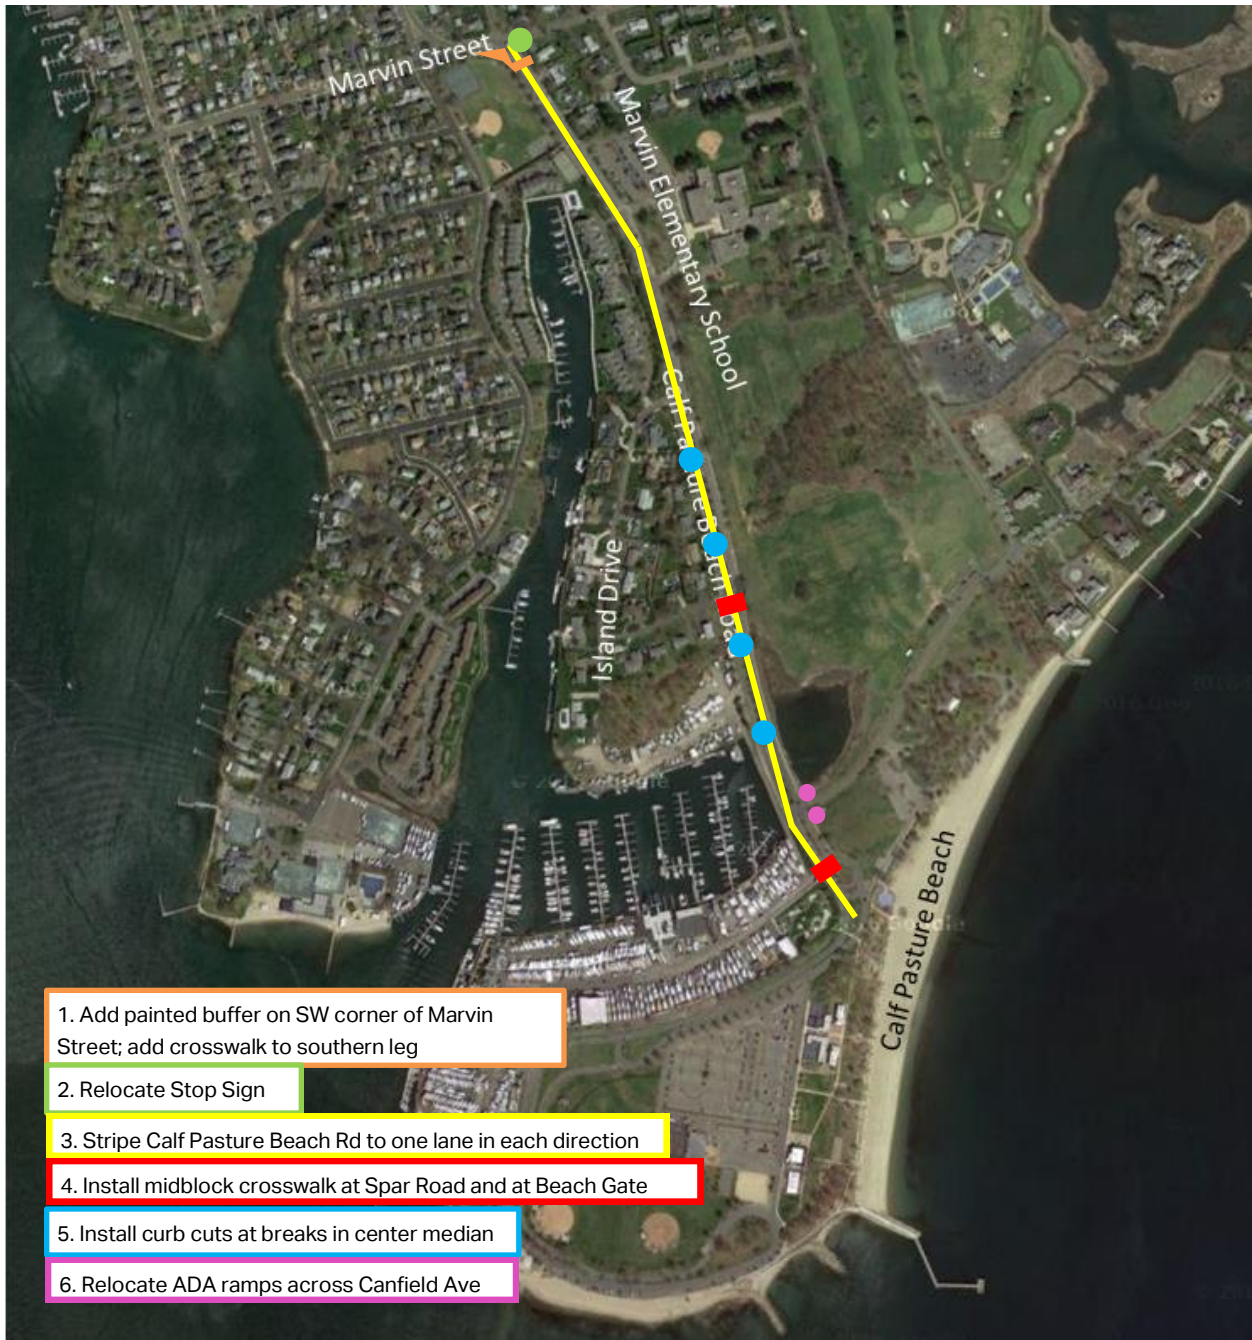
Figure 17. Medium-Term Recommendations

Figure 17 depicts some of the recommendations along Main Street.

1. Reduce the radius on southwest corner of Marvin Street and Calf Pasture Beach Road by adding a painted buffer and install a stop control for the eastbound right turns. Stripe a crosswalk across south Calf Pasture Beach Road approach (Figure 15).

2. Move the stop sign on the Calf Pasture Beach Road approach to Marvin Street closer to the intersection.
3. Stripe Calf Pasture Beach Road as one lane of travel in each direction with the exception of 50 to 100 feet before the beach entrance gate.

4. New midblock crossings:
 - a. Install a midblock crosswalk across Calf Pasture Beach Road from Spar Road to the dog park entrance. The crosswalk can be placed on the north side of Spar Road in order to not create a pedestrian vehicle conflict with left turn movements. A sidewalk across the median should be provided for pedestrians.

- b. Install a midblock crosswalk by the gate entrance to solve the discontinuous sidewalk on east side of Calf Pasture Beach Road. Consider rectangular rapid flashing beacon for additional warning (Figure 16).

6. Relocate ADA ramps and crosswalk across Canfield Avenue to better direct pedestrians and provide a shorter crossing.

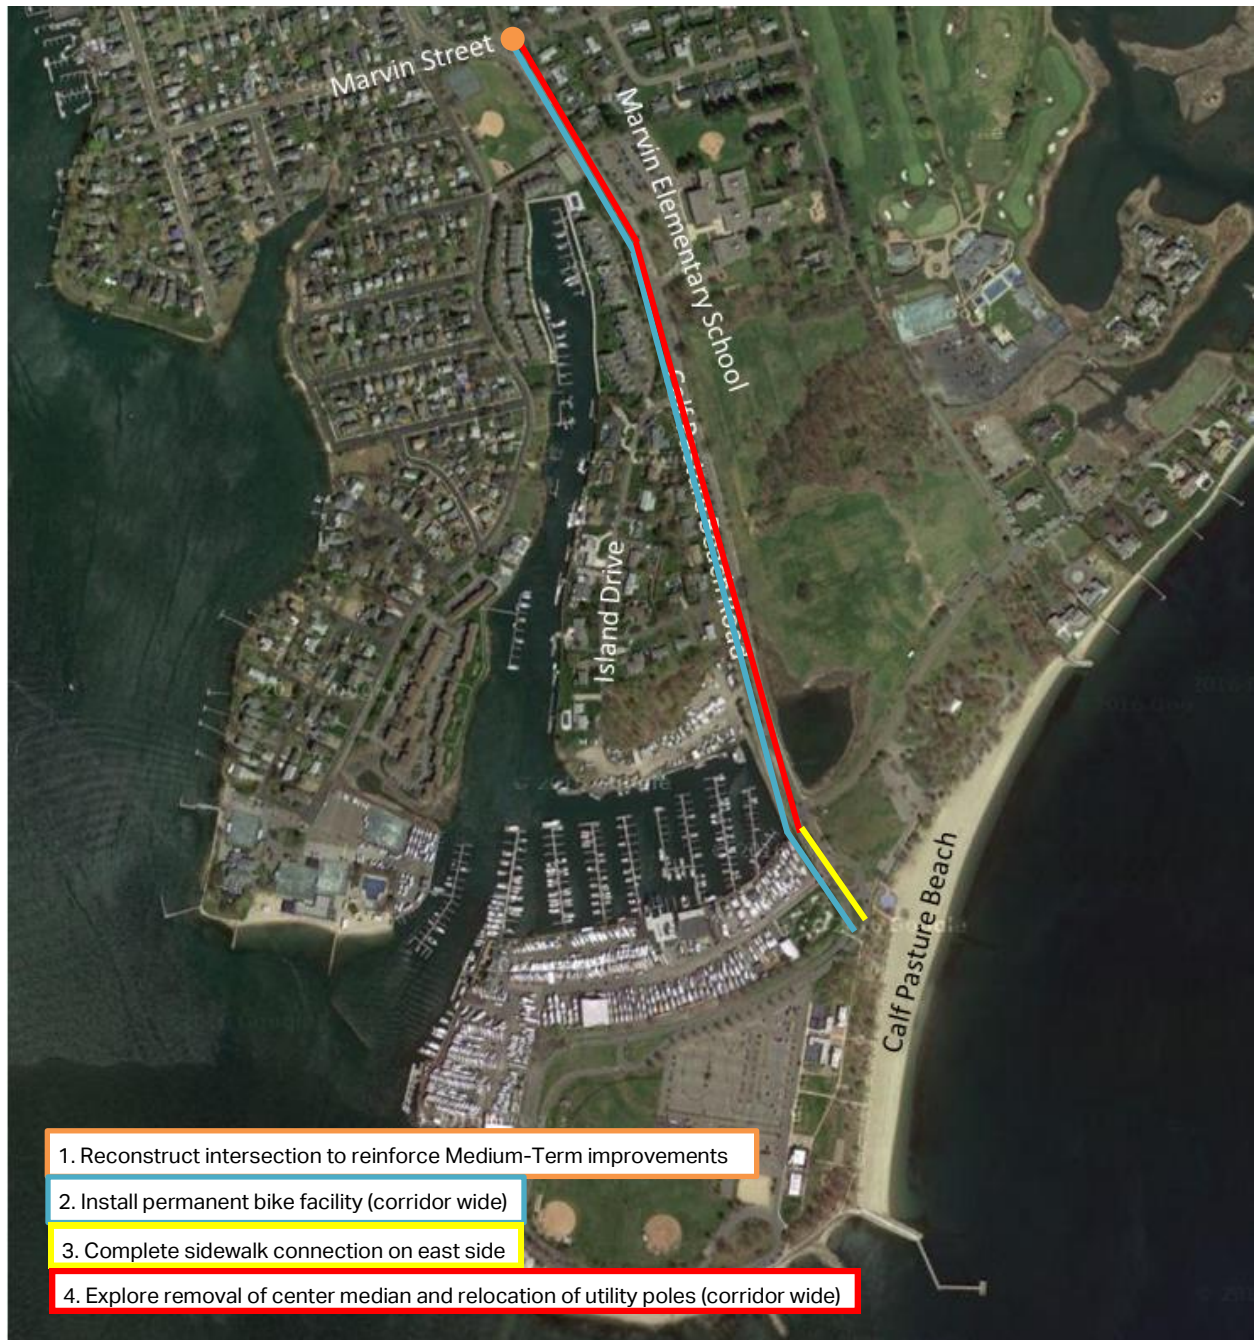
Figure 18. Long-Term Recommendations

Figure 18 depicts some of these recommendations.

1. Reconstruct intersection of Marvin Street and Calf Pasture Beach Road to permanently convert the eastbound right turn slip lane to stop-controlled with a standard turn radius. Expand and extend sidewalks and add crosswalks on all approaches to provide continuous pedestrian and bicycle access through the intersection and to Calf Pasture Beach Road.
2. Install a permanent bike facility and convert the majority of Calf Pasture Beach Road to one lane of travel in each direction.
3. Extend sidewalk on the east side of Calf Pasture Beach Road to the beach.
4. Explore the complete removal of the center median on Calf Pasture Beach Road and relocation of utility poles to provide the best opportunity for a complete and multi-modal street.
