# Norwich

Main Street – Road Safety Audit

November 10, 2016

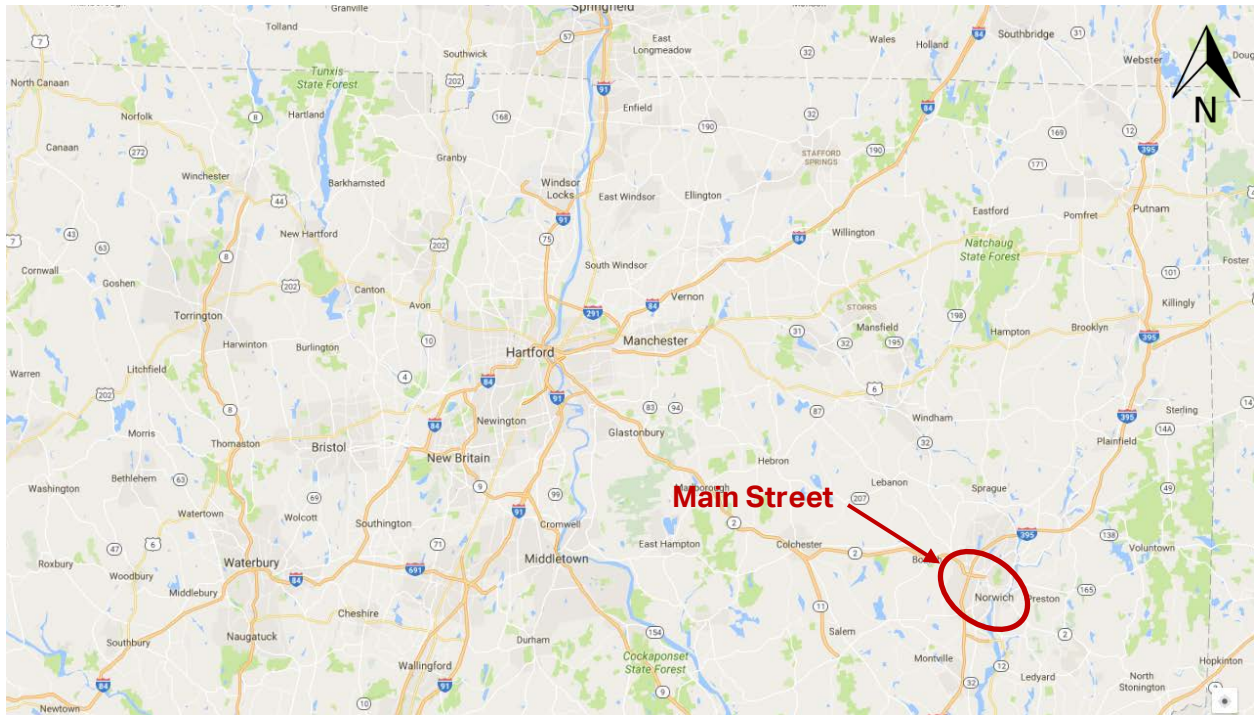
Figure 2. Study Area – Regional Context

There are several vertical curves and some steep profiles on the downtown roads that contribute to challenges that walkers and bicyclists face. Additionally, several of the shoulders in the study area are very narrow making bicycle maneuvers challenging. Figure 2 shows the study area in a regional context.

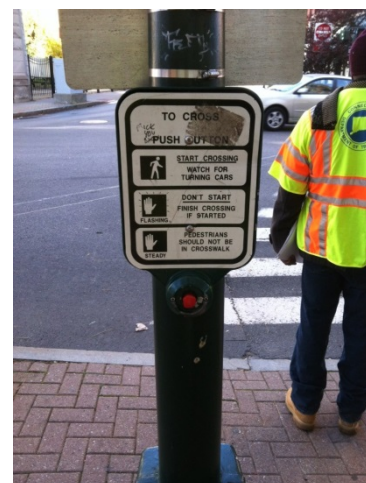
Figure 5. Pedestrian pushbutton

- Pedestrian signals are outdated; the latest standards are audible pushbuttons, countdown signals and longer pedestrian phases (Figure 5, Figure 7).
- Street trees are in conflict with street lighting in several locations (Figure 6).
- There are many vacant buildings in the area.
- Most streets have brick paver sidewalks on both sides of the road (Figure 7).

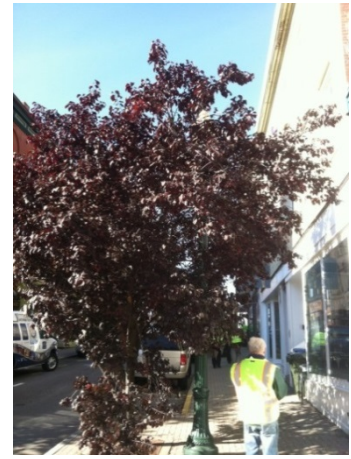
**Figure 6. Street tree obstructing illumination**

1. City to trim trees that are in conflict with existing illumination.
2. City to replace the missing pedestrian signal at the intersection of Main Street and Broadway/Courthouse Square.

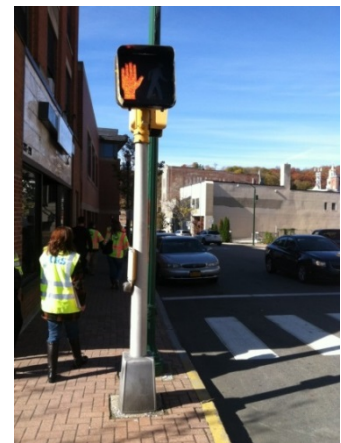
**Figure 7. Pedestrian signal, brick paver sidewalk**

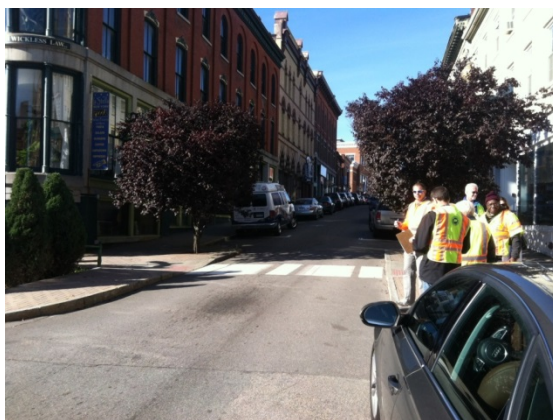
- Crosswalks at the intersection with Broadway and Courthouse Square are diagonal and very long as a result. The longest was measured at 72-feet (Figure 8).
- One of the pedestrian signals at the intersection with Broadway and Courthouse Square is missing, causing the signal to not function properly.
- Pedestrian crossing signs are missing from the mid-block crosswalk near Market Street (Figure 9).
- One of the driveways to the former donut shop at the intersection with Church Street, West Main Street, Chelsea Harbor Drive and Water Street is in the intersection.

**Figure 8. Mid-block crossing without pedestrian signs**

3. City to install the latest pedestrian crossing signs at midblock crossings.
4. City to coordinate with CTDOT to re-stripe 11-foot wide lanes on West Main Street and provide wider shoulders.

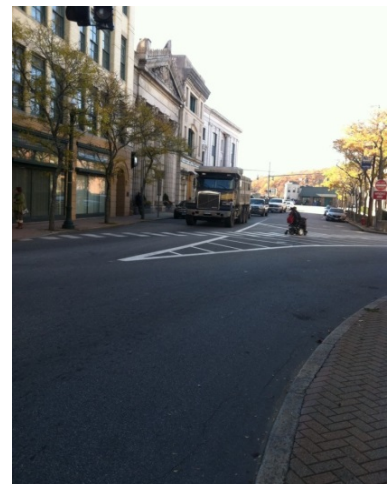
**Figure 9. Diagonal crosswalk at the intersection of Main Street and Broadway/Courthouse Square**

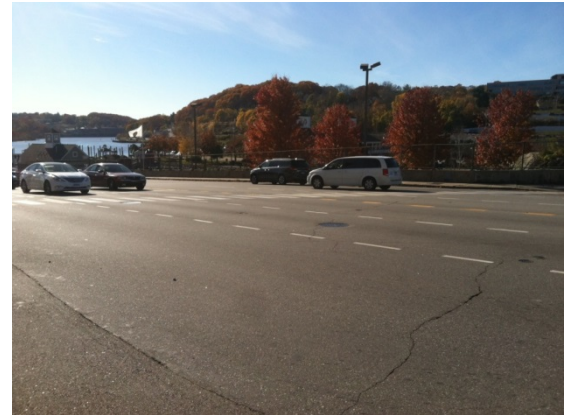
- There is a long (90-feet) diagonal crosswalk at the intersection with Church Street, West Main Street, Chelsea Harbor Drive and Water Street (Figure 10).
  - A straight crosswalk at the same intersection is 69-feet long.
- The intersection with Franklin Street has unconventional geometrical and may be considered for re-design by the City in the future.
- The one way section is 29-feet wide with a 13-foot lane and 8-foot parking lanes on each side.
- The two way section on the east end of the RSA area is 40-feet wide with a 12-foot lane and 8-foot shoulder/parking lane in each direction.
- Catch basin grates are not the bike friendly type.
- At the east end of the RSA area there was a crosswalk that was missing one handicap ramp (Figure 11).

Figure 10. Diagonal crosswalk

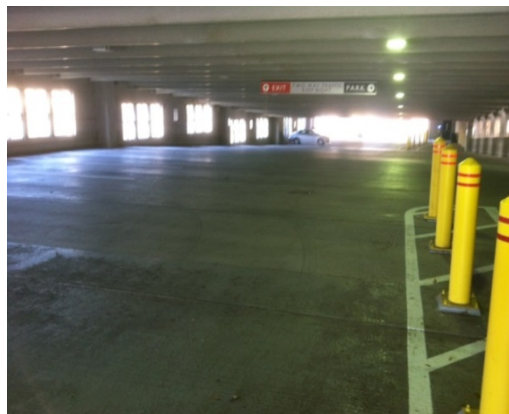
- Lane widths were measured to be 12-feet.
- Vehicles consistently did not yield to pedestrians despite the constant flashing beacons at the mid-block crosswalk (Figure 12).
- The parking garage at the Transportation Center is very lightly used (Figure 13).

Figure 13. Transportation Center parking garage

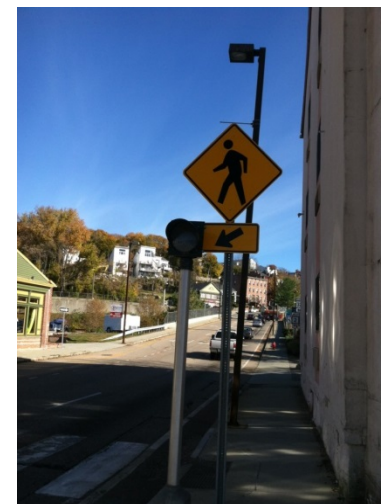
Figure 12. Constant flashing beacon at mid-block crosswalk

- The constant flashing beacons at the mid-block crossing in front of the Transportation Center are ineffective and advanced measures such as rectangular rapid flashing beacons (RRFB) may be more effective.
- 12-foot lanes are currently striped and could be reduced to 11-feet to provide additional shoulder width and encourage slower vehicle speeds.
- The bridge on West Main Street was specifically noted as an area that is not inviting to pedestrians. The City would like to consider options to make this area feel safer for pedestrians including wider

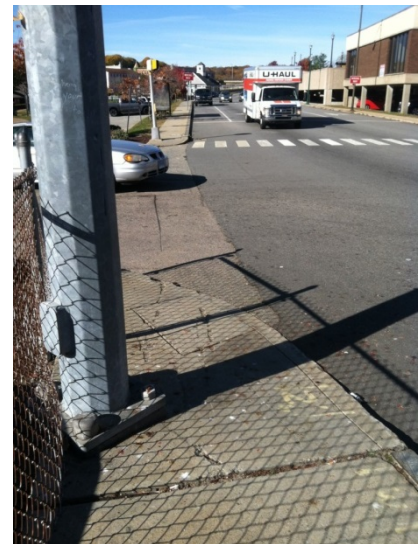
- There are two 11-foot wide lanes, one 13-foot wide lane and a 9-foot shoulder/parking lane.
- Handicap ramps are not aligned correctly for the crosswalks (Figure 15).
- Concrete sidewalks are three feet wide at obstructions.
- Howard Brown Park is a popular pedestrian area.

Figure 15. Mis-aligned handicap ramp

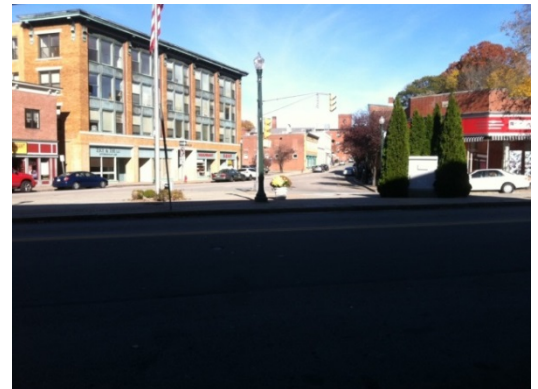
Figure 16. Intersection of Franklin Street and Main Street

- The City would like to consider alternative geometries for the Franklin Street intersection, including a roundabout (Figure 16).
- Plowing is a concern in the downtown area especially Main Street.

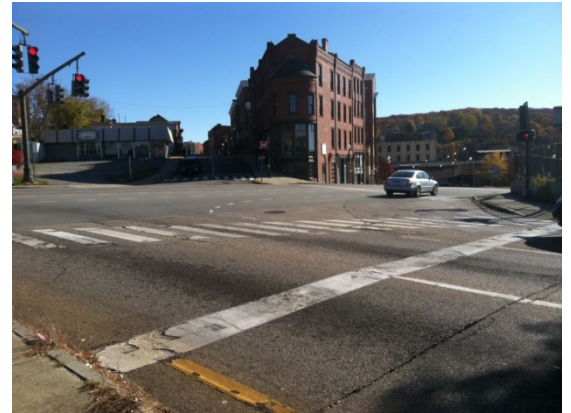
Figure 17. West Main Street right turn onto Chelsea Harbor Drive

- The fee structure for the Transportation Center parking garage may not be optimal and should be studied.
- The right turn from West Main Street onto Chelsea Harbor Drive could be channelized better to improve vehicle operations (Figure 17).
  - The two lanes coming from Washington Street to Chelsea Harbor Drive should be directed to the left two lanes of Chelsea Harbor Drive so that the right lane is available for traffic from West Main Street.
  - Signage and striping changes at the intersection should be considered as part of the CTDOT re-design of the intersection to see if traffic operations can be improved.

5. City to measure illumination levels throughout the RSA area and identify any areas where there are deficiencies.
6. City to coordinate with CTDOT to consider additional signage or striping to channelize the two through lanes on Washington Street into the two left lanes of Chelsea Harbor Drive and the right turn lane on West Main Street into the right lane of Chelsea Harbor Drive.
