# Portland

Main Street (Route 17A) – Road Safety Audit

June 8, 2016

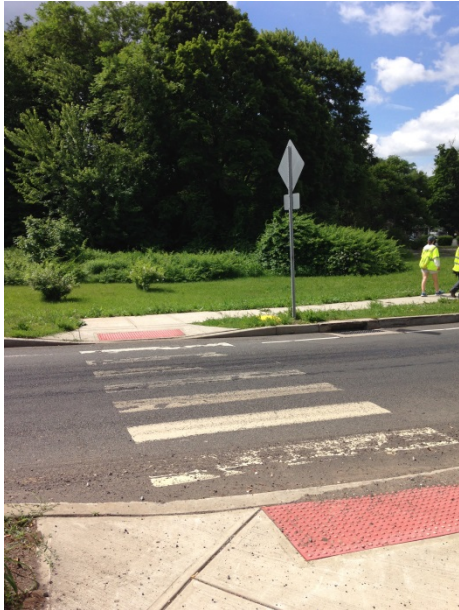
Figure 5. Tactile warning strips

A number of best practices have already been applied to this area of Portland. Portland has an extensive network of sidewalks in the Village Center area connecting Main Street with surrounding local streets as well as the Arrigoni Bridge. To further improve pedestrian amenities, Portland installed tactile warning strips at several crosswalks along Main Street and Marlborough Street (Figure 5). On Main Street, at the Marlborough Street intersection, the snow shelf has been constructed of concrete pavers, and decorative lights were installed in the snow shelf (Figure 6).

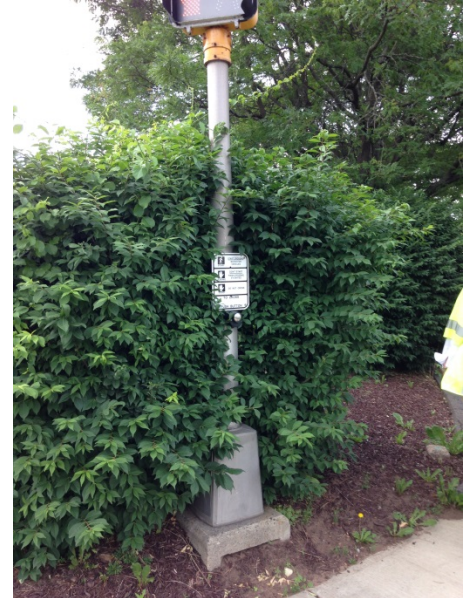
Figure 7. Overgrown vegetation

- There is overgrown vegetation on the corner of the Main Street and Marlborough Street intersection in front of Rite Aid. The overgrown brush is blocking the pedestrian push button as well as the Town's welcome sign (Figure 7).

- 1) Trim overgrown vegetation at the intersection of Main Street and Marlborough Street in front of Rite Aid to increase visibility (Figure 15).
- 2) Coordinate with neighboring towns to share radar speed control signs to enforce vehicle speeds on the Arrigoni Bridge (Figure 16).
- 3) Evaluate potential for parking police cruiser on the triangular channelizing island at the Main Street and Lower Main Street intersection (Figure 17). Presence of a police vehicle may reduce vehicle speeds as motorists travel towards the Village Center area.
- 4) Install advanced warnings signs ahead of crosswalks (Figure 18).

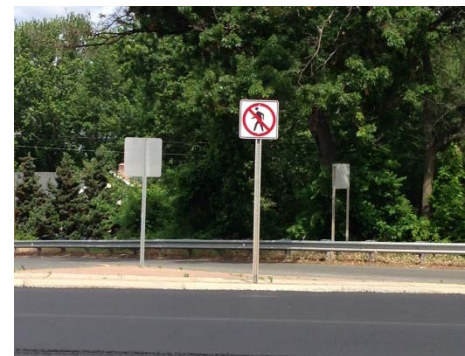
Figure 9. No pedestrian crossing sign

- Pedestrian crossings are prohibited across Main Street in front of the Arrigoni Bridge (Figure 9).
- At the Main Street intersections with Lower Main Street and Marlborough Street, there are triangular channelizing islands. These are used as pedestrian refuges when crossing the streets.

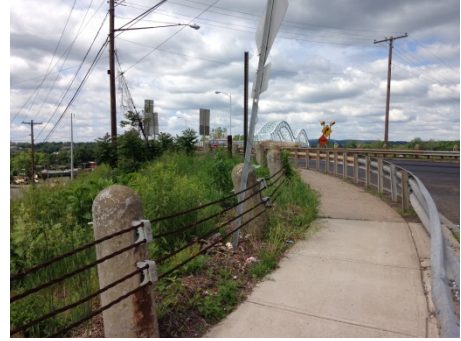
**Figure 10. View of approaching vehicles at the Arrigoni Bridge and Lower Main Street crosswalk**

- The crosswalk at the Arrigoni Bridge and Lower Main Street intersection is located on a curve and slope. Figure 10 depicts the limited visibility between

pedestrians and approaching vehicles at this crosswalk (Figure 10). Pedestrians must also cross without the aid of a crossing signal. There are no advanced pedestrian crosswalk warning signs located on the Arrigoni Bridge to alert motorists of potential crossing pedestrians and cyclists (Figure 11).

- 1) Realign crosswalk at Lower Main Street near the Arrigoni Bridge to improve visibility (Figure 25).
- 2) Evaluate feasibility of installing traffic signal near the Arrigoni Bridge ramp in Portland.
- 3) Evaluate feasibility of a pedestrian bridge near Arrigoni Bridge.
- 4) Evaluate developing access management plan to consolidate commercial driveways on Main Street and Marlborough Street.
- 5) Consider reconfiguring on-street angled parking to back-in angle parking (Figure 26).

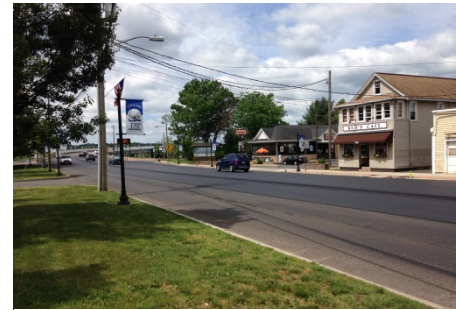
Figure 12. Main Street

1. Portland is interested in a potential road diet on Main Street. Main Street currently has two through lanes in each direction. Reducing Main Street to one lane in each direction might result in traffic congestion or vehicles queuing onto the Arrigoni Bridge. At the time of the RSA, Main Street was being repaved (Figure 12) as part of the Vendor in Place (VIP) program through CTDOT.

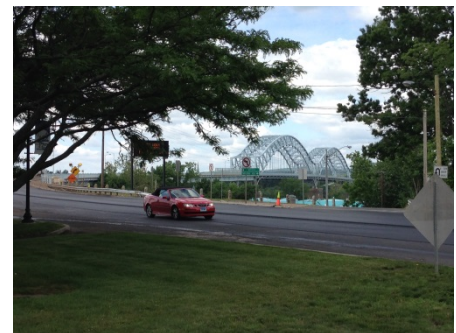
Figure 13. Vehicles entering Village Center area from Arrigoni Bridge

2. Portland is concerned regarding the speed of vehicles on the Arrigoni Bridge. Portland would like vehicles to slow down as they enter the Village Center area. On the opposite end of the bridge, Middletown has a traffic signal which controls the speed and flow of traffic prior to entering their downtown area. Portland believes that motorists travel faster as they approach the Village Center area because of the curve and downhill slope of the bridge (Figure 13).

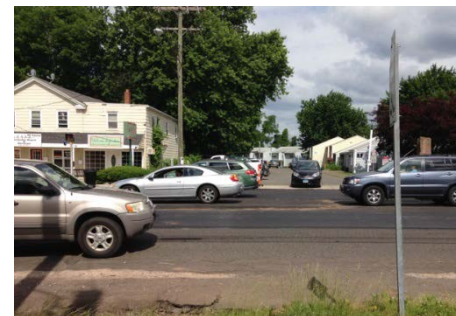
Figure 14. Entrance to Quarry Heights

3. Vehicles have a difficult time turning left into the Quarry Heights development because the traffic signal does not have a dedicated green arrow. The southbound lane also blocks this driveway due to the location of the stop bar (Figure 14). Portland indicated emergency vehicles have a hard time accessing the development from this driveway.

- 1) Upgrade all pedestrian crossings to be compliant with current ADA standards, including:
  - a) Tactile warning strips (Figure 20).
  - b) Pedestrian signal heads with countdowns (Figure 21).
  - c) Audible crossing signals.
- 2) Evaluate need for pedestrian crossing push button and signal on Marlborough Street at the Main Street intersection (Figure 22).
- 3) At the Main Street and Marlborough Street intersection, move the stop bar further back for southbound Main Street traffic. Moving the stop bar before the entrance to Quarry Heights (Figure 23) will clear the area for turning vehicles.
- 4) Consider adjusting traffic signal to include a green arrow phase for vehicles turning left into the Quarry Heights development.
