# Norwalk

Connecticut Avenue, Van Buren Avenue, Belden Avenue,  
Cross Street, North Avenue and Westport Avenue.

(Route 1) – Road Safety Audit

June 4, 2018

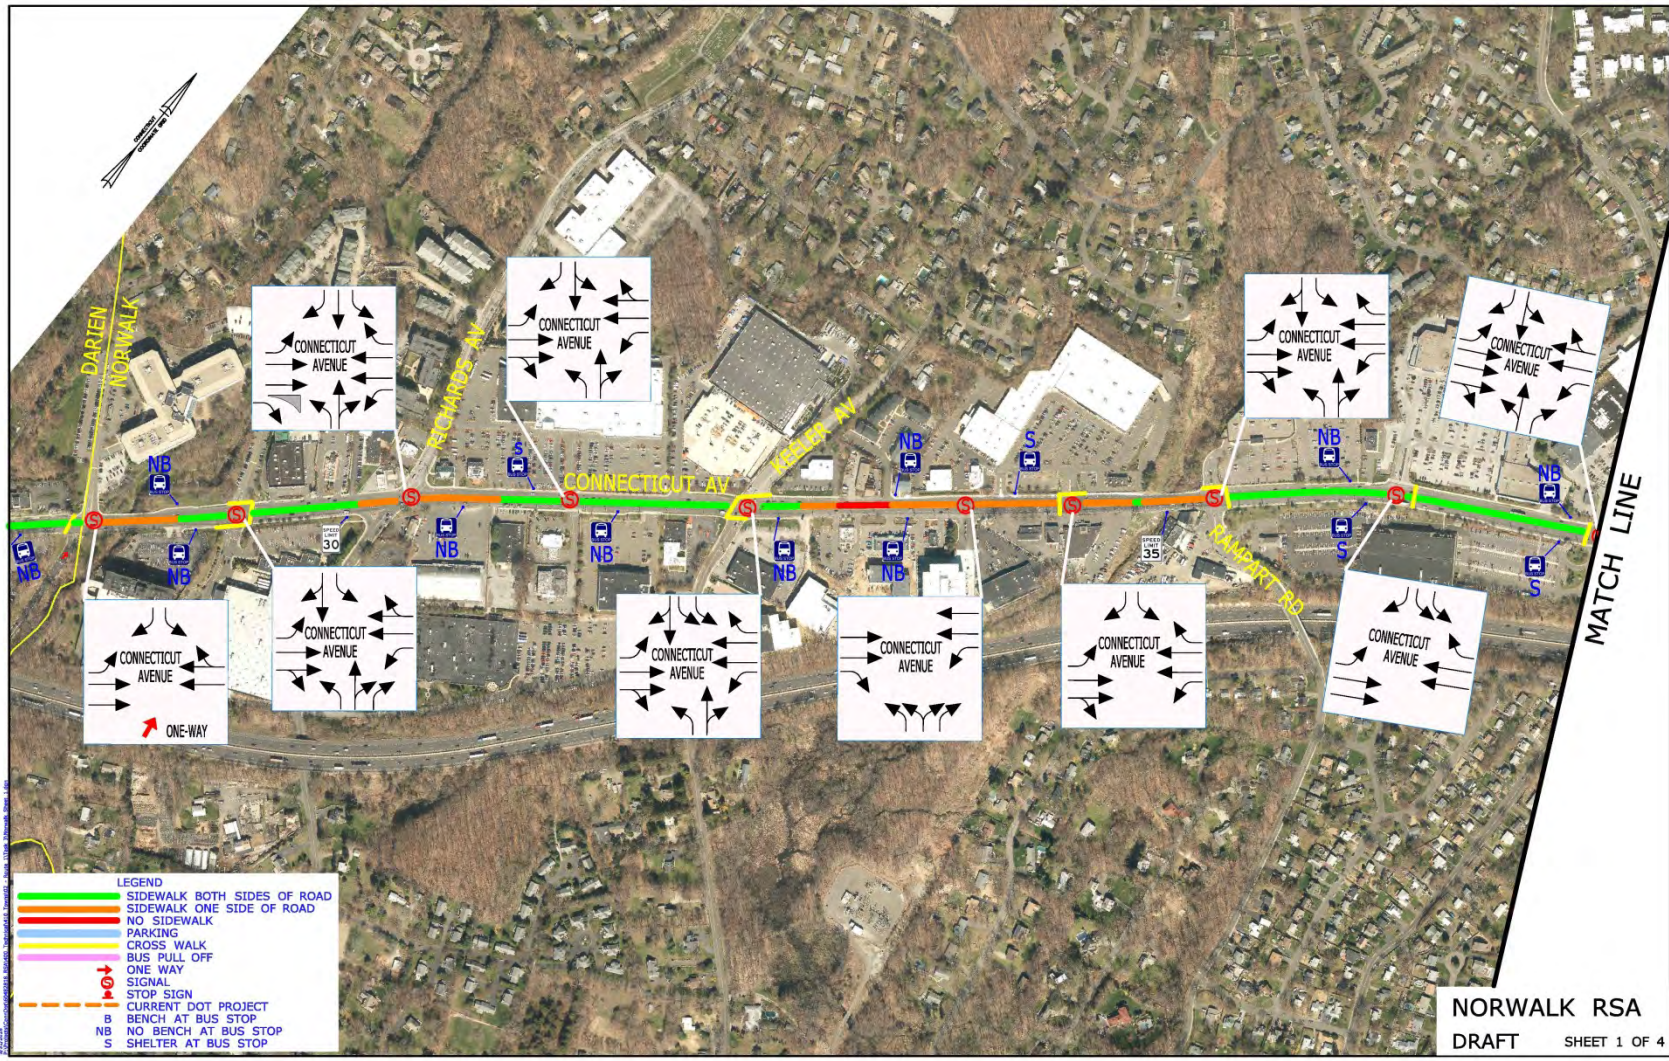
Figure 5. Connecticut Avenue, Norwalk Route 1 - Road Geometrics

Roadway geometrics for study corridor roadways and intersections are shown in Figure 5, Figure 6, Figure 7 and Figure 8. An inventory of existing conditions of the intersections can be found in Table 3.

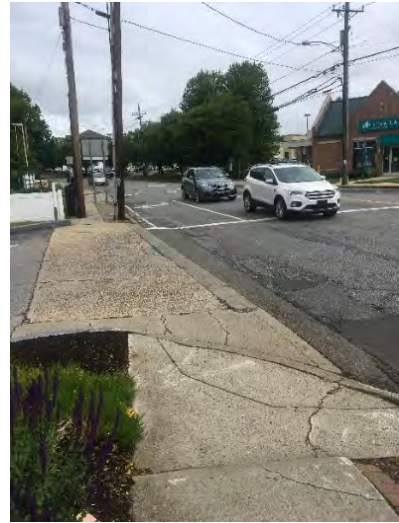
Figure 9. Gas Station Driveway in Intersection

- The diagonal crossing measured 80 feet and the pedestrian signal permitted 25 seconds which is adequate for pedestrian clearance time.
- Wide intersection.
- Intermittent sidewalks. (no sidewalk along Bowling Alley frontage on south side of Route 1)
- Driveways at gas station on northwest corner are very close to signalized intersection.
- Grassy median on southern leg of Richards Avenue and US-1.
- Channelized right turn lane for US-1 eastbound and Richards Avenue.
- Stop bar on southbound Richards Avenue at US-1 is set behind gas station driveway (Figure 9).
- No sidewalk for far side bus stop, eastbound.

4. Prohibit left turns into the gas station on US-1 at Richards Avenue.
5. Add a no Turn on Red Sign on Richards Avenue and US-1 (Figure 16).
6. Conduct Turning Movement counts at Richards Avenue and US-1.

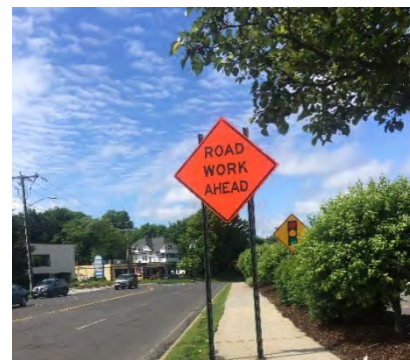
Figure 11. Sign Blocked by Vegetation

- This is a four-way signalized intersection.
- US-1 measures 68 feet across.
- Sidestreet green activated by push buttons in the NE and SE corners.
- The crosswalks are faded (Route 1 has been repaved & restriped since audit) (Figure 10)
- The southbound US-1 *signal ahead* sign is blocked by vegetation (Figure 11).
- The intersection warning sign for the signal at the entrance to the Starbucks (900 ft. south of Rampart Road) is blocked by vegetation.

12. At US-1 and Rampart Road:
  - a) Trim vegetation around the intersection warning sign.
  - b) Move sign if not visible after vegetation is managed.
  - c) Repaint faded crosswalks.

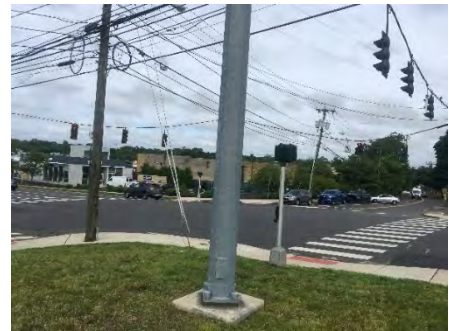
Figure 12. US-1 and Scribner Ave. Intersection

- Sidewalk ramps are ProWAG compliant, not ADA compliant -the grade is steep at this location.
- The sidewalks were recently redone and crosswalks painted (Figure 12).

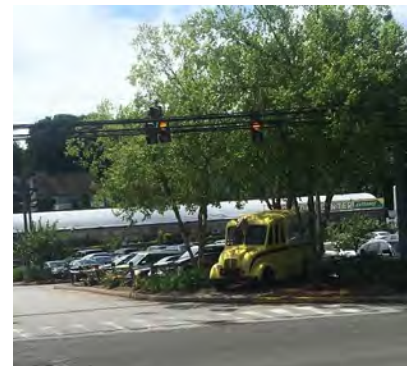
Figure 13. Signal Heads Blocked by Powerline

- This is a four-way signalized intersection.
- Signal head controlling Dry Hill Road traffic is blocked by power lines (Figure 13).
- There are crosswalks on the southern side and east leg of the intersection.
- The crosswalks are faded
- The crosswalk crossing Stew Leonard's Driveway along US-1 is 85 feet long.
- The US-1 crossing is 58 feet long.
- There is a Stew Leonard's employee parking lot in NW corner that has no crosswalk and pushbuttons to cross west leg of Route 1 to the store.

10. Add crosswalk along western leg of US-1 and George Avenue to connect employee parking lot and Stew Leonard's. (Figure 17)
11. Trim vegetation that blocks signal heads at US-1 and Dry Hill Road.

3. Add pedestrian refuge island or extend curbs at US-1 and Keeler Avenue to reduce crosswalk length on the northern leg of Keeler Ave (Figure 23)
4. Relocate wires that block signal head at US-1 and Stew Leonards from the Dry Hill Road approach.
