# Darien

Post Road (Route 1)

Road Safety Audit

June 14, 2018

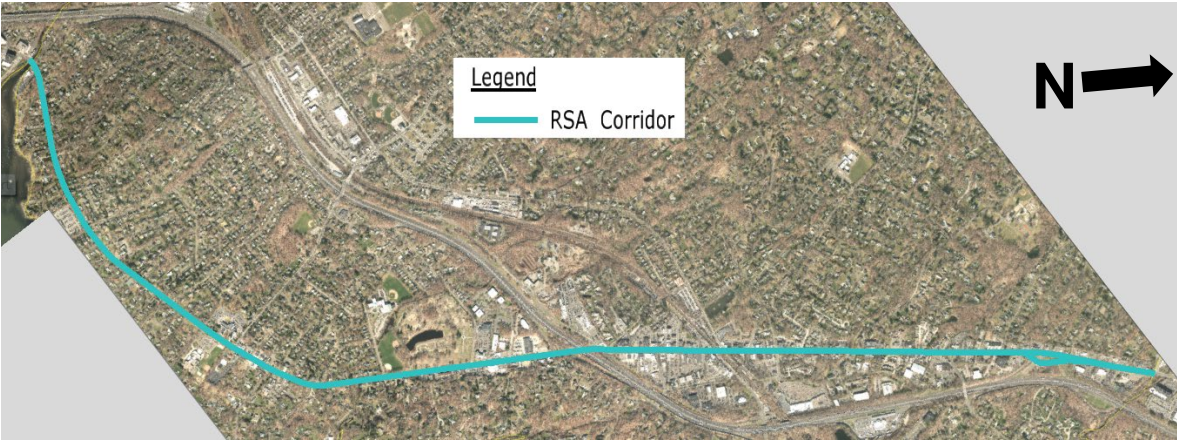
Figure 1-1. Post Road (Route 1) Darien

The RSA corridor includes US Route 1- Post Road (Figure 1-1). Figure 1-2 shows the study area in a regional context. Route 1 is classified as a principal arterial and runs parallel to Interstate 95. Route 1 in Darien is designated a Diversion Route for incidents along I-95. The Average Daily Traffic (ADT) on Post Road ranges from 9,100 vehicles per day (vpd) to 22,800 vpd. These are considered moderate volumes for suburban/urban roadways. The corridor has two lanes in each direction except for the section between Ledge Road and I-95 Exit 13 (just south of Richmond Drive) which has a single lane in each direction. All major intersections throughout the study area are controlled by traffic signals.

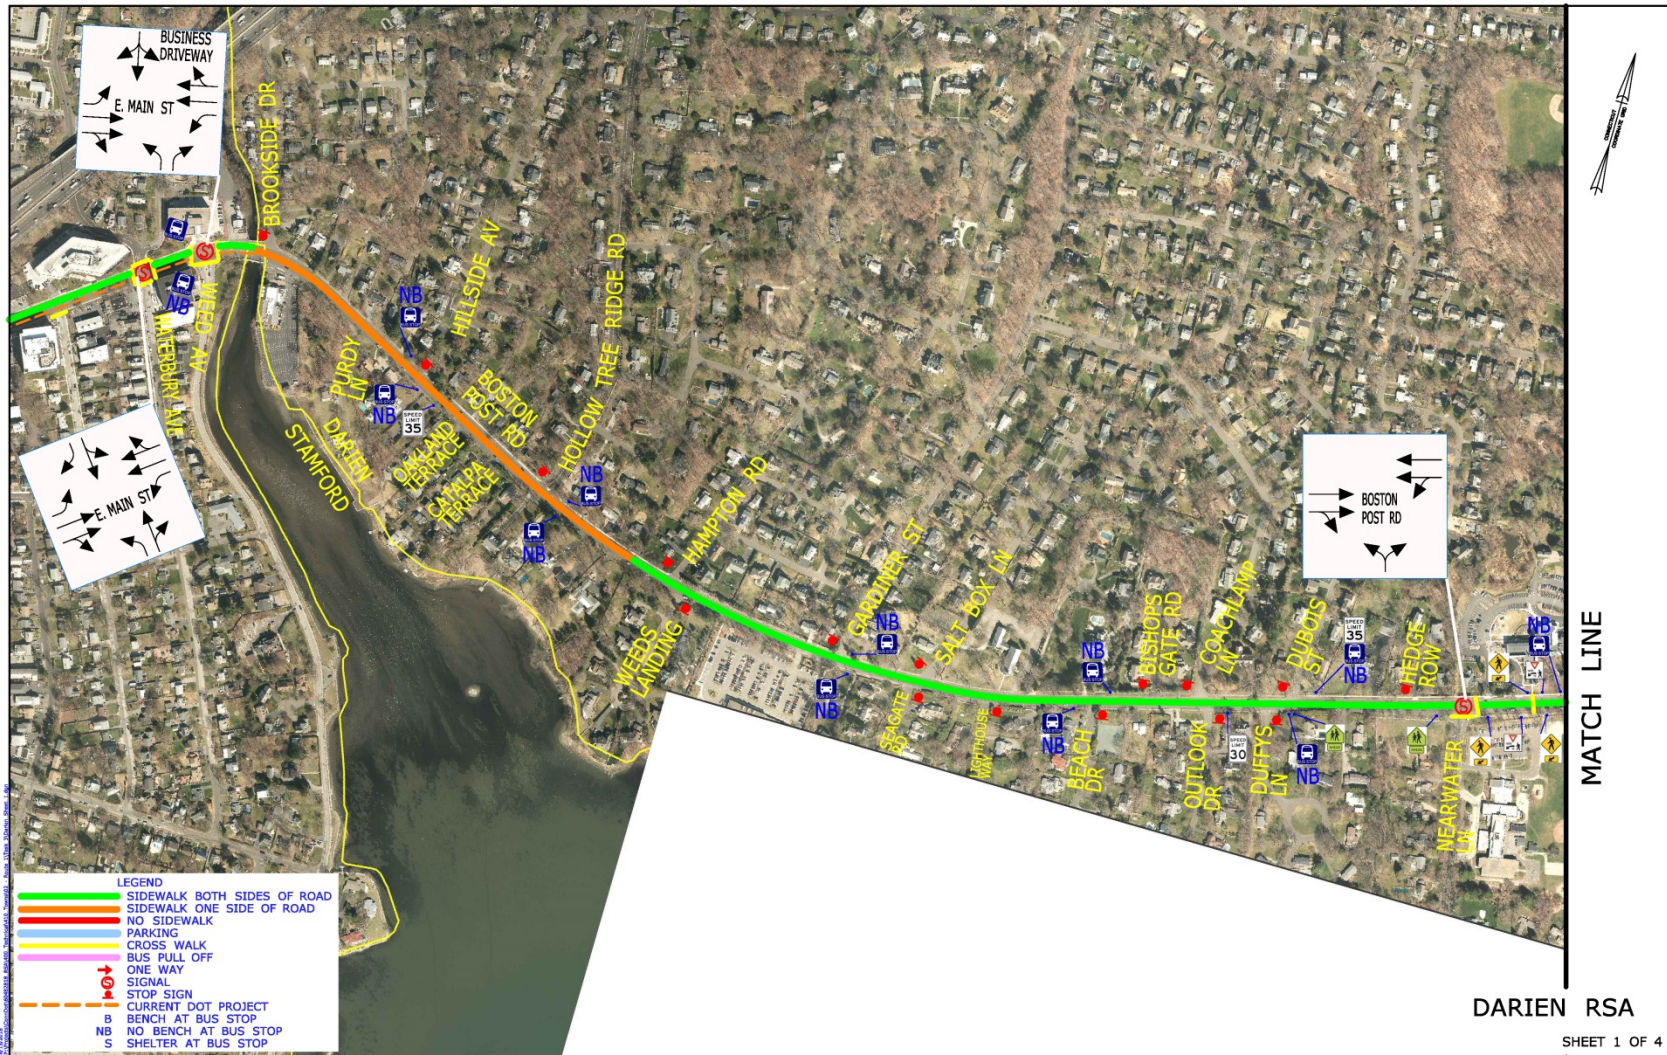
Figure 2-3. Post Road, Darien Route 1 - Road Geometrics

Roadway geometrics for study corridor roadways and intersections are shown in Figure 2-3, Figure 2-4, Figure 2-5, and Figure 2-6. An inventory of existing conditions of the intersections can be found in Table 3.

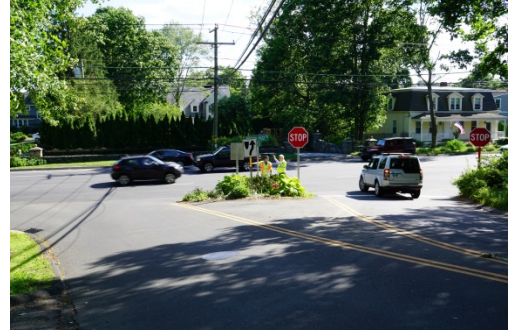
Figure 2-7 Small pedestrian refuge island

- Hollow Tree Ridge Road is stop controlled with Post Road free flowing. It provides primary access to Noroton Heights train station.
- There is a small pedestrian refuge island in the center of Hollow Tree Ridge Road (Figure 2-7).
- Curb ramps are provided on the north side of Post Road but are not ADA compliant. Marked crosswalks are not provided.
- Middlesex Middle School and Darien High School are off of Hollow Tree Ridge Road on the northern end.
- Study for signalization.
- Speeding is an issue.
- Sidewalks are narrow and have no buffer to separate them from traffic.

- Need painted crosswalks on the northern side of Post Road and for crossing Post Road.
- Study for signalization or alternative traffic control, such as a HAWK, including in the area of the YMCA.

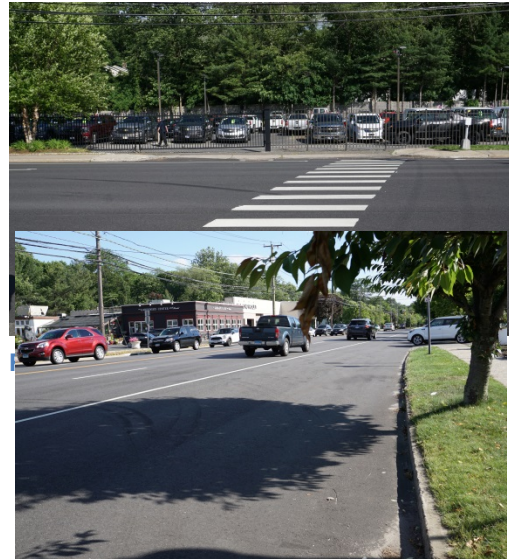
Figure 2-9 Wide shoulder

creating an overly wide section of pavement in front of Nielsen's Florist & Garden Shop (Figure 2-9).

3. Narrow the roadway and/or provide a parking cut-out in front of Nielsen's Florist & Garden Shop. (Town has already identified intersection of Post Road and Thorndal Circle for geometric realignment.)

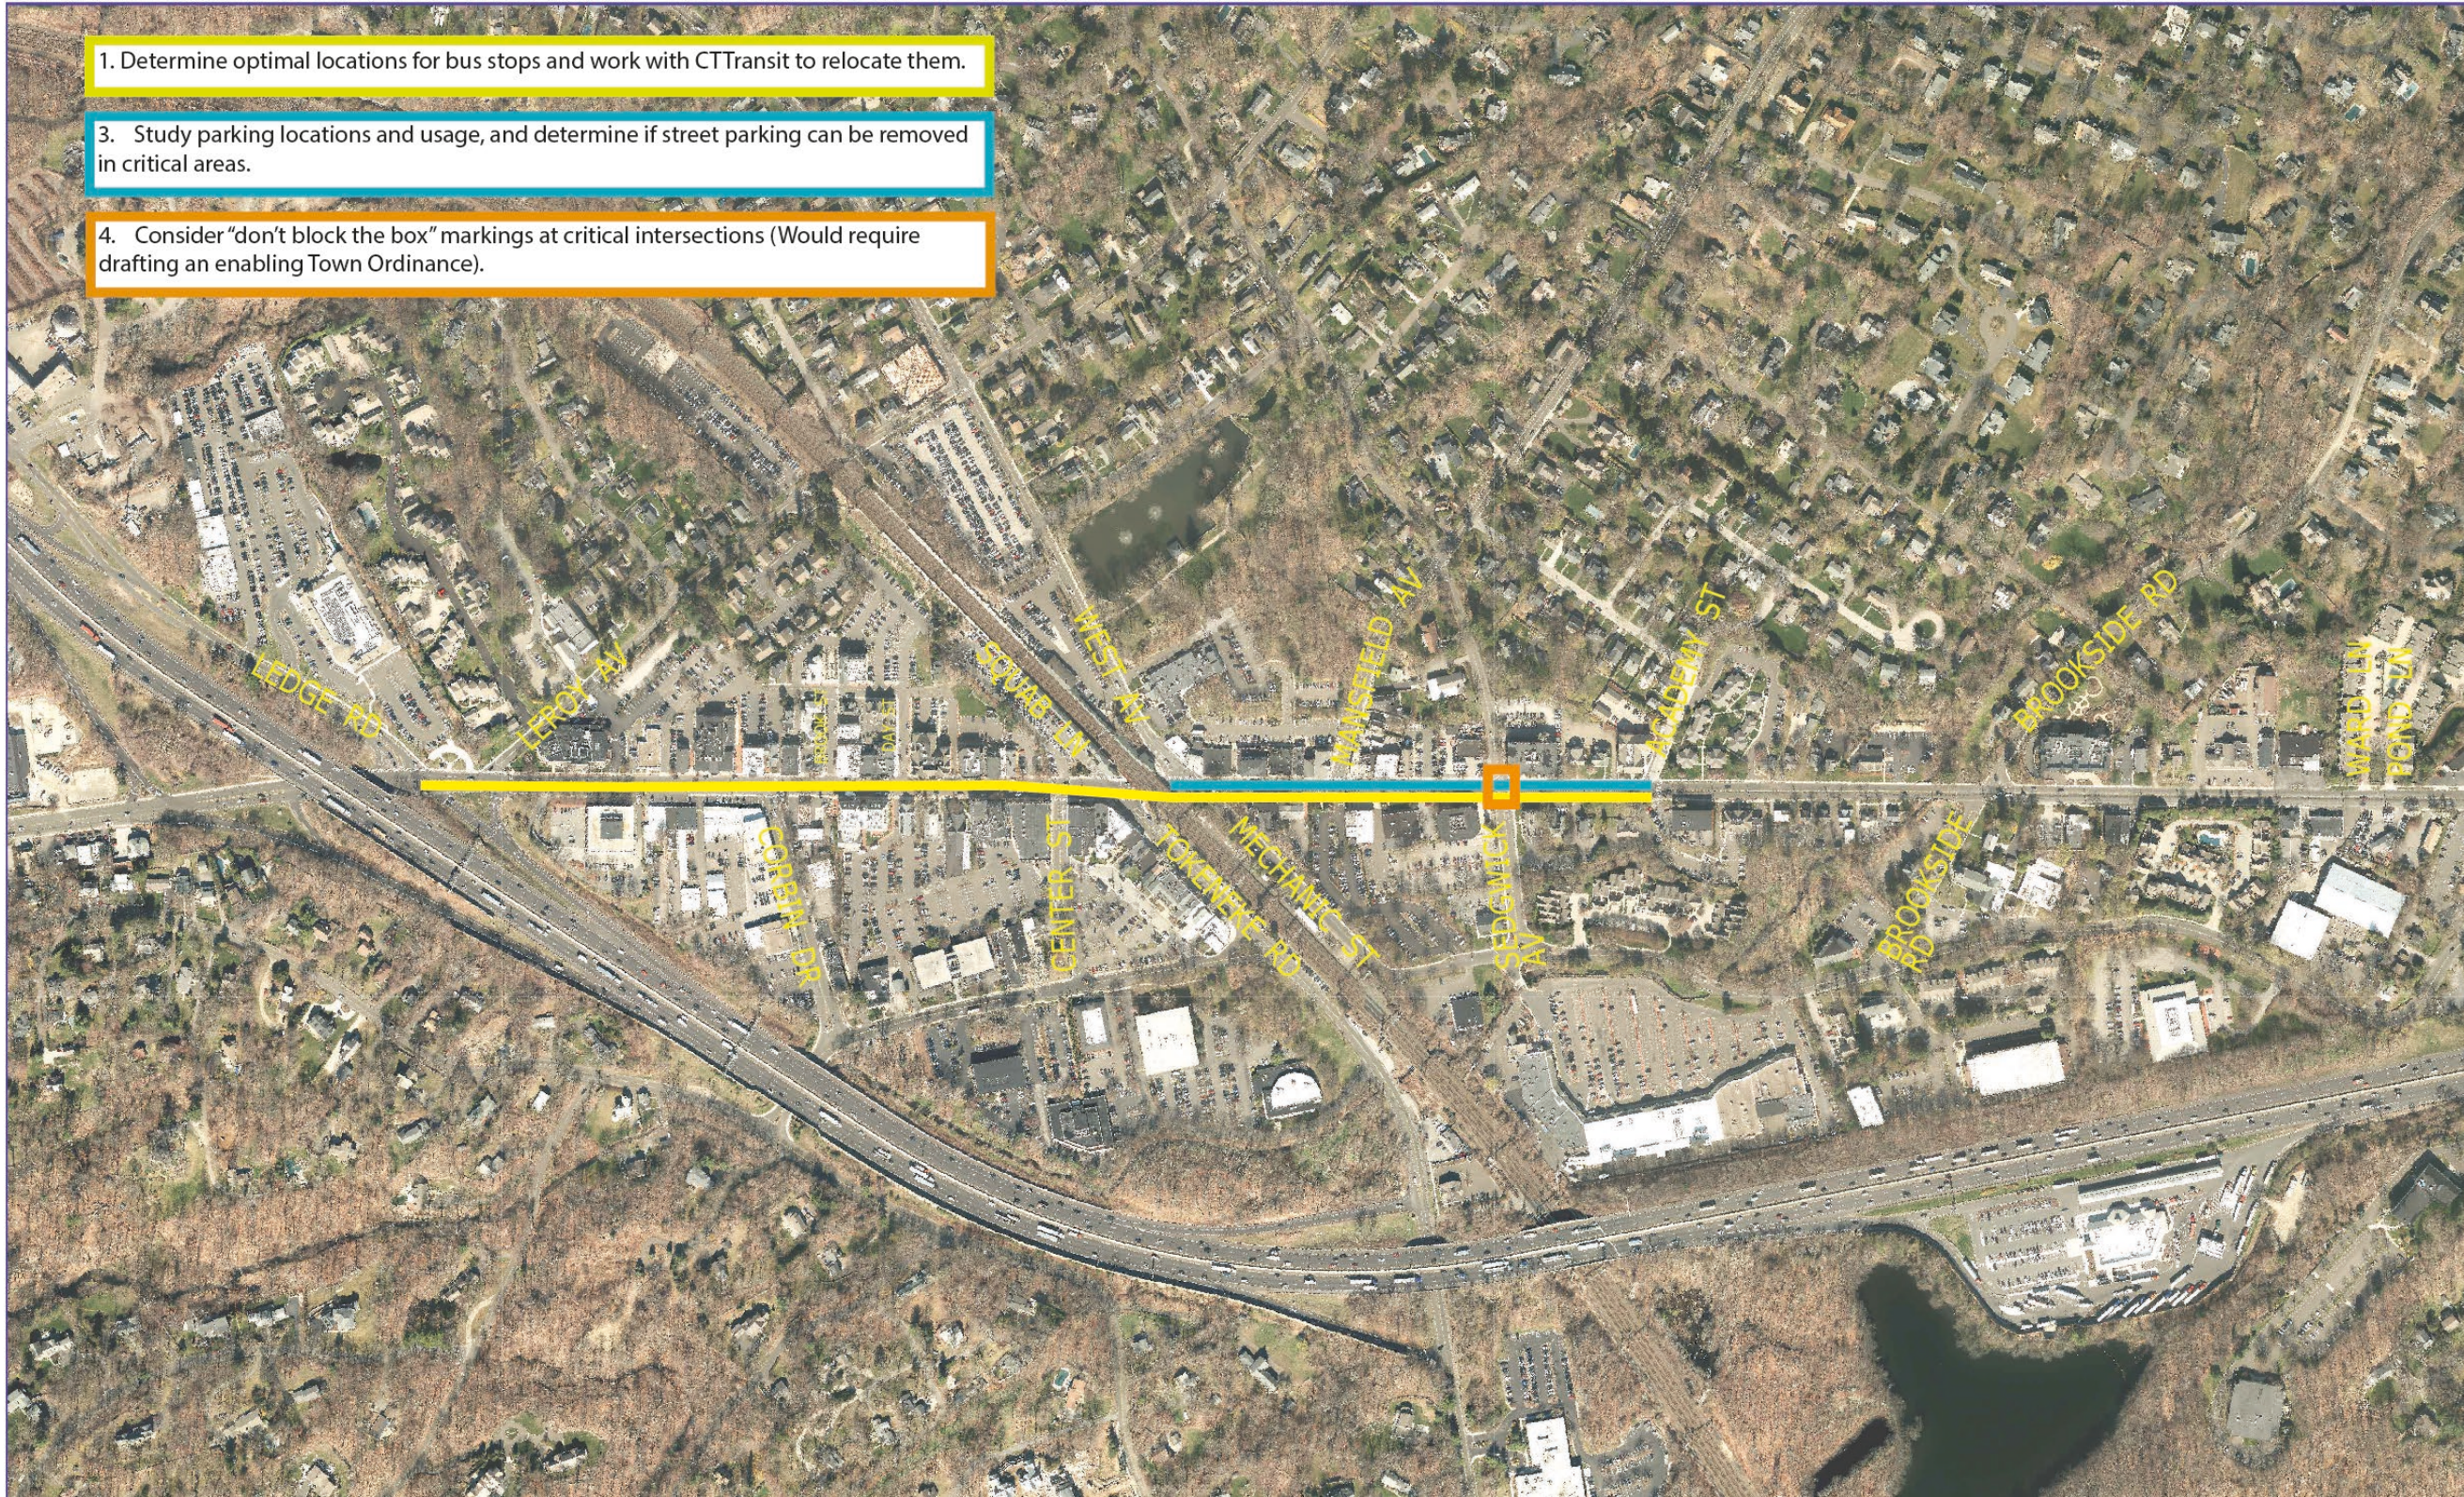
Figure 3-3 Short Term Recommendations

Note: No Recommendations in this area.

Figure 3-1, Figure 3-2, Figure 3-3, and Figure 3-4 depicts these recommendations.
