COMMUNITY
connectivity program

Salisbury

Route 44 Salisbury to Lakeville – Road Safety Audit

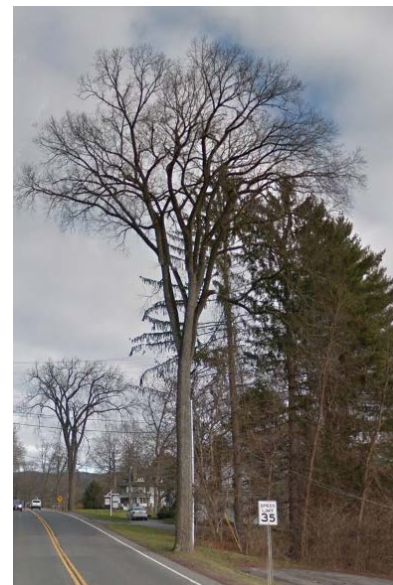
Figure 9. Protected Elm Trees

- The roadway is not always centered in the right-of-way.
- East of the fire station there are large protected Elm trees near the road edge (Figure 9).
- The "Railroad Ramble" rail trail is owned by the town, and parallels this route. It is grass (not paved) and is not maintained in the winter.
- There is access off Brook Street for the rail trail but it is poorly marked. The town recently converted Brook Street to a public way and will soon be designating parking.
