COMMUNITY
connectivity program

Shelton Avenue– Road Safety Audit

April 5, 2016

With assistance from AECOM Transportation Planning Group

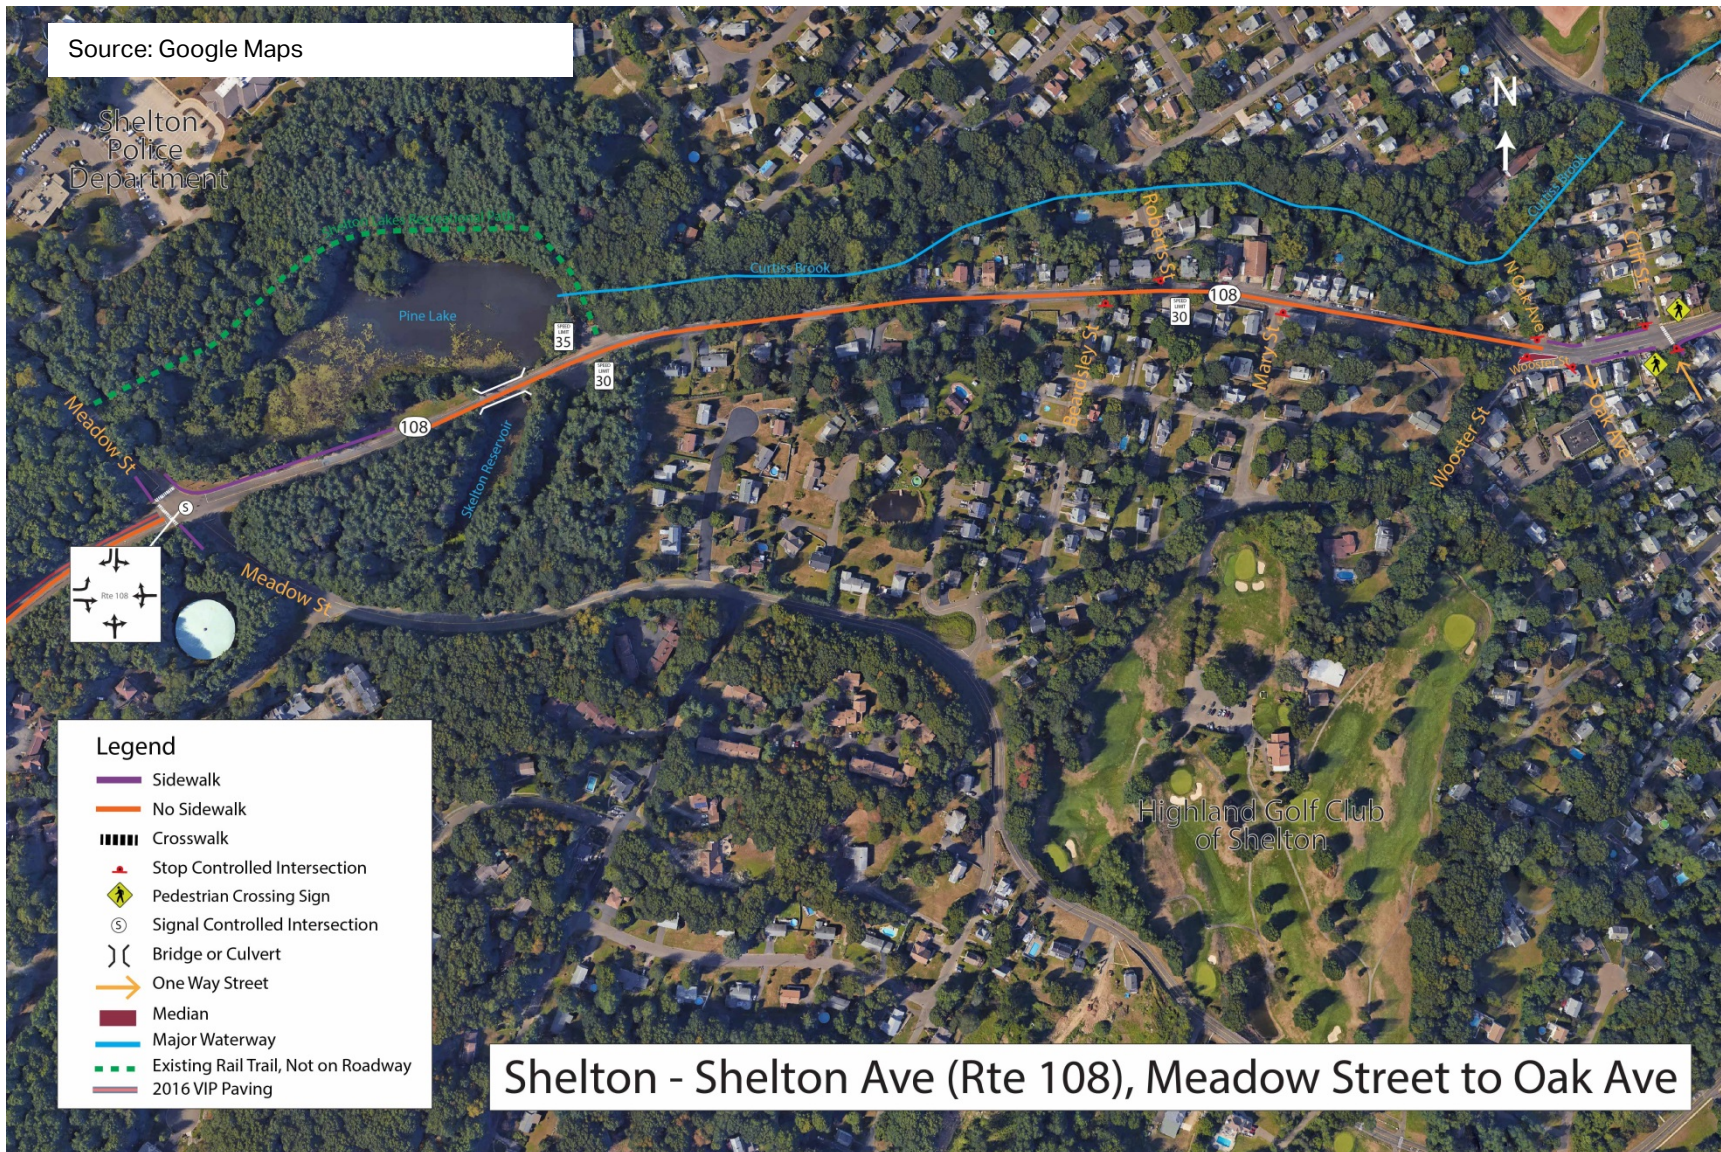
Figure 4: Shelton Avenue Road Geometrics

Route 108 (Shelton Avenue) is a two-lane, state owned road with a posted speed limit of 30 and 35 mph. The travel lanes on Shelton Avenue are approximately 12 feet wide, with the striped shoulder width ranging between one and seven feet wide (average three feet wide). From the east, the concrete sidewalk on Shelton Avenue ends at Oak Avenue. There is intermittent bituminous sidewalk on the north side that is often used as on-street parking for residents in the adjacent homes. The Rec Path, a multi-use crushed stone facility, crosses Meadow Street and wraps around the north side of Pine Lake, connecting Meadow Street with Shelton Avenue.

There is one signal in the corridor at the intersection of Meadow Street and Shelton Avenue. It is a four-way signalized intersection with crosswalks and countdown pedestrian signals across the north Meadow Street leg and the west Shelton Avenue leg. Shelton Avenue eastbound has two approach lanes, with a dedicated left turn lane and shared through-right turn lane. Shelton Avenue westbound has two approach lanes with a shared left-through lane and an exclusive right-turn lane. The two Meadow Street approaches have one lane each (Note - This signal was recently upgraded in 2016, which included revising the Meadow Street southbound approach to a shared left-through lane and an exclusive right-turn lane). All other intersections in the study corridor are Stop controlled. The geometry of the corridor is shown in Figure 4 and described in Table 3.

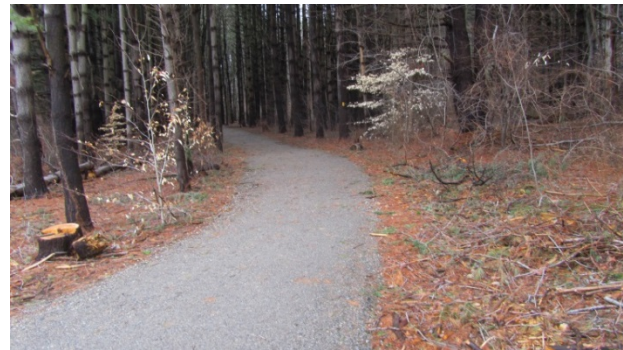
Figure 5: Rec Path near Shelton Avenue trail head

Shelton Avenue has been re-paved and striped by the CTDOT sometime in the year of 2015 . In 2012 the City completed the 4.1-mile multi-use Shelton Lakes Recreation Path (Rec Path) that links Shelton Avenue with Huntington Center. The path is made of crushed stone and ranges between 8 and 12 feet wide. See Figure 5.

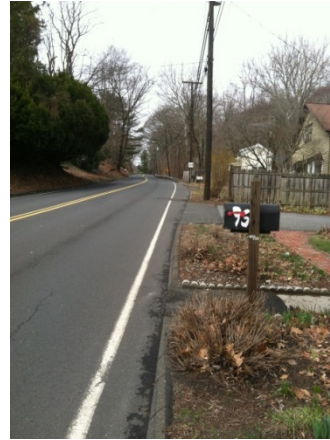
Figure 6: Utility poles close to road

- Right of way boundaries need to be researched.
 - Coordination with property owners along the corridor will be critical for the project's success.
- Utility poles are close to the curb throughout the corridor and will be a design constraint.

1. City to trim hedge encroaching on sidewalk at 79 Shelton Avenue or coordinate with owner.
2. City to contact the utility company to determine the disposition of utility poles marked for relocation/replacement and long-term plans as they may affect construction of a new sidewalk on Shelton Avenue.

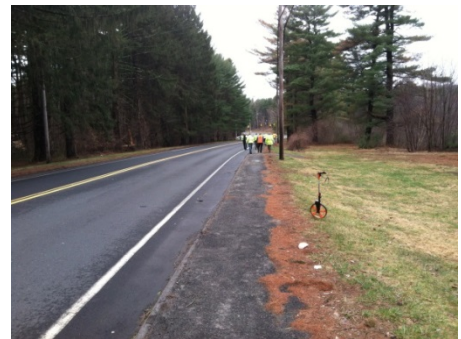
Figure 8: Overflow parking area

- There is a grass area west of the Rec Path parking lot on the north side of the road that the City indicated is occasionally used for overflow parking for events. See Figure 8.

- The City indicated that any future design should allow this overflow parking use to remain.
- Several of the catch basins in the corridor are clogged. See Figure 9.

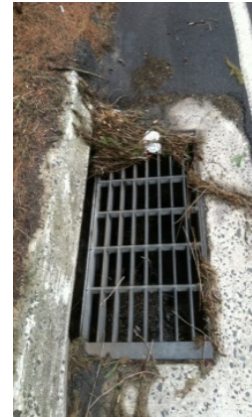
Figure 10: Non-bicycle friendly catch basin grate

- At least one non-bicycle friendly catch basin grate was observed in the corridor. See Figure 10.
- The bituminous sidewalk on the north side of the road at the west end of the corridor (near Meadow Street) is in poor condition and shows signs of drainage problems. See Figure 11.
- At 125 Shelton Avenue the road consists of 12.5-foot wide lanes and 2-3-foot wide shoulders in each direction.

1. Replace catch basin grates with bike friendly grates.
2. Install handicap ramps and detectable warning strips as needed at the intersection of Shelton Avenue and North Oak Avenue.

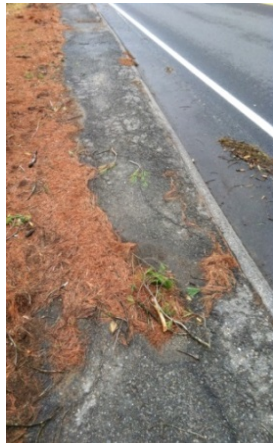
Figure 11: Existing bituminous sidewalk on Shelton Road near Meadow Street

- At the west end of the corridor there is an existing bituminous sidewalk in poor condition.
- Any recommendations to change the layout at the west end of the corridor should allow the overflow parking grass area to remain functional.
- Throughout the corridor, lane widths are typically 12-12.5-feet wide. The CTDOT allows 11-foot wide lanes on roadways such as Route 108.
- Several students were observed walking in the corridor. See Figure 18.
 - The City indicated that the students typically use the Rec Path to get to the High School, unless there is heavy snow.
- The City believes that pedestrians and bicyclists would prefer to make a loop around Pine Lake using the existing Rec Path and a planned sidewalk on Shelton Avenue.
 - The driveway at the Rec Path parking lot could also be improved as part of a sidewalk construction project.

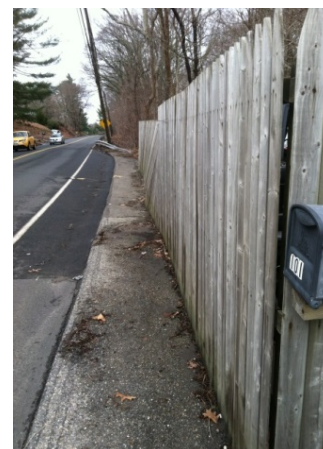
Figure 13: Wood fence along sidewalk at 110 Shelton Avenue

- At 116 Shelton Avenue the road consists of 12-foot wide lanes and 1-foot wide shoulders in each direction. This is the minimum roadway width within the RSA corridor.
- At 112 Shelton Avenue there is a rock structure directly behind the guiderail on the north side. There is a steep drop off behind the guard rail with views of Curtiss Brook. See Figure 12.
- At 110 Shelton Avenue there is a 3-foot wide bituminous sidewalk with a wood fence directly abutting it. See Figure 13.
 - It was unclear if the wood fence was on State right of way.

- At 110 Shelton Avenue the road consists of 12-foot wide lanes in each direction with a 4-foot wide westbound shoulder and a 2-foot wide eastbound shoulder.

- The existing bituminous sidewalk in this area is deteriorating and will continue to degrade over time. See Figure 22.
- The wood fence at 110 Shelton Avenue may be on State right of way.

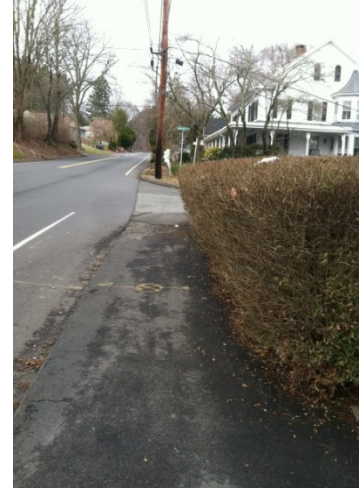
Figure 14: Hedge encroaching over sidewalk at 79 Shelton Avenue

- A hedge is encroaching over the sidewalk, limiting the usable width. See Figure 14.
 - A utility pole is located in the sidewalk.
 - A resident indicated that a 30 mph speed limit sign is missing for the westbound direction.

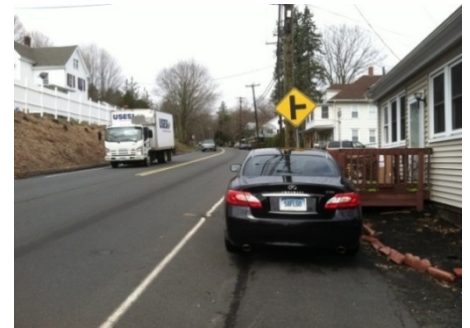
Figure 15: Car parked on sidewalk

- Residents park on the sidewalk in some areas because there is insufficient shoulder width.
 - Some residences are multi-family homes with minimal parking and steep driveways, which forces residents to park in the street or on the sidewalk.

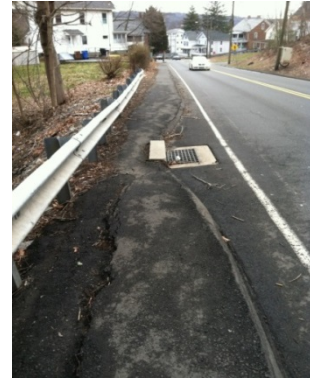
Figure 16: Catch basin encroaching into sidewalk

- There is a catch basin encroaching into the sidewalk at this location. See Figure 16.
- The sidewalk behind the catch basin is only 2-feet wide.
- There is an eastbound pedestrian sign at the intersection of Shelton Avenue and Wooster Street that is dented and outdated and may be unnecessary. See Figure 17.
- There are no handicap ramps across North Oak Avenue on the north side of Shelton Avenue.
- Several pedestrians (students), two bicyclists and a runner were observed travelling along the corridor. See Figure 18.

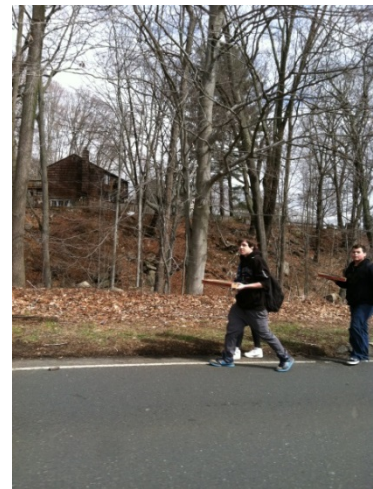
Figure 18: Students walking in shoulder on Shelton Avenue towards High School

- Many teenagers walk in the shoulder currently and some skateboarders use the shoulder. Very few adults walk along the corridor since they perceive the corridor to be unsafe. It was estimated that approximately 20 students per day walk through the corridor.

- Several students were observed walking in the shoulder during the audit.
 - The safety of these students could be improved by providing a sidewalk.
- Some driveways at the east end of the corridor are very steep and have retaining walls on one or both sides. This will be a design constraint.

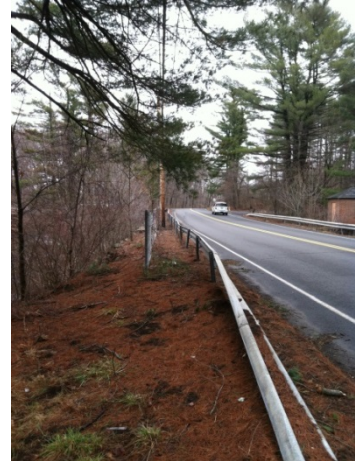
Figure 19: Narrow width between fence and guiderail

- Just west of the Rec Path parking lot there is a pinch point where a fence and guiderail abut the road on both sides. See Figure 19.
 - There is a space approximately 4 feet wide between the fence and the guiderail.

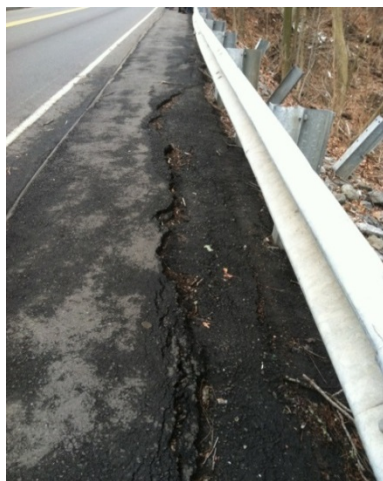
Figure 22: Washed out guiderail/degrading sidewalk

- On the north side of Shelton Avenue between #39 and #5 there is a steep drop-off with a guide rail. There are indications that there have been road wash outs in the past. The sidewalk slopes downward to Curtiss Brook and show signs of deterioration.

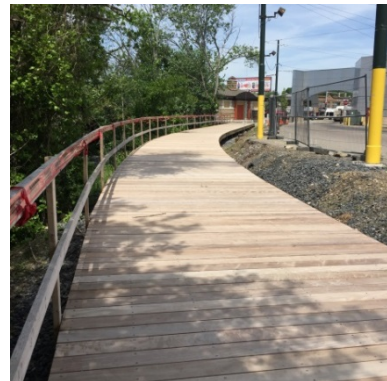
Figure 21: Example of cantilevered boardwalk above a river

- A design incorporating a cantilevered sidewalk/boardwalk above the ravine/stone wall should be considered through this section. See Figure 21.
- There was evidence of a previously washed-out section of guiderail near the east end of the corridor (between #39 and #5 Shelton Avenue) that was destroyed over five years ago.

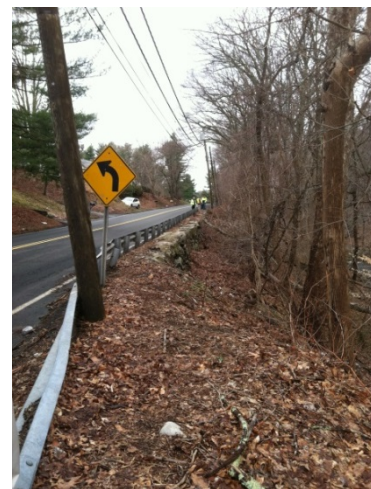
Figure 24: Sign behind utility pole

- There is a curve ahead sign located behind a utility pole just west of 101 Shelton Avenue. See Figure 24. This sign should be relocated.
- There is a tree at the northeast corner of Shelton Avenue, Wooster Street and North Oak Avenue that is limiting sight distance. See Figure 25.

5. City to request the CTDOT investigate the missing 30 mph speed limit sign in front of 79 Shelton Avenue and replace as necessary.
6. City to request the CTDOT relocate the curve ahead sign that is behind a utility pole just west of 101 Shelton Avenue.
