COMMUNITY
connectivity program

Simsbury

Farmington Canal Heritage Trail Crossings

June 1, 2016

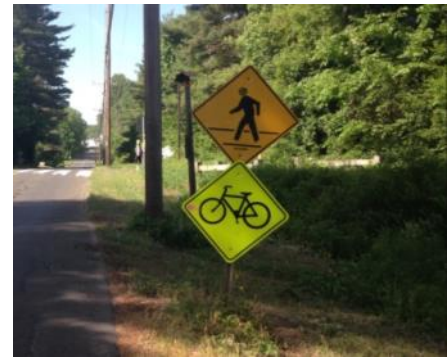
Figure 12. Signs with Inconsistent Colors and Low to the Ground

- Existing signs are low to the ground and inconsistent in color (Figure 12).
- Signs are blocked by overgrown vegetation.
- Crosswalk is located at the crest of the road. Its location may reduce visibility to motorists.
- Very little visual cue for motorists that there is a trail crossing.

1. Signage:
 - a. Correct signage height to meet MUTCD standards.
 - b. Use consistent colors for all signs.
 - c. Use combined pedestrian and cyclist sign to decrease the number of posted signs (Figure 21).

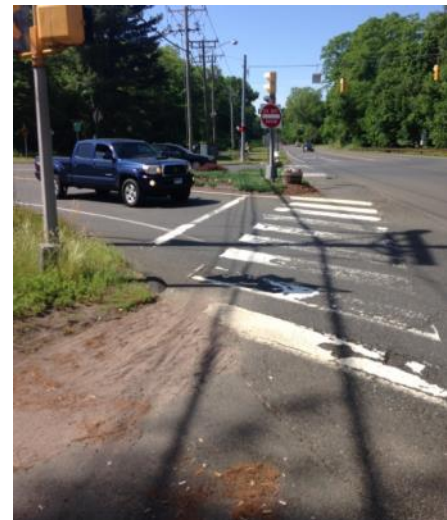
Figure 13. Triangular Channelizing island and Sand Buildup at Crosswalk.

- Pedestrian push button is located on the wrong side of the trail.
- Only one pedestrian signal has a countdown.
- Pedestrian crossing signal is 40 seconds long.
- If a pedestrian or cyclist is on the triangular channelizing island, there is no pedestrian push button to grant a crossing (Figure 13).
- Vehicles turning right onto Route 10 from Hopmeadow do not always obey the traffic signal. Simsbury indicated that motorists have been observed rolling past the stop bar.
- The corners on each side of this crosswalk have a buildup of sand/dirt (Figure 13).

3. Crosswalk at Route 315
 - a. Repaint crosswalk and define the crosswalk in the pedestrian refuge/ triangular channelizing island (Figure 22).
 - b. Investigate methods to prevent buildup of dirt/sand at corners of the crosswalks.

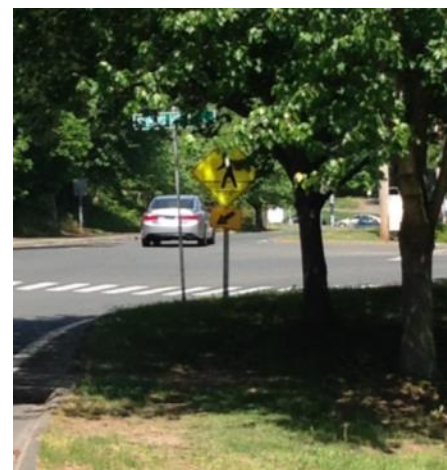
Figure 14. Overgrown Vegetation

- Overgrown vegetation is blocking existing signage (Figure 14).
- Iron Horse Boulevard has a bike path. It is not clear if cyclists are allowed on the sidewalks in this area or should remain on roadway in bike path.
- Vehicles travelling westbound on Drake Hill Road have little visibility of pedestrian sign due to overgrown vegetation.

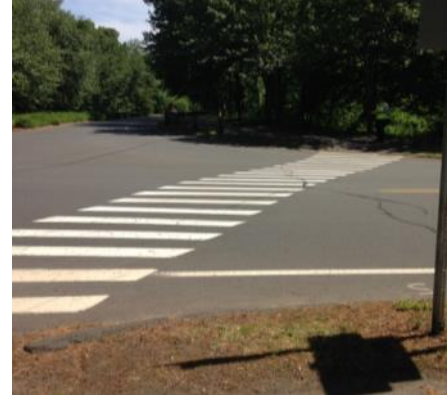
Figure 15. Crosswalk is Painted at an Angle

- Crosswalk is at an angle. During the audit, pedestrians and cyclists were observed crossing this intersection in paths other than the painted crosswalk (Figure 15).

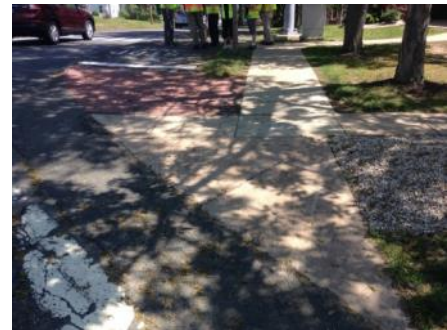
Figure 16. Sidewalk and Trail Have Multiple Surface Types

- A bollard is only on the south side of this crossing.
- Pavement in the crosswalk area is in poor condition.
- The north side of this crossing has concrete, brick and asphalt (Figure 16).

6. At the northern side of the Ensign-Bickford/Dyno-Nobel crossing, move the existing concrete sidewalk and asphalt trail path closer to the building. This will create a buffer area between the trail and roadway.

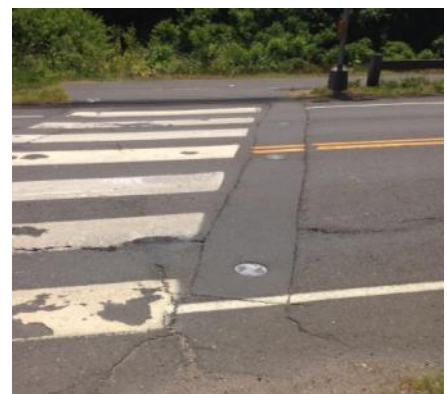
Figure 17. LED Flashers

- LED flashers in road do not appear to be functional (Figure 17).

6. Install advanced warning signs on trail that an intersection with a commercial driveway is approaching (due to heavy truck traffic) near the Ensign-Bickford/Dyno-Nobel crossing.
7. Remove bollard on south side of Ensign-Bickford/Dyno-Nobel crossing (Figure 24).
8. Install wood guardrail between Canal Street and the trail path (Figure 25).
9. Remove bollard on the trail at the Canal Street intersection.
10. Replace LED lights in pavement at the Weatogue crossing (Figure 26).

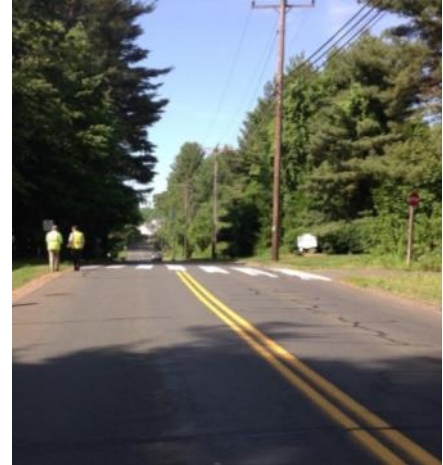
Figure 18. Crosswalk on Crest of Hill

3. Not all crosswalks have advanced warning signs to alert motorists that a pedestrian crosswalk is approaching.
4. The crosswalk at Wolcott Road is located on the crest of the hill and may be difficult for motorists to see (Figure 18). The crosswalk is also skewed, which makes it a longer distance to cross.

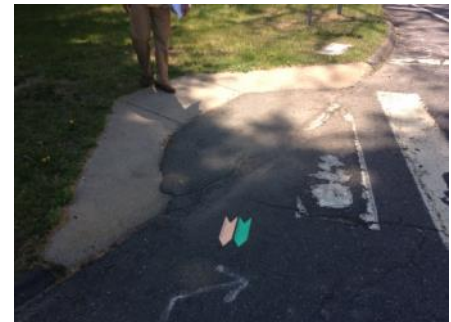
Figure 19. Small Landing Area

6. Pedestrians and cyclists at the Canal Street and Route 10 intersection have been observed crossing diagonally instead of on the painted crosswalks. The landing shoulders at this intersection are small and there is not enough room to accommodate multiple pedestrians and cyclists at a time (Figure 19).

7. Expand refuge areas at the Canal Street and Route 10 intersection to increase room for additional pedestrians and cyclists (Figure 32).

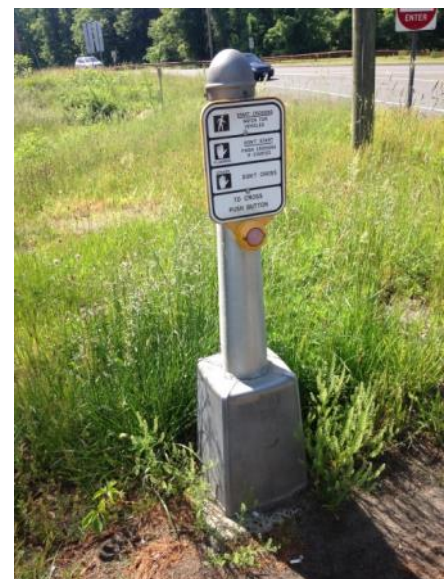
Figure 20. Pedestrian Pushbutton

7. Pedestrian crossing signal heads and pushbuttons are not up to current ADA standards (Figure 20).
8. Bollards on the trail are inconsistent and some are in poor condition.

1. Investigate narrowing lane widths on local roads near the trail crossings.
2. Upgrade all pedestrian crossing signals to meet current ADA regulations, including:

- a. Audible signal.
 - b. Countdown pedestrian head (Figure 28).
3. Consider implementing the following upgrades at the pedestrian refuge/triangular channelizing island at the Route 10 and Route 315 intersection:
