COMMUNITY
connectivity program

South Windsor

Ellington Road (Route 30) – Road Safety Audit

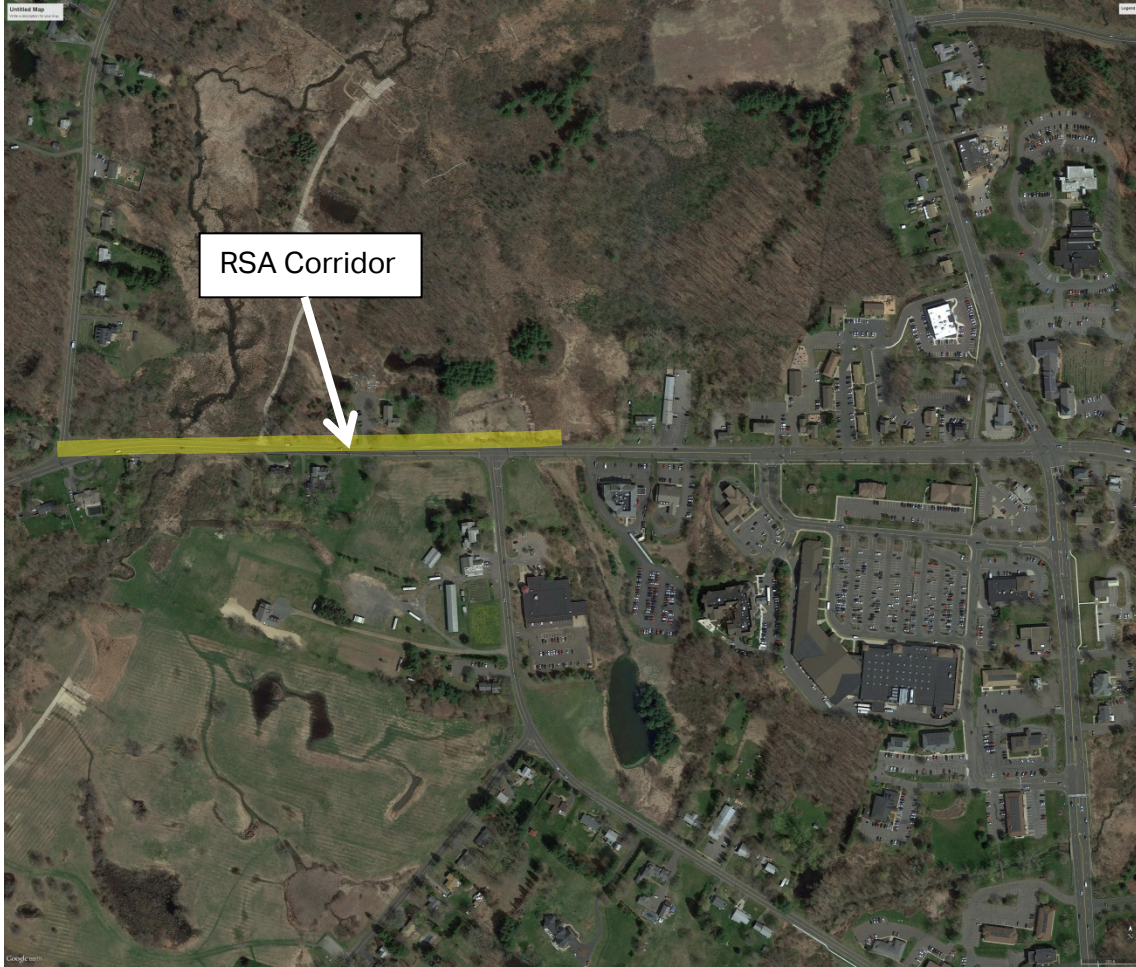
Figure 1. Ellington Road (State Route 30), South Windsor

The RSA site is the section of Ellington Road (State Route 30) between Pierce Road and Clark Street (Figure 1). The Average Daily Traffic (ADT) on Ellington Road near the Clark Street intersection is 10,100 vehicles per day (vpd). Ellington Road consists of a single lane in each direction, separated by a double yellow center line. There are striped shoulders on each side of the road, with widths that vary from less than one foot up to 7 feet.

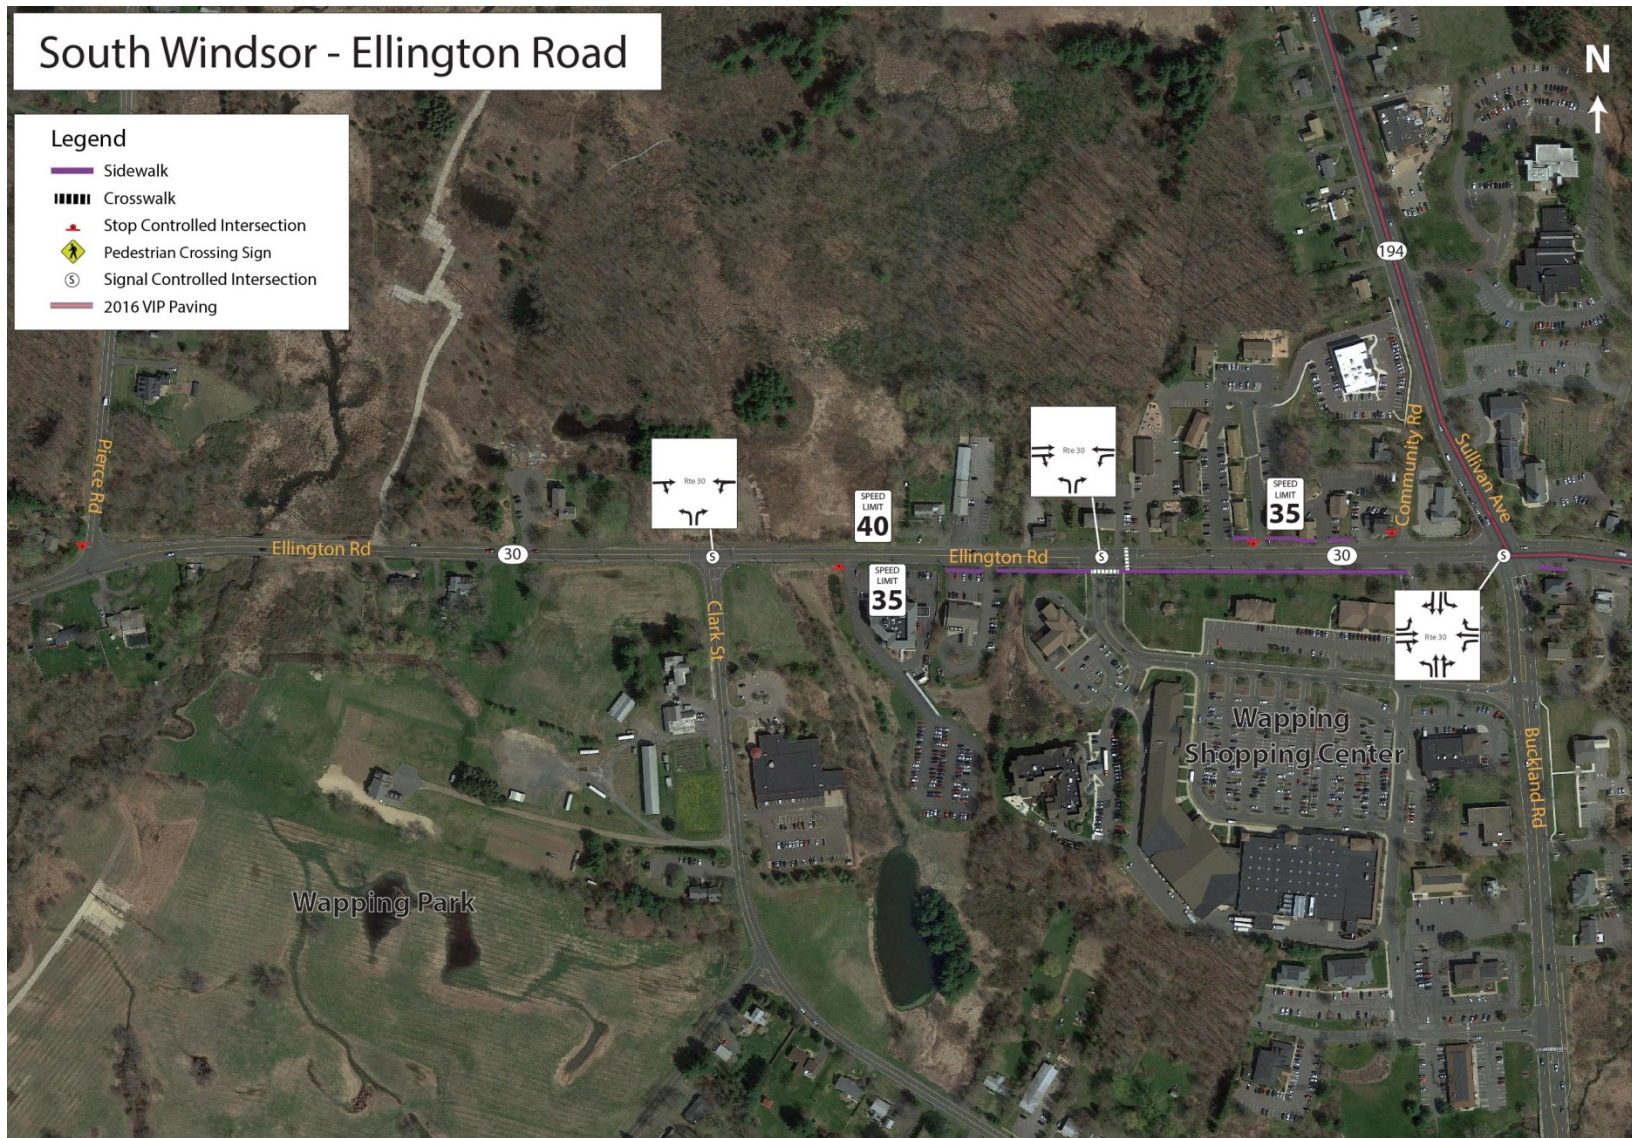
Figure 4. Ellington Road Geometrics

The RSA study area encompasses the intersections of Pierce Road and Clark Street, local roads that are collector roads for other local streets to the north and south of the study corridor. Pierce Road and Clark Street both provide a single lane in each direction, although Clark Street widens to two lanes (right turn and left turn) on its approach to Ellington Road. All three roadways have striped shoulders on each side of the road, with widths that vary from less than one foot up to 7 feet.

Figure 4 depicts the roadway geometry throughout the study area, and Table 3 presents data on the physical features of these roads.

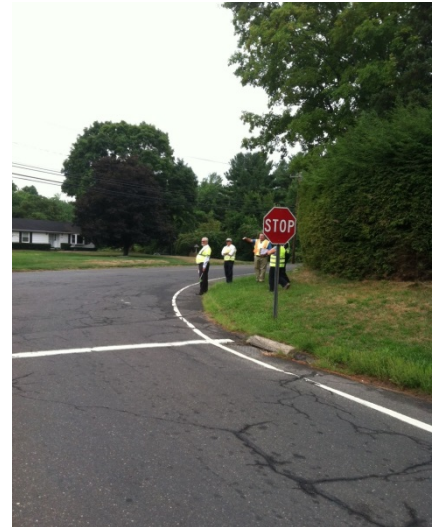
Figure 5. Intersection of Pierce Road and Ellington Road

A second concern is related to the intersection of Pierce Road and Ellington Road. There is a hedge on private property on the northwest corner of the intersection that currently limits the sight distance for vehicles left turning from Pierce Road onto Ellington Road eastbound. This causes vehicles to pull up well past the stop bar in order to see far enough to turn left onto Ellington Road.

- There is insufficient sight distance when making a left turn out of Pierce Road onto Ellington Road due to the hedge (Figure 5).
- The existing curb radius is very large.
- The existing widths on Ellington Road in this area are 6' WB shoulder, 13' WB lane, 14' EB lane and 5' EB shoulder.
- The stop bar is set back significantly from the intersection; this compounds sight line problems.
- There is a municipal bus stop in the area of the intersection (Figure 5).
- Possible improvements to the intersection were discussed.
 - Shifting the Pierce Road yellow line to the east could allow for better sight line.
 - The stop bar could be moved forward to improve sight line.
 - Tightening the lane widths and curb radii could shrink the intersection and make it easier to navigate while also increasing sight distance.

1. Re-align the Pierce Road centerline further to the east and more perpendicular to Ellington Road to provide better sight distance for left turning vehicles. Consider the possible use of painted islands at the Pierce Road/Ellington Road intersection to channel vehicles into optimal positioning.
2. Consider the use of dotted edge line extensions to identify the shoulder line on the north side of Ellington Road as it crosses the Pierce Road/Ellington Road intersection.
3. Move the stop bar on Pierce Road closer to the intersection to provide better sight distance.
4. Investigate where Ellington Road is on the VIP list for future paving.
5. Re-stripe 11' lanes on Ellington Road if VIP paving is done.

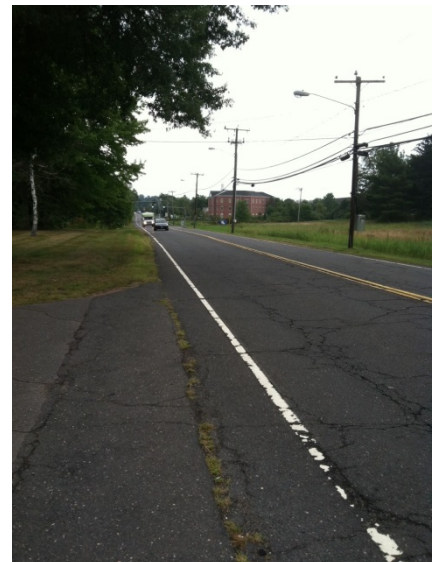
Figure 6. Ellington Road Facing East

- A proposed sidewalk can run along the north side of Ellington Road from Clark Street to Pierce Road (Figure 6).
- There is a significant culvert (stream crossing) located approximately 400 feet east of Pierce

Road. Ellington Road widths at the culvert are 7' WB shoulder, 13' WB lane, 15' EB lane, and 4' EB shoulder.

- There is approximately 4' between the edge of pavement and the culvert headwall behind the guide rail.
- Ellington Road widths east of the culvert are 2' WB shoulder, 11' WB lane, 13' EB lane, and 1' EB shoulder.
- There is a section of shoulder pavement on the north side of Ellington Road that is in poor condition (broken up) at 1610 Ellington Road (Figure 7).
- There are trails behind 1610 Ellington Road right now with some possibility for a future connection to Ellington Road.
- The existing end of sidewalk on the south side of Ellington Road is much higher than the area to its west, which would have to be re-graded to allow the sidewalk to be continued.

- A sidewalk on the north side of Ellington Road from Pierce Road to Clark Street is feasible given the existing conditions.
 - Narrowing the existing lane widths can generate the necessary width to construct a sidewalk on the north side without infringing on wetlands at the existing culvert.

- A standard section of two 11' lanes with 5-6' shoulders would provide plenty of space for a sidewalk on one side of the road and still provide adequate shoulder width for bicycle use.

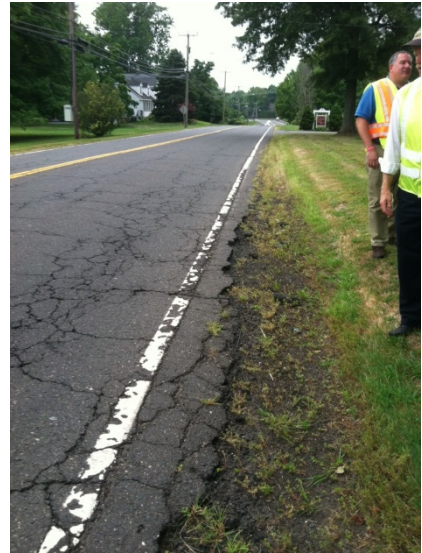
Figure 7. Broken Up Shoulder Pavement

- There are wetlands on both sides of Ellington Road around the intersection.
- The only pedestrian facilities at the intersection are pedestrian push buttons on two corners.
- Current phasing for this pedestrian crossing is Side Street Green.
- There are commercially zoned areas on Deming Street.
- There is evidence that some vehicles travelling west on Ellington Road come off the road to bypass left turning vehicles.
- The catch basin on the corner of Clark Street and Ellington Road does not have a bicycle safe grate.
- There is not much space on the south side of Ellington Road east of the intersection between the existing edge of road and the wetlands to construct a sidewalk.

- On the north side of Ellington Road there is 9-10' between the existing edge of road and a culvert outlet in the wetlands.

- The pavement condition in this area is poor and the town would like to find out where it falls on the VIP list.
 - The pavement condition may be too poor to warrant VIP paving and may instead warrant full reconstruction.
