# Southington

Queen Street (Route 10) – Road Safety Audit

August 1, 2016

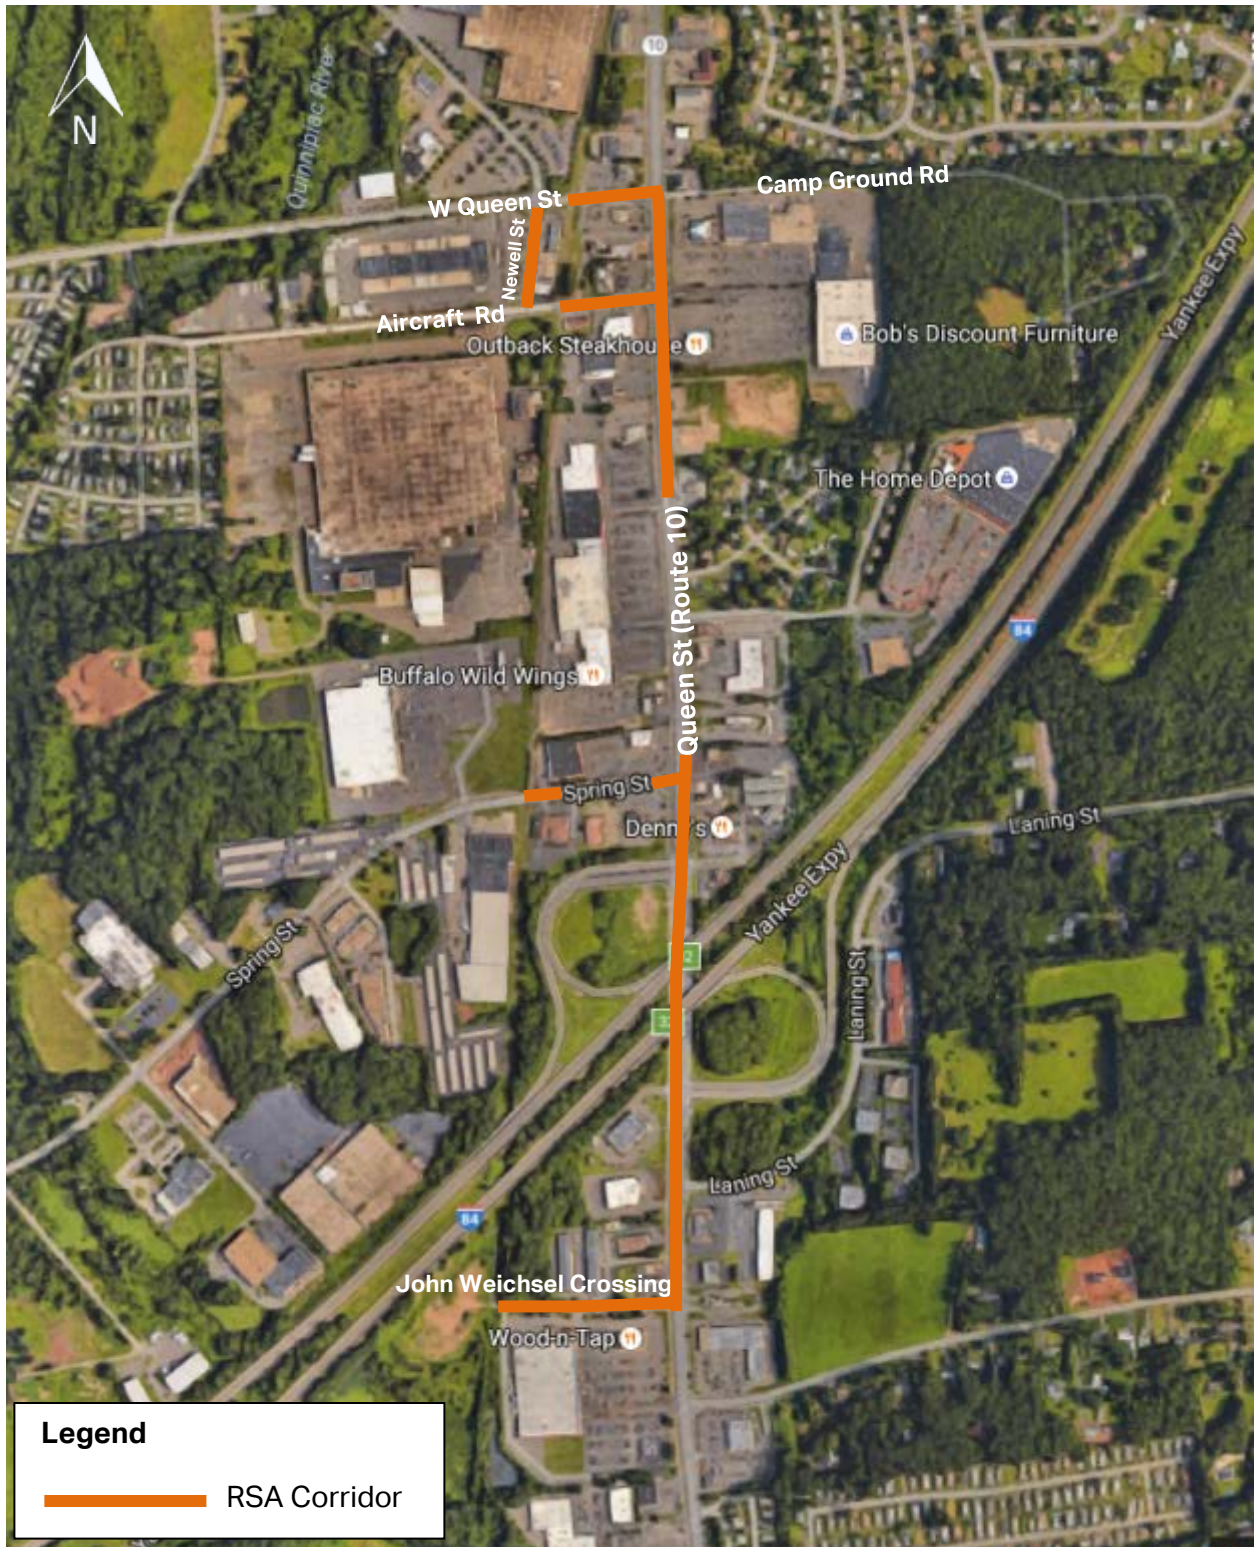
Figure 1. Queen Street (Route 10), Southington

The RSA corridor includes Queen Street (Route 10) from John Weichsel Crossing to West Queen Street/Camp Ground Road with particular focus on the Spring Street, Aircraft Road, West Queen Street/Camp Ground Road, and John Weichsel Crossing intersections, and connections to the Farmington Canal Heritage Trail (Figure 1). Queen Street (Route 10) is classified as a Principal Arterial and John Weichsel Crossing, Spring Street and Aircraft Road are classified as Local Roads. Average Daily Traffic (ADT) on Queen Street ranges from 23,700 to 31,900 vehicles per day (vpd). This section of roadway contains a significant number of driveways, adding complexity to walking and bicycling maneuvers through the area. Figure 2 shows the regional context of the study area.

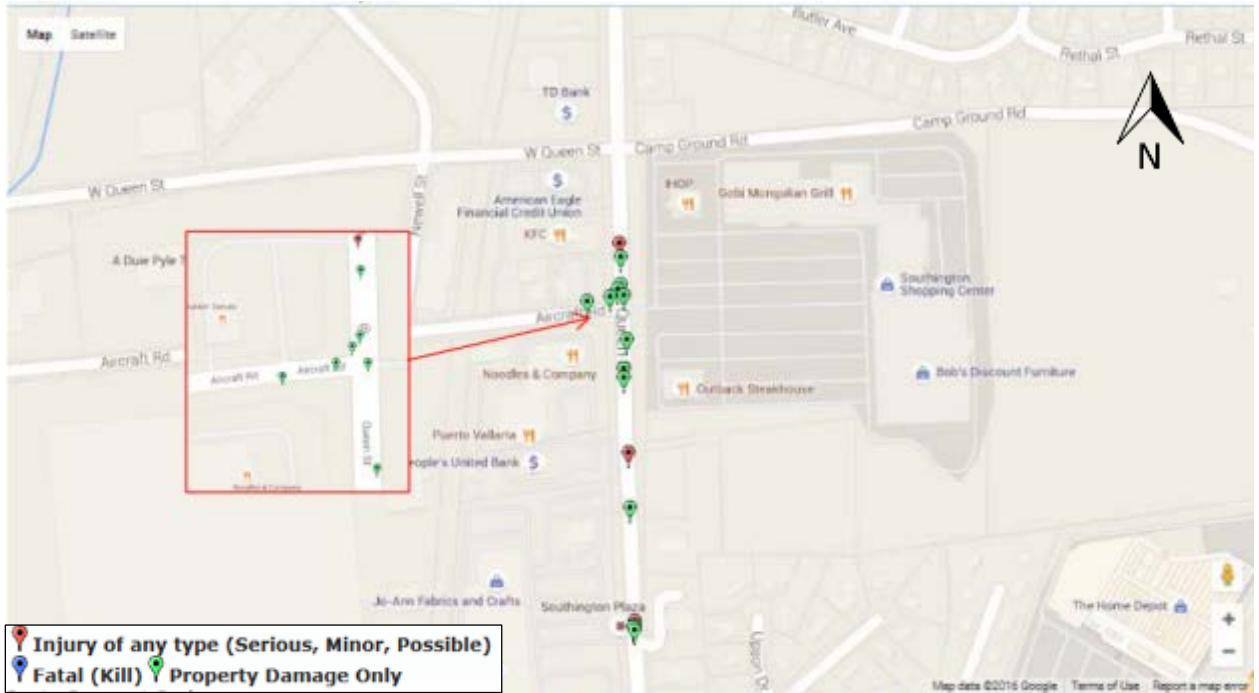
**Figure 3. Crashes that Occurred in 2015 (Connecticut Crash Data Repository)**

Figure 3 displays crashes that occurred in this area during 2015. The crash history for year 2015 shows an even distribution of crashes along Queen Street with a significant cluster of crashes at the intersections of Queen Street with Aircraft Road; Interstate Park Drive; Spring Street; I-84 westbound and eastbound on-and off-ramps, and with Laning Street.

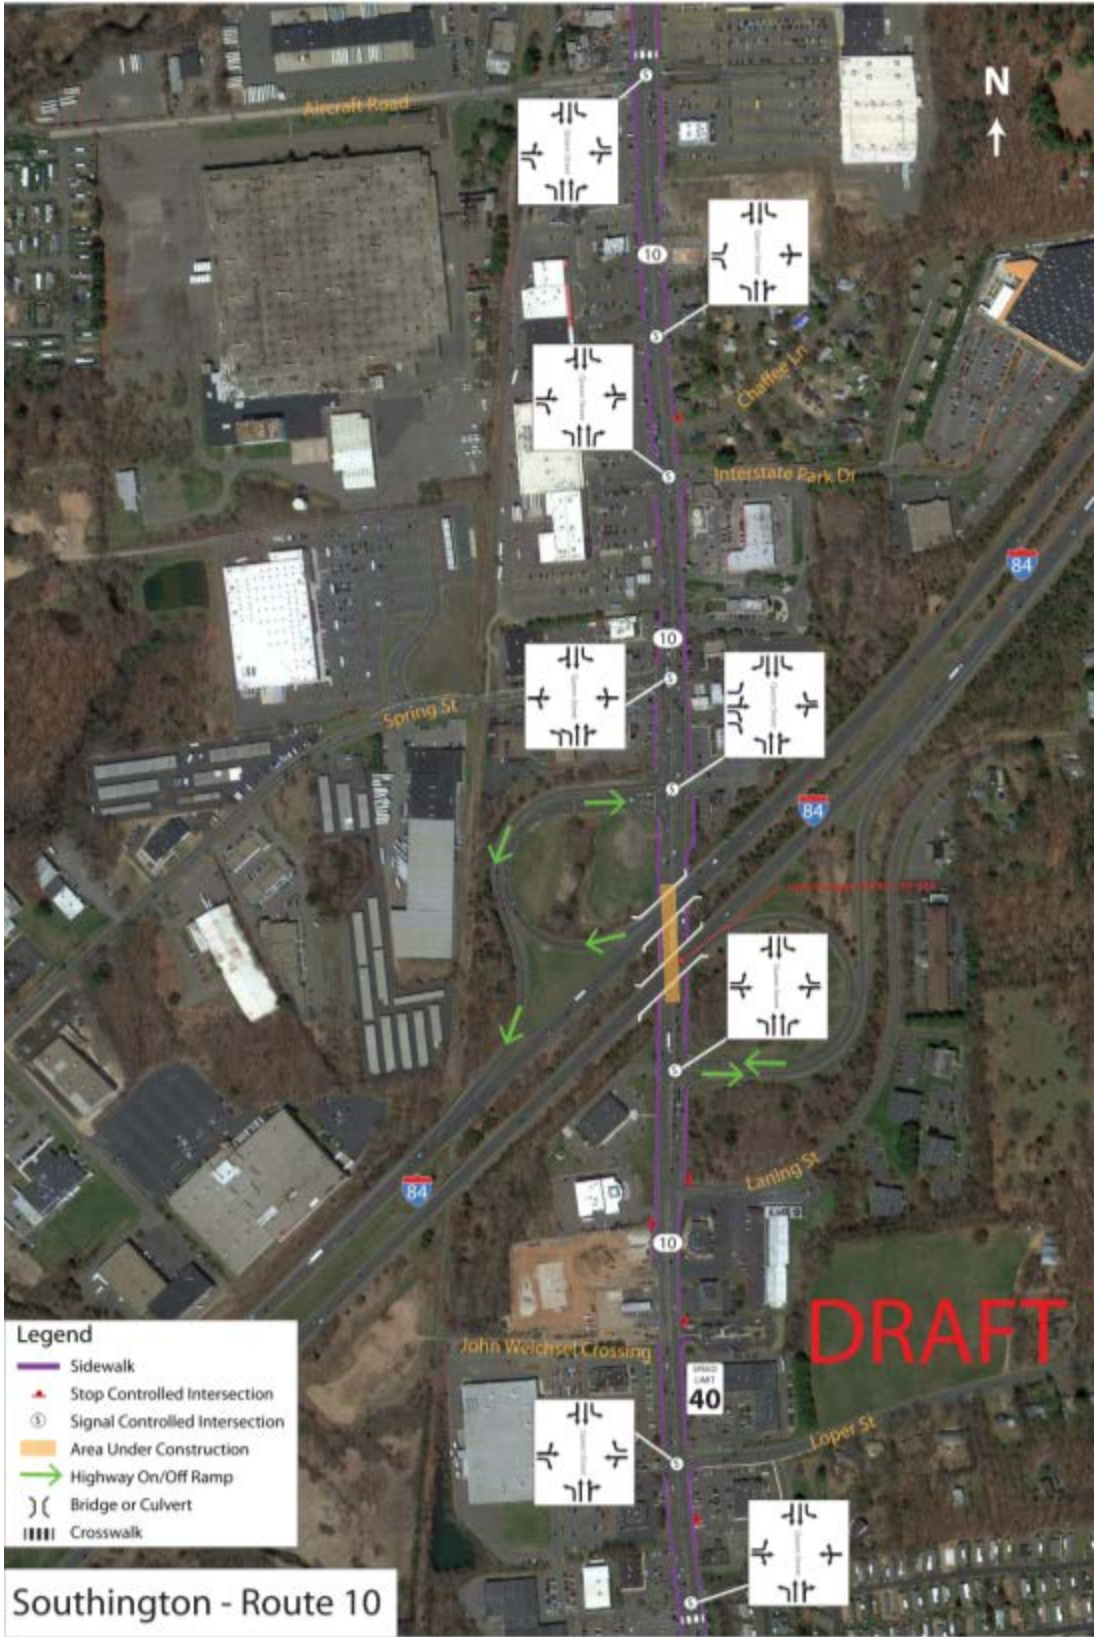
Figure 4. Queen Street (Route 10) Road Geometrics

Queen Street has two travel lanes in each direction that are 11 feet wide. Shoulders (two feet wide on average) are provided. A seven-foot wide median is located on Queen Street between I-84 eastbound and westbound off ramps. Sidewalks (five feet wide) are provided on both sides. There is one pedestrian crossing across Queen Street north of Aircraft Road within the RSA corridor. The posted speed limit on Queen Street is 40 mph. There are several shopping malls and commercial areas with driveways along Queen Street. Most of the driveways along Queen Street do not have crosswalks through the driveway.

Roadway geometrics and traffic volumes for the study roadway are shown in Figure 4 and described in Table 3.

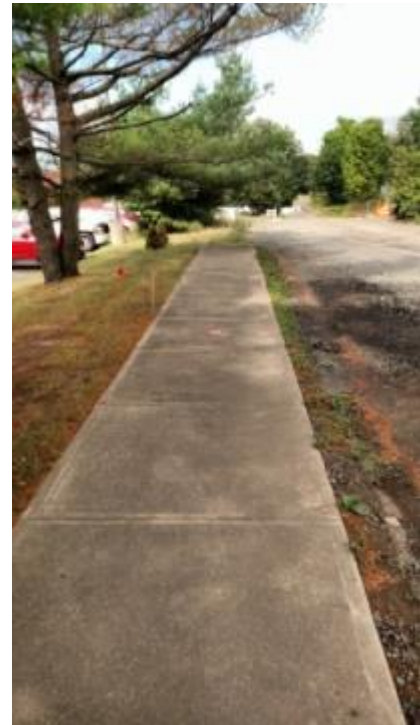
Figure 5. John Weichsel Crossing Looking West Showing Sidewalk and Road Construction

- This is a town owned road.
- There is no traffic signal at the intersection with Queen Street, it will remain unsignalized. Traffic can use the signal at the Price Chopper plaza.
- There is an existing sidewalk on the south side of John Weichsel Crossing from Queen Street for approximately 200 feet west (See Figure 5).
- The rail line crosses at the end of the road. The tracks have been removed and the trail cleared in anticipation for the extension of the rail trail. The trail would become part of the Farmington Canal Heritage Trail (see Figure 6).
- The Town is currently performing full depth reconstruction and new sidewalk up to the Price Chopper driveway. The Town is trying to get an encroachment permit to connect to the drainage.
  - According to the final design plans the road will be 24-26 feet wide. Sharrows could be considered.

- The new sidewalk would end at the Price Chopper driveway and not extend to the new trail.
- Since the road is being reconstructed, now would be the opportune time to create access for the future rail trail. An-eight foot wide sidewalk trail would be ideal.
- Just west of the rail trail crossing the land is zoned business. The developer is going to install dry utility lines, since the road is under construction, in anticipation of it being developed.
- There is a snow shelf against the existing sidewalk, the snow shelf could be reduced and the sidewalk widened since there is a need to create a connection to the future rail trail.
- It may be possible to work with the Price Chopper plaza owner to install a sidewalk.

3. Town to paint sharrows on John Weichsel Crossing.
4. CTDOT to replace the missing/broken curbing on Queen Street under the I-84 bridge.
5. CTDOT to reinstall the I-84 sign which was removed during bridge repairs.

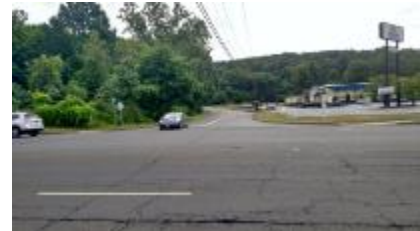
Figure 7. Laning Drive Approach to Queen Street

- There is no traffic signal at the intersection with Queen Street; it will remain unsignalized (Figure 7).
- There are sidewalks on both sides of Queen Street with handicap ramps across Laning Street and driveway on the west side. There are no crosswalks.
- Laning Street is approximately 400 feet south of the signalized intersection for the I-84 eastbound ramps. The queue from the signal for the I-84 ramp can back to Laning Street.
- Vehicles have a very difficult time taking a left out of Laning Street.

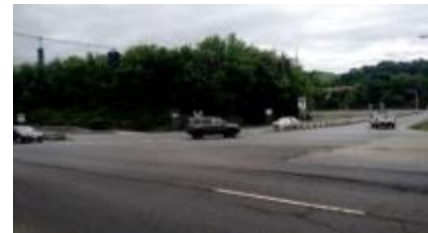
Figure 8. I-84 Eastbound Ramp Approach to Queen Street

- There are sidewalks on both sides of Queen Street.
- There are no detectable warning strips or crosswalks (Figure 8).

- There are no pedestrian signal heads. A sign prohibits pedestrians from crossing Route 10 on the south leg.
- Vehicles pull past the stop bar.
- Left turn vehicle queues are long.
- The I-84 leg of the intersection has a long crossing with a median island.
- Curb is missing on the southbound Queen Street approach and under I-84 (Figure 9).
- The grass buffer strips on Queen Street at I-84 need mowing (Figure 10).
- Large vehicles turning left from the I-84 off-ramp to Queen Street are close to the median island, making it uncomfortable for pedestrians waiting to cross.
- The median island at the I-84 leg of the intersection extends out into the pedestrian path.

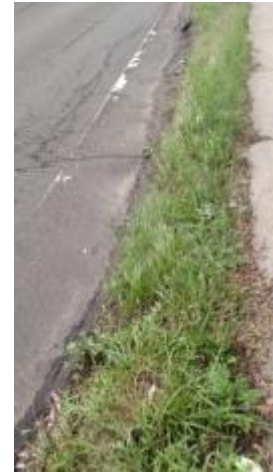
Figure 9. Missing Curb on Queen Street West Side Near I-84

- There are several commercial driveways along Queen Street.
- The shoulder varies, but averages approximately two feet in width.
- Under the I-84 overpass the snow shelf narrows to two feet and the curbing is missing/broken. Tire tracks were evident in the snow shelf.

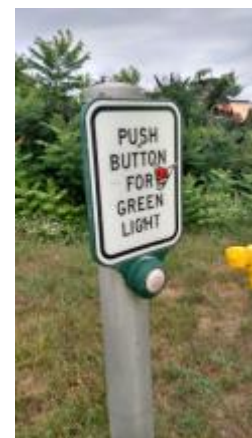
Figure 11. Pedestal With Pedestrian Push Button at Queen Street/I-84 Westbound Ramps (north)

- There are sidewalks on both sides of Queen Street.
- There are no crosswalks.
- There are no pedestrian signal heads. The intersection has “push for green” buttons on the northeast and northwest corners for concurrent crossing (Figure 11).
- There are handicap ramps on the northwest and southwest corners with detectable warning strips only on the southwest corner.
- The ramp on the northeast corner is not ADA compliant.
- The sidewalk on the east side crosses the driveway at grade.
- The median island at the I-84 leg of the intersection extends out into the pedestrian path.
- BJ’s Wholesale Club is coordinating with CTDOT on wayfinding signage on off-ramp.

11. Town requests that CTDOT replace the “push for green” pedestrian buttons with current standard pedestrian equipment (Figure 23 and Figure 24) and crosswalks as necessary at the following locations along Queen Street:

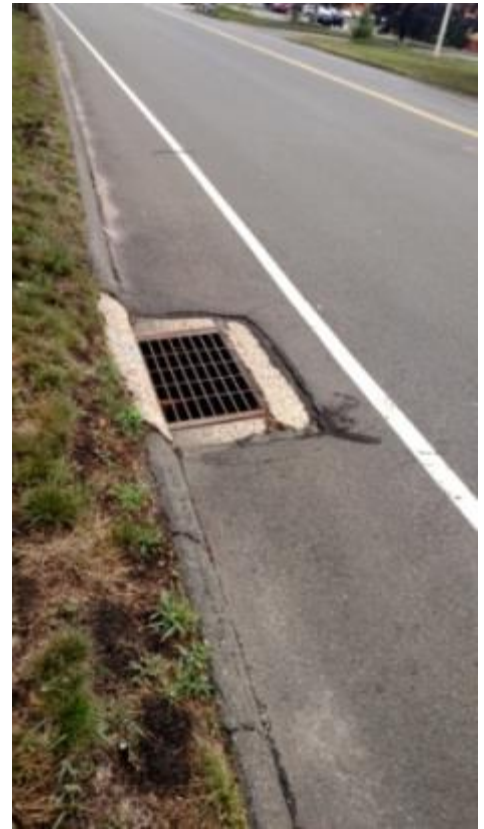
**Figure 15. Non-Bicycle Friendly Catch Basin Grate.**

- There is a small snow shelf.
  - The sidewalk extends through the driveways.
- There are non-bicycle friendly catch basin grates (Figure 15).
- The road tapers down from two lanes westbound to one lane just before the rail crossing (Figure 16). The two lanes are needed because of the two left turn departure lanes from Queen Street northbound.

1. Coordinate with CTDOT to replace old catch basin grates with bike friendly catch basin grates.
2. Coordinate with CTDOT to replace worn out signs with new retroreflective signs.

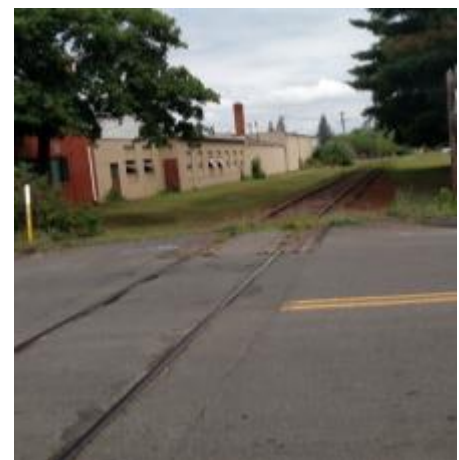
Figure 18. Rail Road Tracks Across Aircraft Road

- The sidewalk in front of 24-38 Aircraft Road is in poor condition (Figure 17).
  - There is no snow shelf.
- The rail tracks are still in place, and this is an active crossing (Figure 18). Metal Works (to the north) receives deliveries via rail and often the trains must back up as far as the road to unload.

- The proposed trail may deviate from the tracks here if the tracks are to remain active. CTDOT and Southington are still in the planning phase and coordinating with the railroad company.

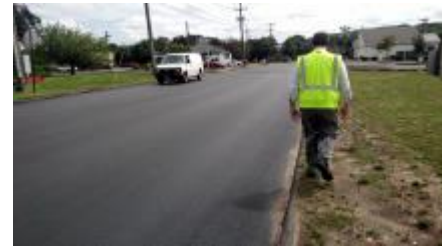
Figure 19. Newell Street

- This is an optional route for the rail trail.
- There were several faded no parking signs.
- There is no sidewalk on either side.
- The roadway width is 29 feet wide (15 feet northbound and 14 feet southbound) (Figure 19).
- The posted speed limit is 25 mph.
- The stop bars are faded at all Newell Street intersection approaches at Aircraft Road and West Queen Street.

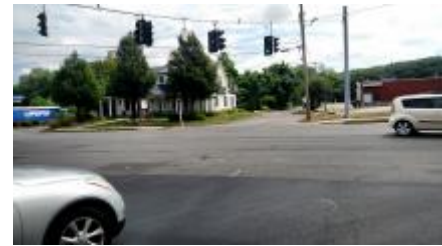
Figure 20. Intersection of Queen Street and West Queen Street

- This is an optional route for the rail trail via Newell Street.
- This street was just recently repaved and will be restriped.
- The roadway width is 40 feet.
- There are sidewalks on both sides from Queen Street to just before the tracks. Both sides have snow shelves.
- At the Queen Street intersection there are no crosswalks (Figure 20).
- There is an old (non-standard) pedestrian signal head on the northeast corner. The intersection has "push for green" buttons in the northeast and northwest corners for concurrent crossing.
- There are handicap ramps on each corner, but only the northeast corner has detectable warning strips.

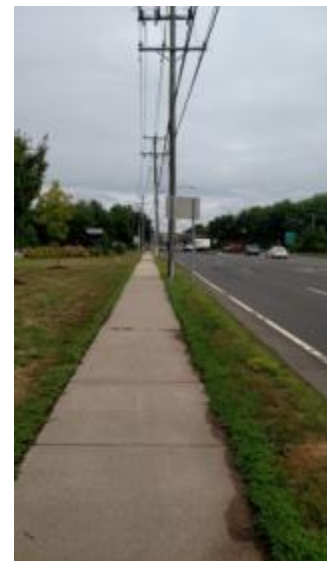
Figure 21. Typical Sidewalk on Queen Street

- There are sidewalks along both sides of Queen Street (Figure 21).
  - All sidewalks are concrete.
  - Sidewalks range from four to five feet wide.
  - There is a grass snow shelf on both sides; it averages four feet in width. In many

locations the grass on the snow shelf is overgrown.

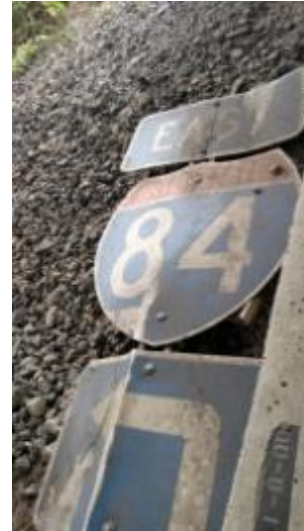
Figure 22. I-84 Sign on Ground Under Bridge

- It is dark under the I-84 overpass due to missing/broken lighting.
- The sign for I-84 on southbound Queen Street was taken down during recent bridge painting and was not put back up (Figure 22).

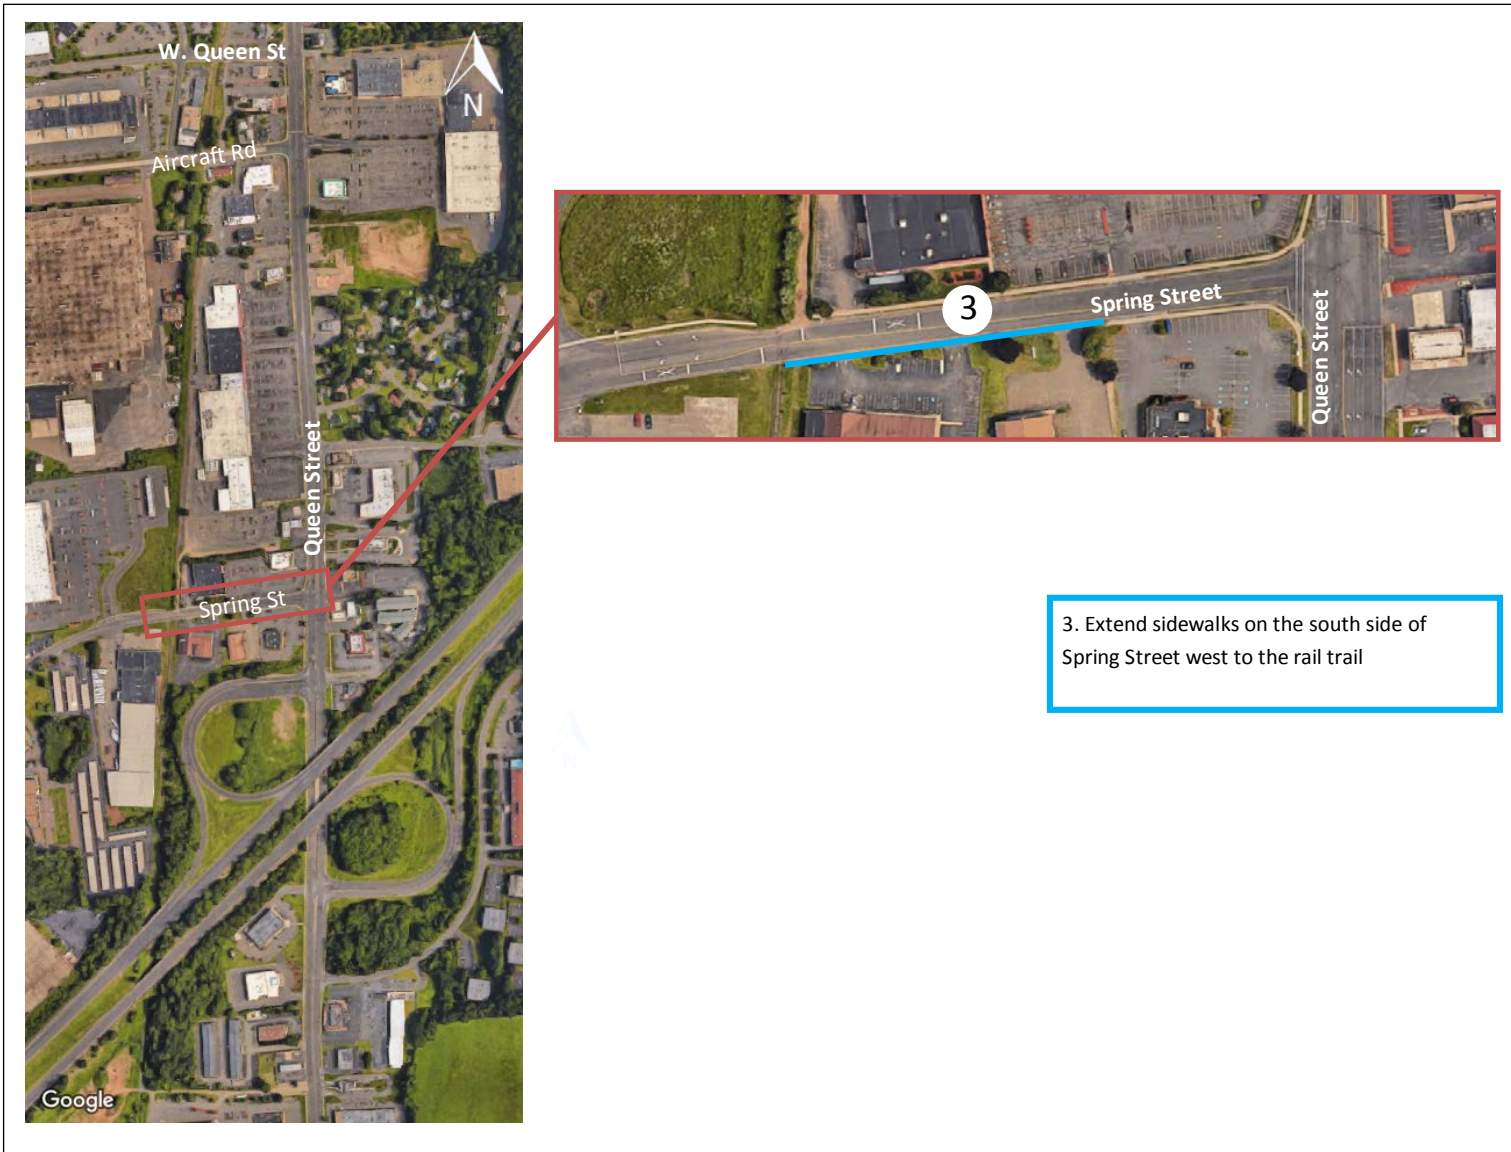
Figure 27. Long Term Recommendations

Figure 27 depicts these recommendations.
