COMMUNITY
connectivity program

Main Street (Route 254, Route 6), Branch Road (Route 109) and Northfield Road (Route 254) – Road Safety Audit

October 12, 2016

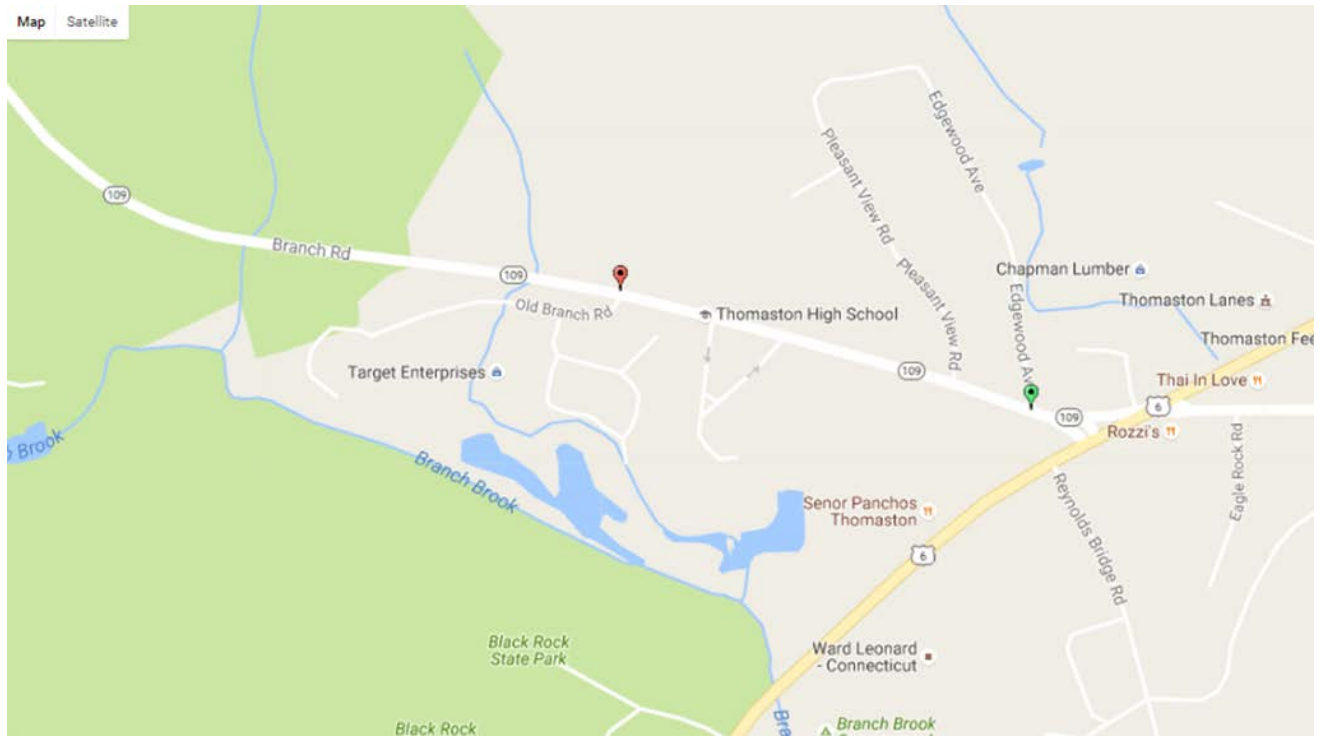
Figure 4. Crashes that Occurred on Route 109 in 2015 (Connecticut Crash Data Repository)

The crash history for Route 109 in front of Black Rock Elementary School and at the intersection of Route 254 and Walnut Hill Road were both considered separately since both locations were outside of the Main Street corridor. The crash history in both locations was moderate and neither had any accidents involving pedestrians or bicyclists between 2012 and 2014 (Table 3, Table 4, Table 5, and Table 6). The most common crash type for Route 109 in front of Black Rock Elementary School were 10 rear-end type crashes (63%) and the most common crash type at the intersection of Route 254 and Walnut Hill Road were 3 angle

crashes (38%). Figure 4 and Figure 5 show the crashes that occurred in these two areas in 2015.

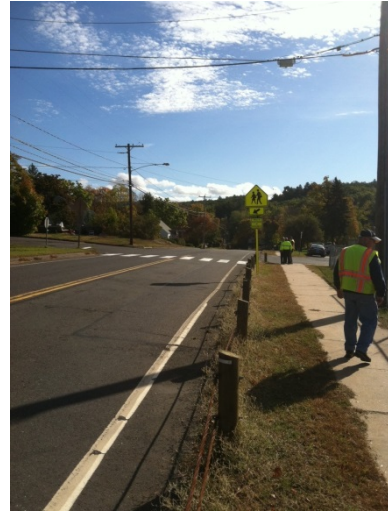
Figure 7. One crosswalk visible, one behind crest

- A vertical crest restricts drivers' view of the crosswalk markings (Figure 7).
- There are currently advance pedestrian signs (Figure 8).
- School zone signs are not placed according to standards.
- The advance flashing sign may be too far in advance (to the west for eastbound motorists) of the crosswalks to be effective.
- There is a 5-foot concrete sidewalk on the south side of Route 109.
- Thomaston High School is adjacent to the Elementary School and houses grades 7-12.
- There are many signs at the southeast end of the study area which can be confusing to drivers.
- Roadway widths were measured as single 13-foot lanes with 3 to 4-foot shoulders in each direction.
- There are no handicap ramps or landings on the north side of the crosswalk at Pleasant View Road and Edgewood Road crosswalk (Figure 9).

- Shifting the eastern crosswalk up the hill (west) could improve visibility for drivers.
- A pedestrian was observed in the crosswalk and complained to the audit team that drivers usually do not yield to pedestrians.

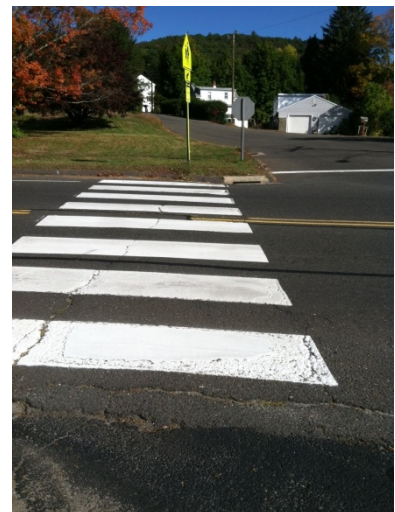
Figure 9. Crosswalk without ramp or landing

- The pedestrian crosswalk sign at Edgewood Avenue facing eastbound traffic is located too far from the crosswalk to be visible to motorists.
- There are no detectable warning strips at the handicap ramps at both crosswalks.

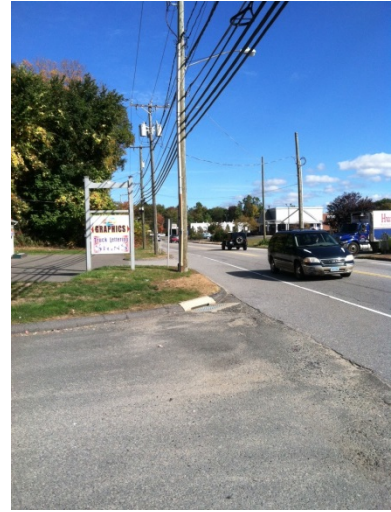
Figure 10. Steven’s Boulevard looking north on Main St.

There is a new multi-family residential development on Steven's Boulevard. It was noted that residents are having difficulty making turns out of Steven's Boulevard onto Main Street due to sight constraints looking north and high traffic volumes.

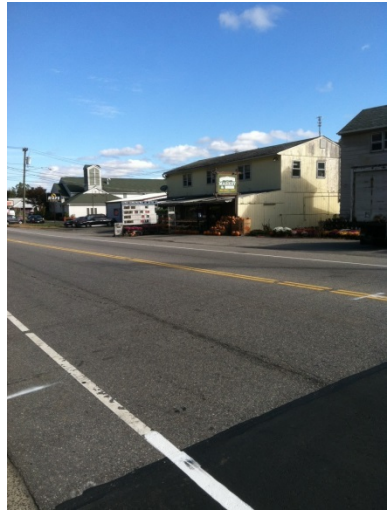
Figure 11. Wide driveways

- Access management is poor in this area, with several wide driveways that create a challenge for pedestrian crossings (Figure 11).
- There are no crosswalks or pedestrian signal heads at the intersection US Route 6/Route 254/Route 109. There is a pedestrian pushbutton on the southeast corner that provides pedestrians with a concurrent crossing with the vehicle phase.

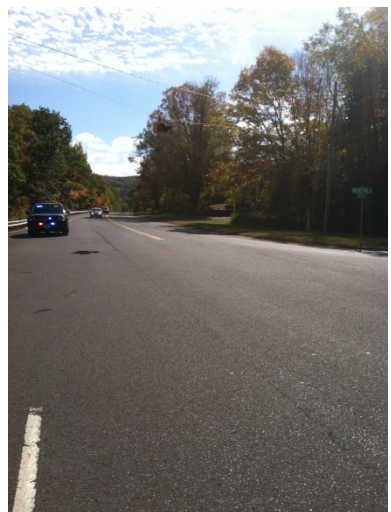
Figure 12. Looking east on Route 254 from intersection

- There is limited sight distance for vehicles making the straight movement across Route 254 from Walnut Hill Road. Several crashes have occurred at this location. (Figure 12).

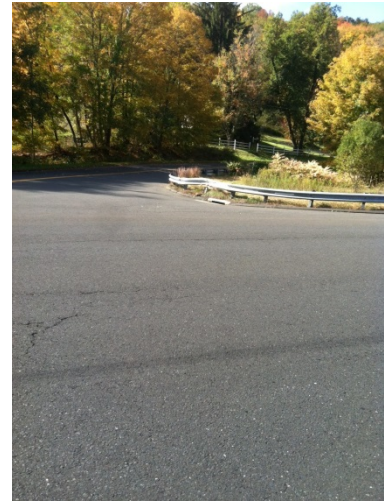
Figure 13. Damaged guardrail

- There is an overhead flashing beacon (yellow for Northfield Road and red for Walnut Hill Road).
- Walnut Hill Road is an access point to a large residential area.
- The intersection is very wide, with additional right of way that may be able to accommodate a roundabout or other intersection improvements.
- There is a large culvert beneath the intersection.
- Guiderails at this location were damaged, indicating that high speed crashes had occurred (Figure 13).

- c. Replace the existing post/cable guard rail on the south side of Route 109 west of Pleasant View Road.
 - d. Construct handicap sidewalk ramps with detectable warning strips and crosswalks on Main Street at the Route 8 northbound exit 39 on- and off ramps and Prospect Street/Pleasant Street.

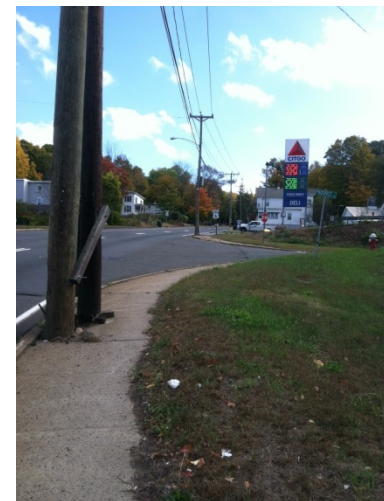
Figure 14. Main St. looking east from off ramp

- The intersection is unsignalized.
- There is limited sight distance for vehicles on the off-ramp attempting to make a left turn onto Main Street.
- Westbound traffic on Main Street is on a long and steep downgrade at this intersection, leading to high vehicle speeds (Figure 14).
- There are 5 foot wide sidewalks on both sides of Main Street, but no snow shelf, crosswalks or handicap ramps (Figure 14).
- The second eastbound lane on Main Street may not be needed until east of the off-ramp (Figure 15).
- The intersection of Main Street with Prospect Street/Pleasant Street is very close to the intersection with the Route 8 northbound on- and off-ramps (Figure 14). There are no crosswalks or handicap ramps at this intersection.
- The steep hill is difficult to travel on during snow storms.

- There are utility poles in the sidewalk, restricting the space available to pedestrians (Figure 14).

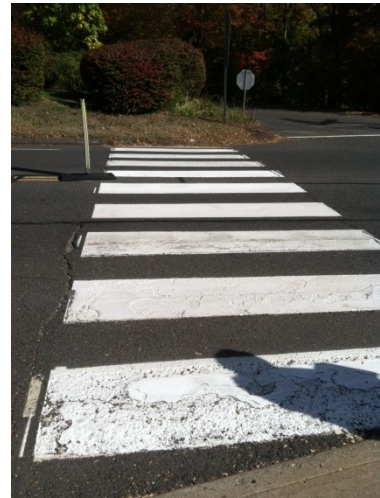
Figure 16. Crosswalk without ramp or warning strip

- A windshield survey of this area noted that some of the handicap ramps are not ADA compliant, and there are no detectable warning strips. Some of the crosswalks are not aligned correctly.

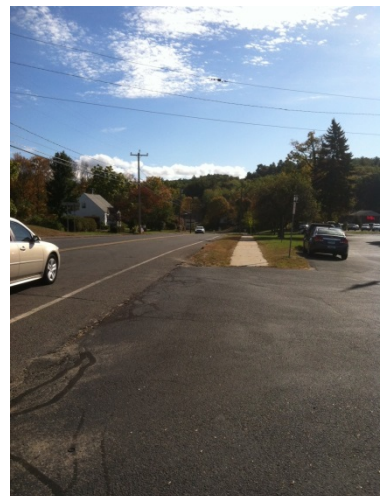
Figure 17. School driveway without a crosswalk

- Vehicle speeds are high in this area and crosswalk visibility is limited due to the vertical crest.
- Flashing beacons or other advanced pedestrian measures should be considered.
- School Zone signage and pavement markings need to conform to industry standards.
- The Town would like to have a 20-mph speed limit through the school zone.
- Sidewalk ramps and detectable warning strips are needed at all crossings (Figure 16).
- There should be crosswalks across both school driveways (Figure 17).
- A stop bar should be added at the eastern school driveway exit.
- A better location for the eastern crosswalk at Edgewood Avenue may be on the west side of the school driveway so that it is shifted up the hill to become more visible.
- The intersection of Route 109 and Watertown Road adjacent to the school promotes high speeds with its wide channelized westbound right

turn lane. A long-term solution would be to realign this movement to 90-degrees.

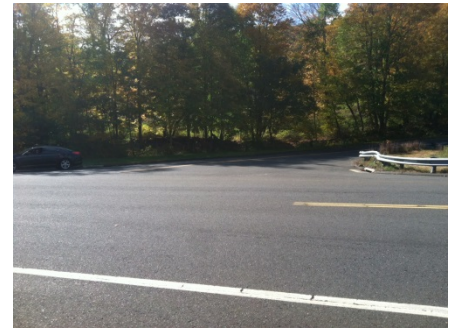
Figure 18. Wide intersection

- The intersection is very wide (Figure 18).
- Vehicle speeds on Route 254 are high through the intersection.
- The flashing beacon at the intersection could be made more visible to drivers.
- Long-term improvement options including a roundabout and other intersection improvements should be considered.
- The large culvert causes some construction limitations, but there should still be space available for several different options.

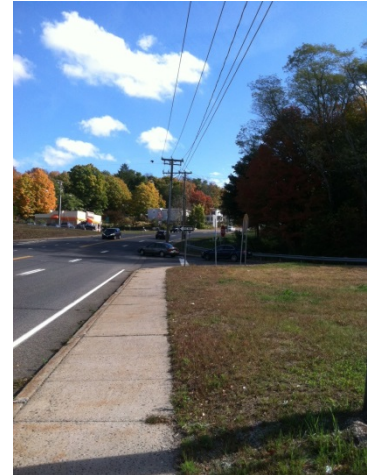
Figure 19. Main St. and Route 8 NB off ramp, looking east

- There are several challenges at this intersection including sight lines, high speeds, a steep grade and close intersection spacing (Figure 19).
- Eliminating one of the eastbound travel lanes on Main Street west of the northbound ramps may improve operations.

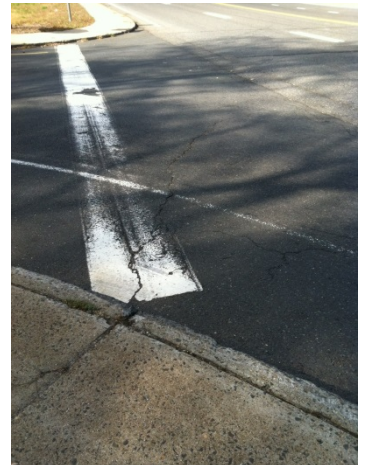
Figure 20. Sidewalks without crosswalk or ramps

- There are sidewalks but no crosswalks or sidewalk ramps at the Route 8 ramps (Figure 20) or at the Prospect Street/Pleasant Street intersection.
- In the morning peak period many vehicles turn in and out of the Dunkin Donuts that has access on Pleasant Street just west of Main Street. This exacerbates turning vehicle conflicts in this area.
