# Thompson

Route 12 & Main Street – Road Safety Audit

May 16, 2016

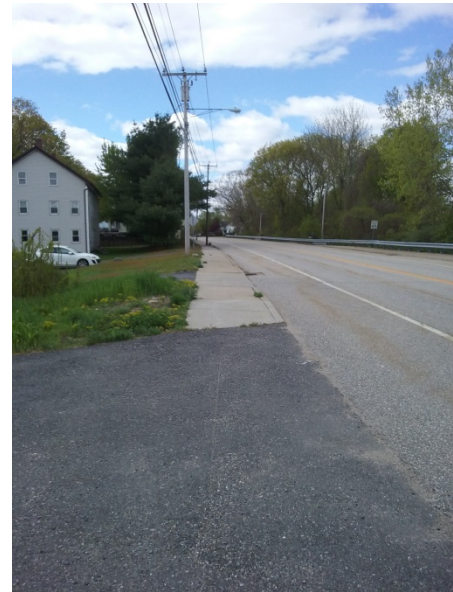
Figure 6. Sidewalk on Route 12

- Construction on the Airline Trail base is complete and stone dust will be laid shortly.
- The sidewalk is on the northbound side of Route 12, and is 5 feet wide (Figure 6).

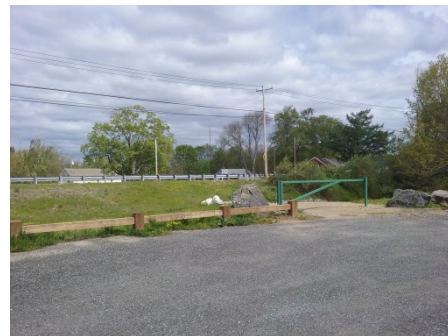
Figure 7. Lack of Lighting in Rail Trail Parking Area

- There is minimal lighting in the parking area for the trail (Figure 7).

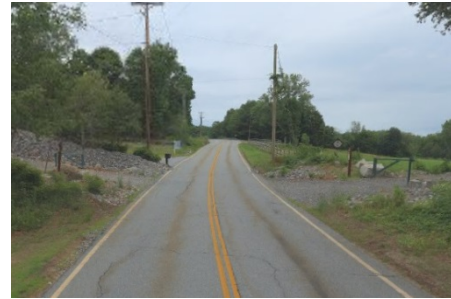
Figure 8. Airline Trail Crossing Route 193

- A new industrial park with proposed rail sidings is being planned. There are concerns that the existing bridge may have geometric or weight constraints that would limit truck traffic.
- CTDOT is currently conducting a study on an additional exit off I-395 to Route 193 in order to eliminate the left hand exit that currently exists.
- The Airline Trail crosses Route 193 at grade. Better geometry, signing and markings are needed (Figure 8).

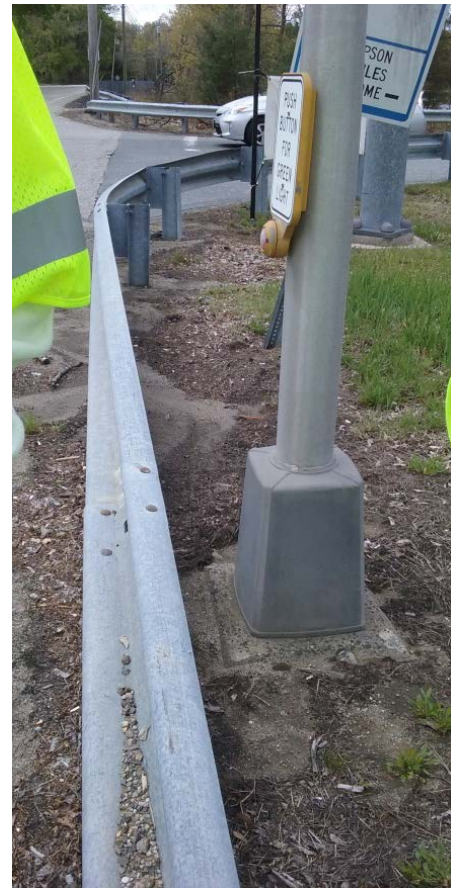
Figure 9. Crossing Push Button Behind Guide Rail

- At the Route 12/Route 193 signal there is no separate pedestrian phase, crosswalks or pedestrian signal heads. A pedestrian push button is provided for a green indication to allow for crossings on the north side of the intersection, but the push button is located behind the guide rail (Figure 9). There are no handicap ramps.
- Lanes are 12 feet wide on Route 12.
- The shoulders are 4.5 feet wide on the northbound side and 5 feet wide on the southbound side.
- The Airline Trail currently crosses the I-395 ramps (using a bridge). A sidewalk should be extended to connect to the trail.

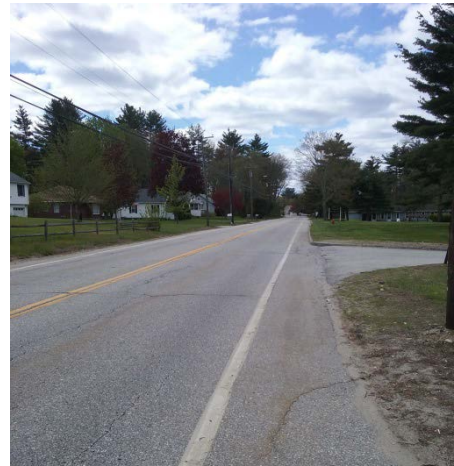
**Figure 10. Lack of Sidewalks Along the Route 12 Corridor**

- In this area the state right of way along Route 12 appears to be wide.
- There are no sidewalks in this area. Sidewalks are needed to connect the housing area to medical facilities by Westfield Drive and to the existing sidewalk at Thompson Hill Road (Route 200) (Figure 10).

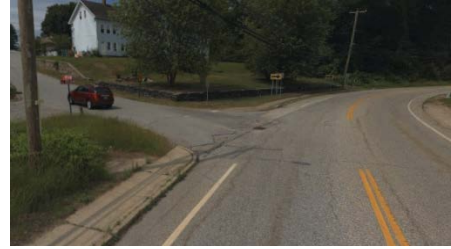
Figure 13. Intersection of Thatcher Road and Route 12

- A crosswalk is needed to connect Thatcher Road to Dollar General (Figure 13).
- The sidewalk in front of Dollar General is 6 feet wide and ADA compliant.
- There is no crosswalk across Route 12 at Thatcher Road or across Thatcher Road.
- A new Dunkin Donuts is being constructed on the east side of Route 12. The sidewalk and curb are in poor condition, the developer has made improvements to some portions of the sidewalk as part of the Dunkin Donuts project.
- The speed limit on Route 12 is 35 mph.

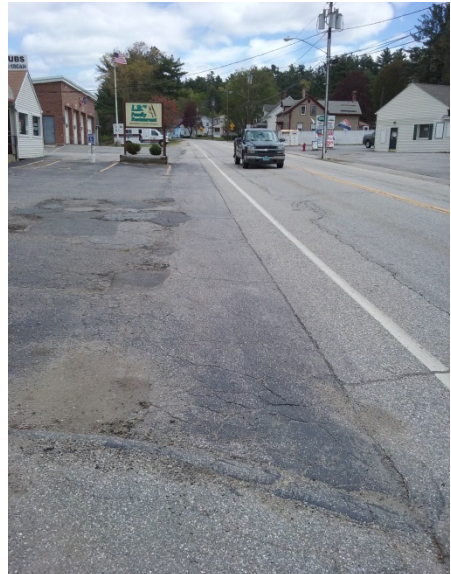
Figure 14. Large Curb Cuts at Cumberland Farms

- The curb cuts are poorly defined (Figure 14). At the gas station, the large curb cuts and asphalt islands are difficult to perceive (Figure 15).
- Route 12 travel lanes are 12 feet. The southbound shoulder is one (1) foot wide, and northbound shoulder is 3 feet wide.
- Pedestrians go behind Cumberland Farms and walk along the railroad tracks to find an opening in the fence. The fence is only on the west side of the tracks.
- Railroad employees sometimes leave the train to stop at Cumberland Farms.
- There is very limited space in the Cumberland Farms parking lot for deliveries.
- Vehicles can go in and out of either driveway at Cumberland Farms.
- The crosswalk across Route 12 is not ADA compliant and there are no handicap ramps. The pedestrian crossing sign is in poor condition.

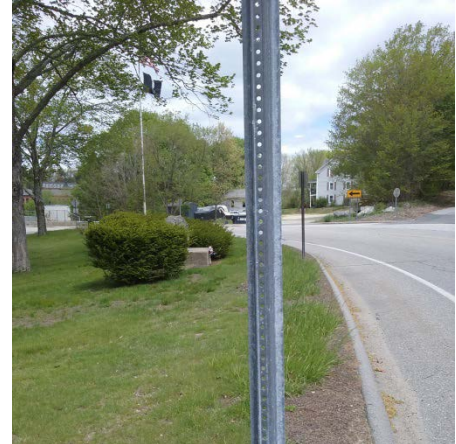
Figure 16. Poor Visibility to Crosswalk at Swanson Park

- The crosswalk does not have handicap ramps or detectable warning strips. The signing is in poor condition.
- The sight line for motorists approaching the crosswalk is limited in both directions by horizontal curves and vegetation (Figure 16).
- The crosswalk does not line up with the sidewalk through the park (Figure 17).
- The sidewalk through the park is narrow.
- There is parking in front of the businesses on the east side of Route 12.

15. Replace old and faded pedestrian signs with new fluorescent signs per MUTCD.
16. Trim vegetation at Swanson Park to improve sightlines or replace with lower vegetation.

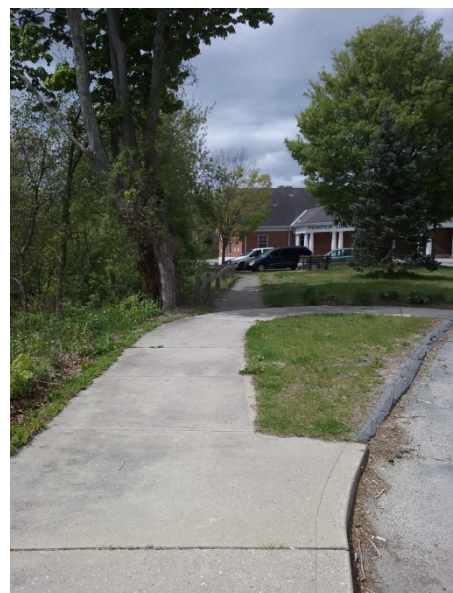
Figure 18. Pedestrian Path by Library

- The pedestrian crosswalk sign on Route 12 is set far back from the actual crossing.
- The crosswalk is ADA compliant.
- The sidewalk on Walker Street zig zags in front of the library. A worn pedestrian path shows people are taking the shortest distance to the library (Figure 18).
- The crosswalk width on Main Street is narrow.
- There is no crosswalk across Walker Street at Main Street to connect the existing sidewalks.
- There is no sidewalk on the west side of Route 12 north of Walker Street. The potential for a sidewalk here is constrained by the topography.

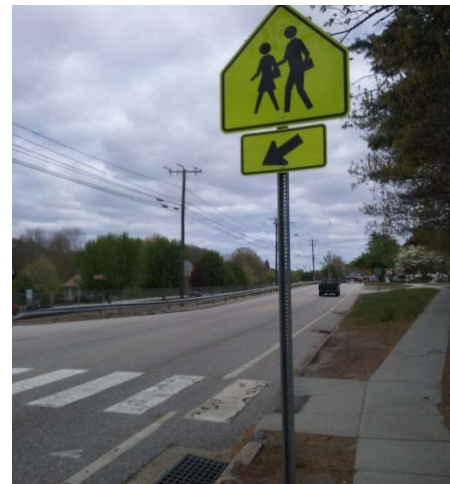
**Figure 20. Non-ADA Compliant Ramp on Route 12 at Main Street**

- The crosswalk is not ADA compliant (Figure 20)
- There is a mix of catch basin grate types.

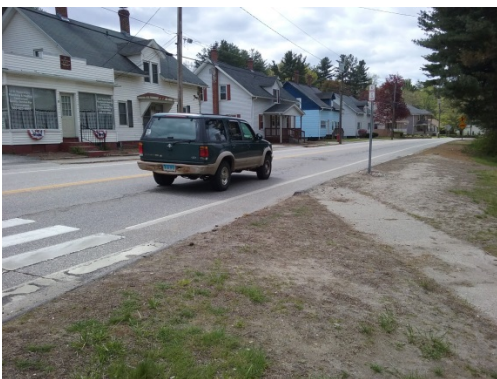
Figure 25. Move on Route 12 at Swanson park Crosswalk to Align with Sidewalk

14. Relocate the crosswalk on Route 12 by Swanson Park south to below the driveway and extend the sidewalk on the west side to meet the new crosswalk location (Figure 25).
