# Torrington

East Main Street Corridor – Road Safety Audit

April 2016

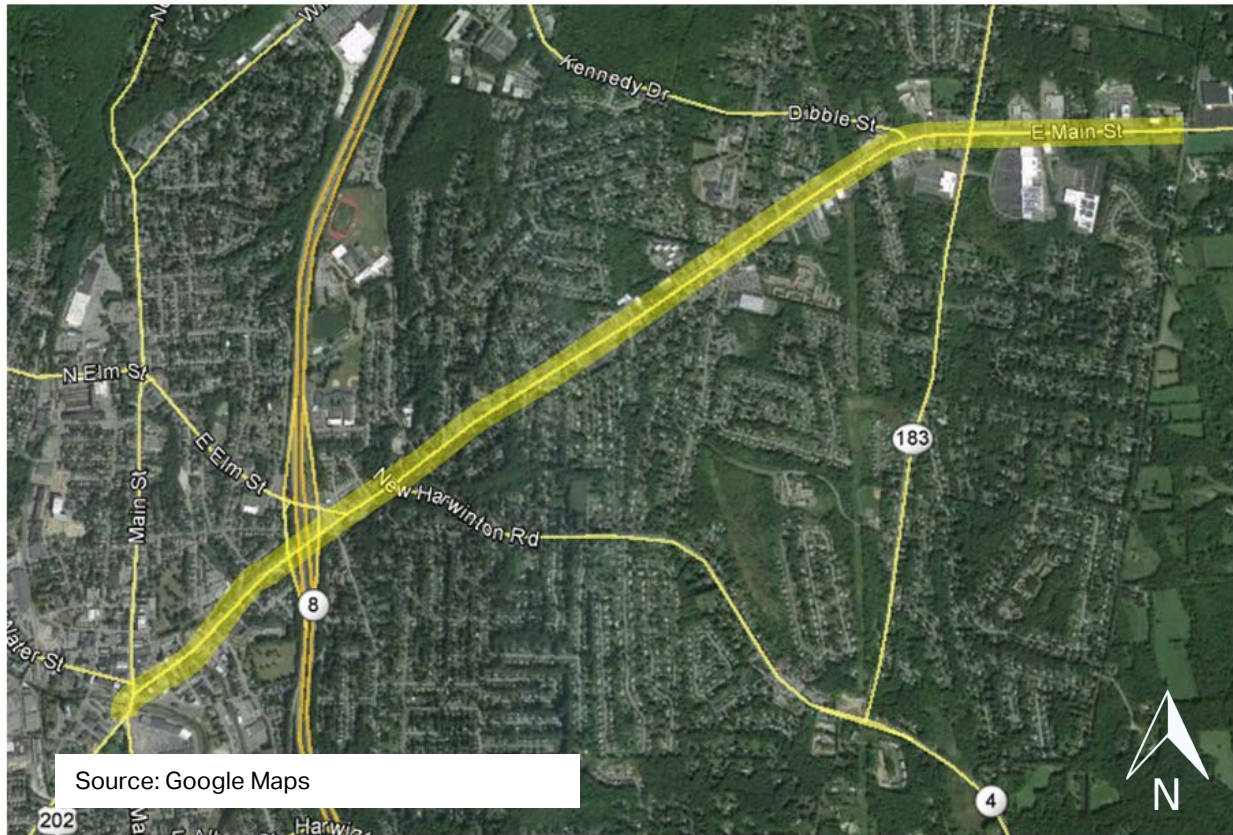
**Figure 1. East Main Street Corridor**

The RSA site consists of the 3.5 mile long East Main Street (Route 202) corridor between the 5-way downtown intersection with Main Street and the New Hartford town line (Figure 1). It includes the downtown intersection of East Main Street, Main Street, South Main Street, Water Street and Franklin Street, as well as the Litchfield Street/South Main Street intersection. The corridor carries a significant amount of local traffic because of substantial commercial development and the fact that it is the primary access to the downtown area. It also carries significant through traffic movements, as Route 202 is the primary east/west corridor in this area of the state, bisected by State Routes 4, 8 (Exit 44) and 183.

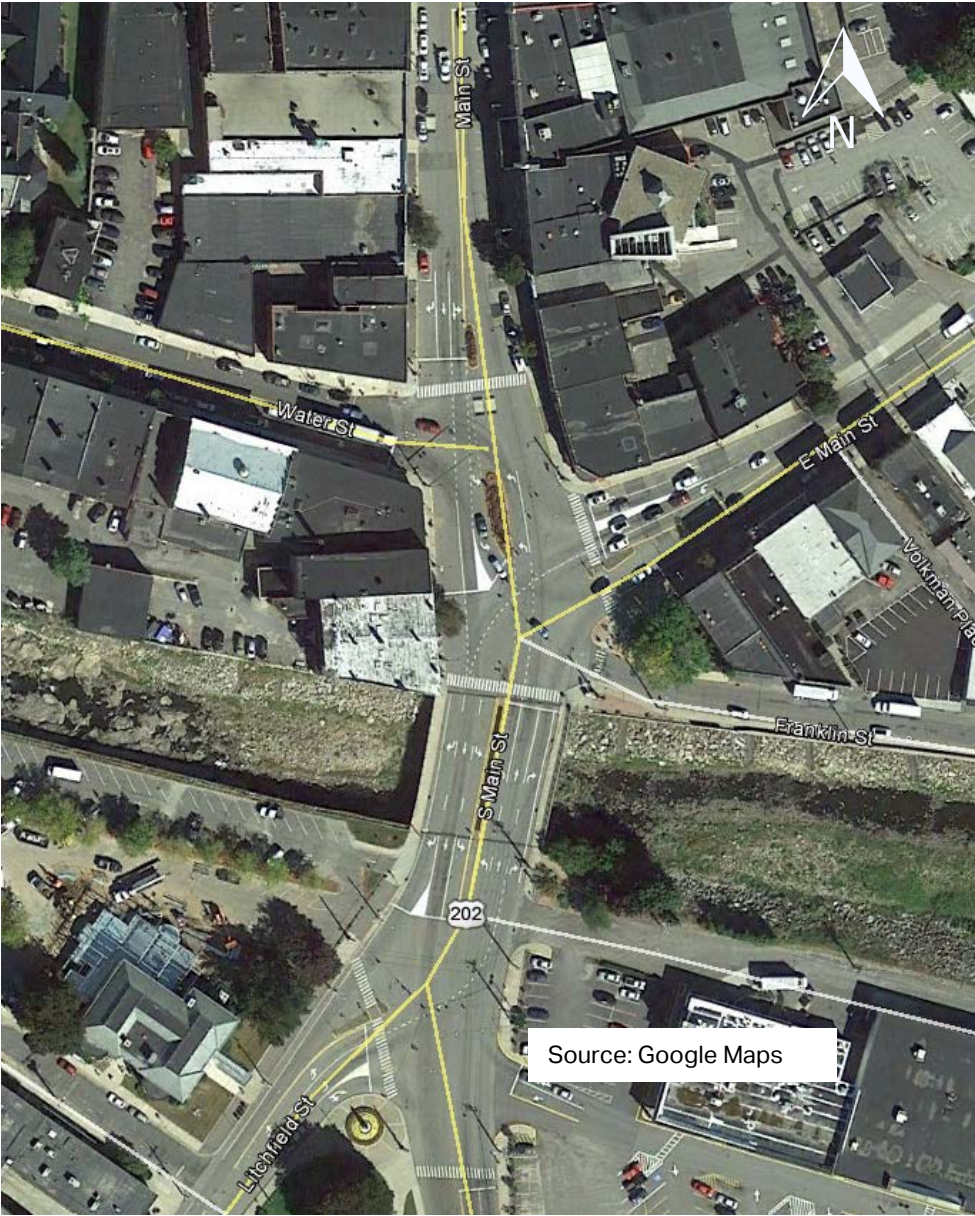
Figure 2. 5-way Intersection

The 5-way downtown intersection is the convergence of Water Street, Main Street, East Main Street, South Main Street and Franklin Street (Figure 2). South Main Street is on a bridge structure over the Naugatuck River, and intersects with Litchfield Street on the south side of the bridge. Route 202 is a "dog-leg" that uses East Main Street to the east, and Litchfield Street to the west, connected by the South Main Street Bridge. The intersection is confusing and challenging for drivers to traverse, with each leg containing multiple lanes. Similarly,

Because of the complexity of this intersection, it is not pedestrian or bike friendly, and it creates a significant pedestrian disconnect between the downtown core and areas south of the Naugatuck River. In April 2016, the City, in conjunction with CTDOT, began the second phase 2 of a Streetscape project along Main Street from Water Street to Maiden Lane. The re-design includes new sidewalk infrastructure, pedestrian friendly amenities, landscaping and lighting.

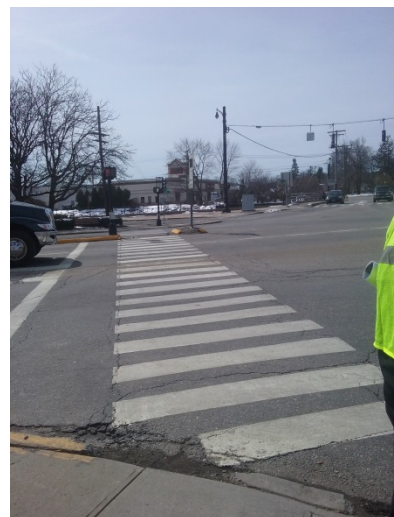
Figure 5. Split Pedestrian Phase

- Across East Main there is a split pedestrian phase. The pedestrian island appears to originally have stamped concrete and then was paved over (Figure 5). The paving is falling apart here causing a tripping hazard.

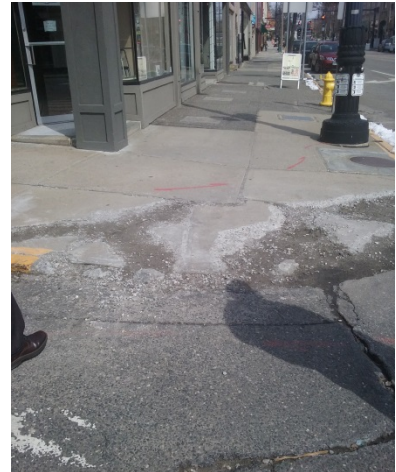
Figure 6. Broken Sidewalk Ramp

- Some of the sidewalk ramps are broken and have missing chunks of concrete (Figure 6).
- The push button between Franklin and East Main Street is located farther than maximum allowed from the actual crossing (Figure 7).

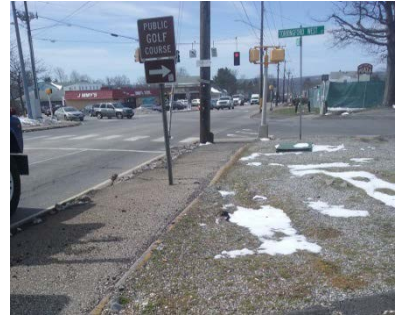
Figure 9. Island that acts as a Sidewalk

- Some paved islands are acting as narrow sidewalks. (Figure 9).
- The intersection angles are skewed, creating a 45 degree angle. To improve the radius of the corners with sharper turns the curb has been pulled back. This creates longer crossing distances for pedestrians.

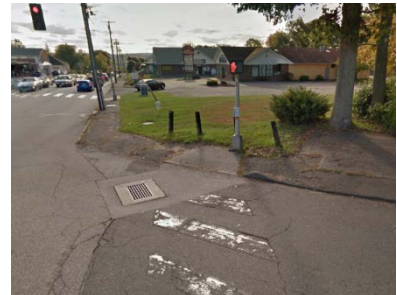
Figure 10. Non-Compliant ADA Ramp, Faded Crosswalk

- Utility poles and signs are in the way of sidewalks.
- The cross slopes of sidewalks in some locations do not meet ADA guidelines (Figure 10).
- There are ramps for pedestrian signals but no sidewalks.

5. Fill in the missing sidewalk gaps along East Main Street.
6. Fix areas with cross slope issues.
7. Eliminate the entrance by the 5-way intersection for the 99 plaza and move up the stop bar to create a more direct crossing to Coe Park.

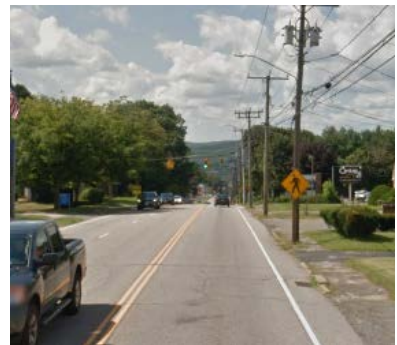
Figure 11. Pedestrian Crossing Sign not Near a Sidewalk

- There are no pedestrian crossing signs (although there is one mid-block before the next intersection. (Figure 11).

9. Make all crossings ADA compliant.
10. Relocate all signs out of the pedestrian way.
11. Complete sidewalk mapping.
12. Add pedestrian crossing signs (Figure 15) and relocate existing improperly located signs.

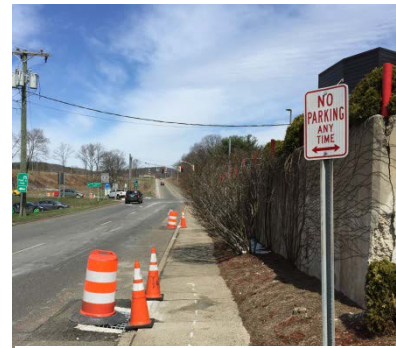
Figure 12. Vegetation Encroaching on the Sidewalk

- Right turn on red from Elm Street to Route 202 is permitted, although this is a difficult turn because of the skew of the intersection and the grades.
- Plantings encroach on the sidewalk (Figure 12).

2. Repaint crossings.
3. Incorporate the Branding and Imaging Plan as well as the corridor plan into any redevelopment.
4. Redesign East Main Street in phases; it is too much to accomplish at once.
5. Require all new developments to add sidewalks.
6. Patch sidewalks where they are uneven or broken.
7. Remove or cut back encroaching vegetation.

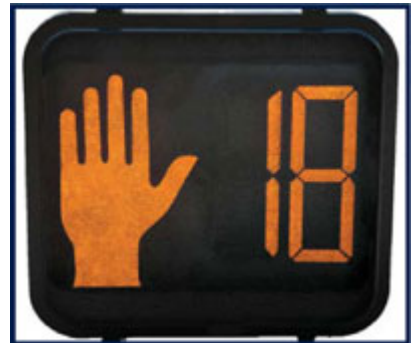
Figure 14. Pedestrian Countdown Signal

6. Replace pedestrian signals with countdown signals (Figure 14).
7. Add audible devices to all pedestrian signals.
8. Add tactile warning strips to all crossings.

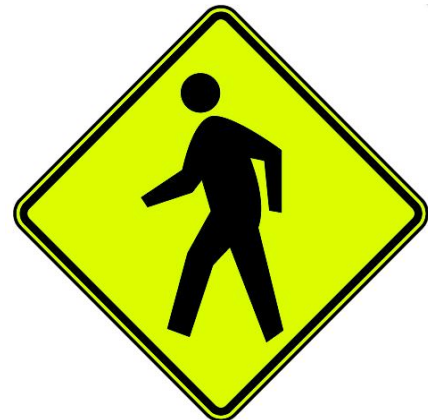
Figure 15. Pedestrian Crossing Sign

- Pedestrian signal heads do not have a countdown.
- Curb cuts are missing tactile warning strips.
- There is a lack of pedestrian crossing signage.
- This is a concurrent pedestrian signal.

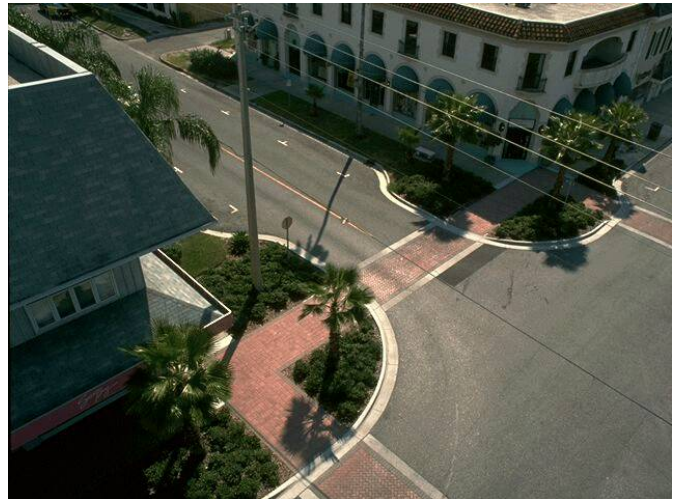
**Figure 18. Typical Pedestrian Crossing Bump outs**

8. Implement Access Management Plan to consolidate driveways.
9. Narrow crossings at 5-way to eliminate split phases and waiting islands.
10. Add bump outs (Figure 18) at crossings to shorten crossing distance.
