COMMUNITY
connectivity program

Woodbury

Main Street (Route 6) – Road Safety Audit

July 20, 2016

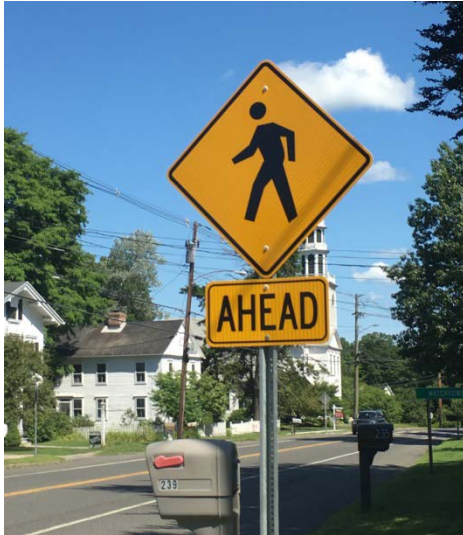
Figure 5. Advanced Pedestrian Warning Sign

A number of best practices have already been applied to this area of Woodbury. The Town has an existing network of sidewalks along Main Street and crosswalks at major intersections. Advanced pedestrian warning signs are located ahead of some of these crosswalks (Figure 5). Some pedestrian pushbuttons have also been upgraded (Figure 6). In some areas, the shoulders on Route 6 are wide enough to accommodate cyclists (Figure 7). Most recently, the Town moved a crosswalk previously located on Route 6 to a local road with less vehicular traffic (Figure 8).

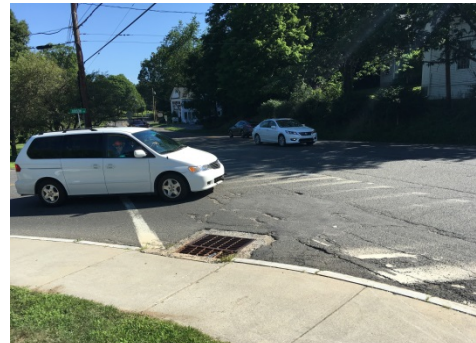
Figure 9. Vehicle Pulled Past Stop Bar and Worn Crosswalk

- Vehicles on Judson Road were observed pulling past the stop bar to see oncoming traffic on Main Street (Figure 9).
- The crosswalk at the Judson Road intersection is faded (Figure 9).

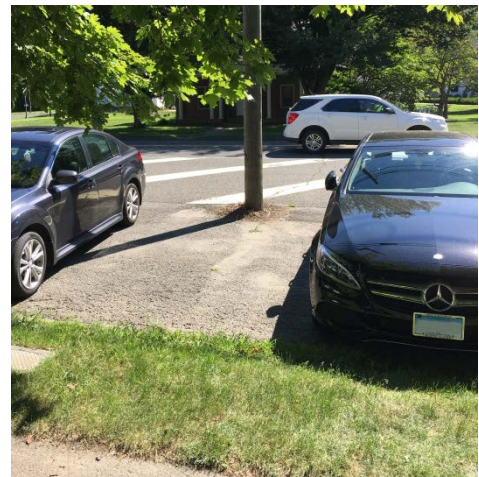
Figure 10. Utility Pole in Parking and Striped Buffer Area

- There are approximately 15 parking spaces on the southbound side of Main Street near the Route 317 intersection. Part of this parking area is interrupted by the location of utility poles (Figure 10).

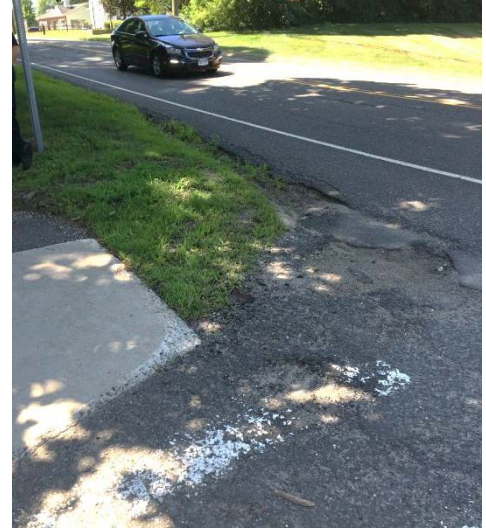
Figure 11. Corner Worn by Vehicles

- At the Main Street and Old Sherman Hill Road intersection, the southeast corner shows signs of northbound vehicles traversing the grass strip and sidewalk (Figure 11).

exacerbate this issue. Visible wear to the grass and sidewalk on the southeast corner indicate that vehicles overrun this corner.

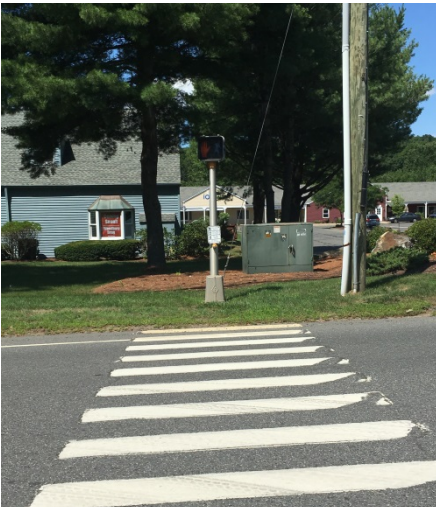
Figure 13. Crosswalk on Main Street at the Route 64 Intersection

- The crosswalks at the Main Street and Route 64 (Sherman Hill Road) intersection are not ADA compliant. At the southwest corner of this intersection, at the Sherman Village Plaza, the pedestrian push button is located on the grass with no sidewalk or landing shoulder (Figure 13).
- Although the pedestrian crosswalk at the intersection of Main Street and Park Road (Figure 12) is removed from the high traffic volumes on Route 6, Park Road experiences a regular volume of truck traffic due to the proximity to the O & G quarry.

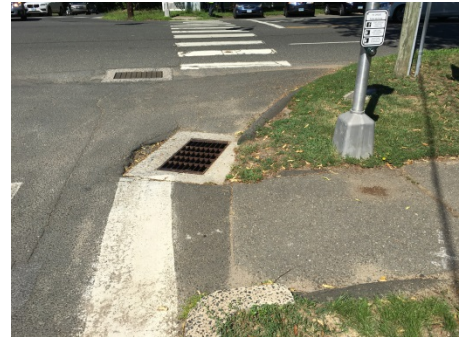
Figure 14. Crosswalks do not have a Ramp to Access Sidewalk

2. The Main Street and Route 317 intersection is not compliant with current ADA standards (Figure 14, Figure 15 and Figure 16). The sidewalks, crosswalks and ramps are non-existent or disjointed. As a result, crossing this intersection may be challenging or impossible for pedestrians with disabilities. The Town would like to improve pedestrian facilities at this intersection for all pedestrians, particularly the elderly, who may be walking to and from the nearby Senior Center.

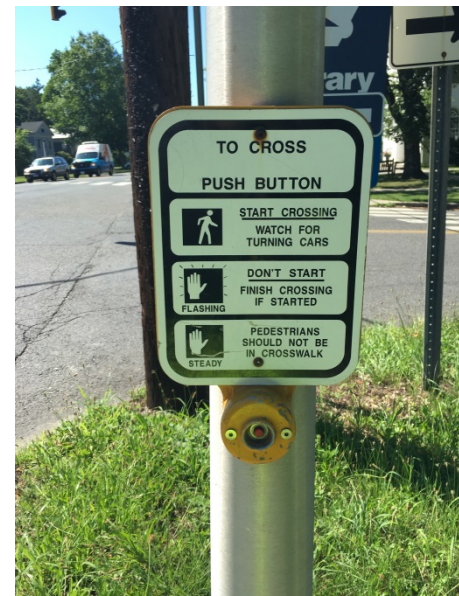
Figure 16. Outdated Pushbutton

- The pedestrian facilities at the Main Street and Route 317 intersection are not ADA compliant. The sidewalk is disjointed and inaccessible for those with disabilities. The pedestrian pushbutton on the northeast corner of this intersection is newer and has audio signals. The pushbutton on the northwest corner is outdated.
