CONNECTICUT DEPARTMENT OF TRANSPORTATION

## REHABILITATION STUDY REPORT

### BRIDGE NO. 01349

*Route 136 over Saugatuck River*

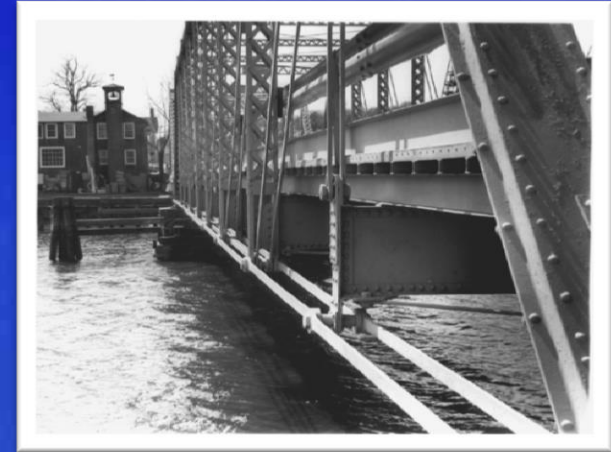
- **Early example of a wrought iron, pin connected truss system**
- **Listed on the National Register of Historic Places on February 12, 1987**
- **Listed on Connecticut Historic Bridge Inventory**
- **Documented in Historic American Engineering Record (HAER)**

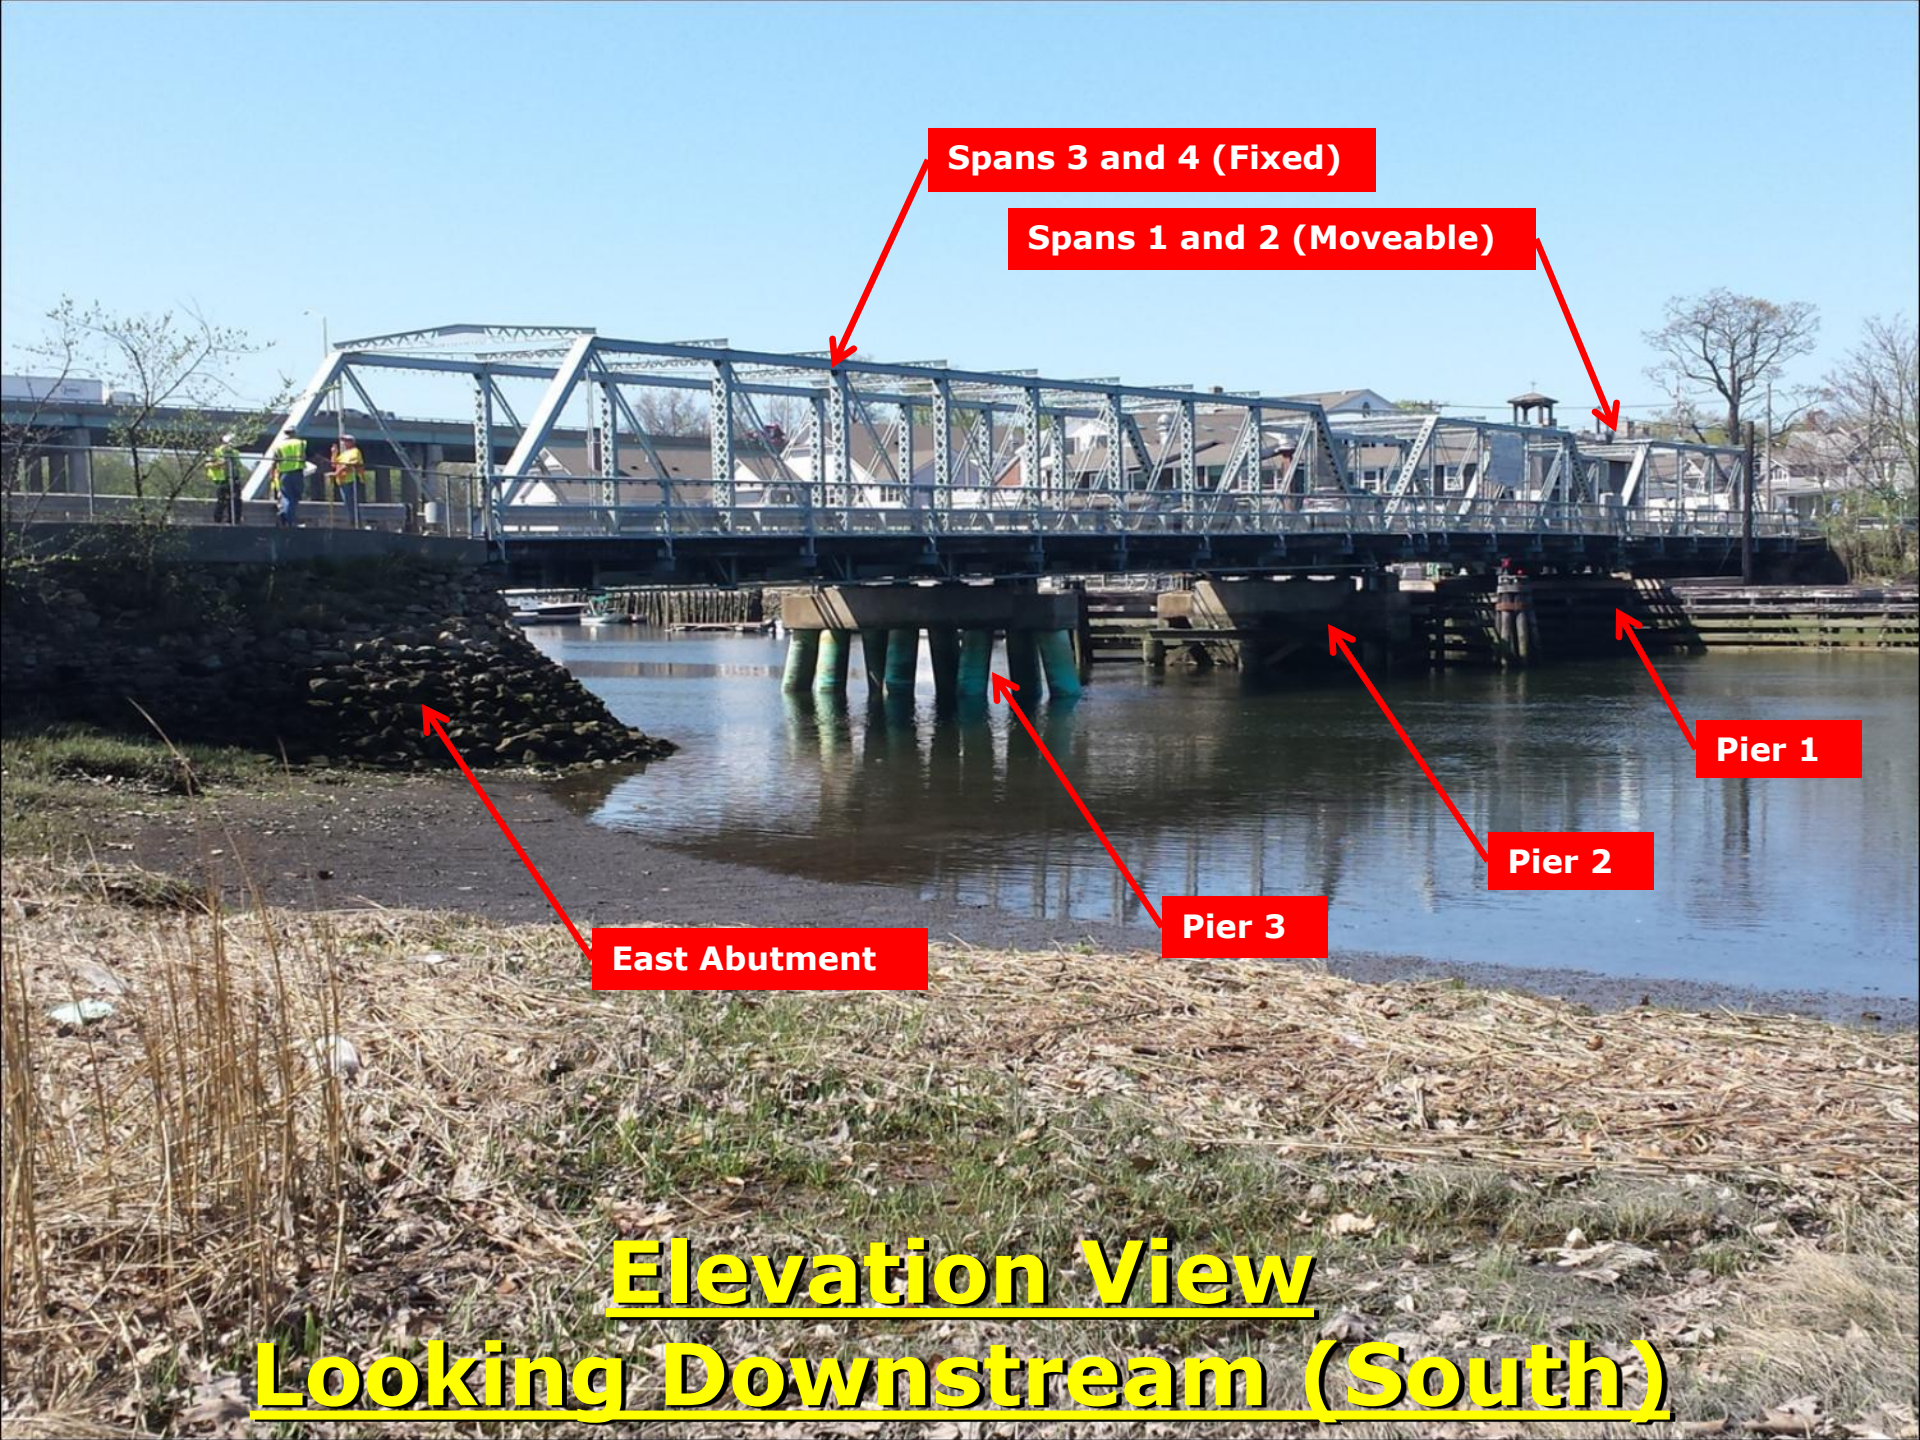
Spans 3 and 4 (Fixed)

Spans 1 and 2 (Moveable)

Pier 1

Pier 2

Pier 3

East Abutment

**Elevation View**  
**Looking Downstream (South)**

- **4-span steel multi-girder swing bridge with ornamental truss**
- **Supported by piers, stone masonry abutments and wingwalls**
- **Structure Dimensions**
  - **Total Length = 287'**
  - **Roadway Width = 19'-6"**
- **Carries one lane of traffic in each direction**
  - **Estimated Average Daily Traffic 13,100 vehicles (2014)**
  - **4-foot timber sidewalk along the north side**
  - **East Coast Greenway Bicycle Route**

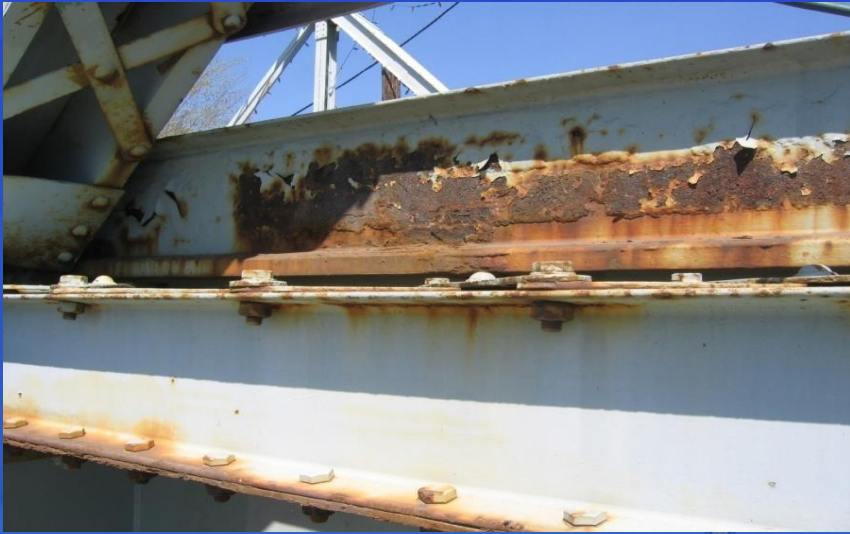
**Rusted Areas**

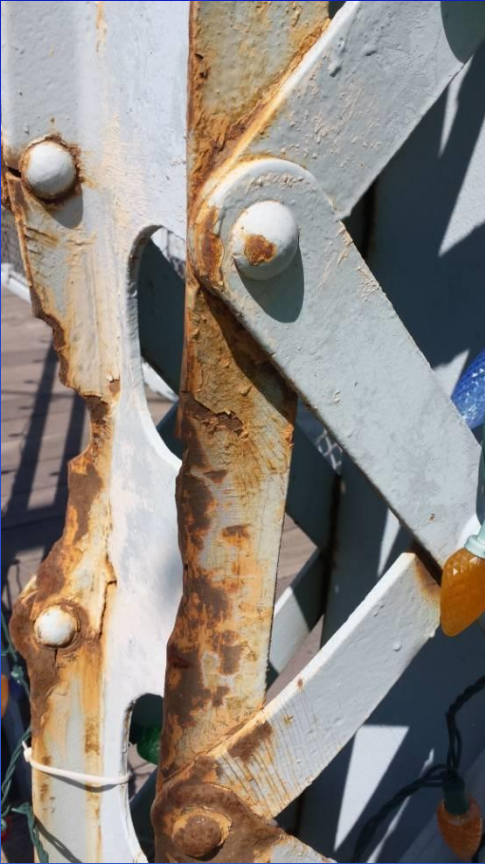
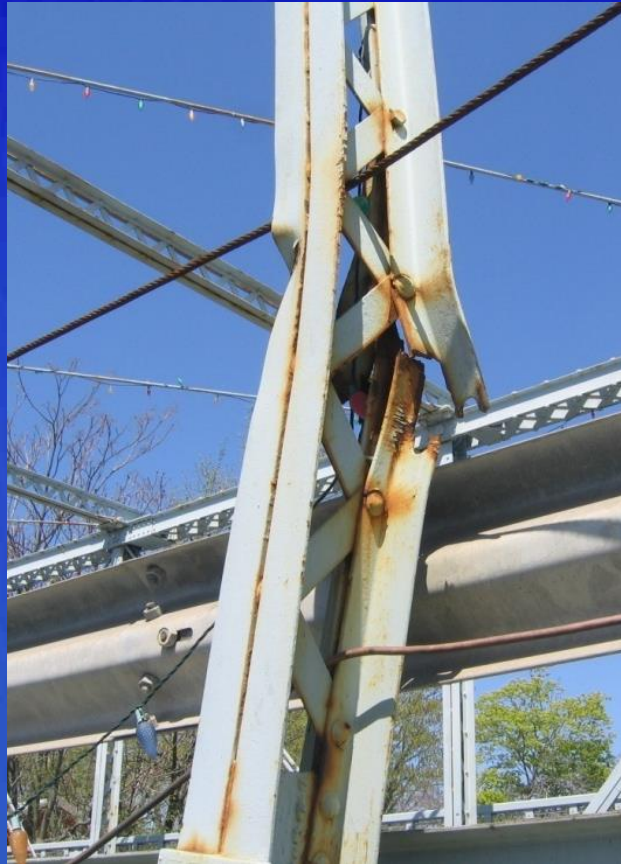
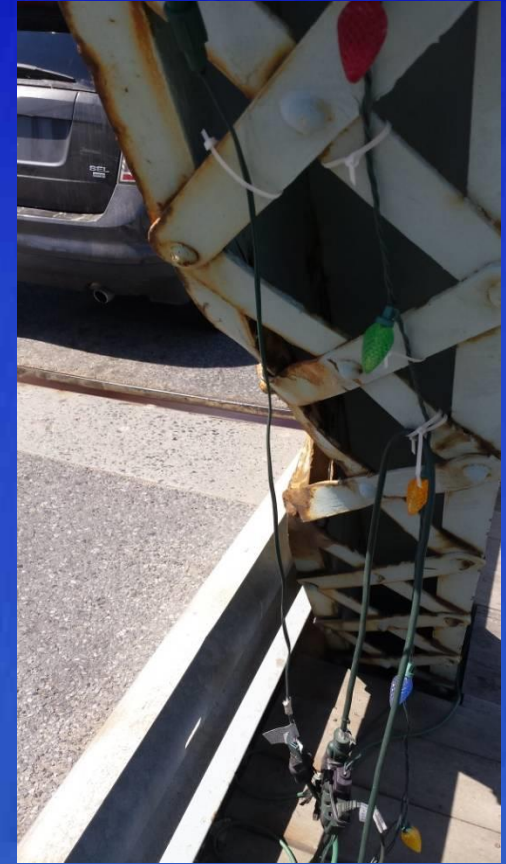
# Ornamental Truss

## Impact Damage

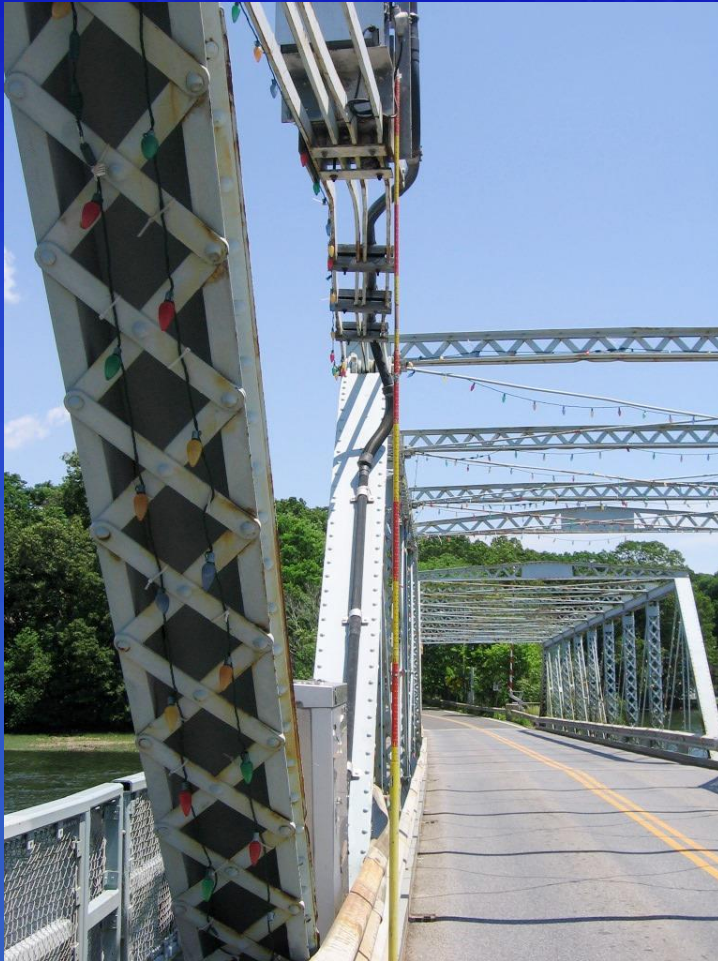
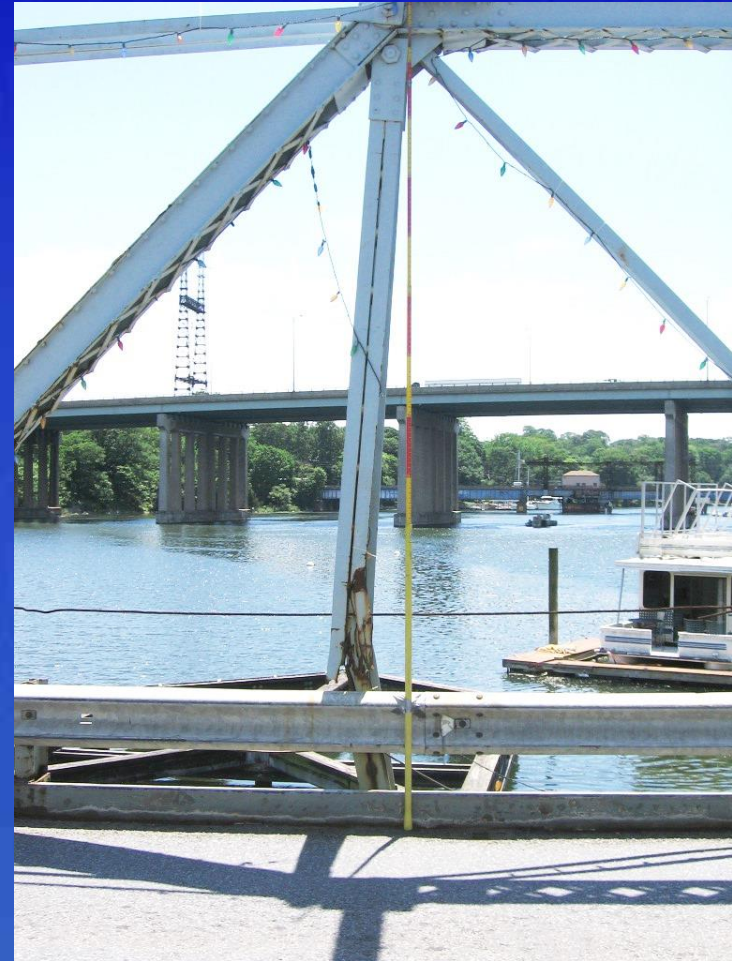
# Ornamental Truss

- **Current Condition Rating**
  - **Deck = 6 (Satisfactory)**
  - **Superstructure = 5 (Fair)**
    - **Truss = 2 (Critical)**
  - **Substructure = 5 (Fair)**
    - **Pier 2 cross bracing = 2 (Critical)**

- **Repair ornamental truss**
- **Shift trusses outward to provide clearance**
- **Install new crash-tested barrier system**
- **Increase vertical clearance from average of 13'-9" to 14'-3" (remove 12'-9" electrical box obstruction)**
- **Strengthen truss connections for wind load**
- **Reconstruct Pier 2 support system**
- **Improve approach roadway and deck**
- **Paint superstructure and ornamental truss**
- **Repair substructure and superstructure**
- **Replace existing fender system at Piers 1 and 2**

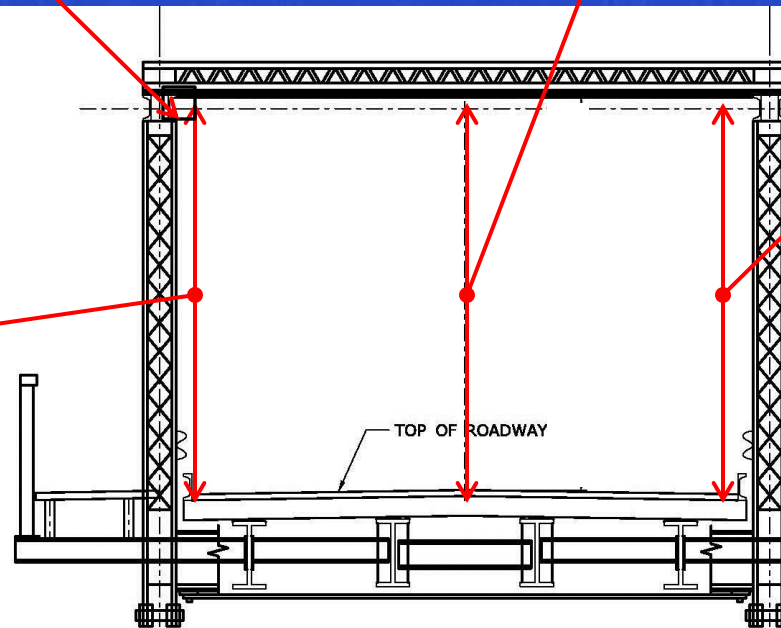
# Vertical Clearance

12'-9" only occurs  
at electrical box

Vertical clearance along  
center of bridge varies:  
13'-7" to 14'-5"

North side  
(Westbound) vertical  
clearance varies:  
12'-9" to 14'-3"

South side  
(Eastbound) vertical  
clearance varies:  
13'-9" to 14'-4"

- **Functionally Obsolete:**
  - **Substandard roadway width of 19'-6"**  
(Functional width = 28'-0")
  - **Substandard vertical clearance - posted for 13'-0"**  
(Functional clearance = 14'-0")
  - **Deck geometry rated 2**
    - "2" = "basically intolerable requiring high priority of replacement"
    - Rating is based upon the comparison of Average Daily Traffic across the bridge versus the curb-to-curb width of the roadway

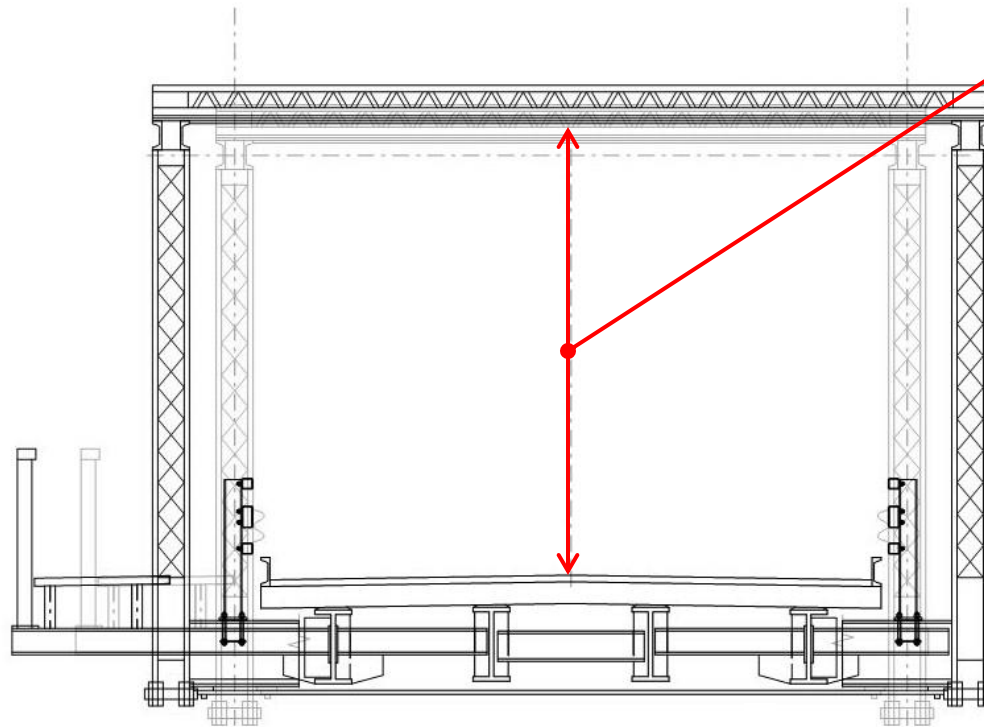
**CROSS SECTIONS**

Vertical clearance to be raised to 14'-3"

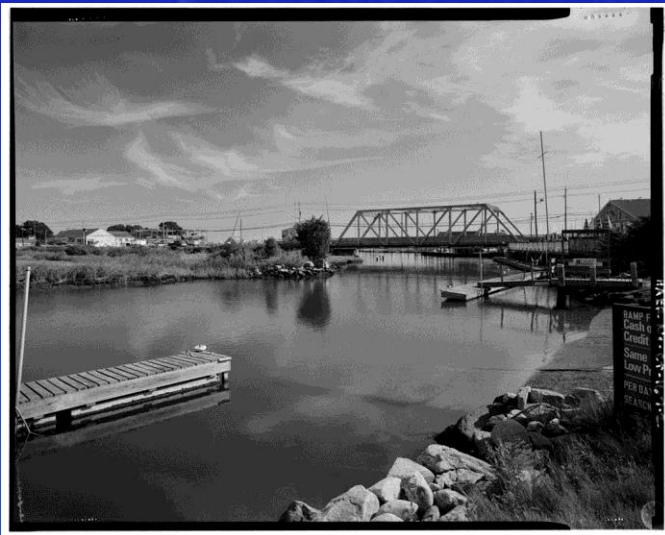
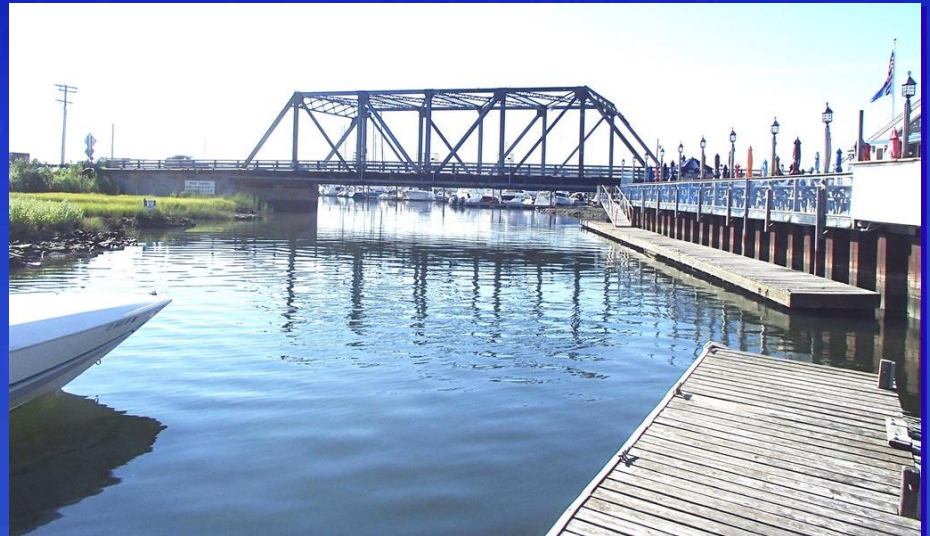
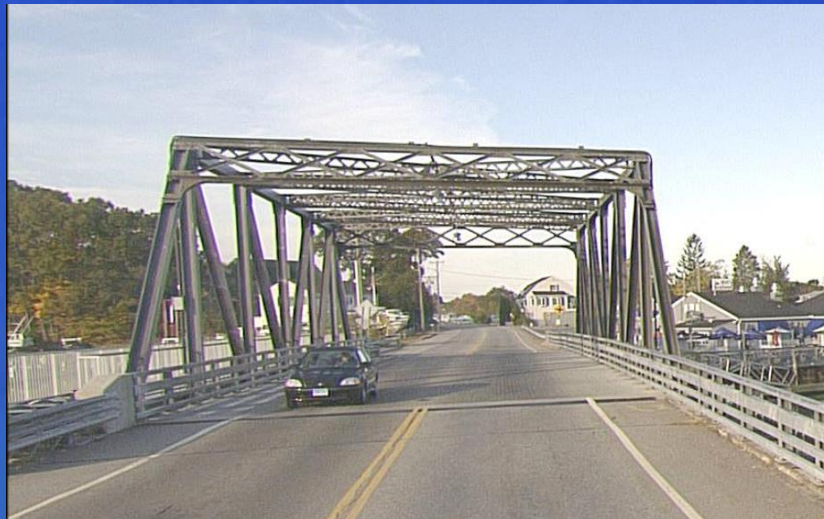
# Example Bridge Replacement

(Route 1 in Westbrook)
