EXISTING CONDITIONS REPORT

New Haven – Hartford – Springfield
Commuter Rail Implementation Study

Memorandum

Subject: **State Project No. 170-2296**
New Haven, Hartford, Springfield Commuter Rail Feasibility Study
Task 6 – Evaluation of Existing Bridges – 33 Largest Total Length

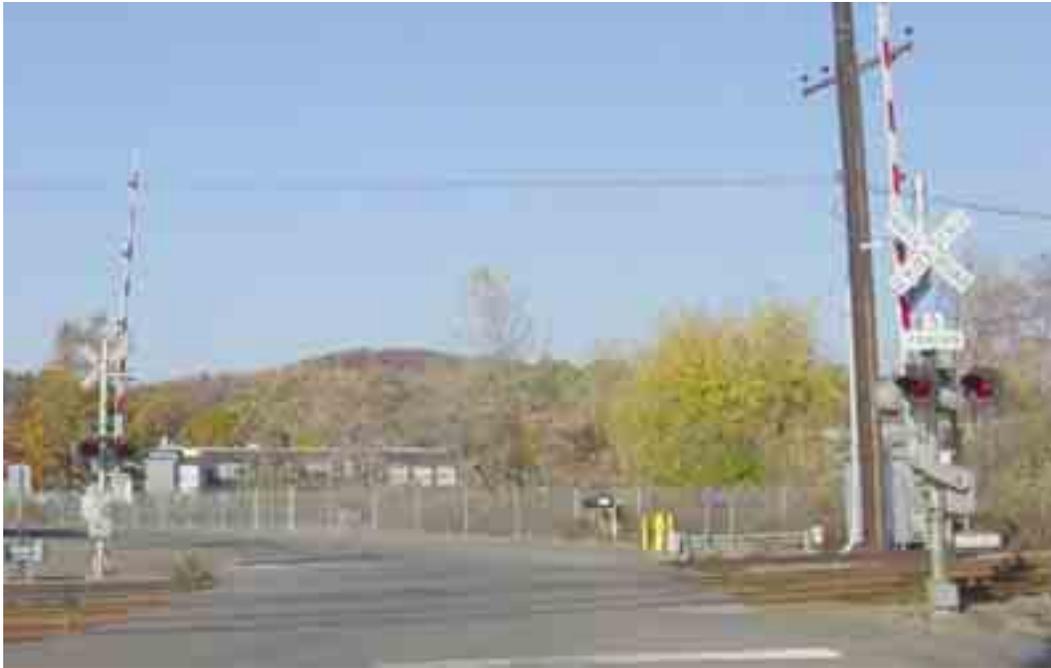
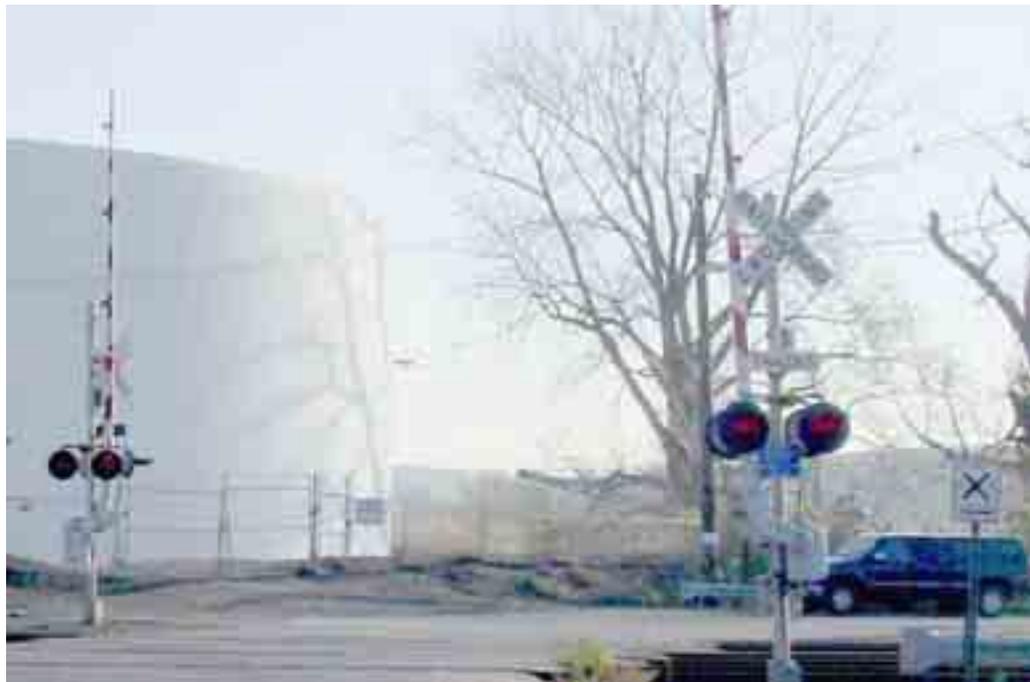
Crossing Name: Benton Street, Milepost 3.1

Summary: 3 tracks; 2 highway gates, 8 flashing lights, 1 electronic bell.
AAR/DOT Number 500619A

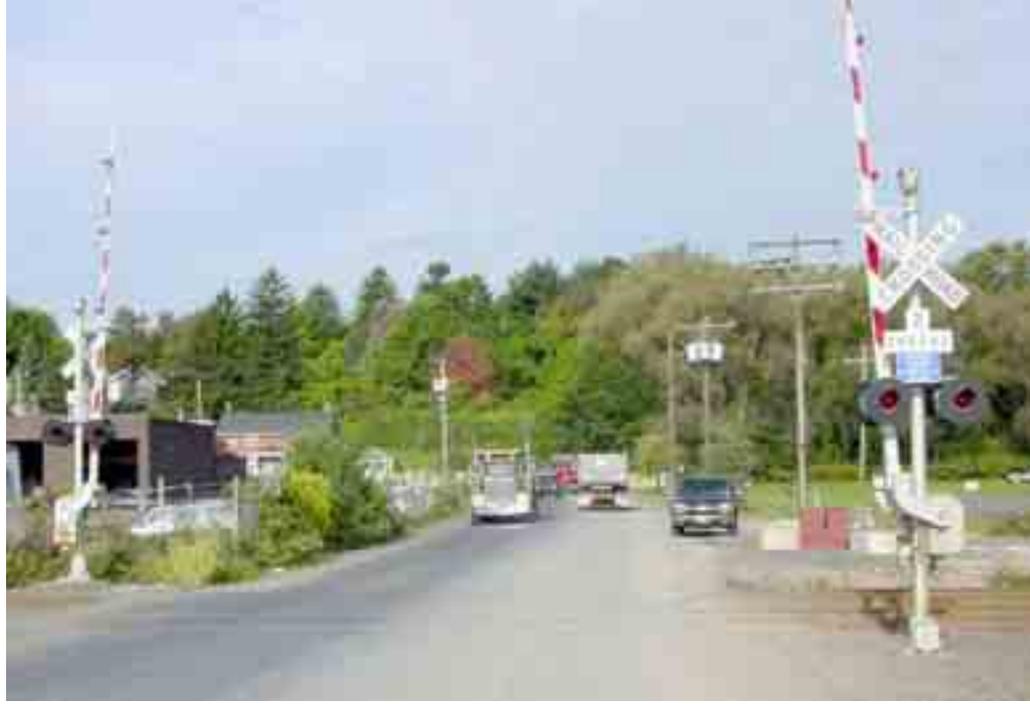
Crossing Name: Winchesters, Milepost 5.0

Summary: 2 tracks; 2 highway gates, 8 flashing lights, 2 mechanical bells.
AAR/DOT Number 500621B

View-West

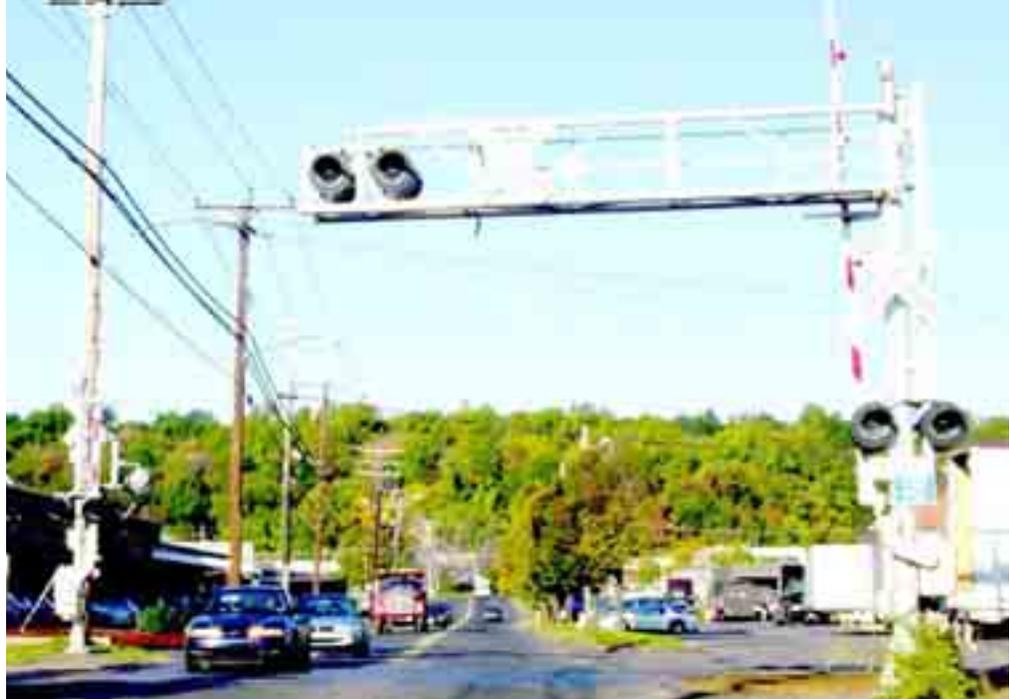
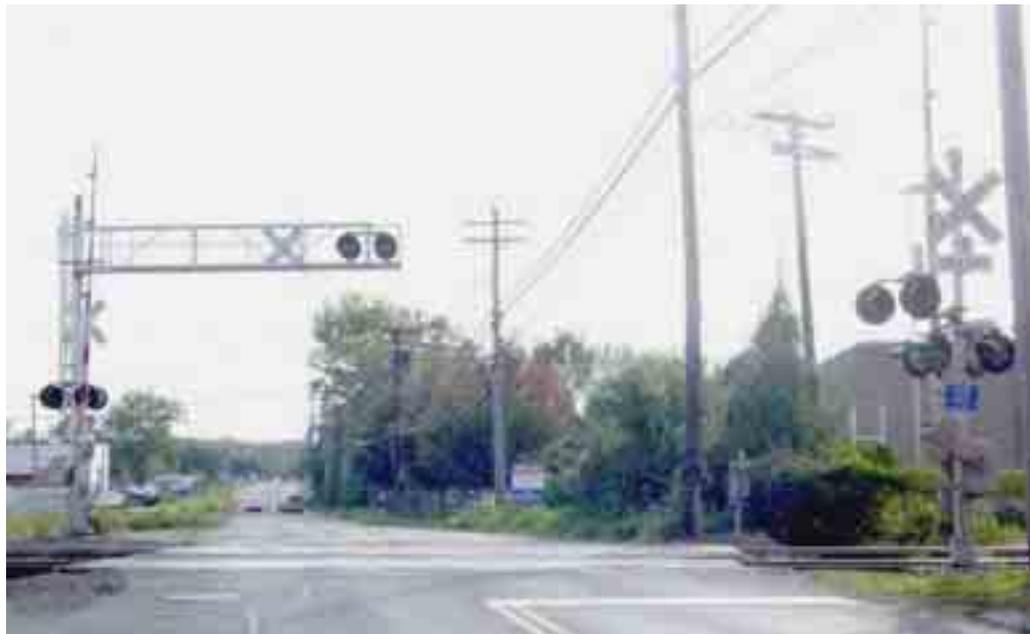
Crossing Name: Sackett Point Road, Milepost 5.9

Summary: 2 tracks; 2 highway gates, 14 flashing lights and 2 mechanical bells,
1 cantilever
AAR/DOT Number 500622H

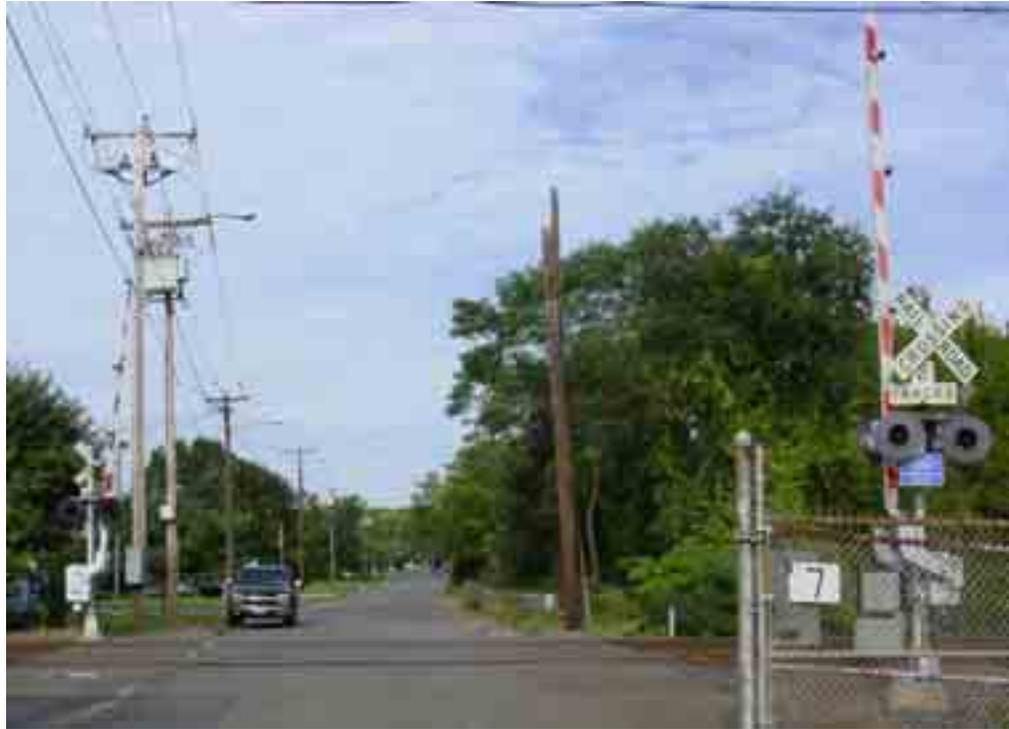
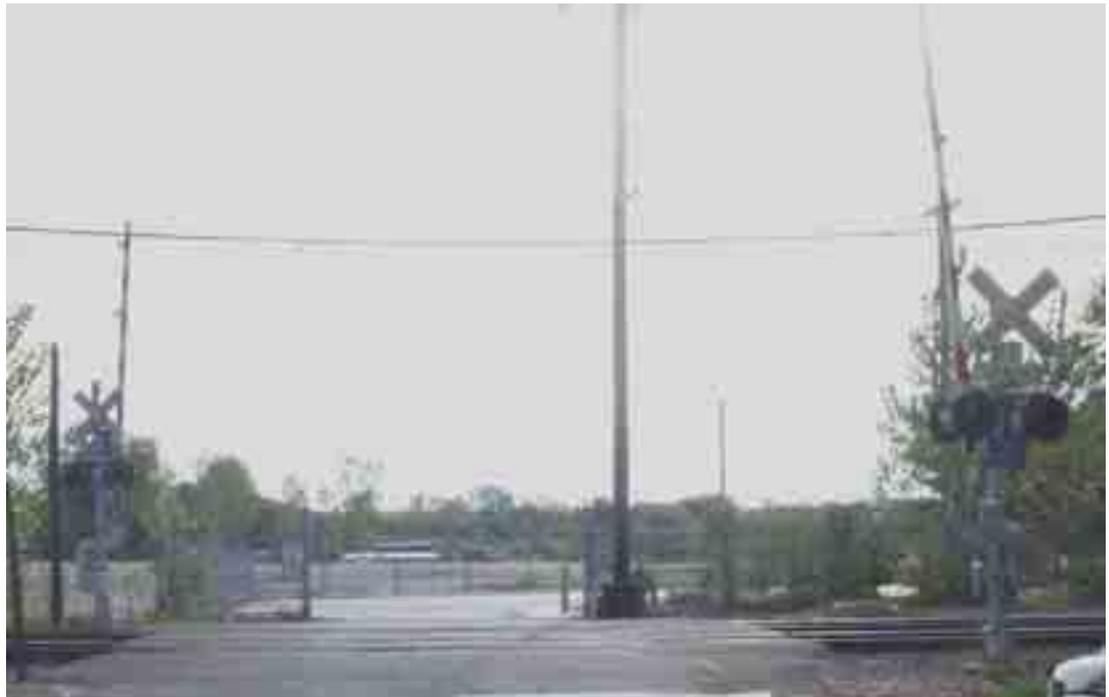
Crossing Name: Stiles Lane, Milepost 6.3

Summary: 2 tracks; 2 highway gates, 8 flashing lights, 1 mechanical bell.
AAR/DOT Number 500623P

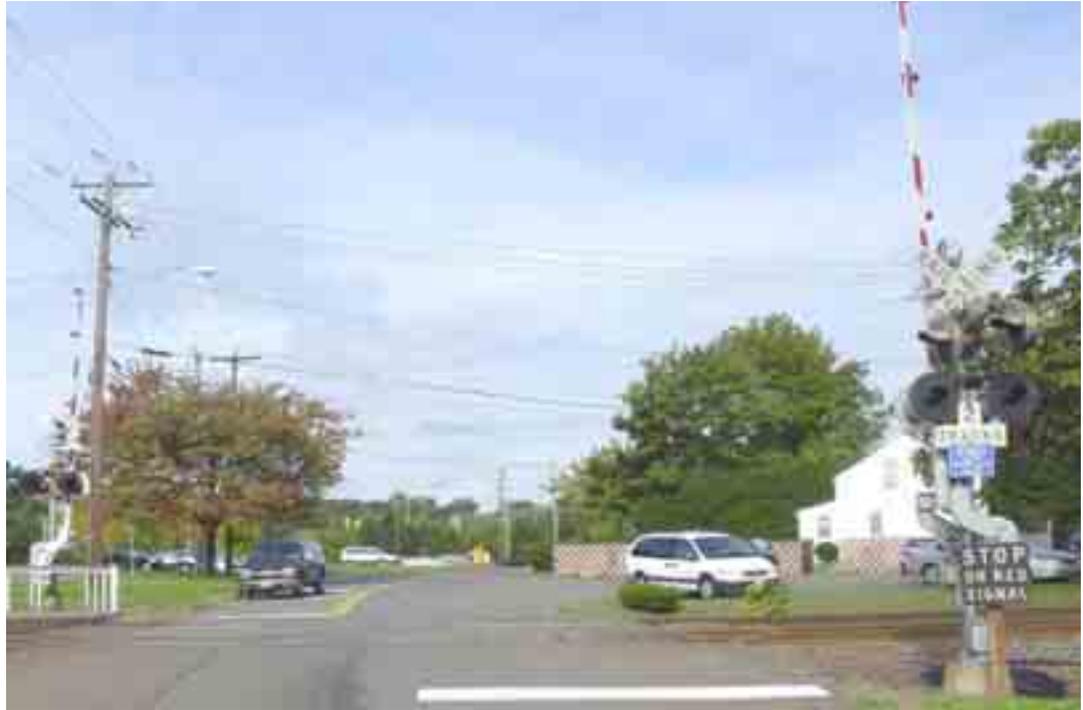
Crossing Name: Devine Street, Milepost 6.4

Summary: 2 tracks; 2 highway gates, 10 flashing lights, 1 mechanical bell.
AAR/DOT Number 500625D

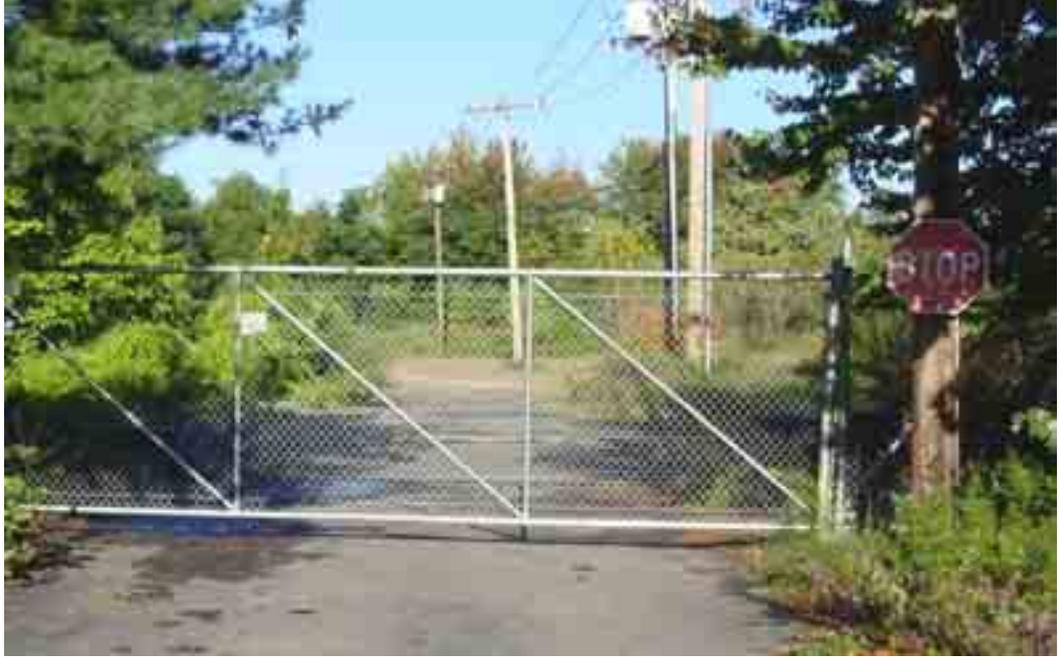
Crossing Name: Sherbans (Ferro Lane), Milepost 8.2 (Closed)

Summary: 1 track; No warning devices
AAR/DOT Number 500630A

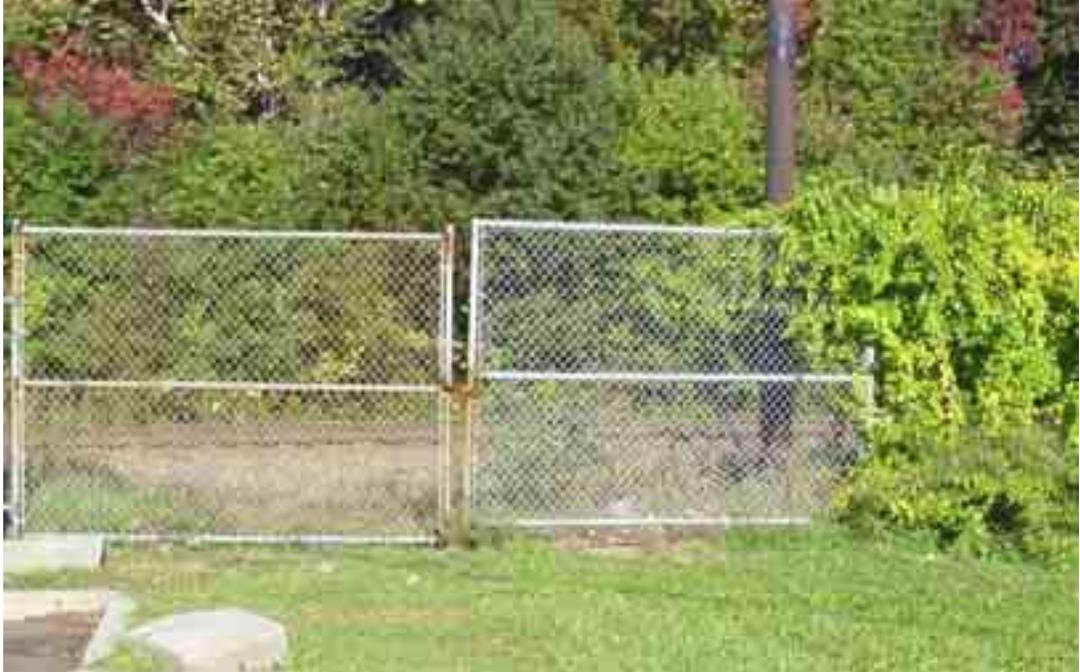
Crossing Name: Grinolds Lumber, Milepost 8.3 (Closed)

Summary: 1 track; No warning devices
AAR/DOT Number 500631G

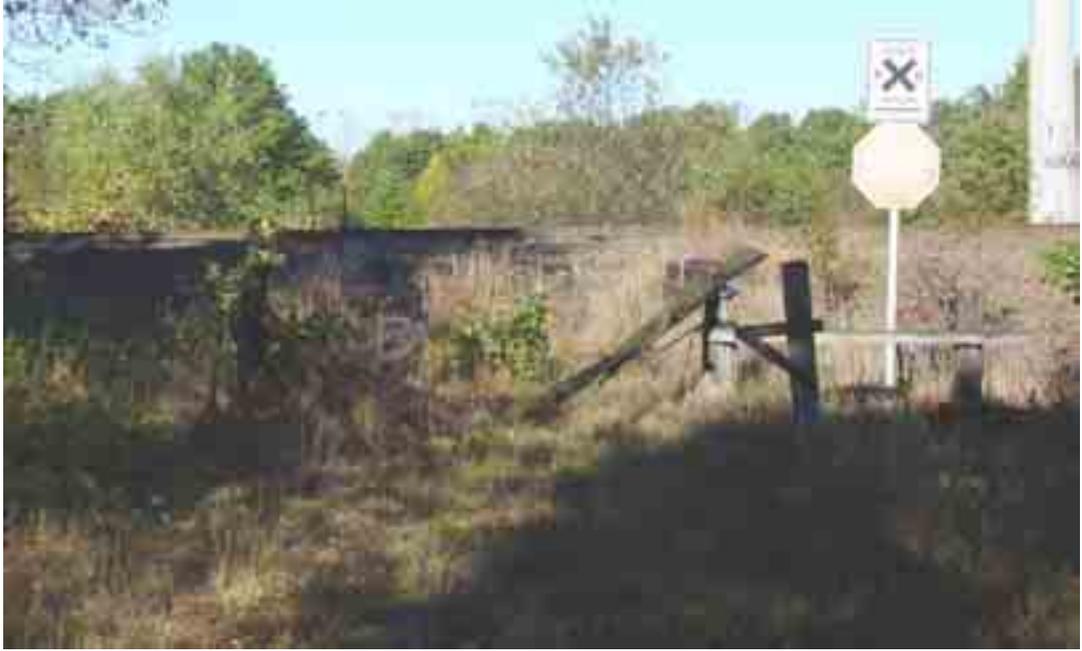
Crossing Name: Parese, Milepost 8.6 (Closed)

Summary: 1 track; No warning devices
AAR/DOT Number 500632N

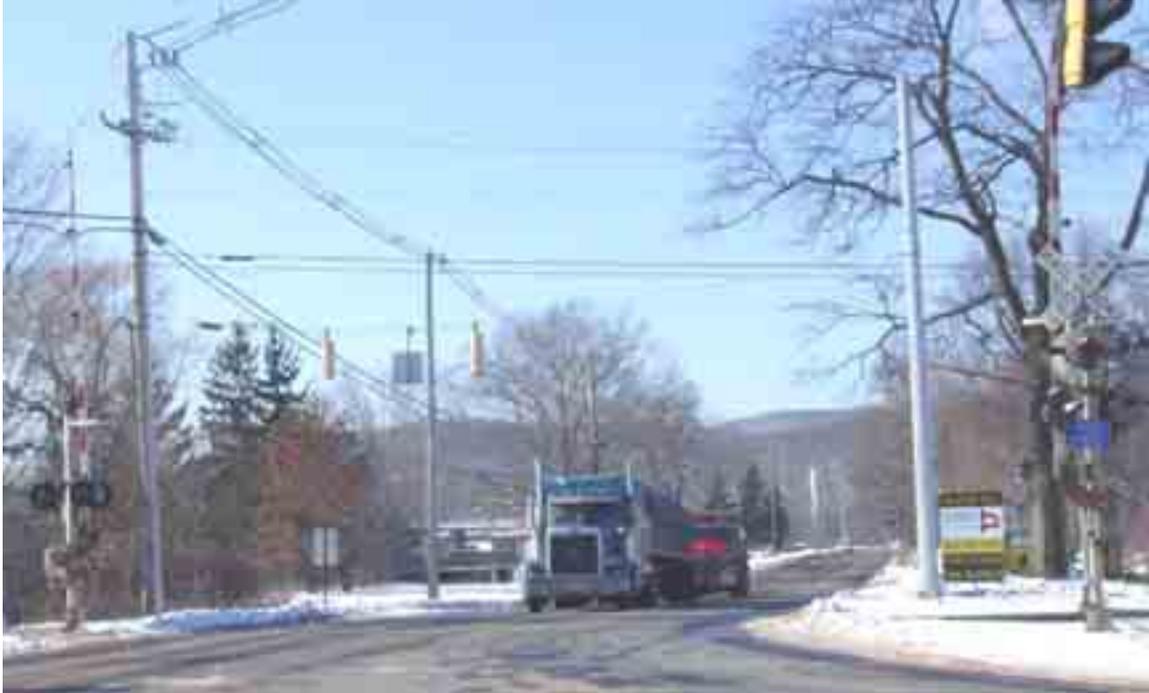
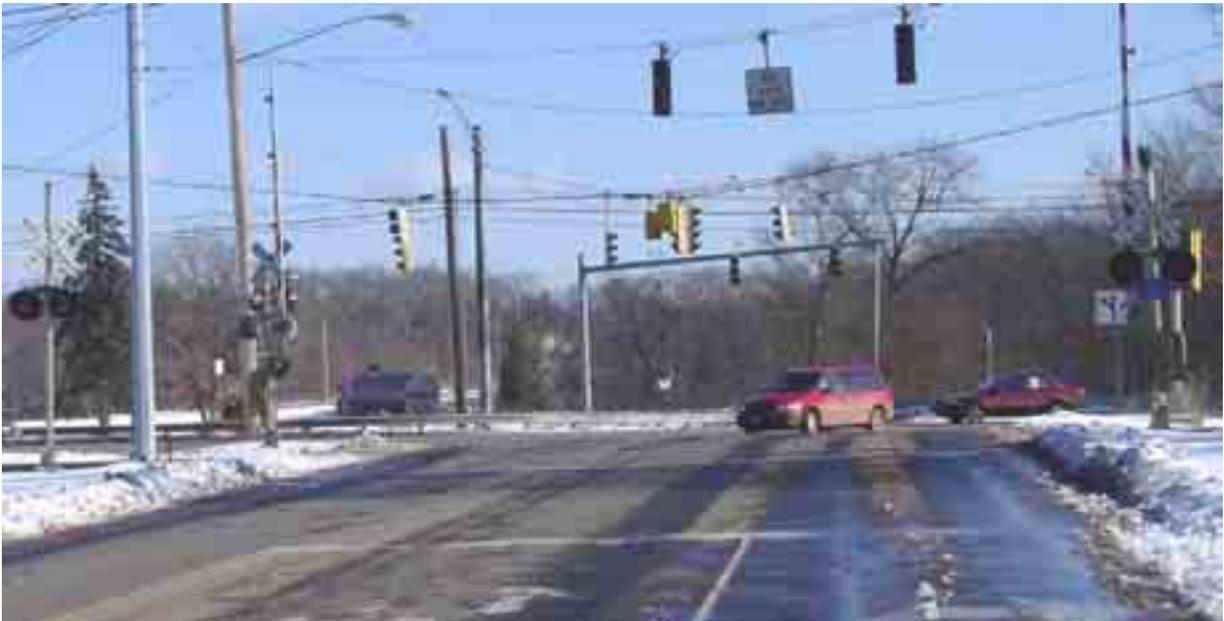
Crossing Name: Toelles Road, Milepost 10.5

Summary: 1 track; 2 highway gates, 14 flashing lights, 1 mechanical bell
AAR/DOT Number 500637X

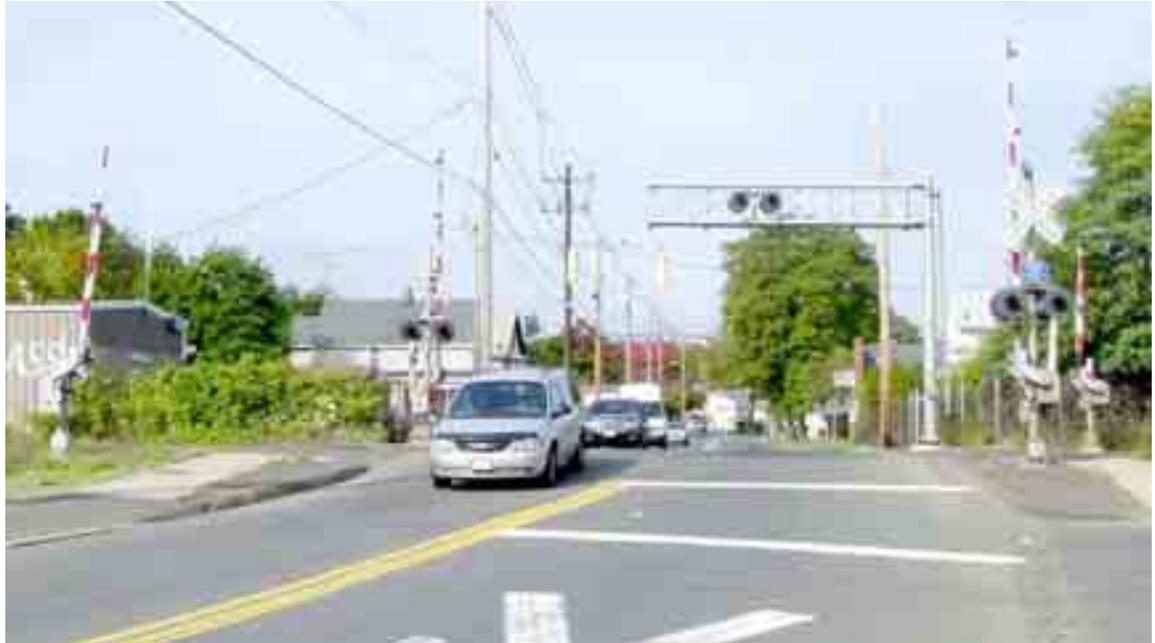
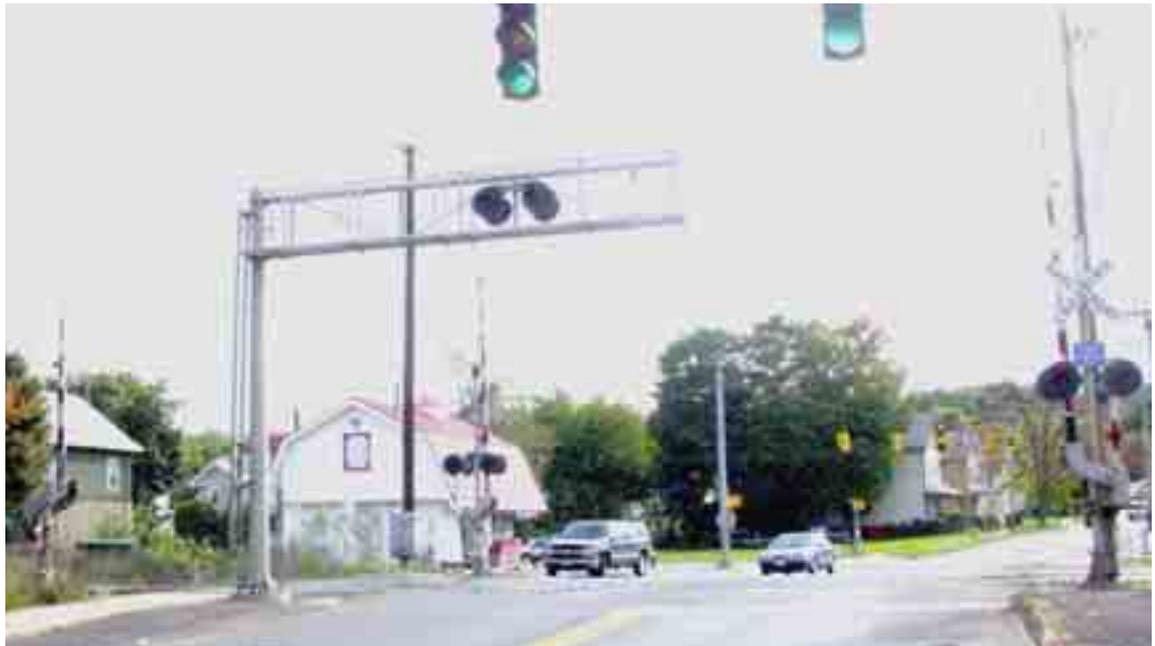
Crossing Name: Ward Street, Milepost 12.3

Summary: 1 track; 2 highway gates, 2 pedestrian gates, 12 flashing lights, 1 mechanical bell, 1 cantilever
AAR/DOT Number 500640F

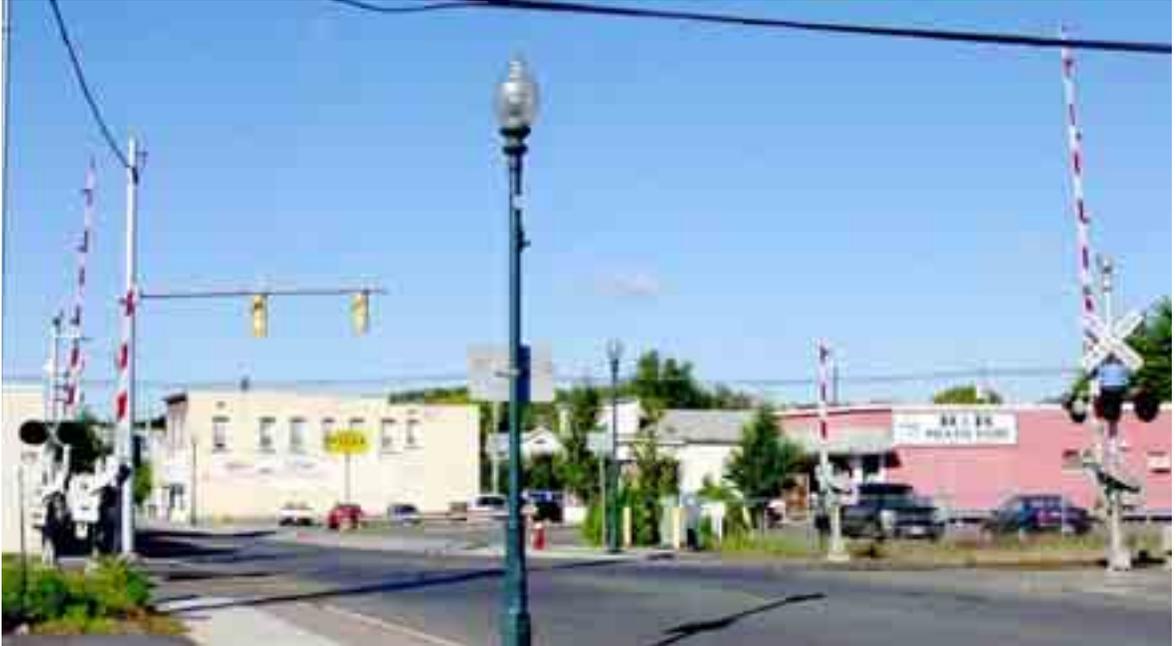
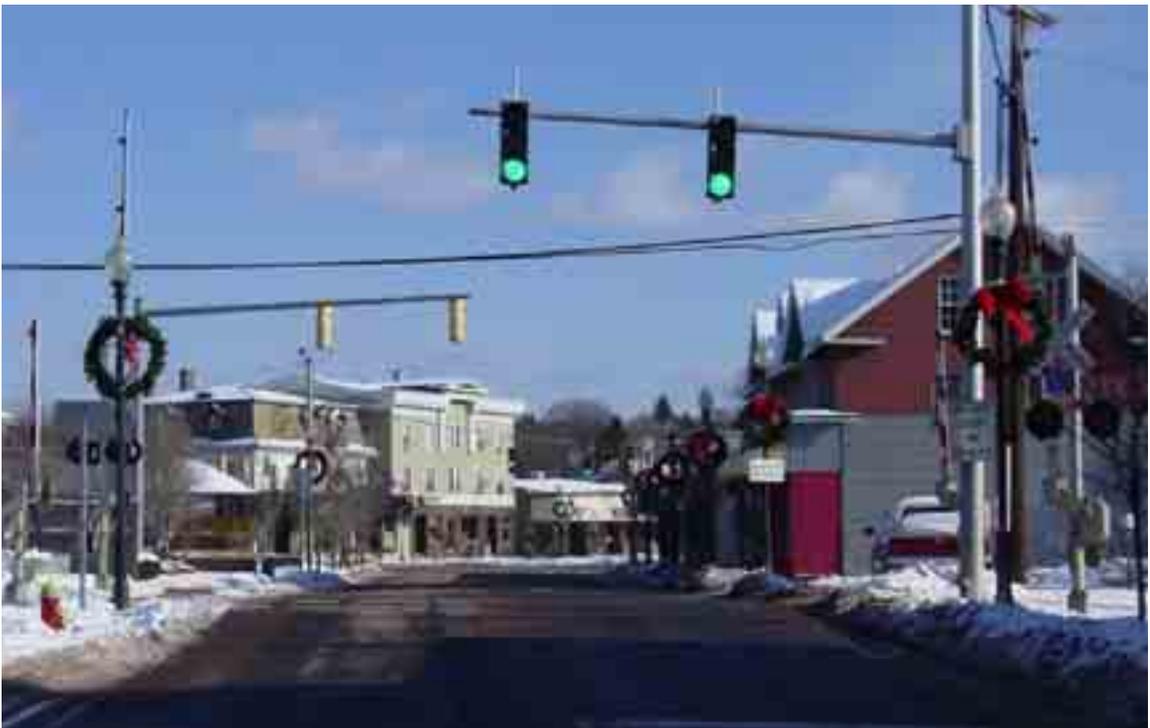
Crossing Name: Quinnipiac Street, Milepost 12.6

Summary: 1 track; 2 highway gates, 2 pedestrian gates, 8 flashing lights, 2 mechanical bells
AAR/DOT Number 500641M

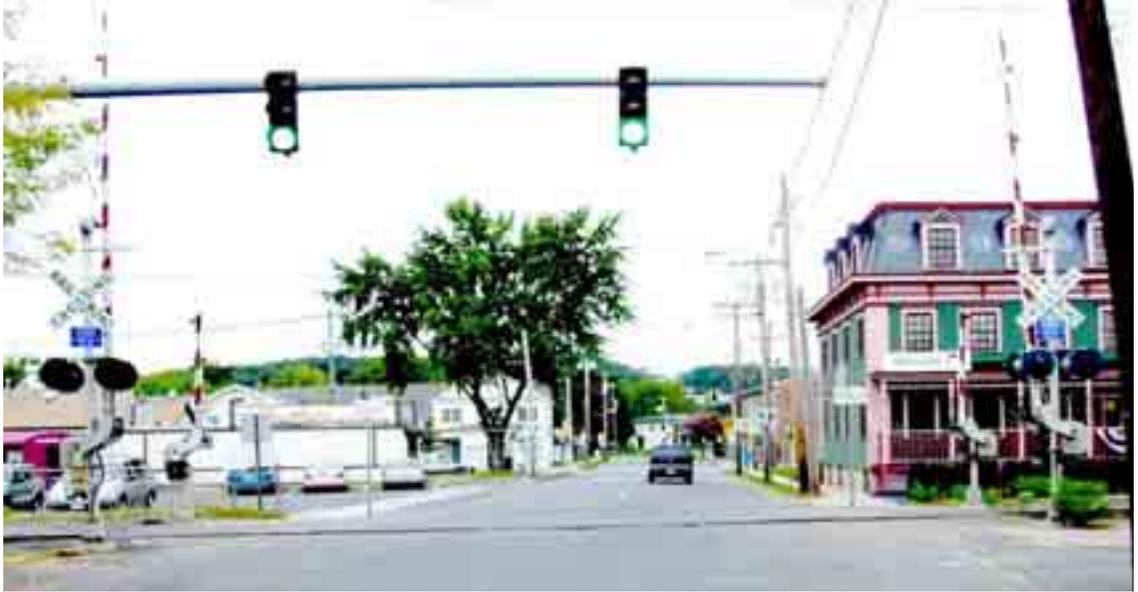
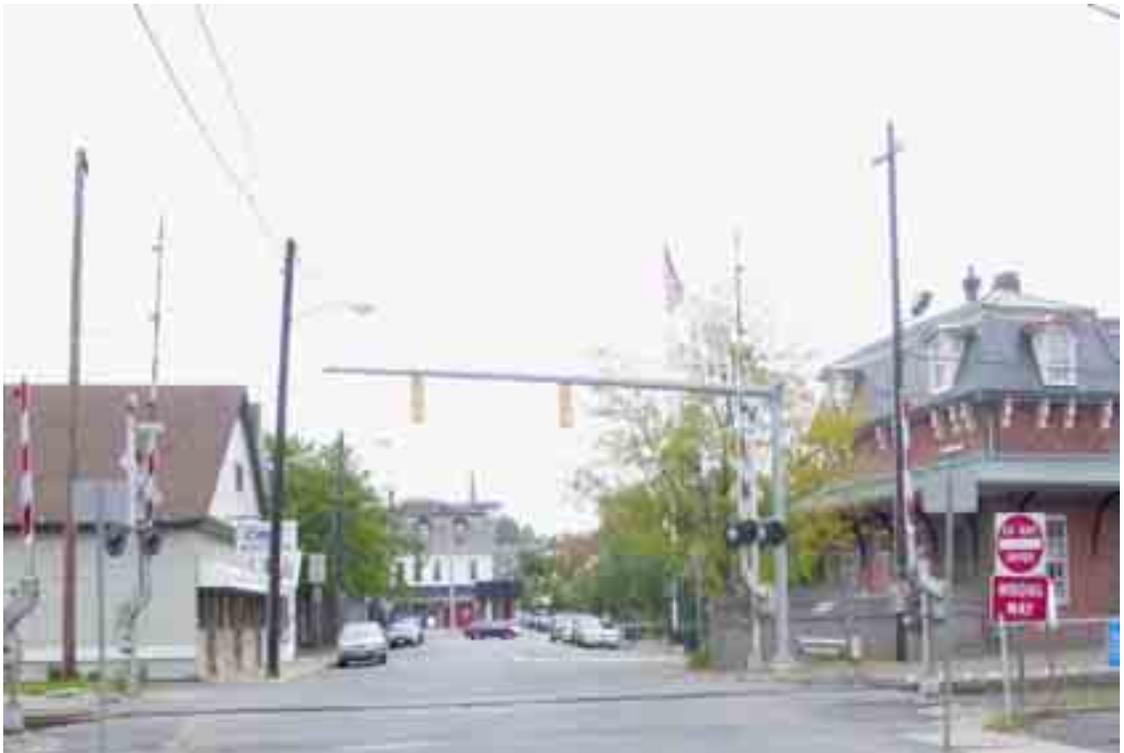
Crossing Name: Hall Avenue, Milepost 12.65

Summary: 1 track, two highway gates, 2 pedestrian gates, 8 flashing lights, two mechanical bells
AAR/DOT Number 500642U

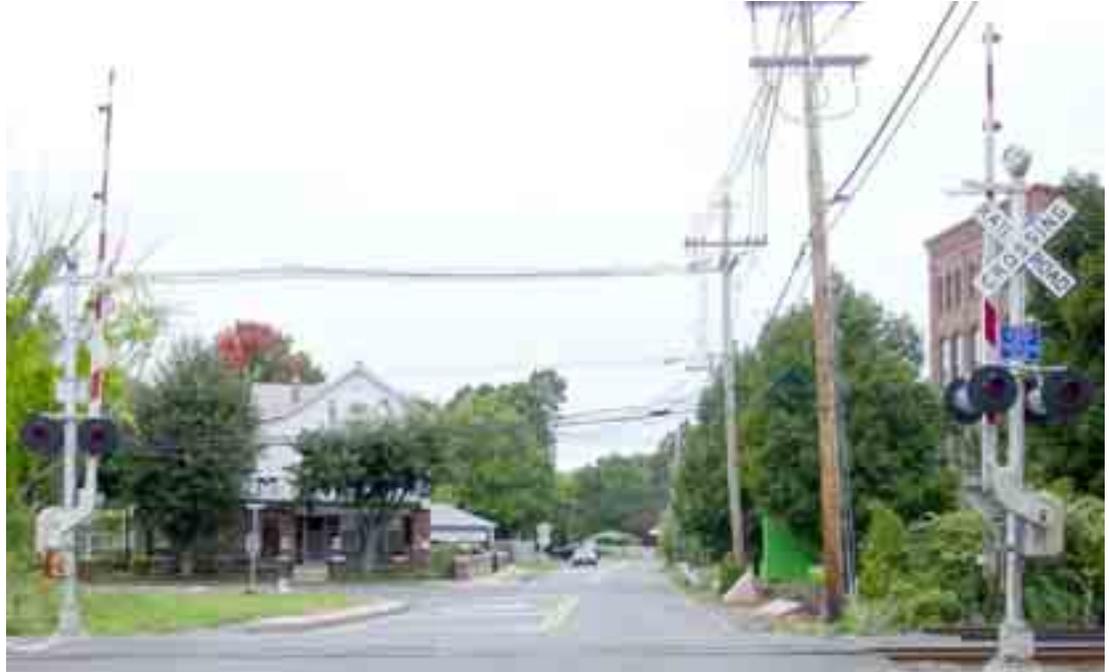
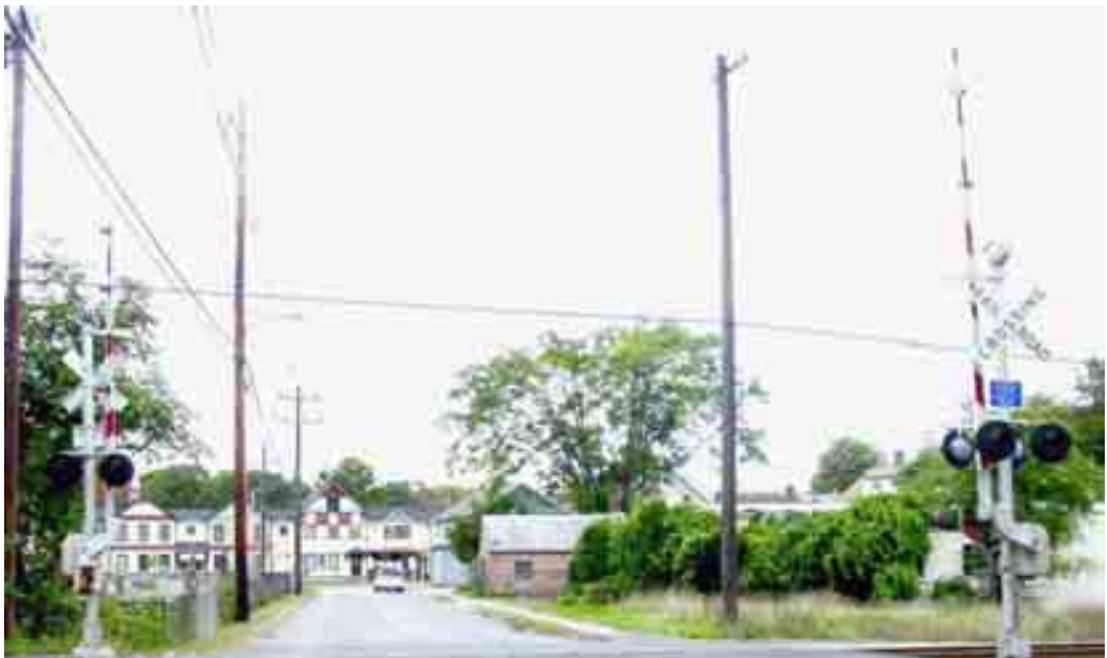
Crossing Name: Parker Street, Milepost 13.0

Summary: 1 track, two highway gates, 8 flashing lights, two mechanical bells.
AAR/DOT Number 500643B

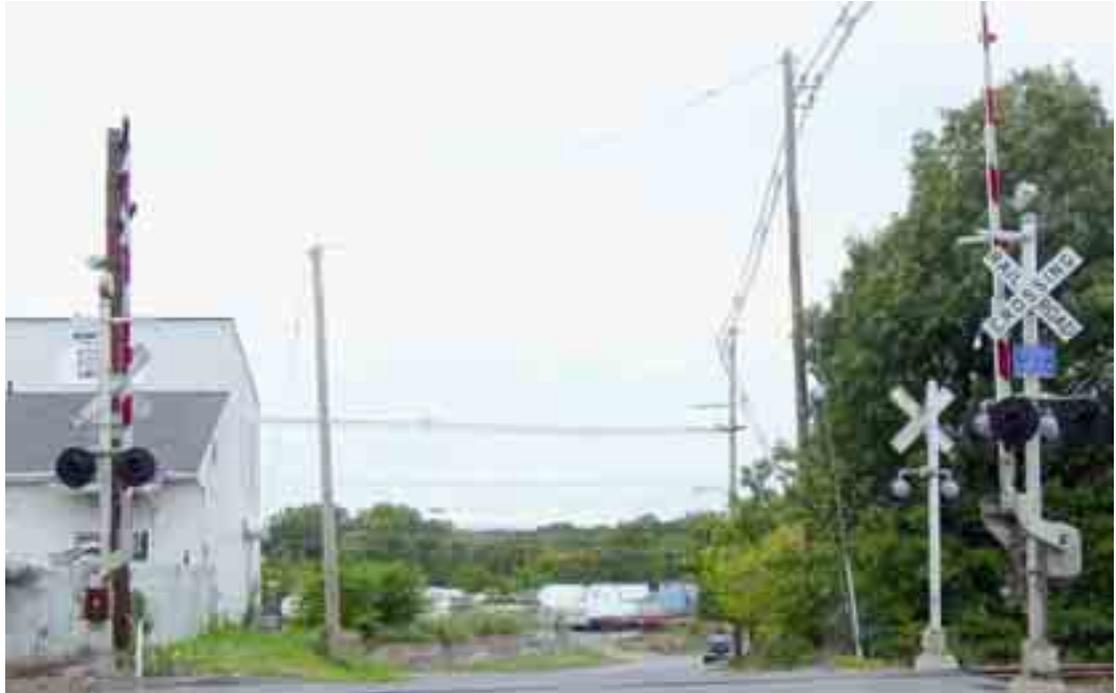
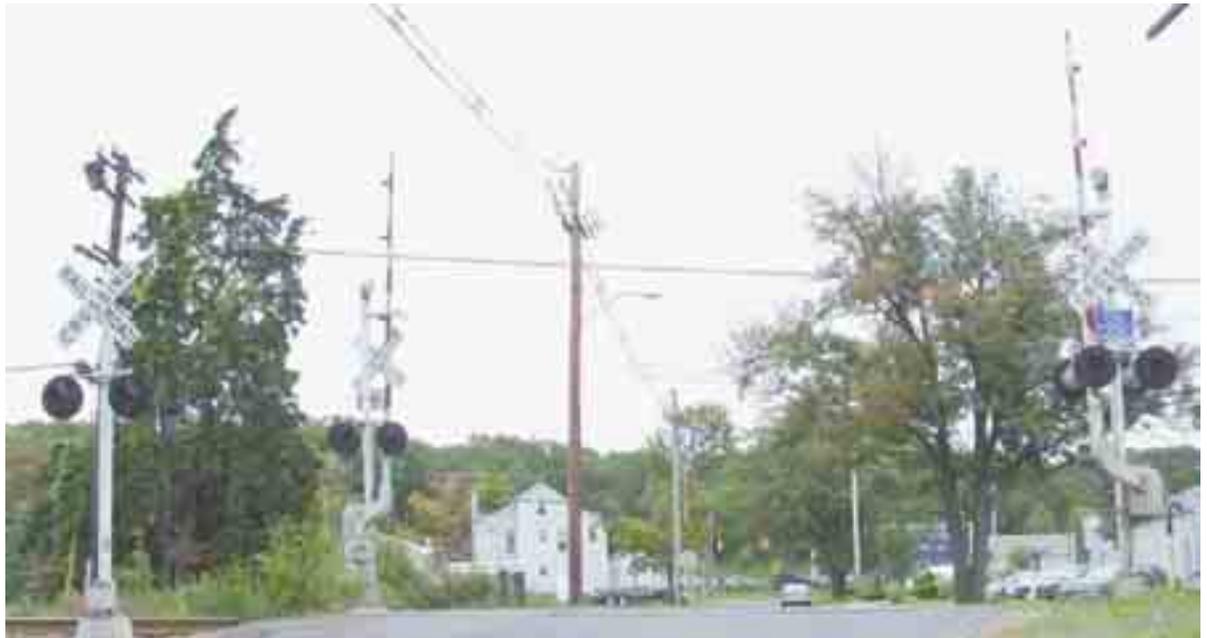
Crossing Name: North Plains Road, Milepost 13.6

Summary: 1 track, two highway gates, 10 flashing lights, two mechanical bells.
AAR/DOT Number 500645P

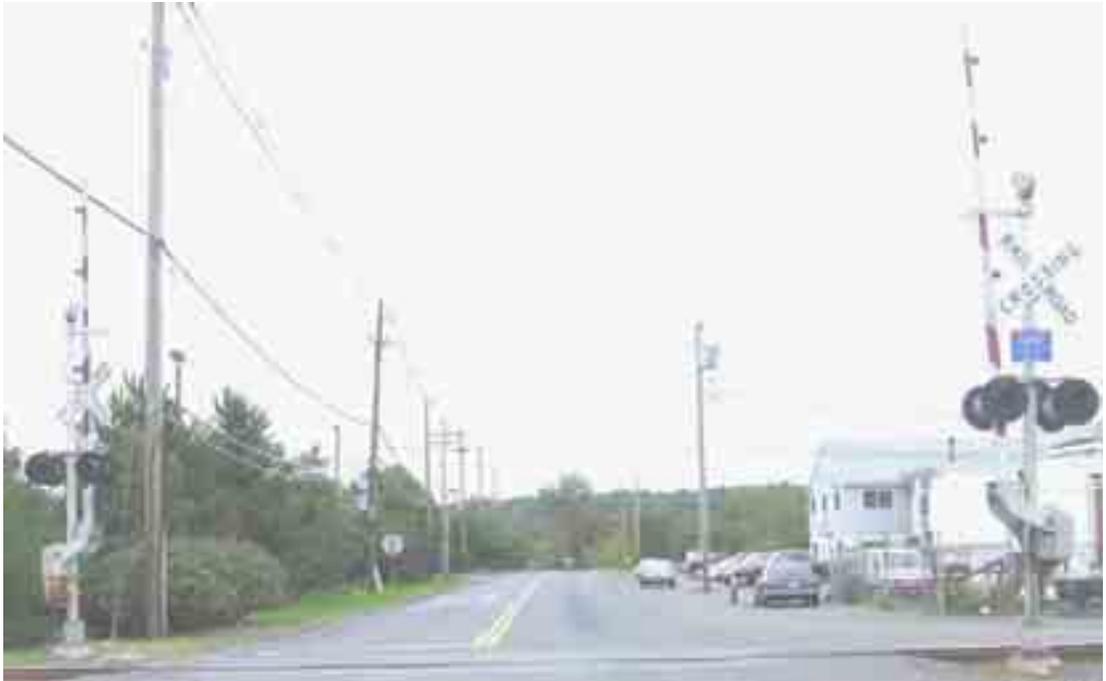
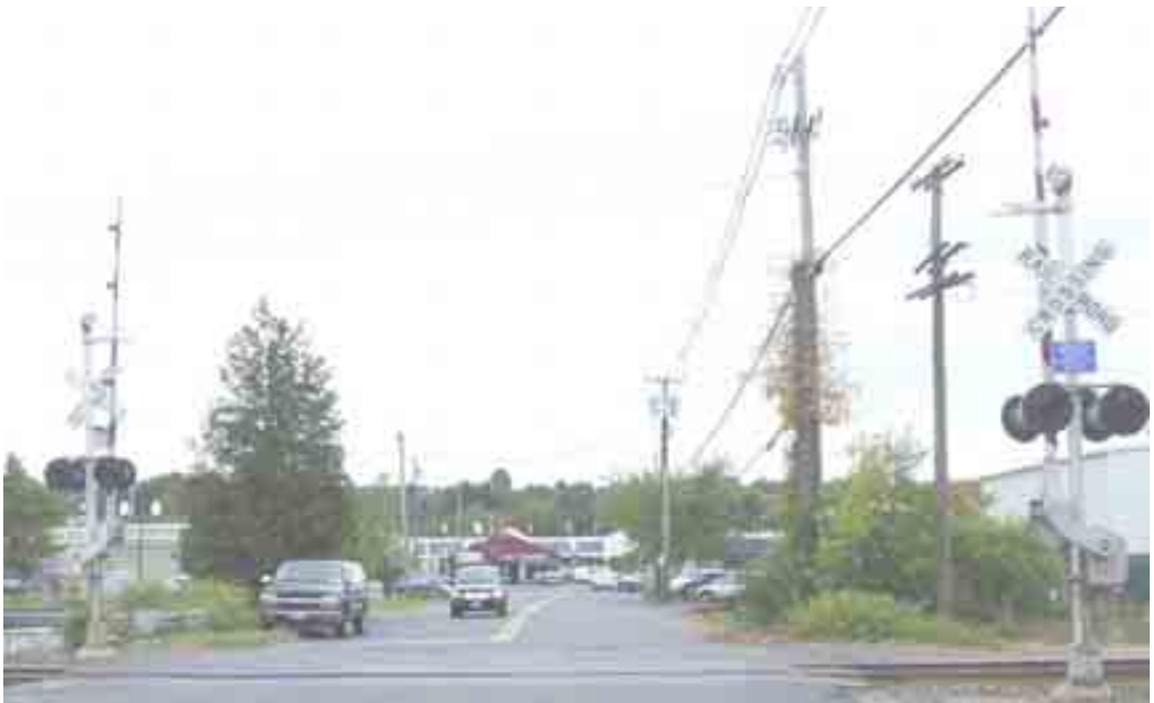
Crossing Name: Pent Highway, Milepost 14.4

Summary: 1 track, two highway gates, 8 flashing lights, two mechanical bells.
AAR/DOT Number 500646W

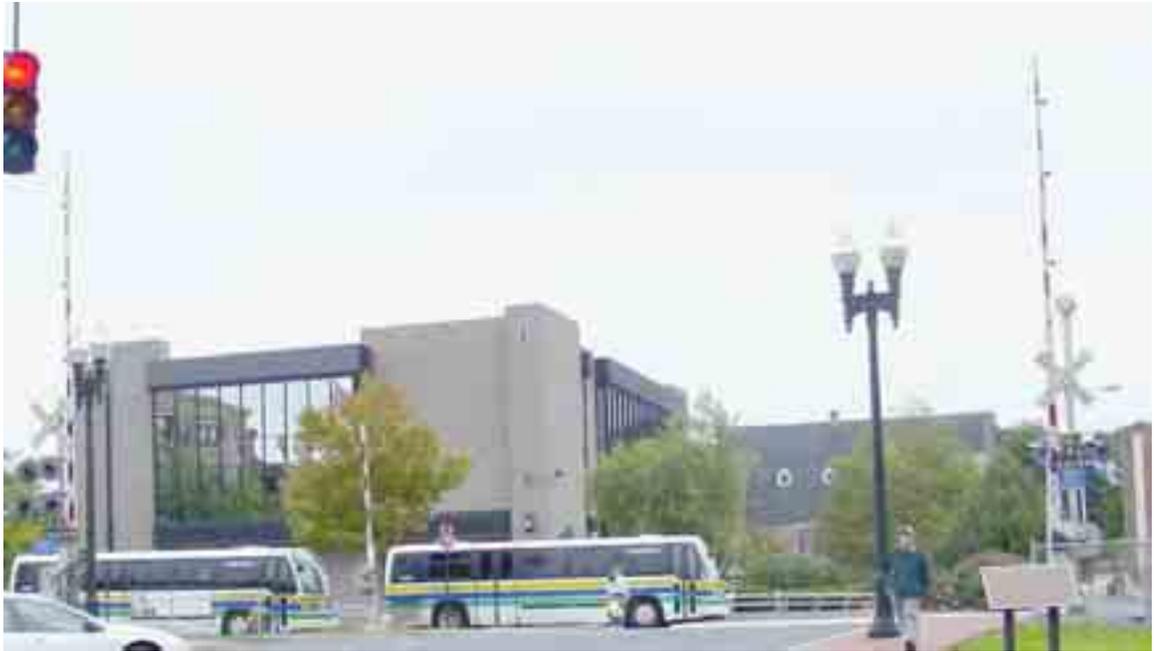
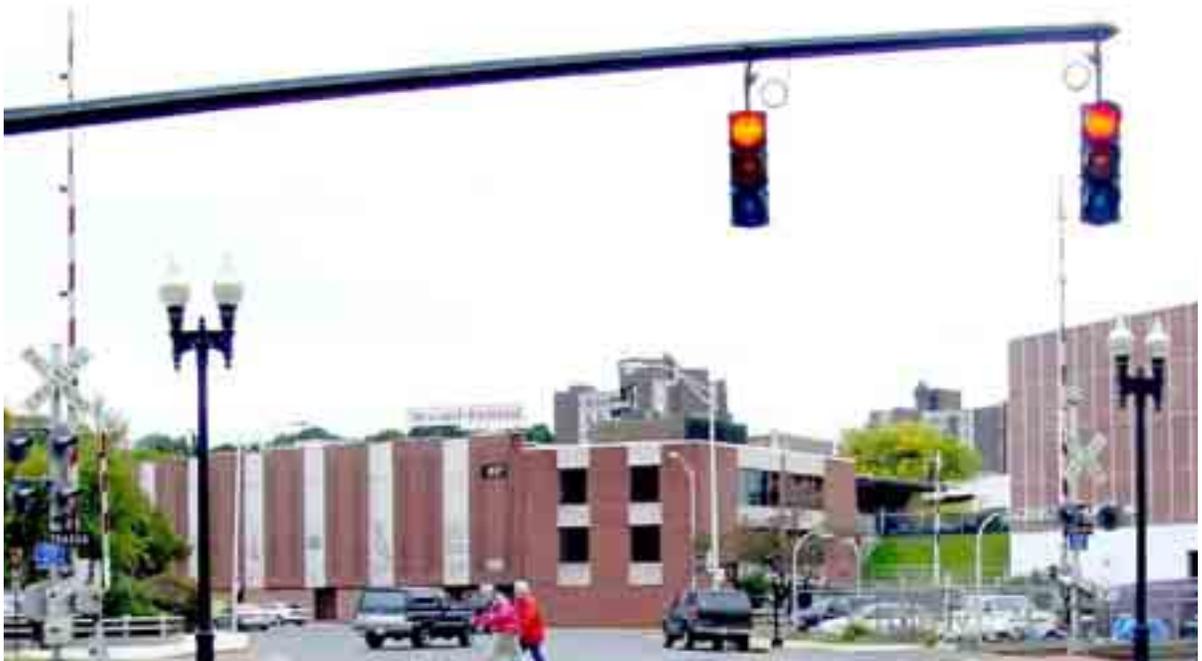
Crossing Name: South Colony Street, Milepost 18.5

Summary: 2 tracks, 2 highway gates, 2 pedestrian gates, 6 flashing lights, 2 mechanical bells
AAR/DOT Number 500655V

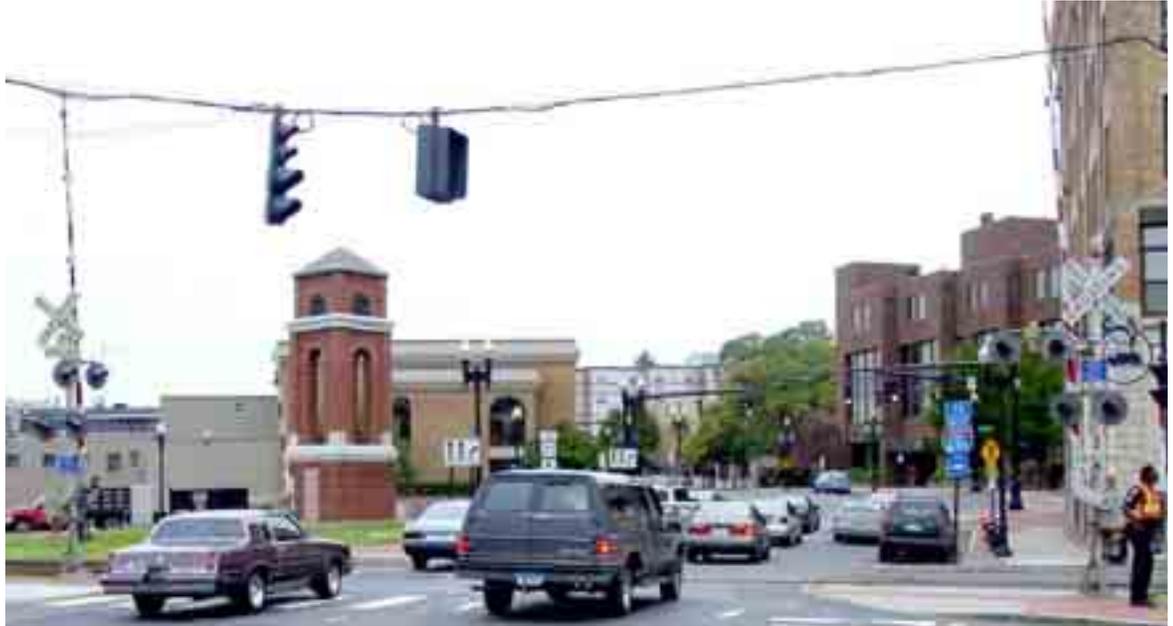
Crossing Name: East Main Street, Milepost 18.6

Summary: 2 tracks, 2 highway gates, 2 pedestrian gates, 8 flashing lights, one mechanical bell
AAR/DOT Number 500656C

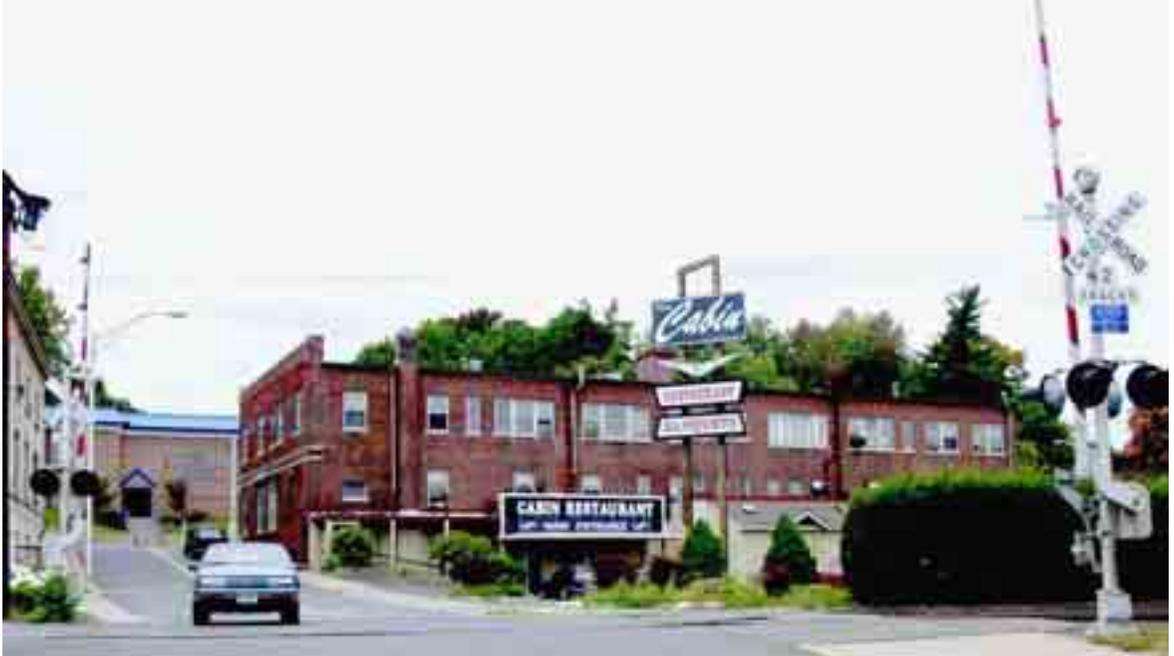
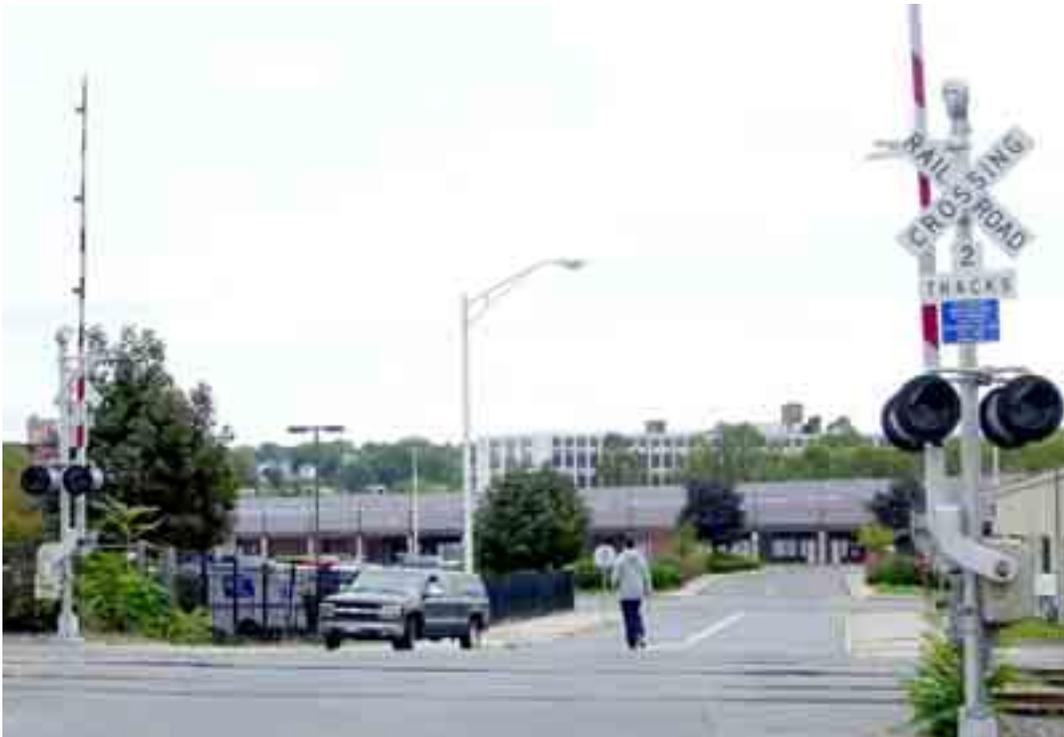
Crossing Name: Brook Street, Milepost 18.7

Summary: 2 tracks, two highway gates, 8 flashing lights, two mechanical bells.
AAR/DOT Number 500657J
