EXISTING CONDITIONS REPORT

New Haven – Hartford – Springfield
Commuter Rail Implementation Study

Memorandum

Subject: **State Project No. 170-2296**
New Haven, Hartford, Springfield Commuter Rail Feasibility Study
Task 6 – Evaluation of Existing Bridges – 33 Largest Total Length

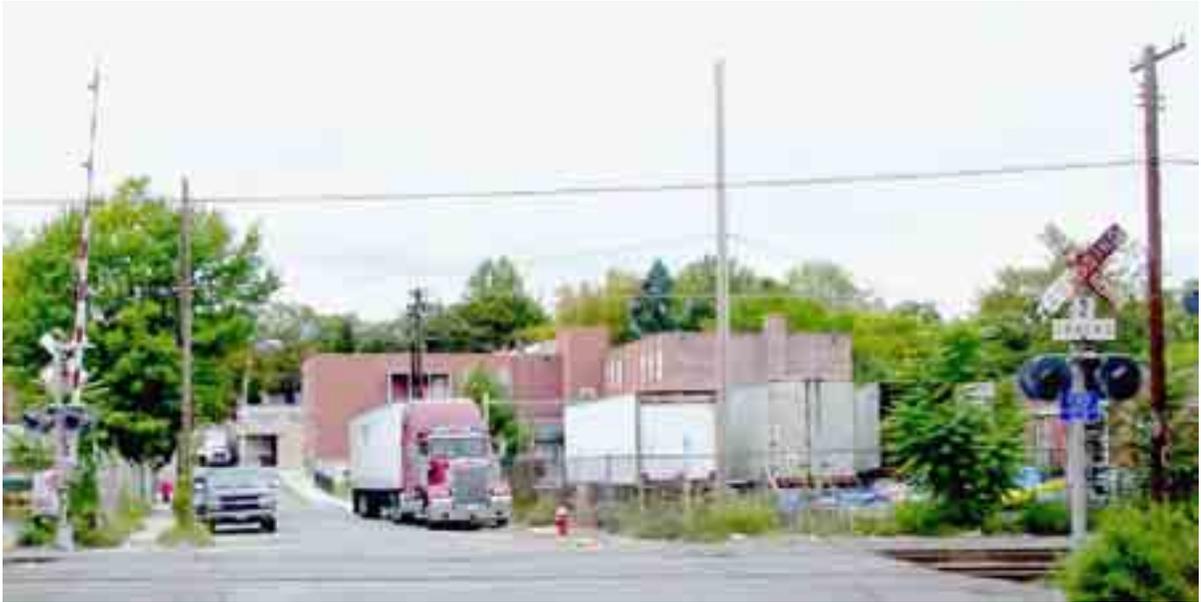
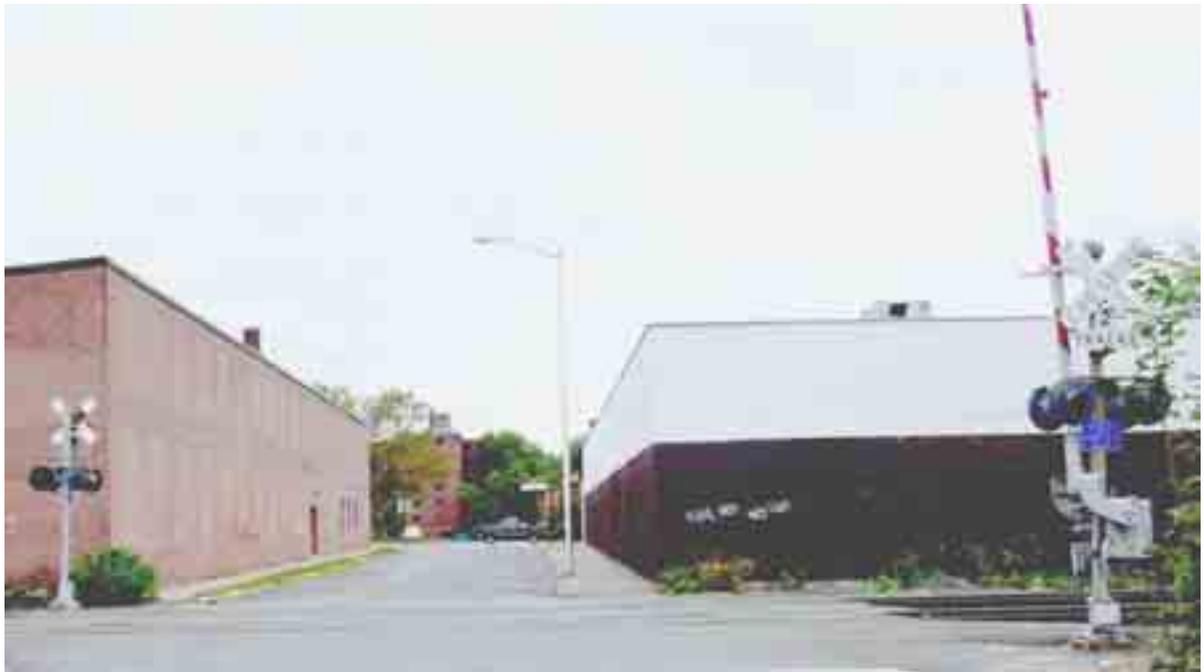
Crossing Name: Cross Street, Milepost 18.8

Summary: 2 tracks, one highway gate, 8 flashing lights, one mechanical bell.
AAR/DOT Number 500658R

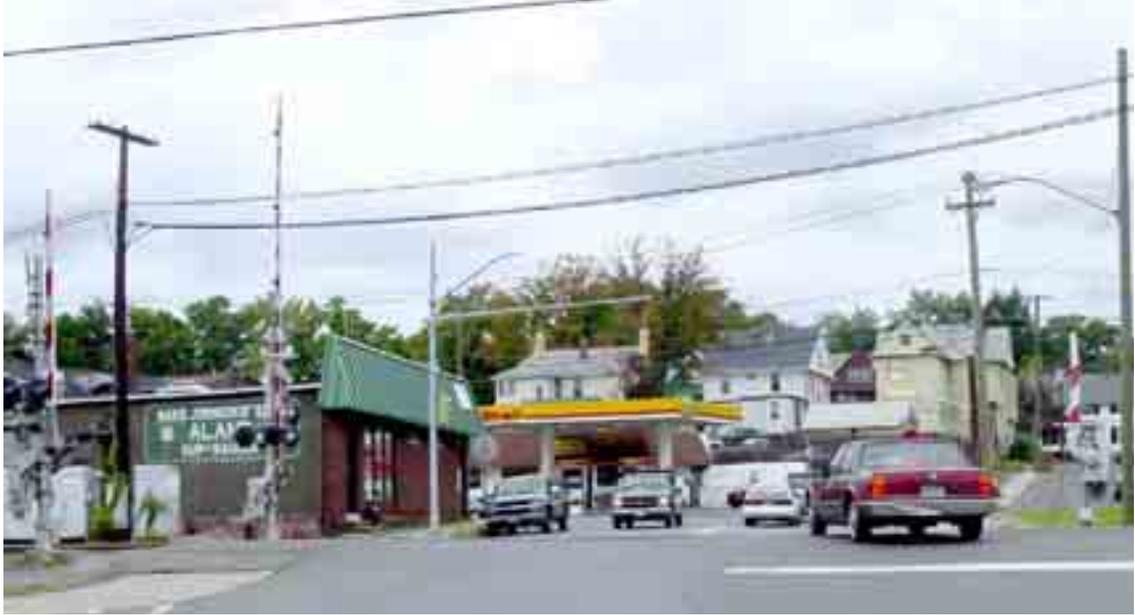
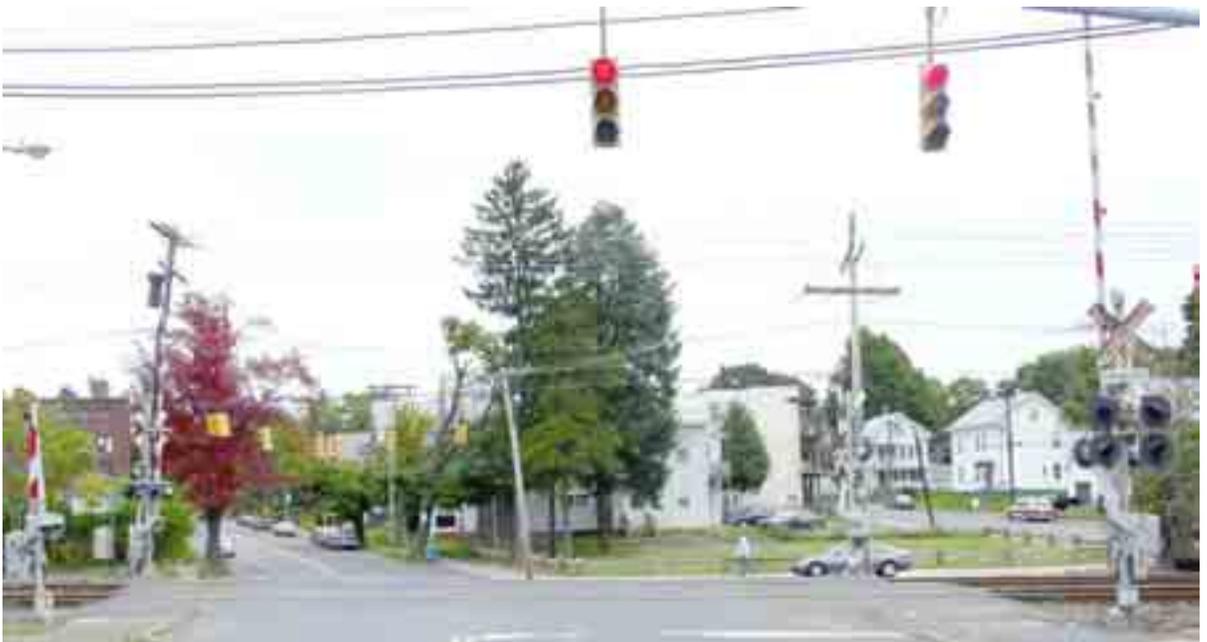
Crossing Name: Britannia Street, Milepost 19.4

Summary: 2 tracks, two highway gates, 14 flashing lights, one mechanical bell, two pedestrian gates
AAR/DOT Number 500661Y.

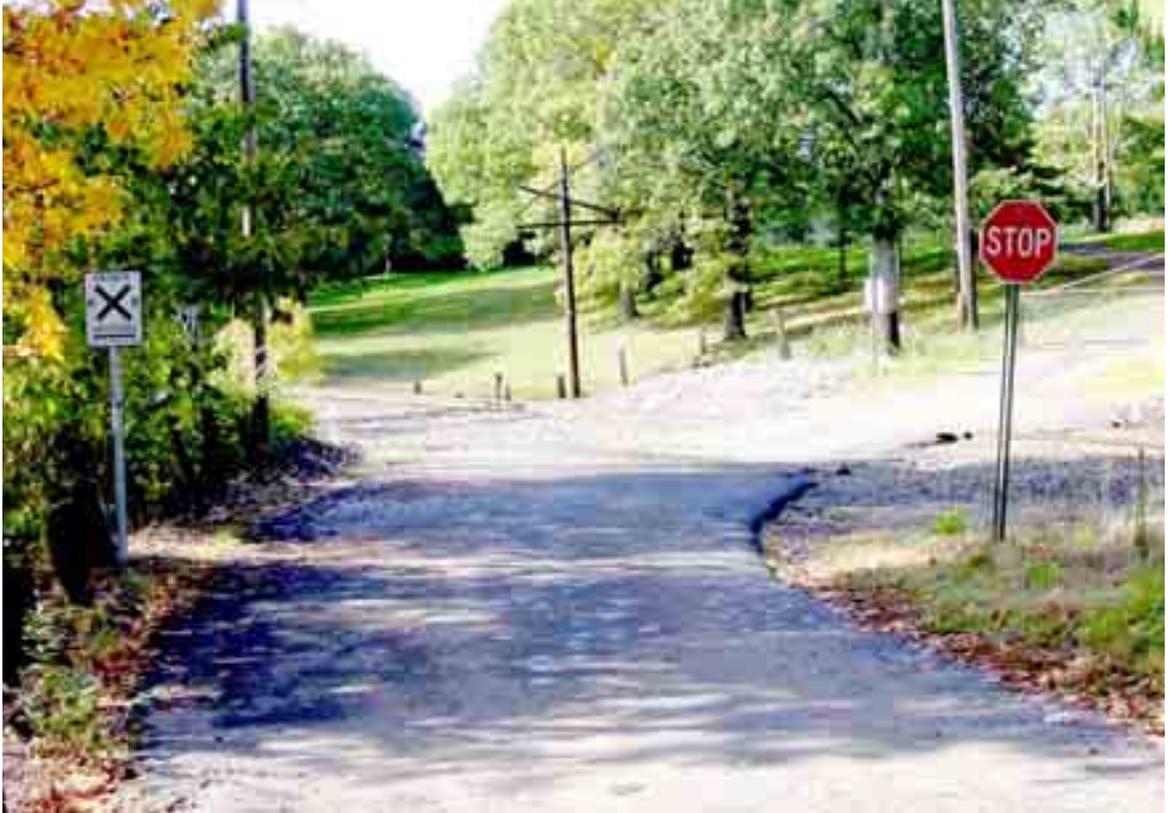
Crossing Name: Silver Lake (Norton), Milepost 22.0

Summary: 1 track, Stop Sign only.
AAR/DOT Number 500685M

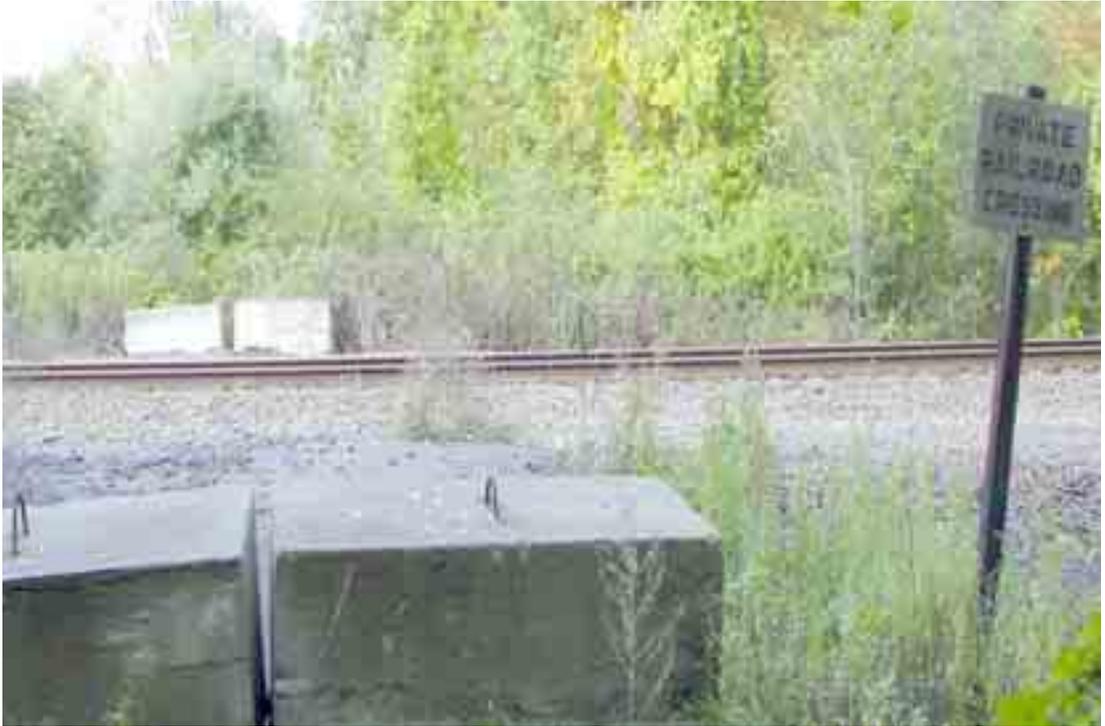
Crossing Name: Fish Pond, Milepost 22.6

Summary: 1 track, No warning devices; Crossing closed.
AAR/DOT Number Not on FRA List

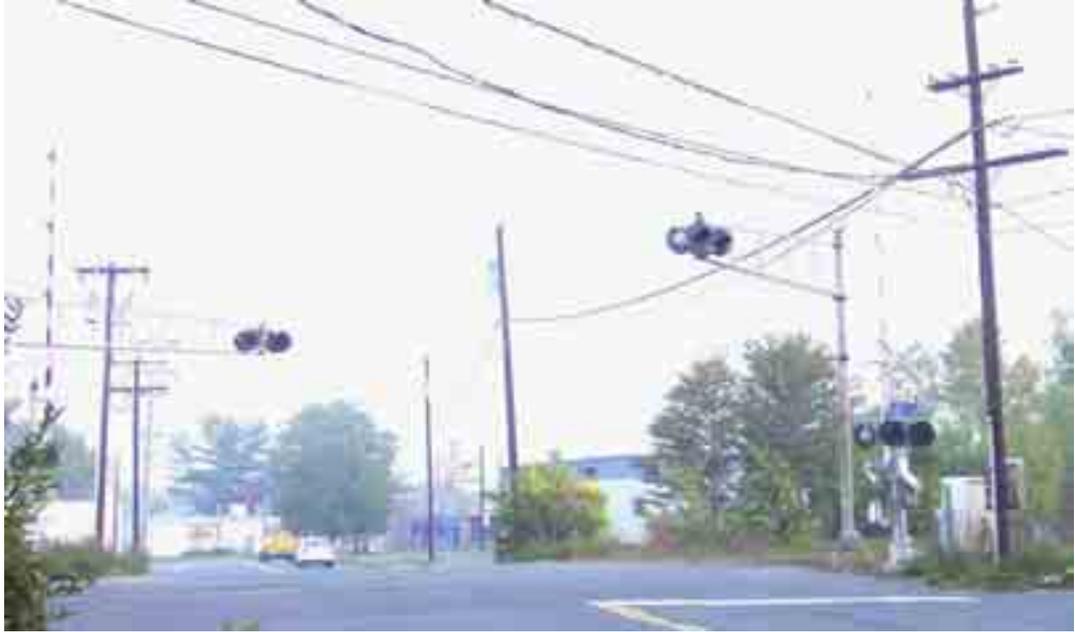
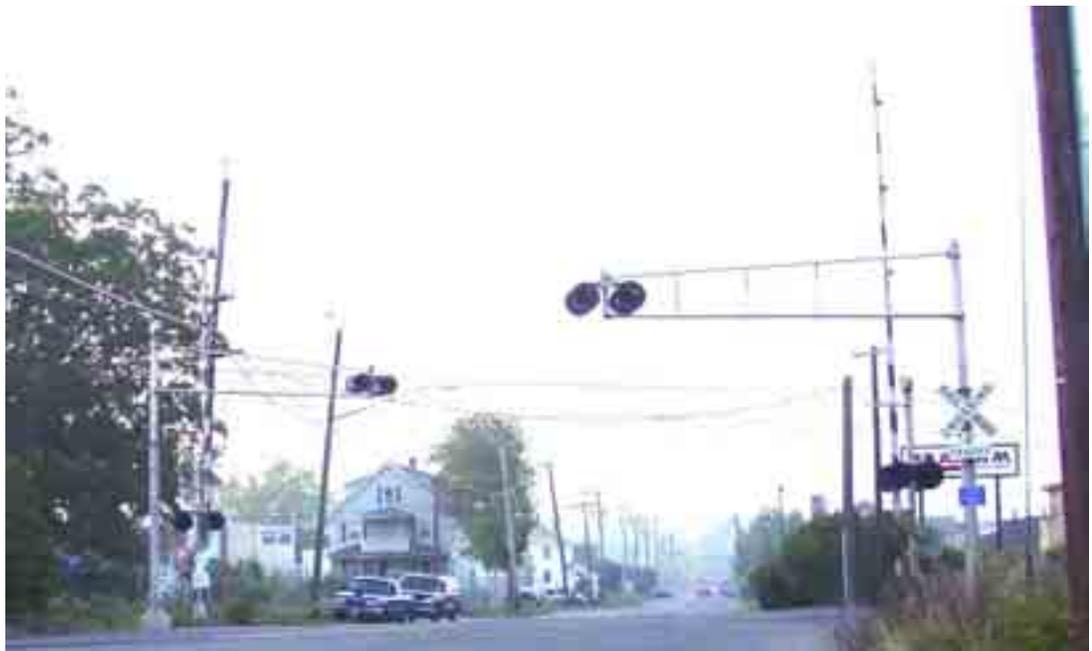
Crossing Name: Oakwood Avenue, Milepost 33.5

Summary: 2 tracks, 2 highway gates, 16 flashing lights, 1 mechanical bell, 2 cantilevers.
AAR/DOT Number 500697G.

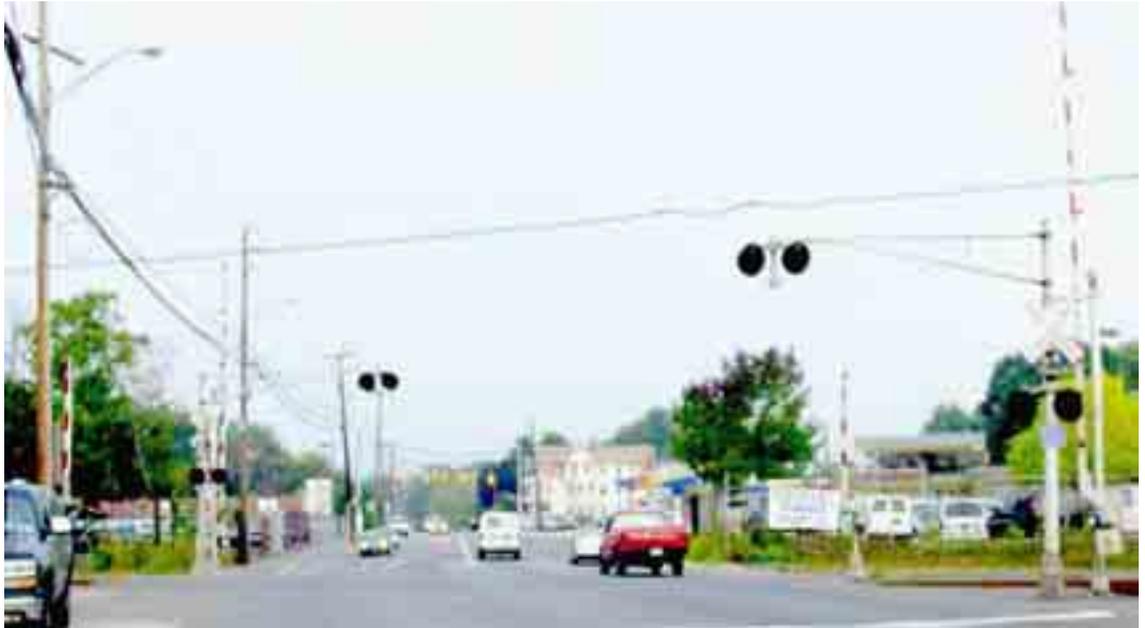
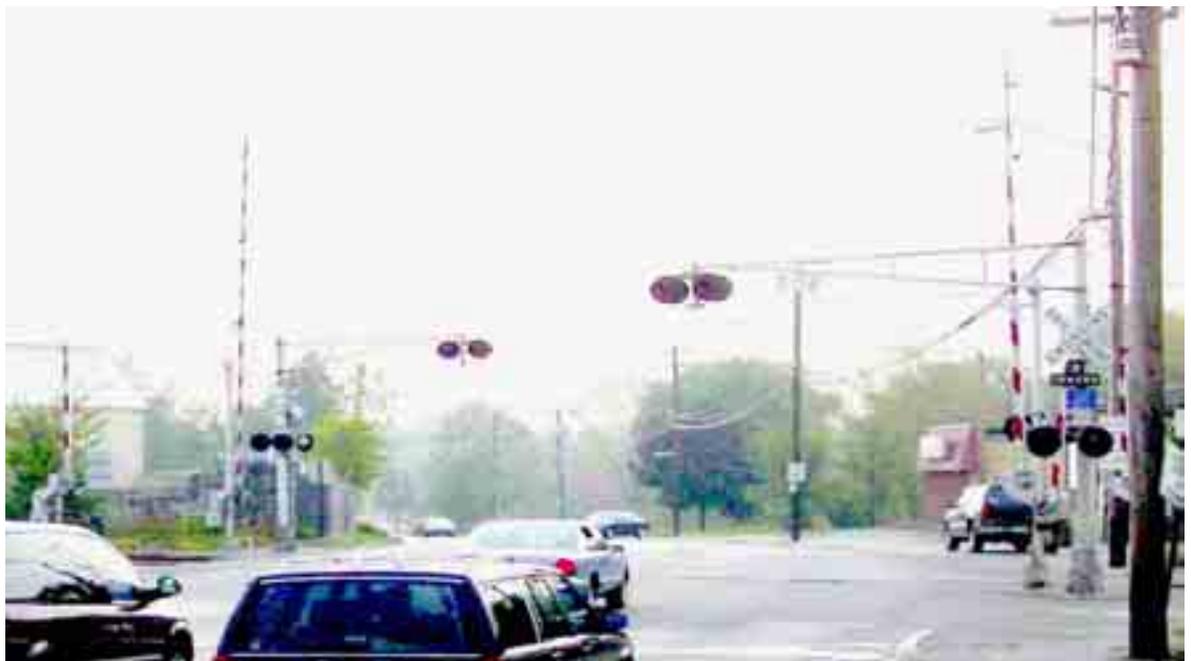
Crossing Name: Flatbush Avenue, Milepost 33.9

Summary: 2 tracks, 2 highway gates, 2 pedestrian gates, 16 flashing lights, 1 mechanical bell,
2 cantilevers
AAR/DOT Number 500698N

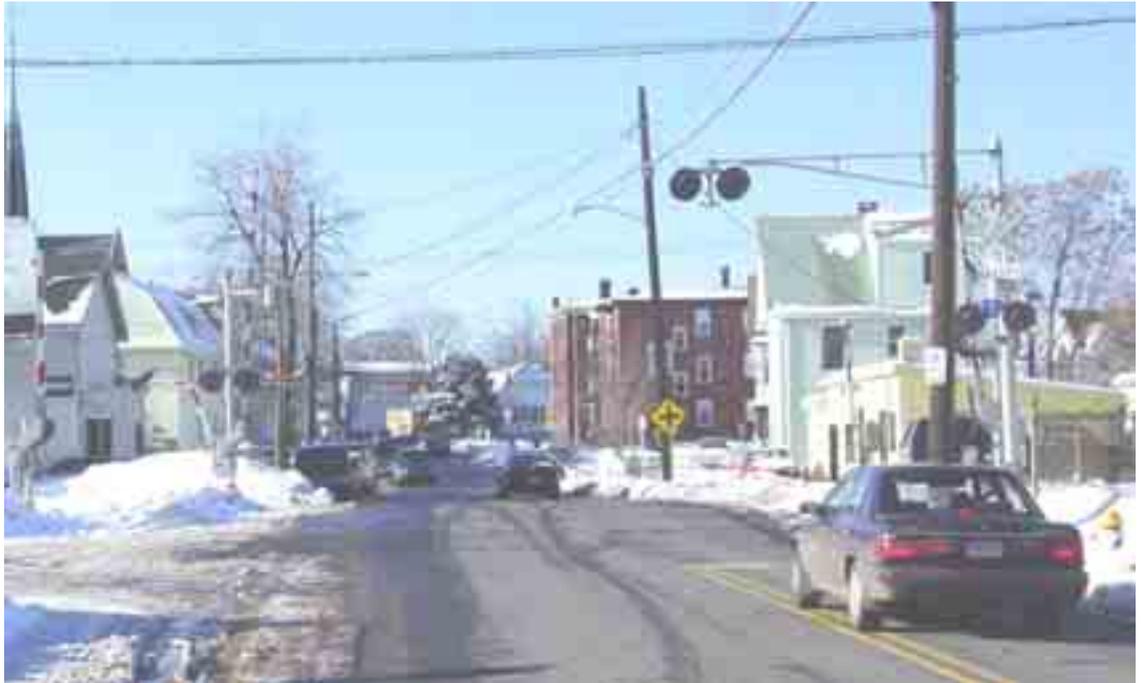
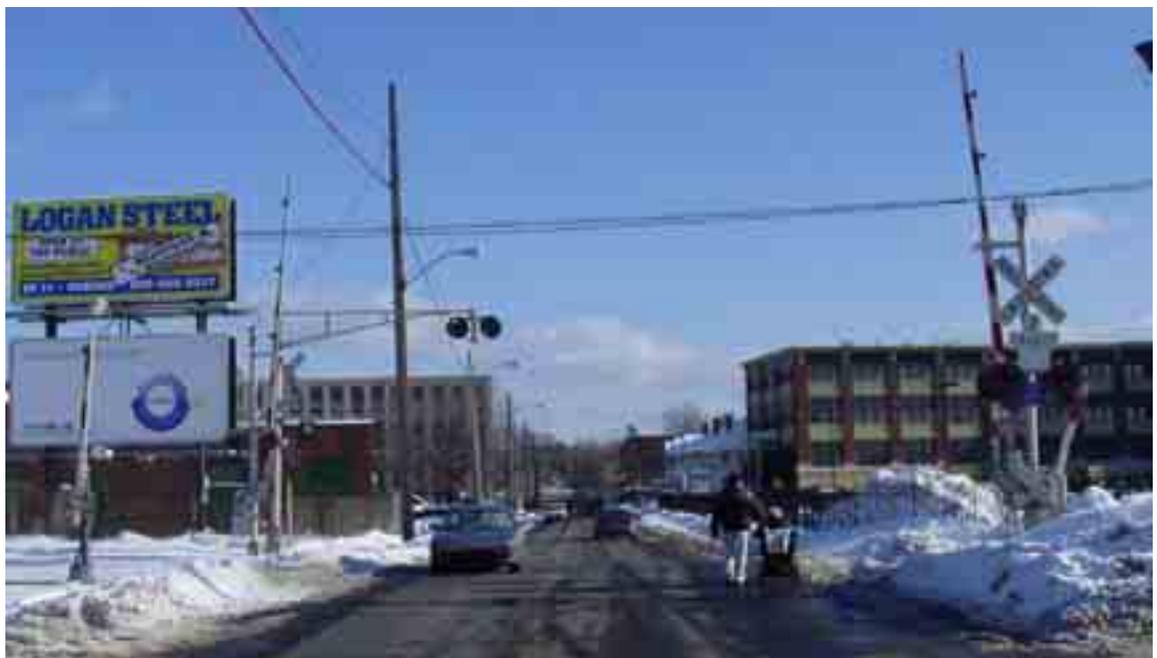
Crossing Name: Hamilton Street, Milepost 34.9

Summary: 2 tracks, 2 highway gates, 2 pedestrian gates, 16 flashing lights, 2 mechanical bells, 2 cantilevers
AAR/DOT Number 500700M

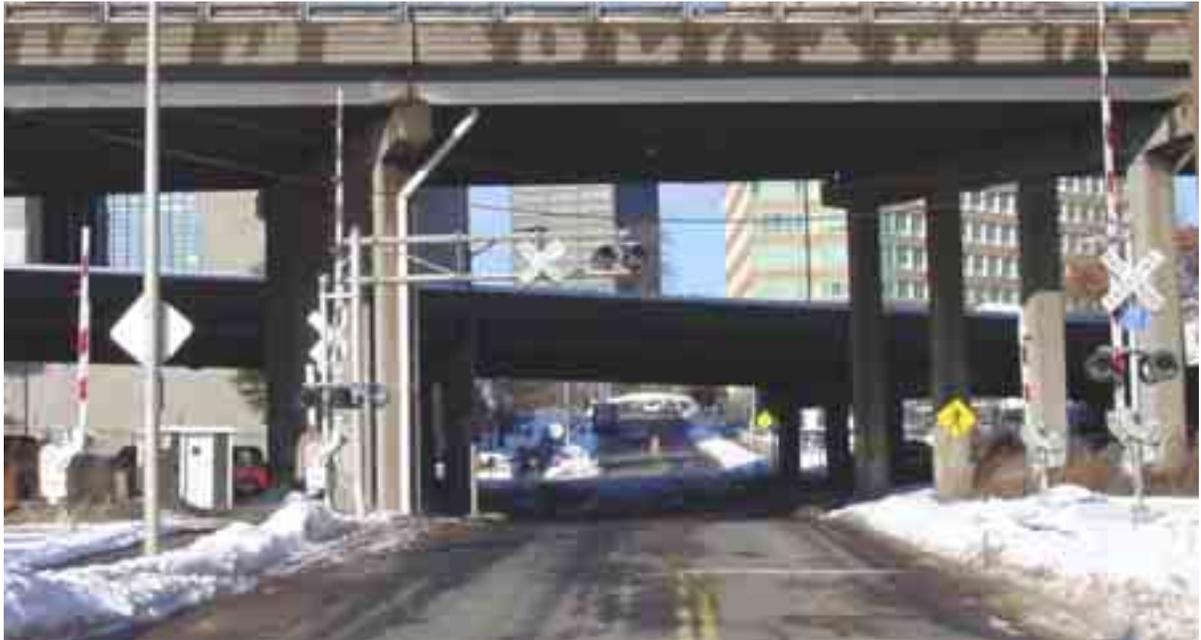
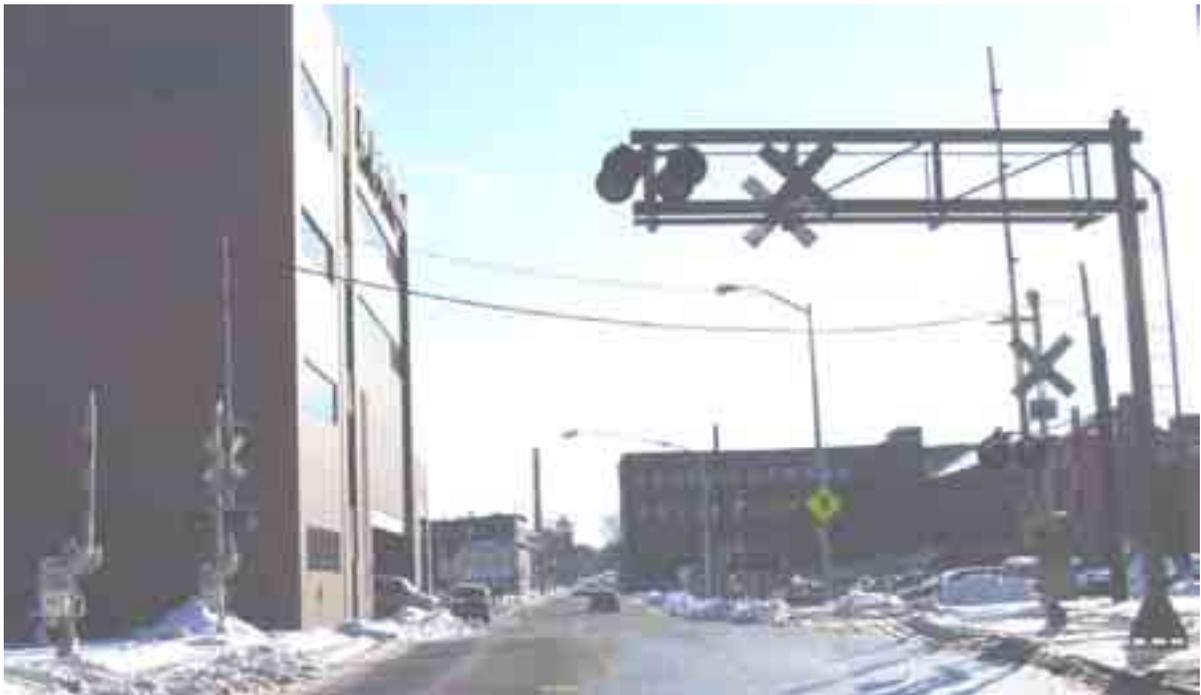
Crossing Name: Flower Street, Milepost 36.2

Summary: 1 track, 2 highway gates, 2 pedestrian gates, 2 mechanical bells,
1 cantilever
AAR/DOT Number 500710T

Hartford	Flower Street	500710T	36.2	1	Flashers and gates, 2 bells 8-3/8" lights	Northwest; Southeast	Constant Warning (AFO)	Southwest side	Adequate	Clear	Fair	Back to back lights on cantilever
Windsor	Meadow Road	500725H	39.7	1	Flashers and gates, 1 bell 8-3/8" lights	None	Constant Warning (AFO)	None	Adequate	Partially impaired	Fair	Cross bucks rusty, broken signal pole junction box southwest side
Windsor	Wilson Ave	500726P	39.8	1	Flashers, 1 bell 8-3/8" lights	None	Constant Warning (AFO)	None	Worn	Clear	Fair	Gravel crossing surface
Windsor	East Barber Street	500727W	40.1	1	Flashers and gates, 1 bell 8-3/8" lights	None	Constant Warning (AFO)	South west side of crossing	Adequate	Clear	Fair	Radio repeater station and hot box/dragging equipment Detector location
Windsor	Island Road	500729K	42.2	1	Flashers and gates, 1 bell 8-3/8" lights	None	Constant Warning (AFO)	None	Adequate	Clear	Fair	
Windsor	Central Street	500731L	42.9	1	Flashers and gates, 1 bell 8-3/8" lights	Northwest; South east	Constant Warning (AFO)	None	Adequate	Clear	Fair

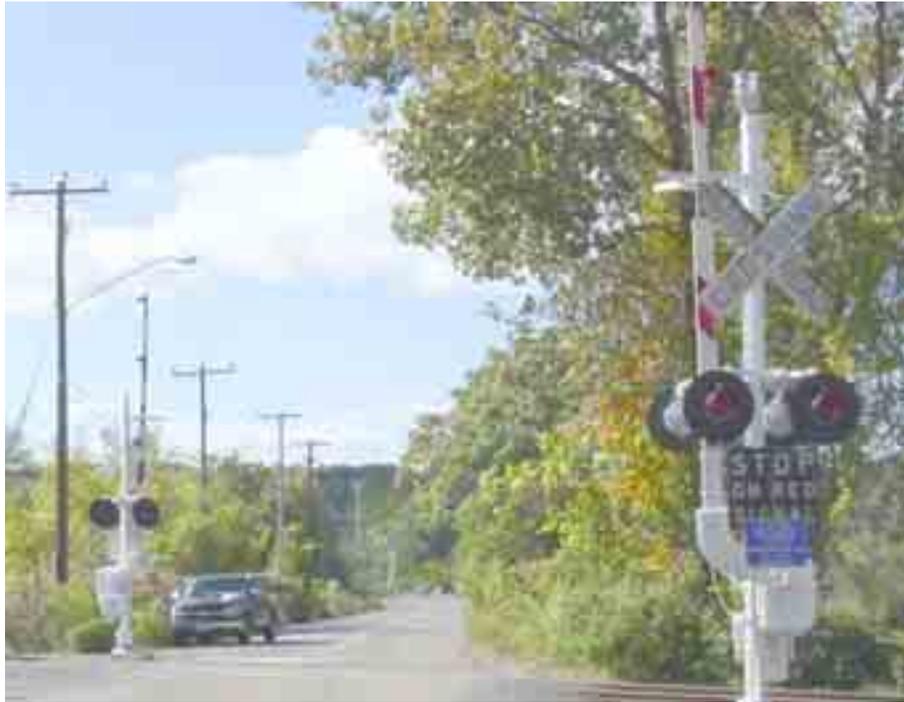
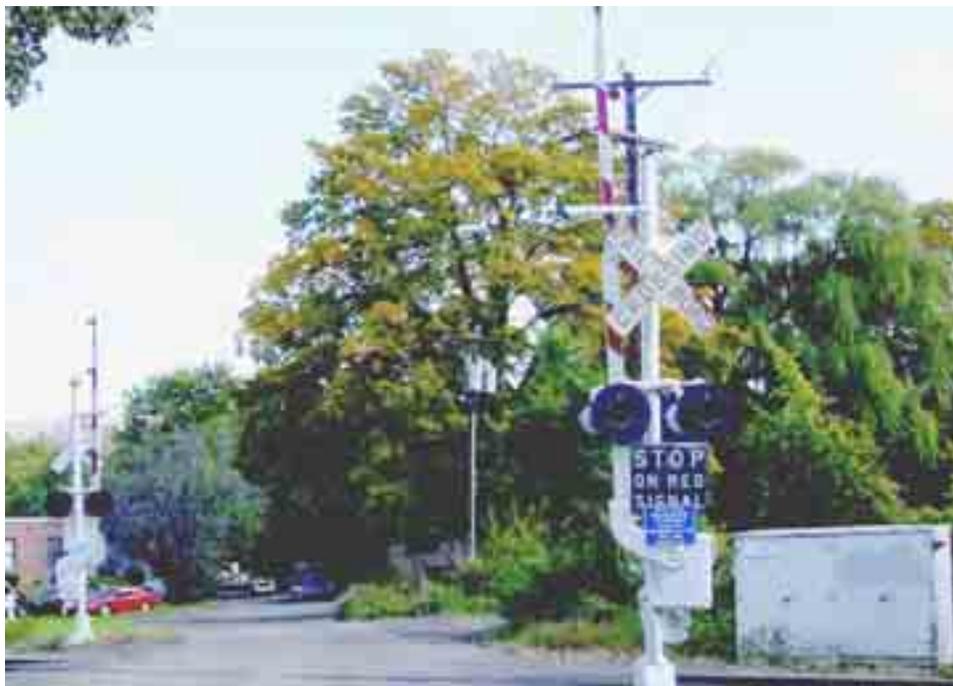
Crossing Name: Meadow Road, Milepost 39.7

Summary: 1 track, 2 highway gates, 8 flashing lights, 1 mechanical bell.
AAR/DOT Number 500725H

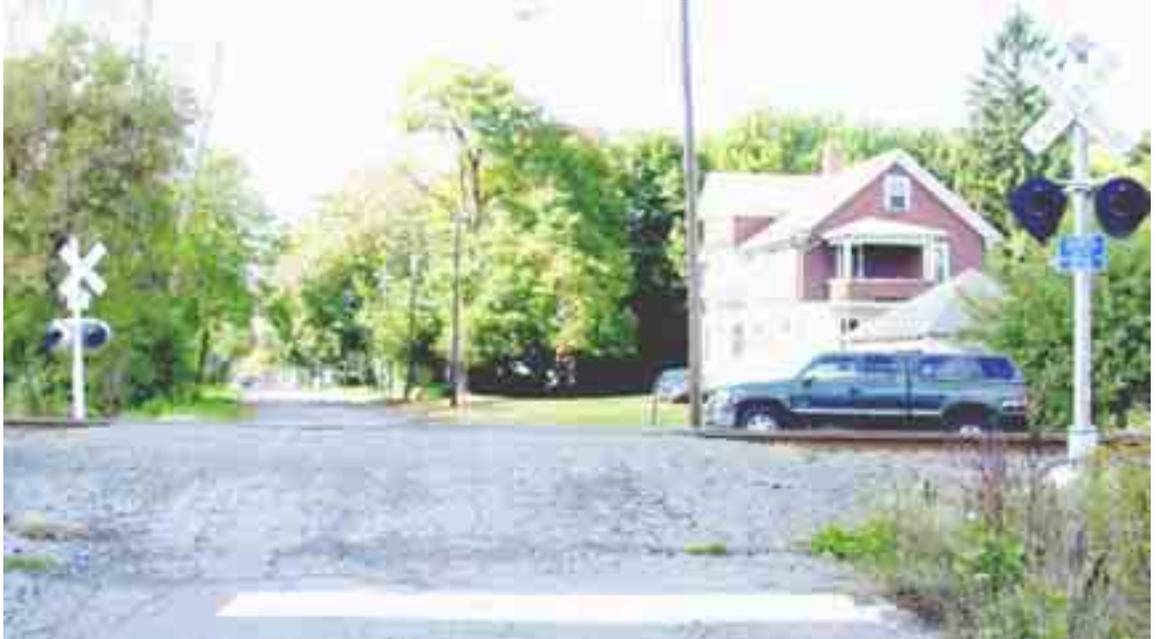
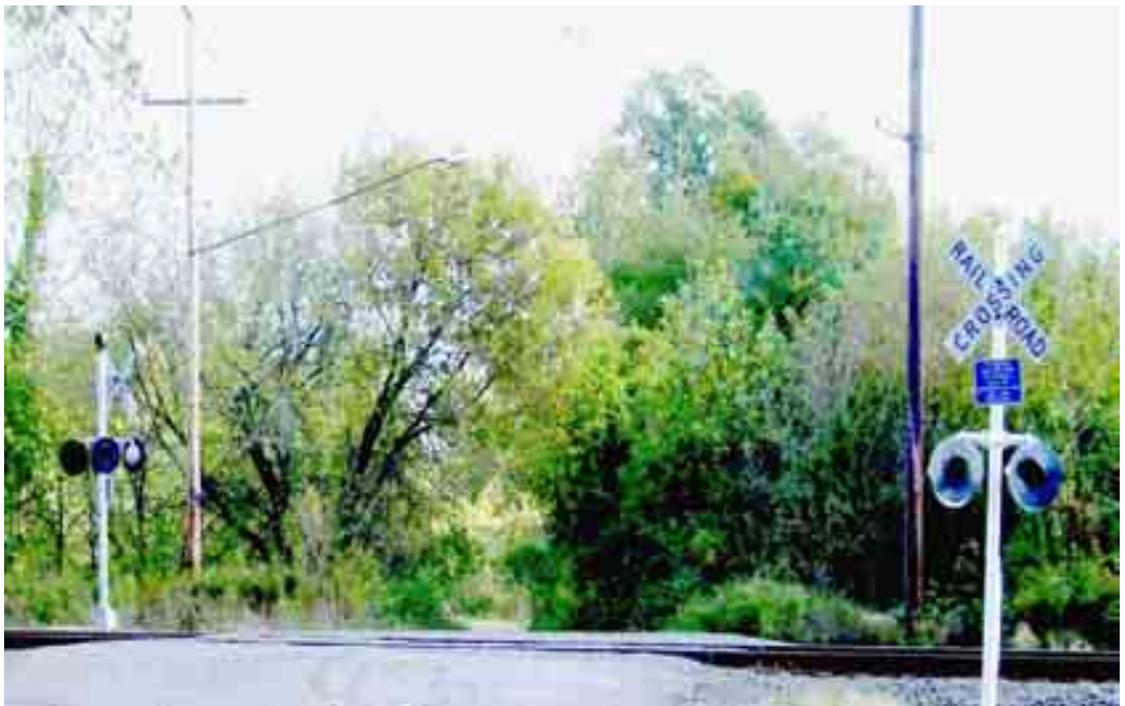
Crossing Name: Wilson Avenue, Milepost 39.8

Summary: 1 track, 8 flashing lights, 1 mechanical bell.
AAR/DOT Number 500726P

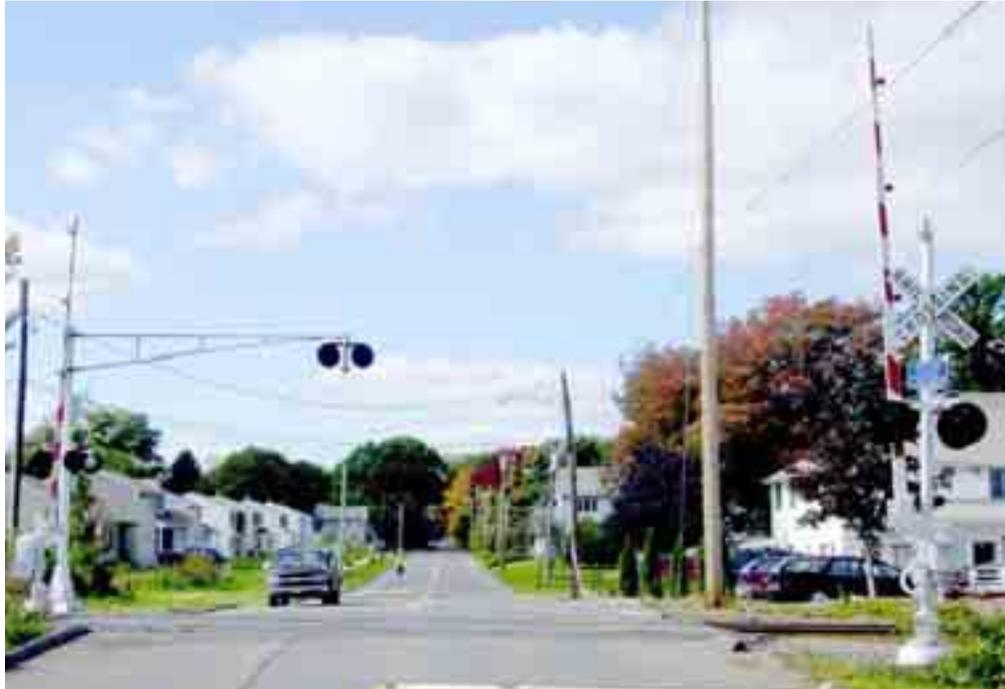
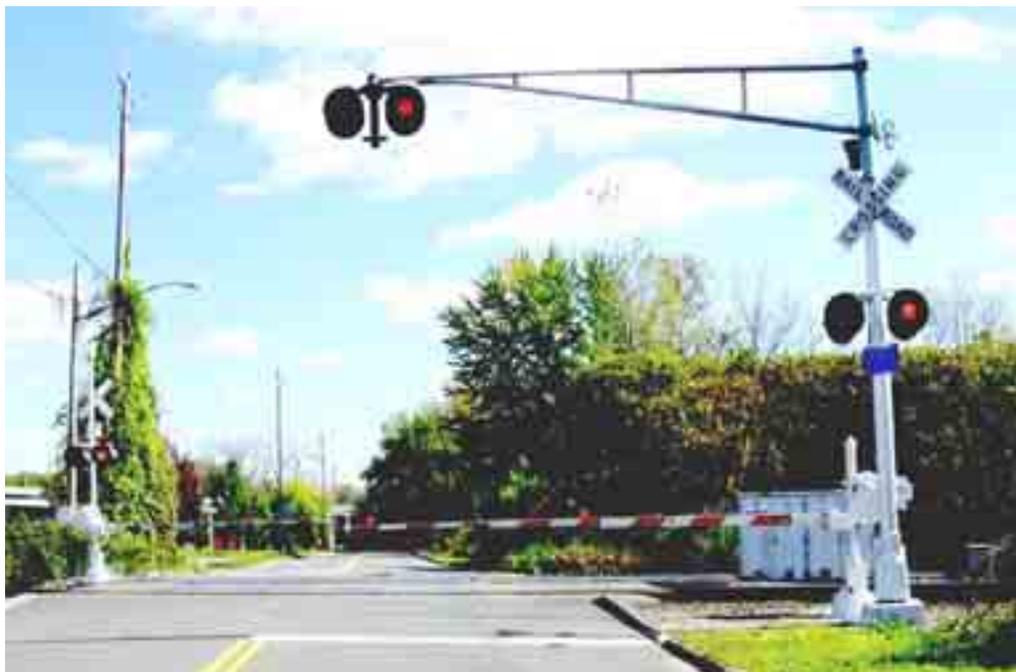
Crossing Name: East Barber Street, Milepost 40.1

Summary: 1 track, 2 highway gates, 12 flashing lights, 1 mechanical bell, 1 cantilever
AAR/DOT Number 500727W

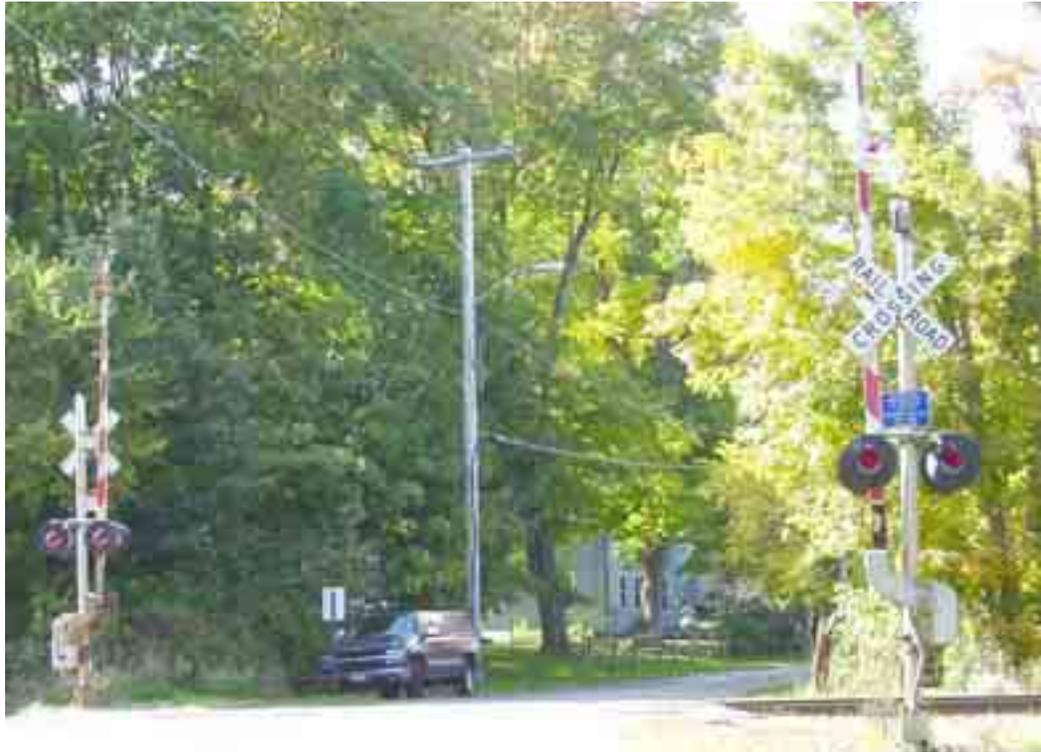
Crossing Name: Island Road, Milepost 42.2

Summary: 1 track, 2 highway gates, 8 flashing lights, 1 mechanical bell.
AAR/DOT Number 500729K

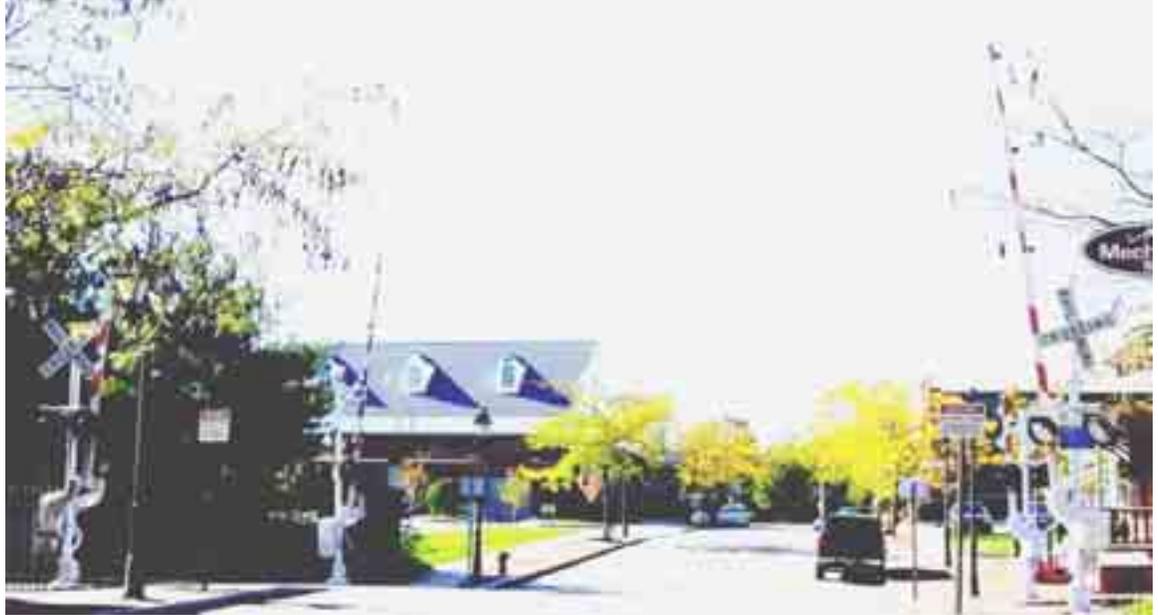
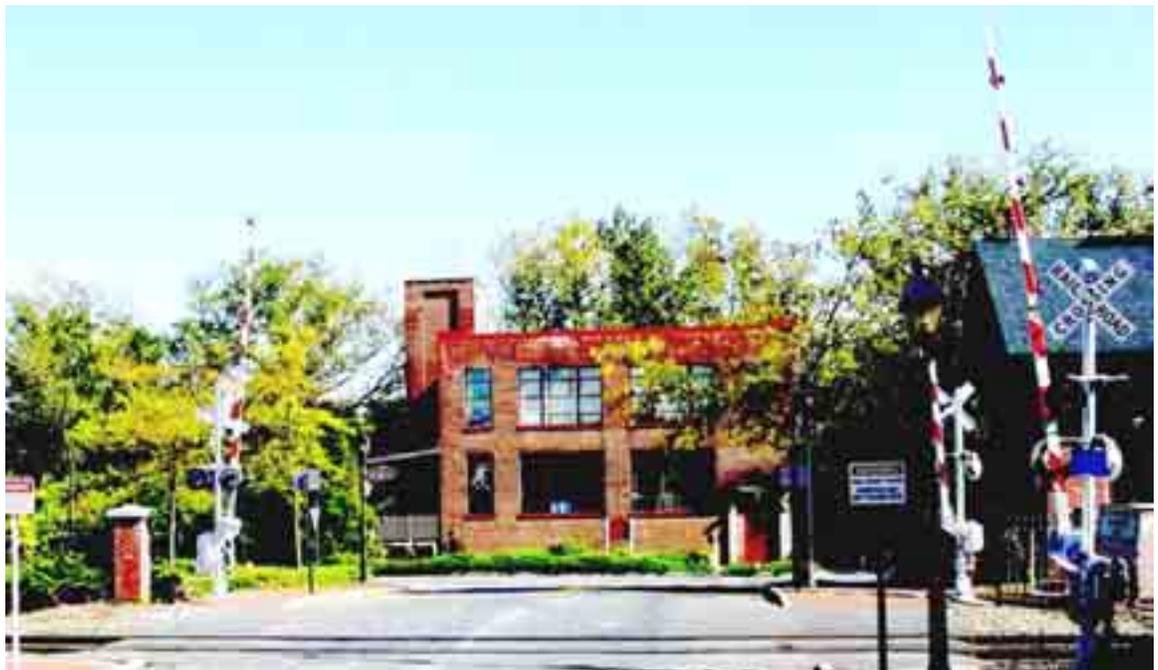
Crossing Name: Central Street, Milepost 42.9

Summary: 1 track, 2 highway gates, 2 pedestrian gates, 10 flashing lights, 1 mechanical bell
AAR/DOT Number 500731L

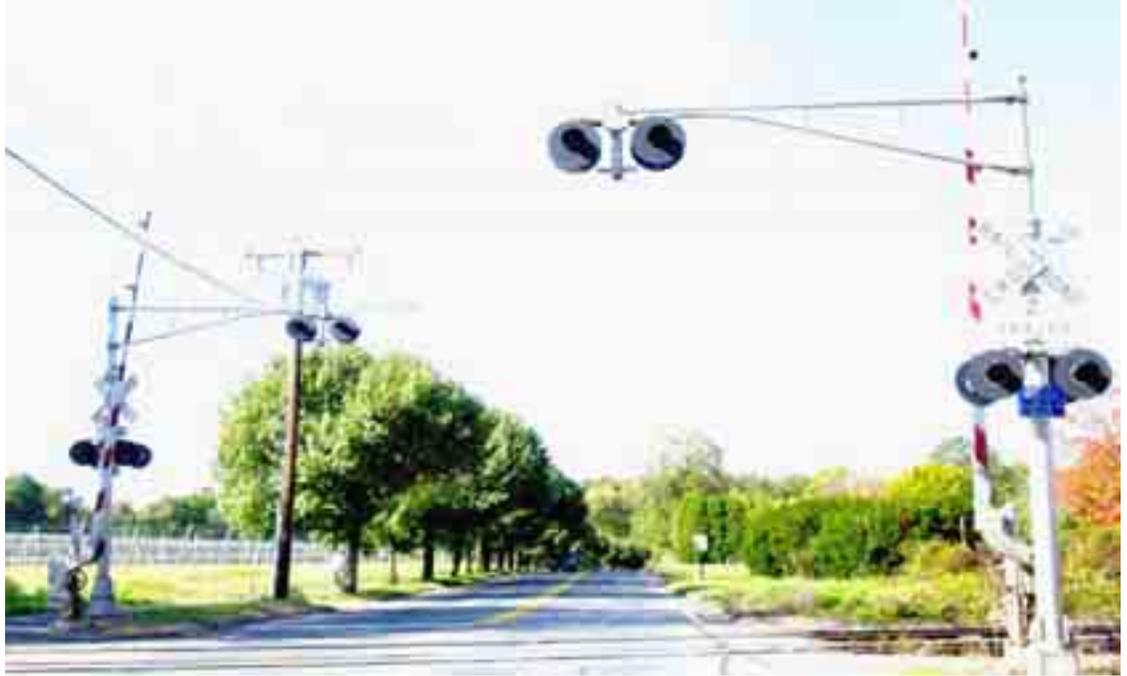
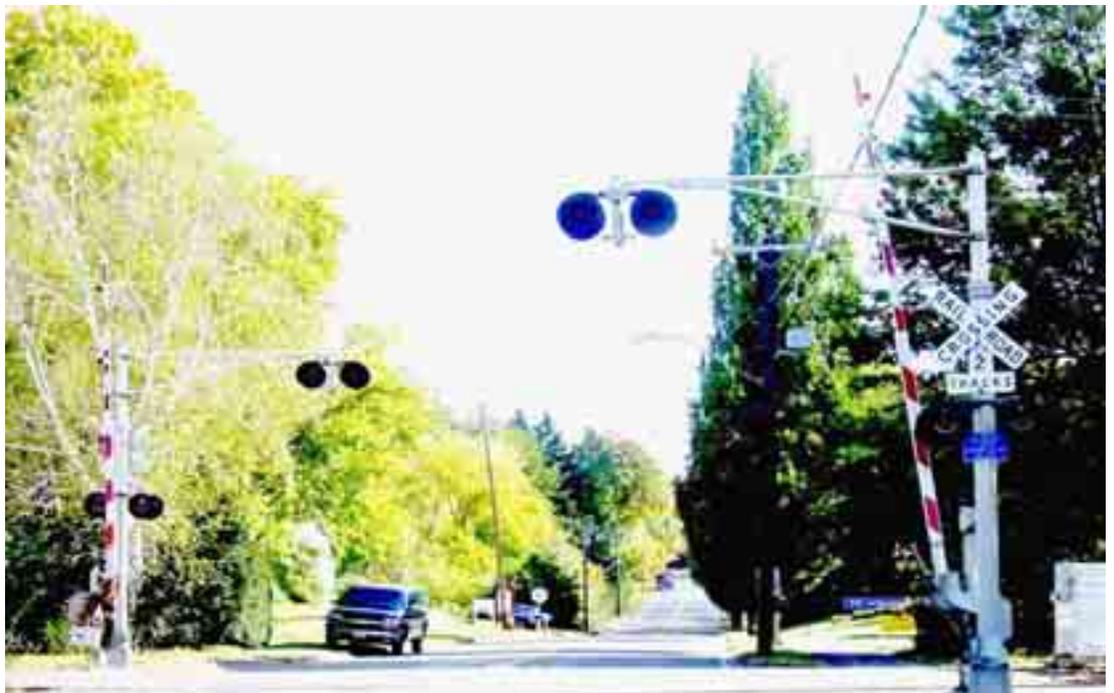
Crossing Name: Pierson Lane, Milepost 43.6

Summary: 2 tracks, 2 highway gates, 16 flashing lights, 1 mechanical bell, 2 cantilevers.
AAR/DOT Number 500734G

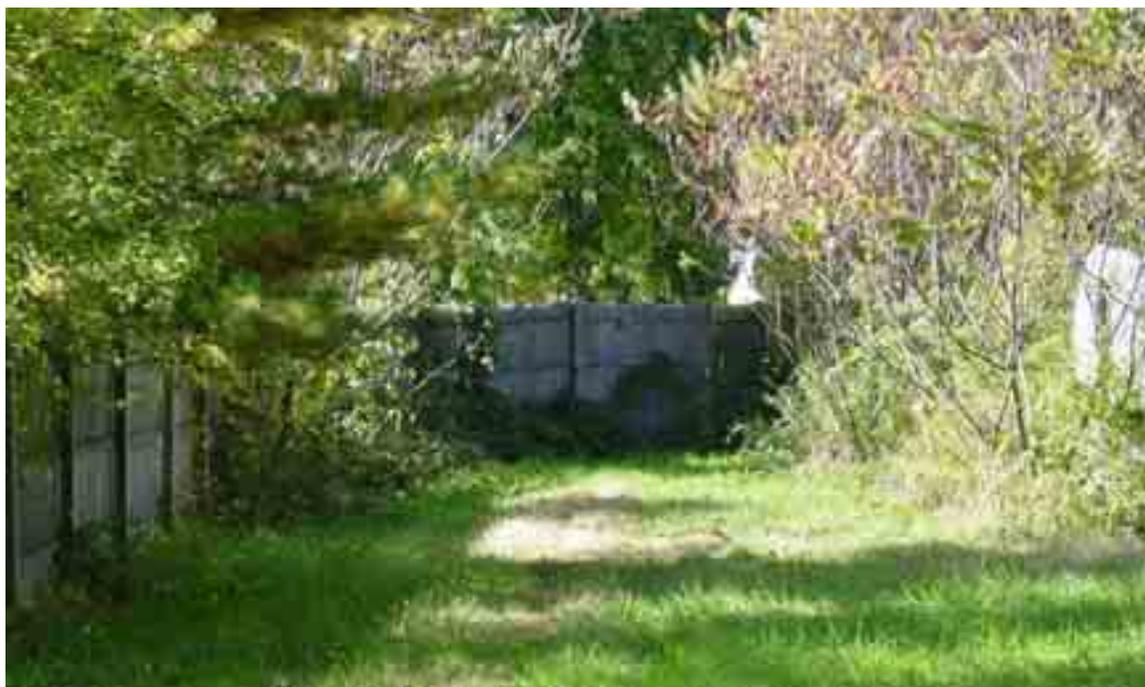
Crossing Name: Christiansons, Milepost 44.5

Summary: 2 tracks, No warning devices (Crossing closed).
AAR/DOT Number - No Number assigned, not on FRA list

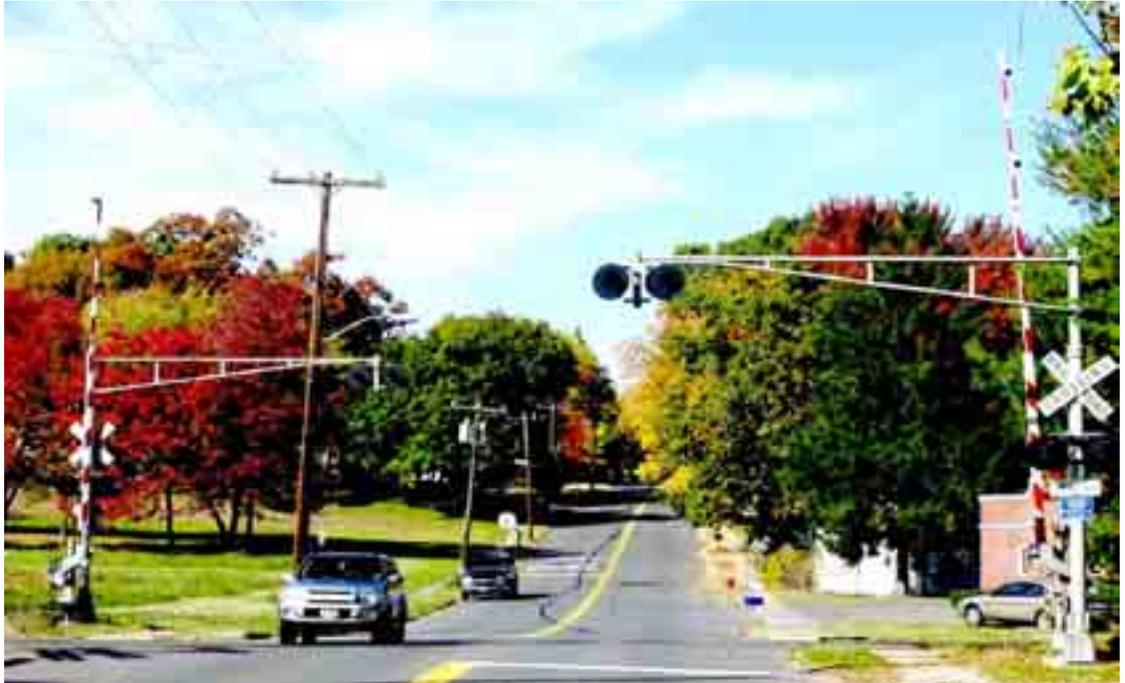
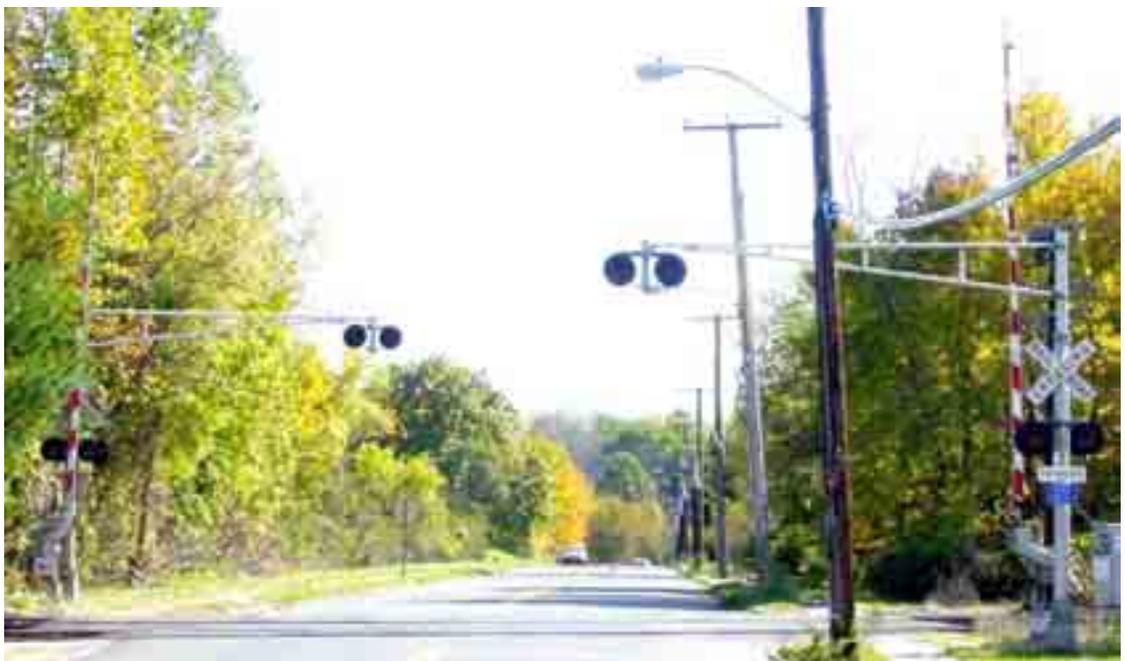
Crossing Name: Macktown Road, Milepost 45.0

Summary: 2 tracks, 2 highway gates, 16 flashing lights, 1 mechanical bell, 2 cantilevers.
AAR/DOT Number 500739R
