EXISTING CONDITIONS REPORT

New Haven – Hartford – Springfield
Commuter Rail Implementation Study

Memorandum

Subject: **State Project No. 170-2296**
New Haven, Hartford, Springfield Commuter Rail Feasibility Study
Task 6 – Evaluation of Existing Bridges – 33 Largest Total Length

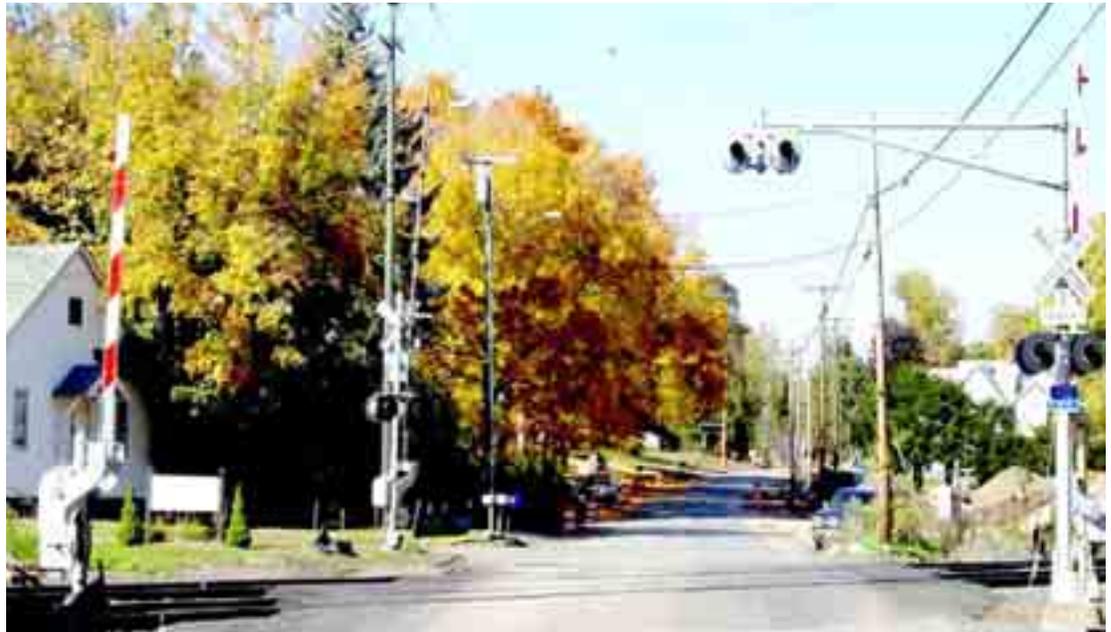
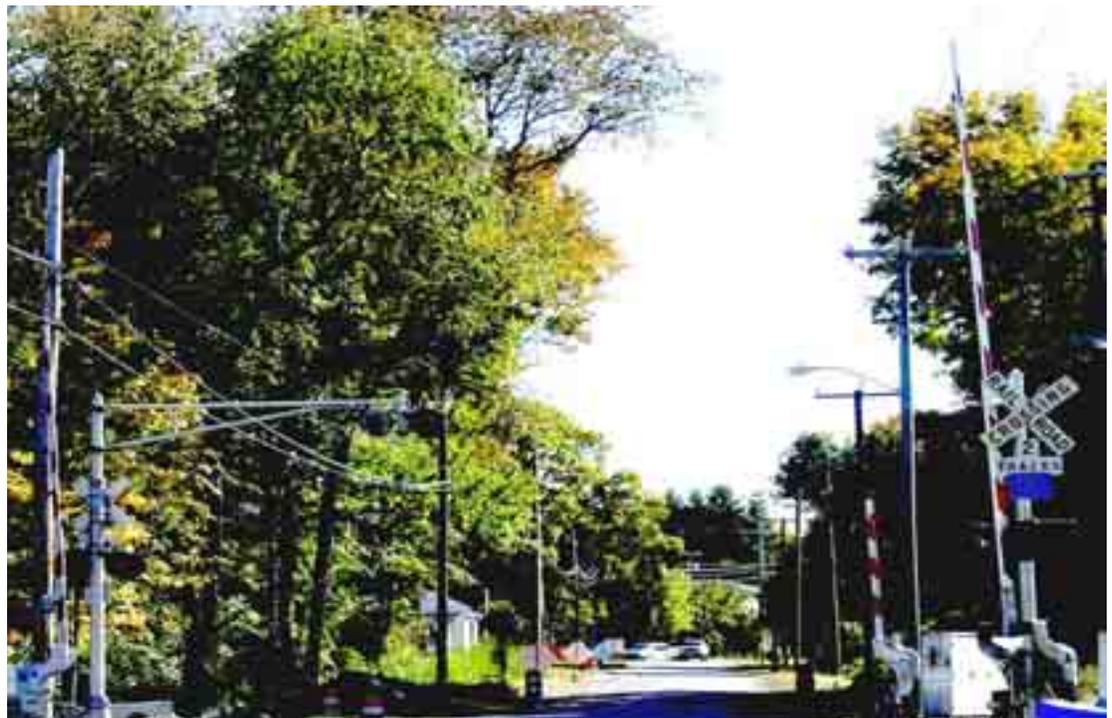
Crossing Name: Hayden Station Road, Milepost 45.6

Summary: 2 tracks, 2 highway gates, 1 pedestrian gate, 12 flashing lights, 1 mechanical bell, 1 cantilever
AAR/DOT Number 500741S

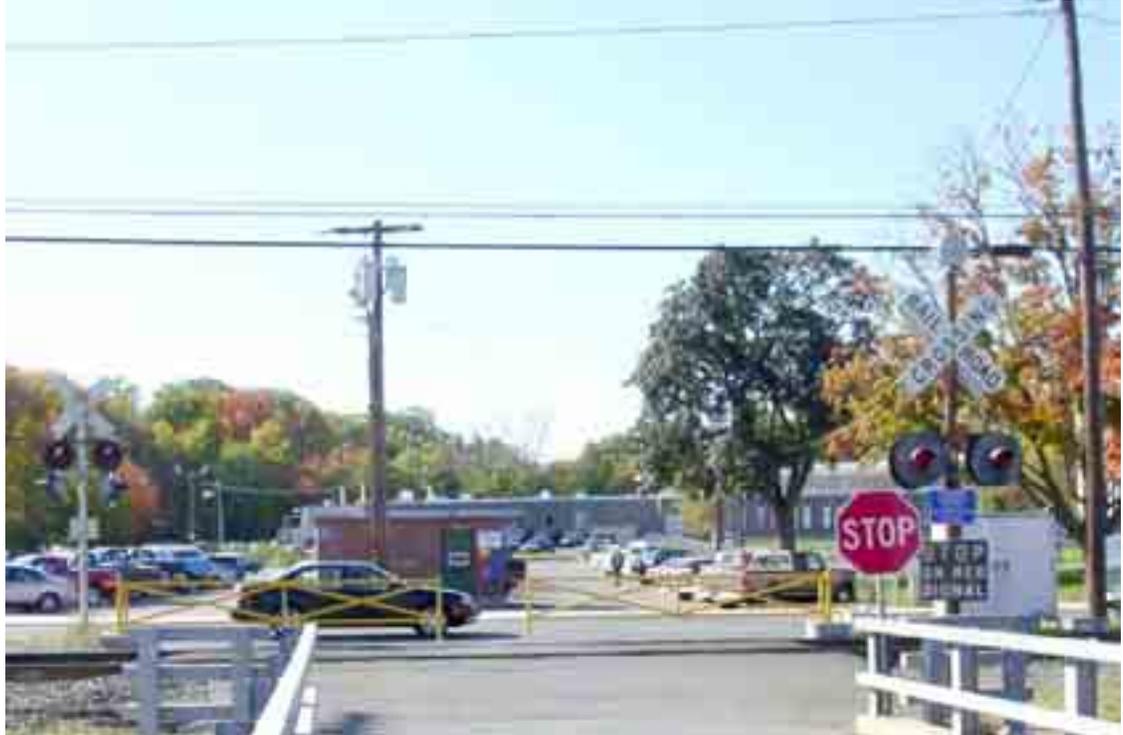
Crossing Name: Dexter Mills, Milepost 48.1

Summary: 1 track, 10 flashing lights, 1 mechanical bell.
AAR/DOT Number 500746T

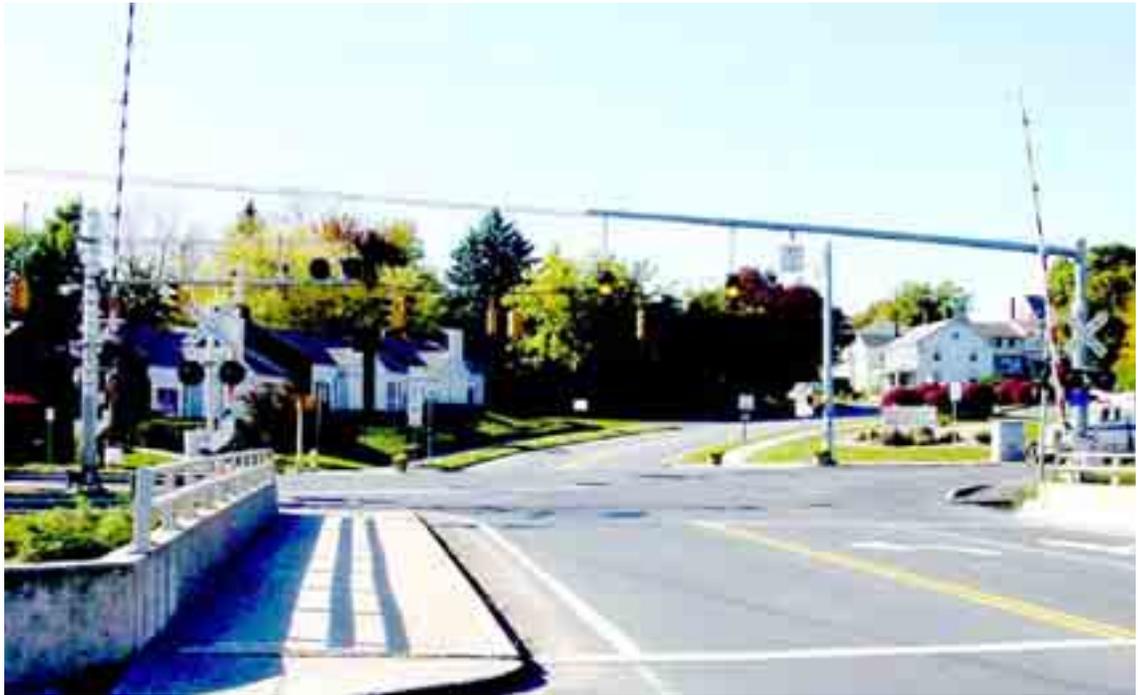
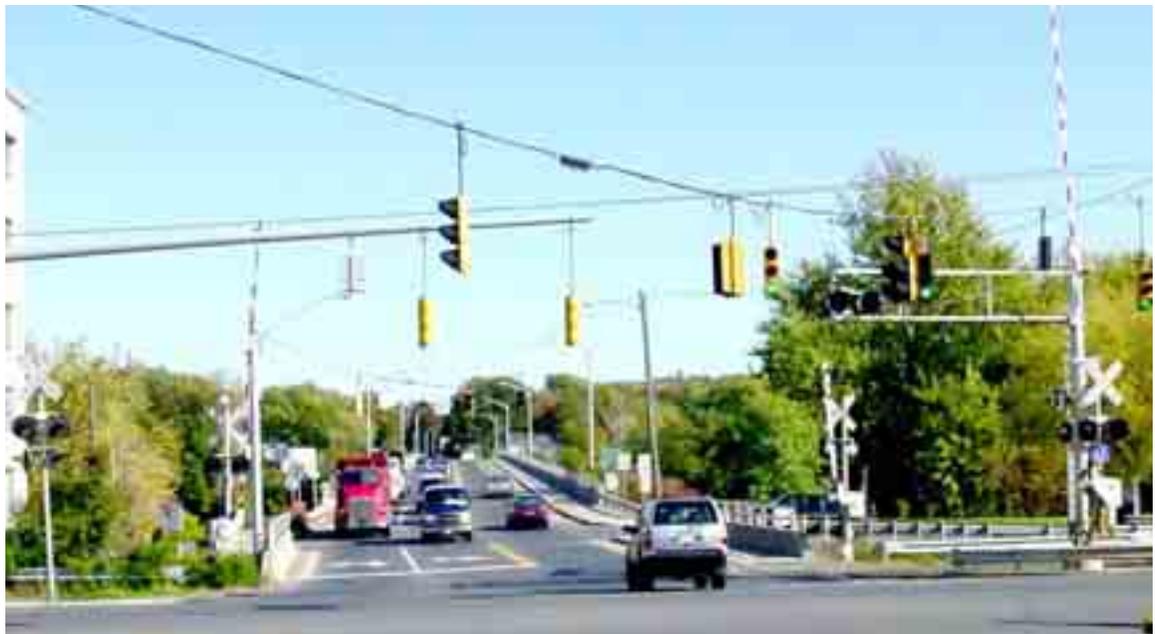
Crossing Name: Bridge Street, Milepost 48.4

Summary: 1 track, 2 highway gates, 1 pedestrian gate, 14 flashing lights, 2 mechanical bells, 1 cantilever
AAR/DOT Number 500747H

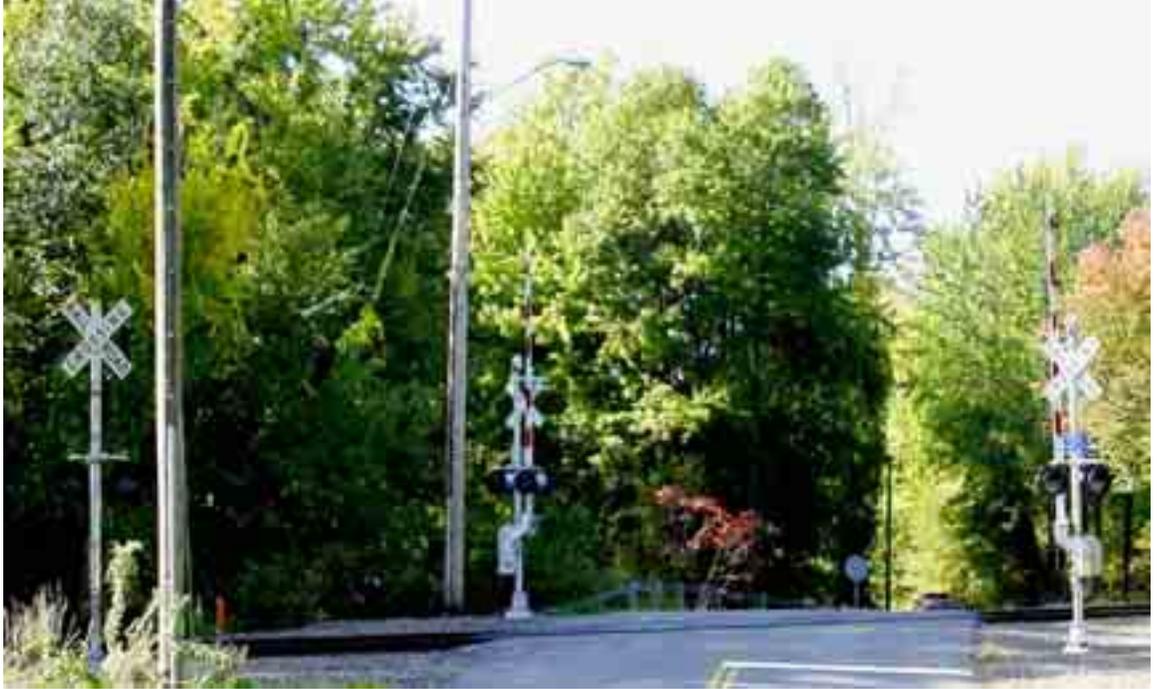
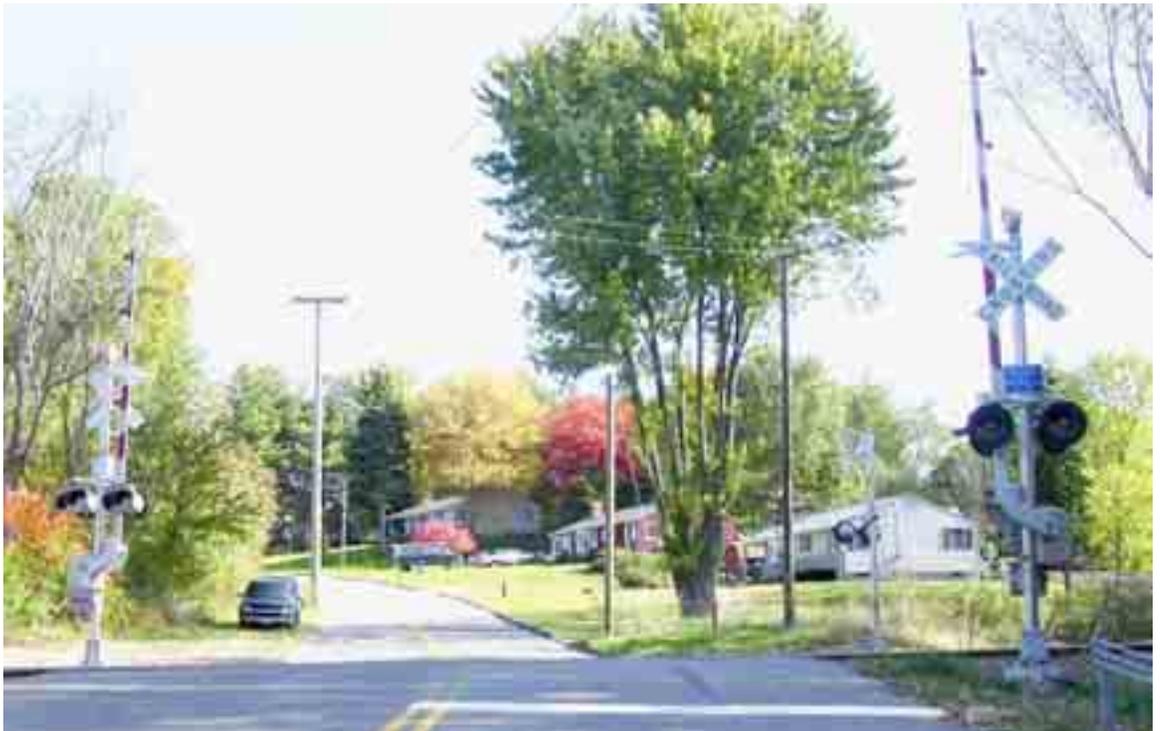
Crossing Name: Parsons Road (Dares), Milepost 51.4

Summary: 1 track, 2 highway gates, 8 flashing lights, 2 mechanical bells.
AAR/DOT Number 500749W

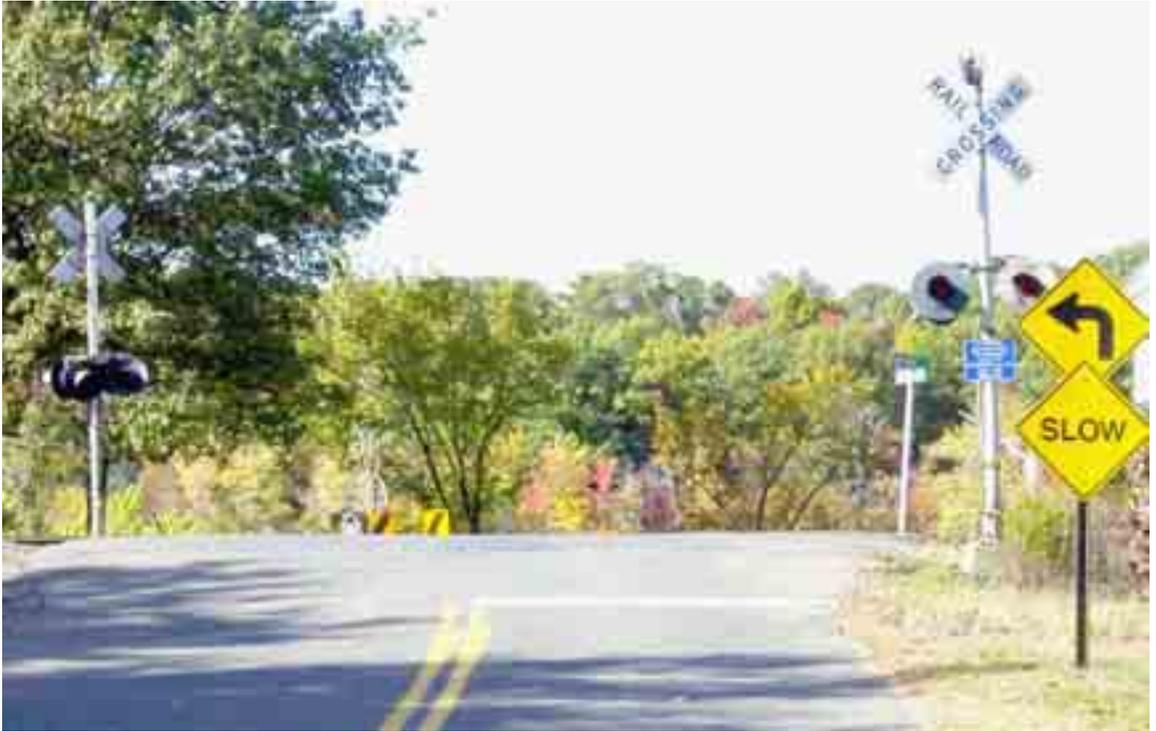
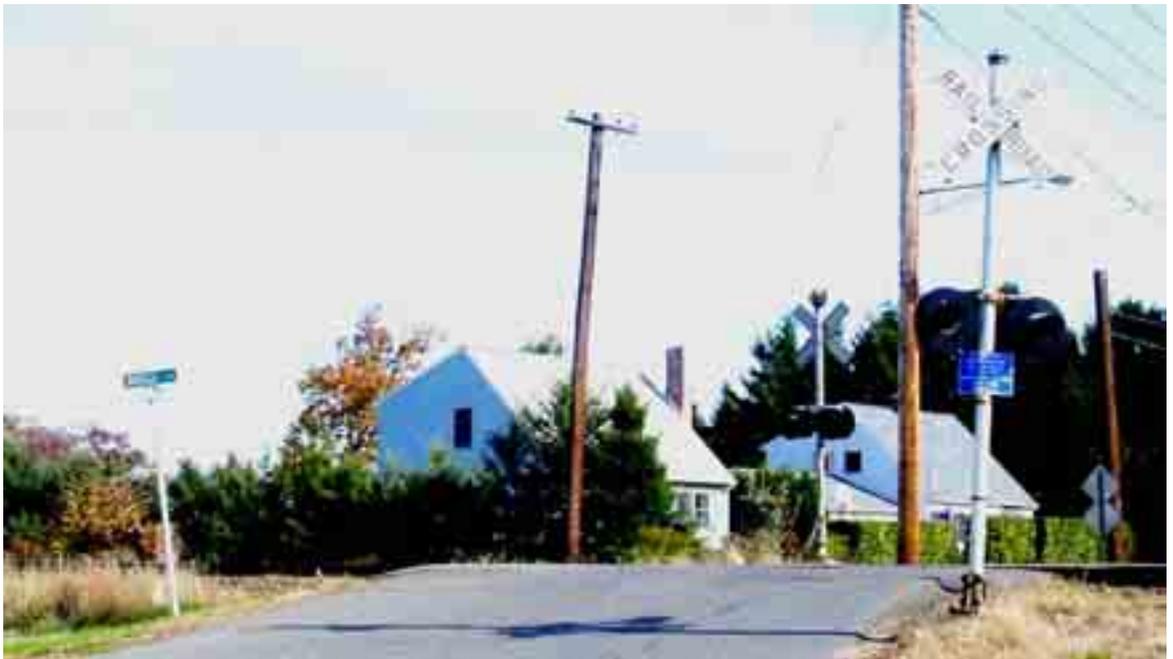
Crossing Name: Bridge Lane, Milepost 52.3

Summary: 1 track, no gates, 8 flashing lights, 1 mechanical bell
AAR/DOT Number 500749W

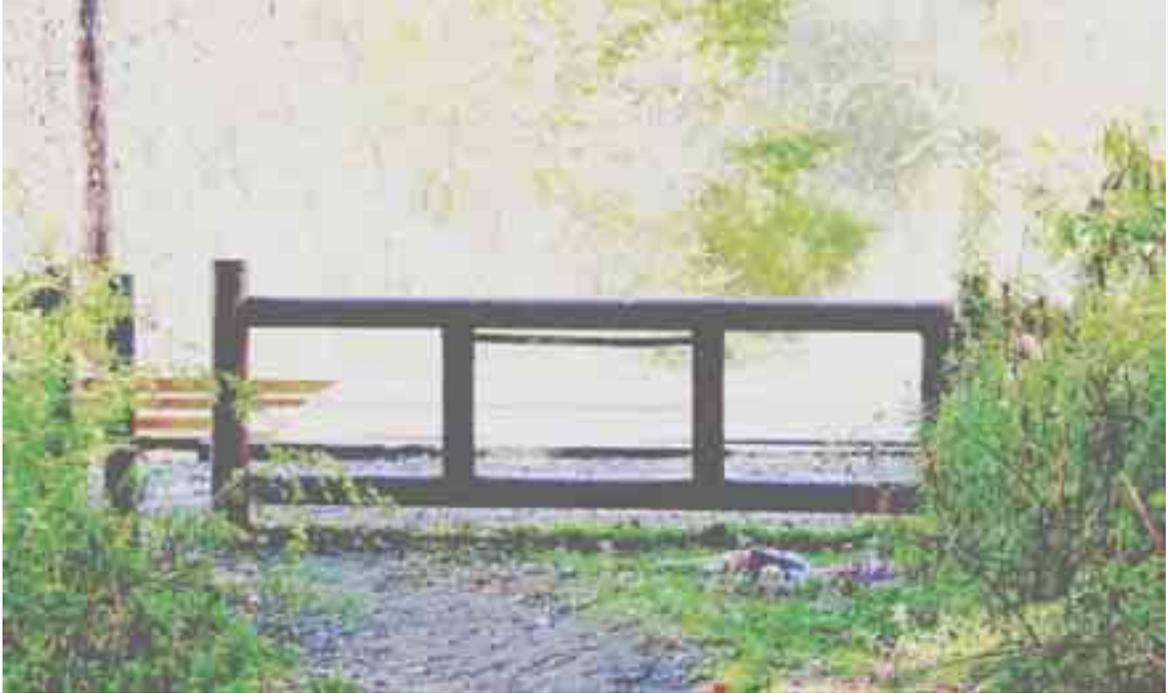
Crossing Name: Saw Mill Road, Milepost 55.6

Summary: 2 tracks, no warning devices, crossing is closed.
AAR/DOT Number 500753L

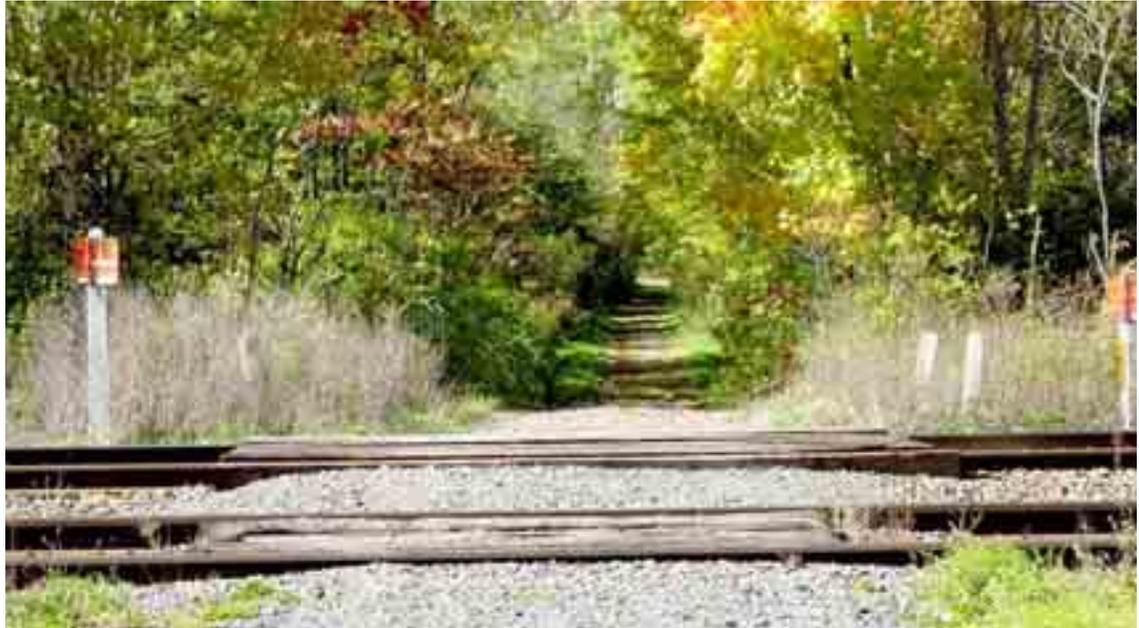
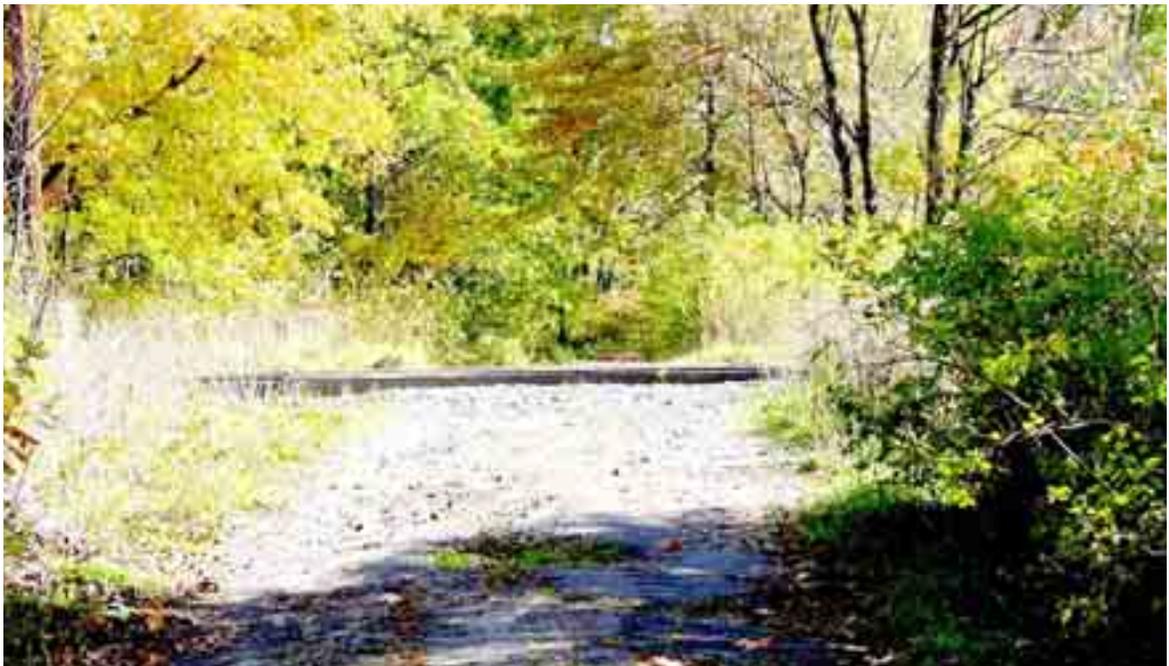
Crossing Name: Bark Haul Road, Milepost 56.7

Summary: 2 tracks, no warning devices, crossing is limited access
AAR/DOT Number No number assigned, not on FRA List

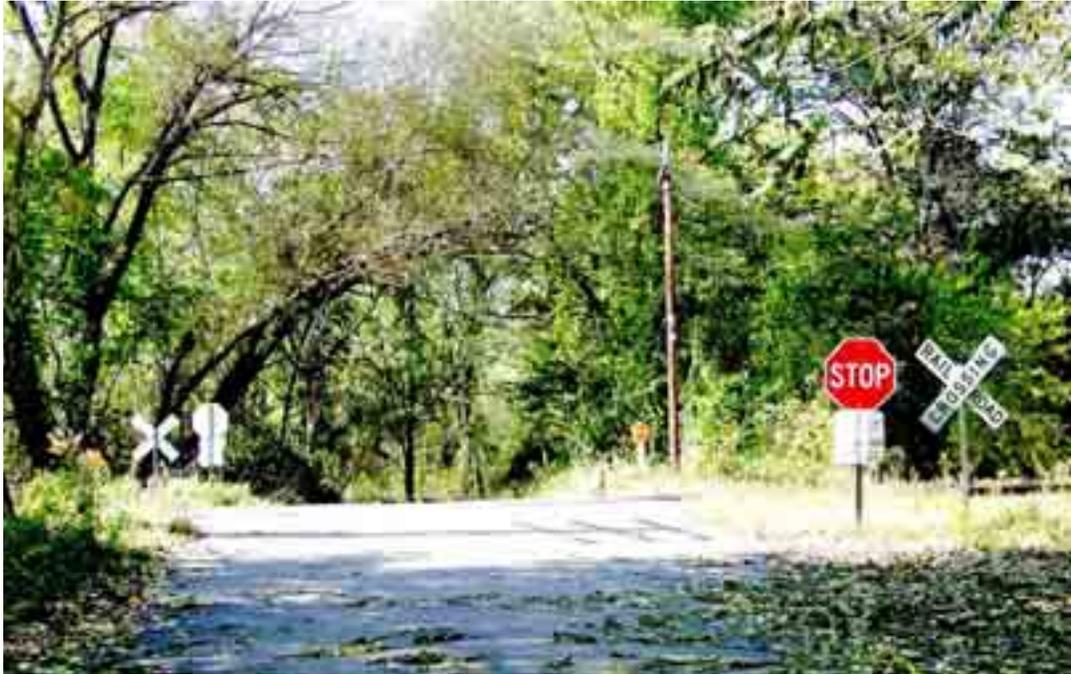
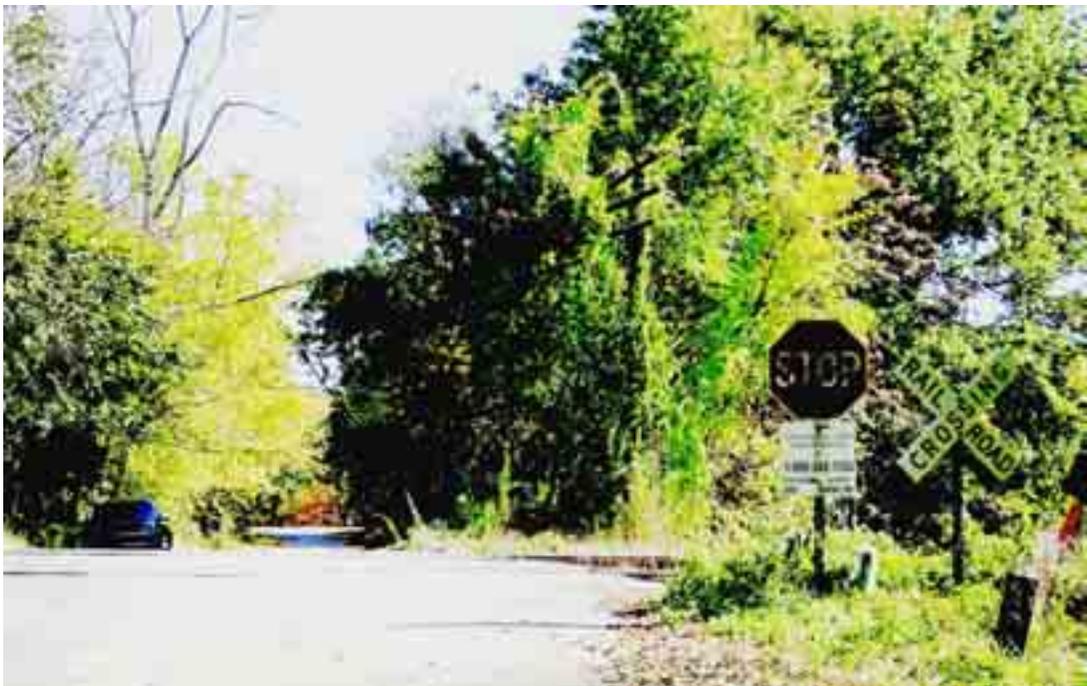
Crossing Name: Birnie Road, Milepost 57.3

Summary: 2 tracks, Stop signs and cross bucks only
AAR/DOT Number - No number assigned, not on FRA List

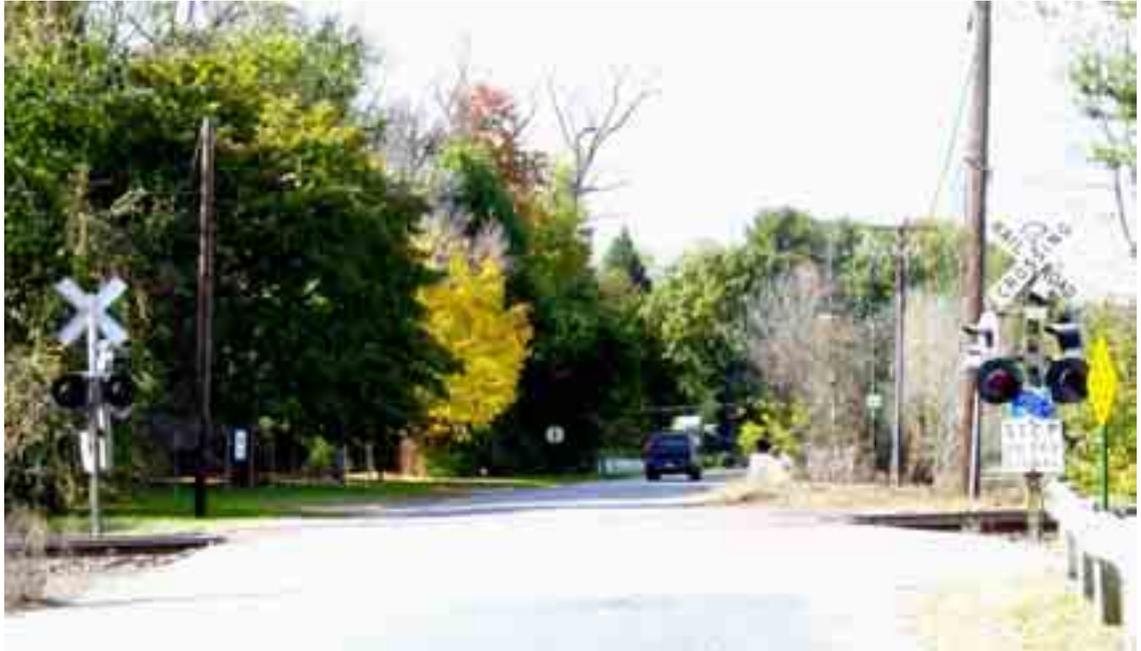
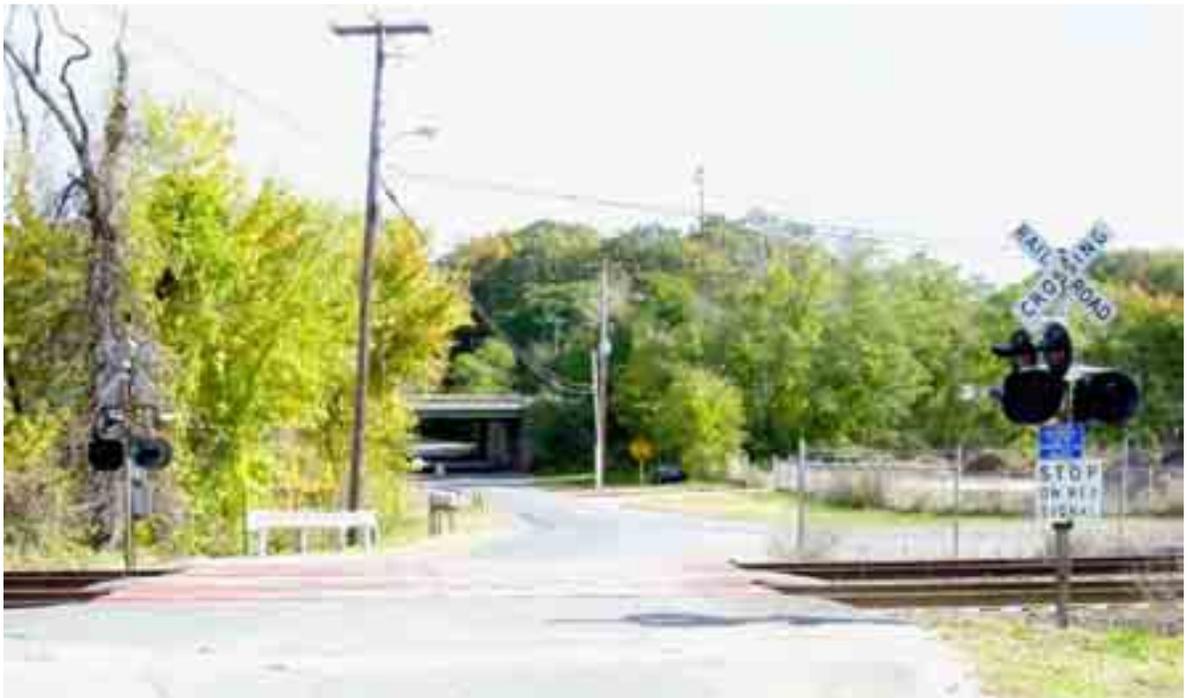
Crossing Name: Emerson Road, Milepost 58.1

Summary: 2 tracks, 2 signal masts, no gates, 12 flashing lights, 1 mechanical bell
AAR/DOT Number 501940X

East Longmeadow, MA	Emerson Road	501940X	58.1	2	Flashers, 1 Bell 8-3/8" lights	None	Constant Warning (AFO)	None	Worn	Clear	Fair	Highway markings worn
Springfield, MA	State Street	Not on FRA list	61.2	2	No warning devices				No Markings	Clear	Fair

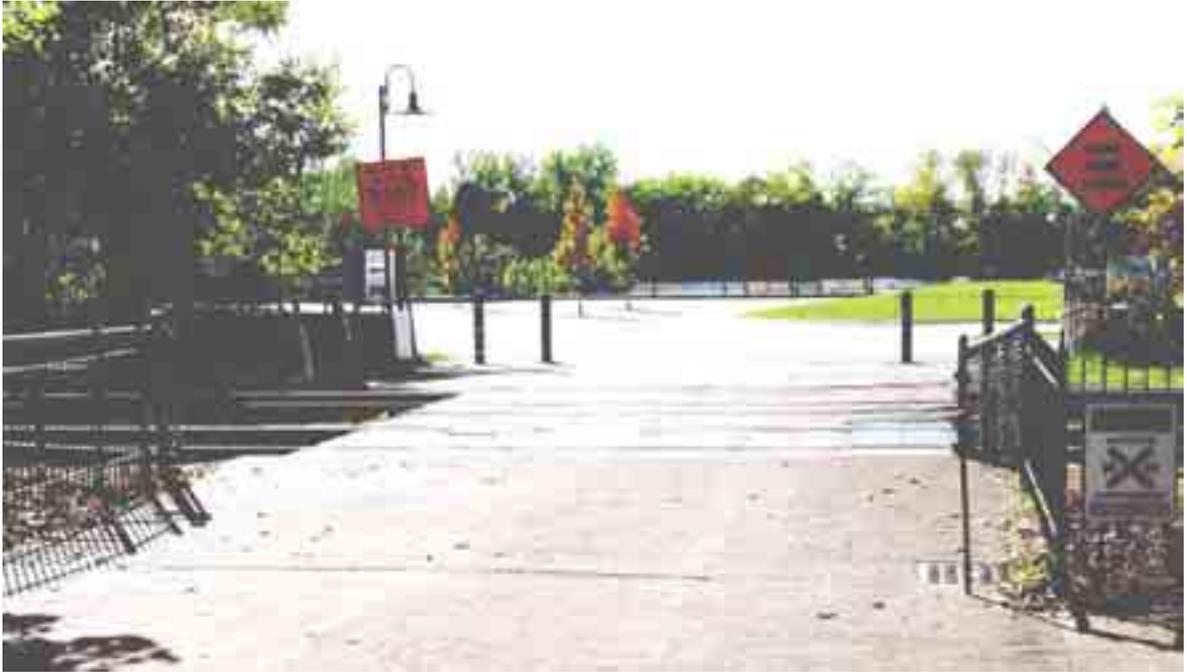
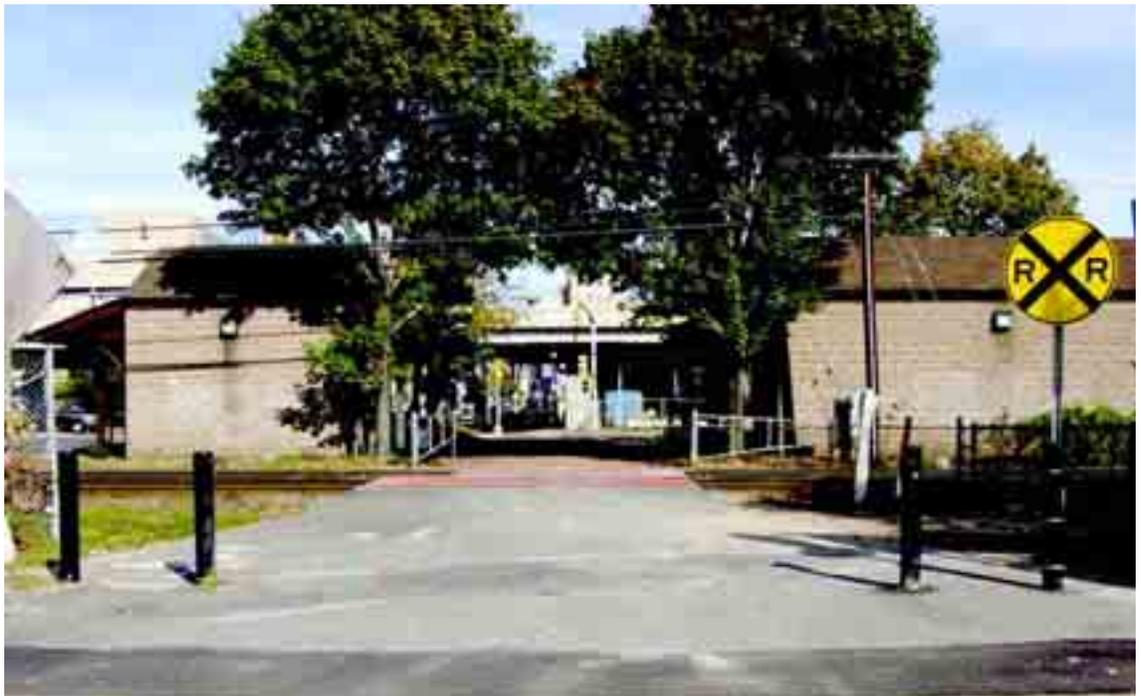
Crossing Name: State Street, Milepost 61.2

Summary: 2 tracks, no warning devices
AAR/DOT Number No number assigned, not on FRA List
