BETHEL TRAIN STATION
VISUAL INSPECTION REPORT

January 2007

Prepared by the Bureau of Public Transportation
Connecticut Department of Transportation

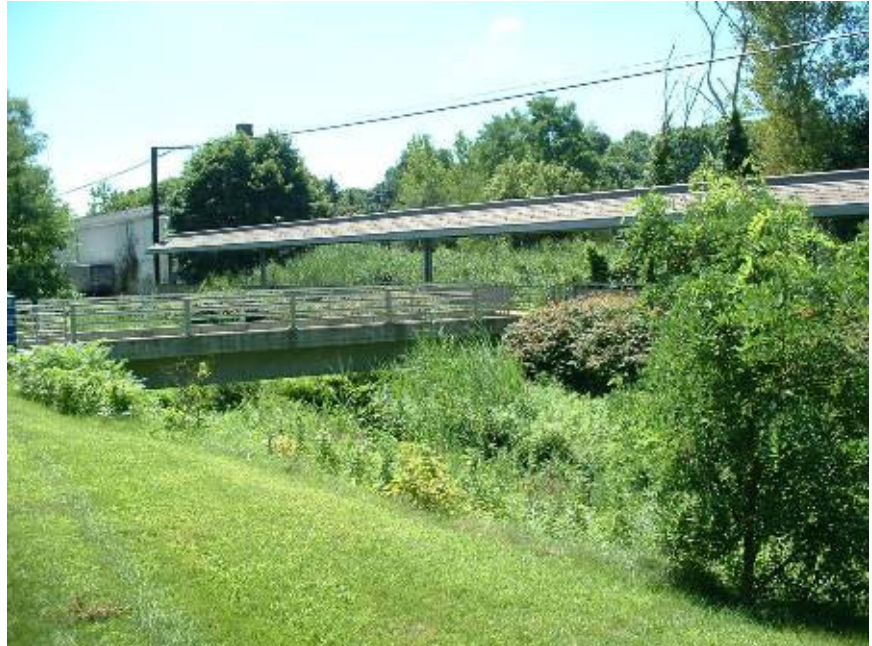
The station was built 10 years ago. It was relocated from downtown Bethel. The new facility includes a brick station building, pedestrian bridge, platform, and parking lot. Although closed during the site visit, the building appears to be clean and comfortable. The area appears to be adequately illuminated.

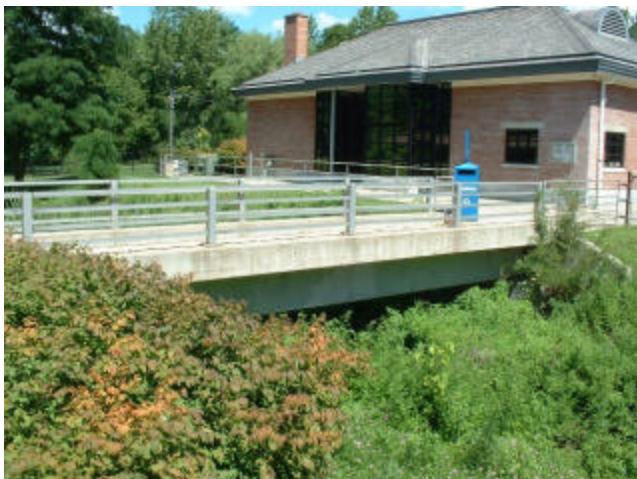
Walks/Paths – The concrete walks, pedestrian bridge over the brook and bridge railings are in good condition.

Footbridge to Platform at Bethel Station

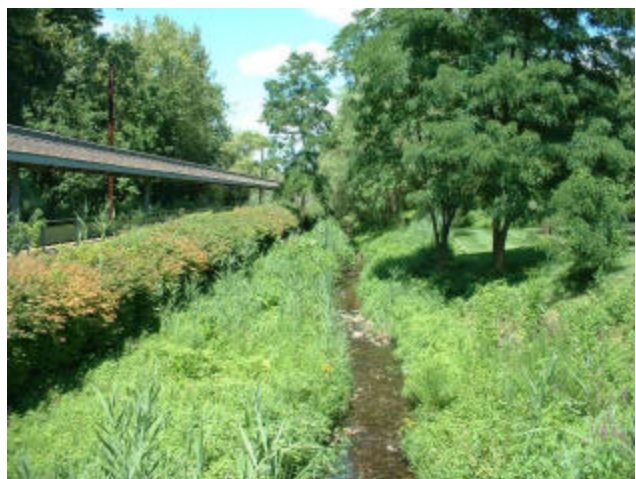
Brook behind Platform at Bethel Station
