CANNONDALE TRAIN STATION

VISUAL INSPECTION REPORT

January 2007

Prepared by the Bureau of Public Transportation
Connecticut Department of Transportation

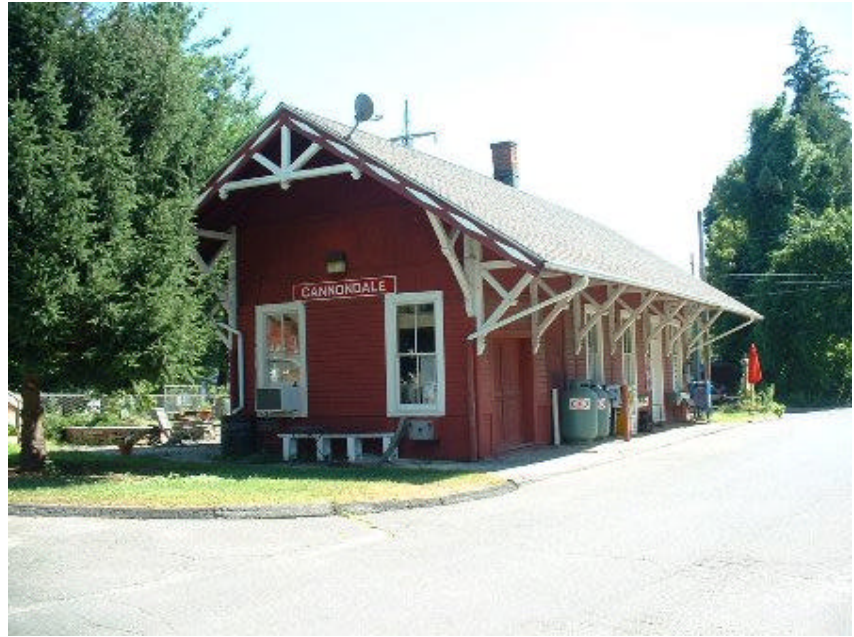
The station building houses a coffee shop. The rear of the building is landscaped with tables provided for coffee shop patrons. The building currently has no rest rooms.

However, the Department plans to install public rest rooms in a separate building on the station property within the next year or so.

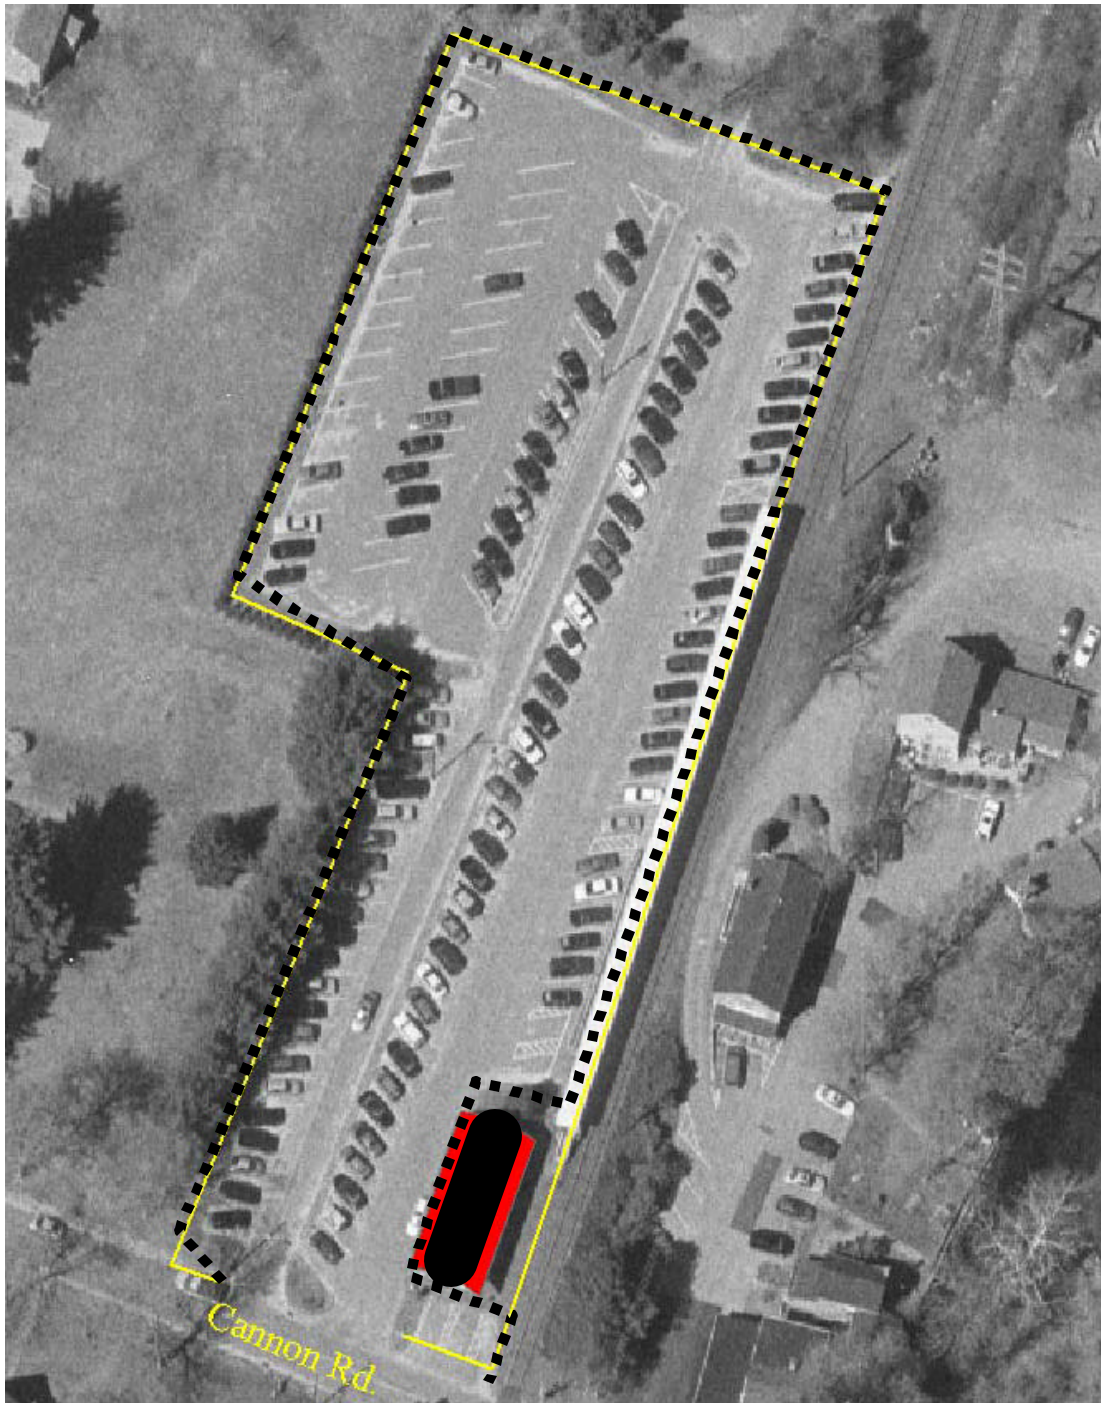
Station Layout:

Aerial Photo by Aero-Metric, Inc. – Graphics by Urbitran as part of the Rail Governance Study

Station Building
State-Owned Parking Area

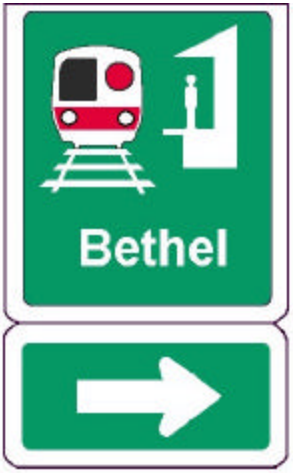
Typical Trailblazing Sign

Highway Access – Access from Route 7 is available via Cannon Road. A trailblazing sign has been placed at the intersection. Once on Cannon Road, the station is easy to locate. However, a station sign at the entrance is still recommended.

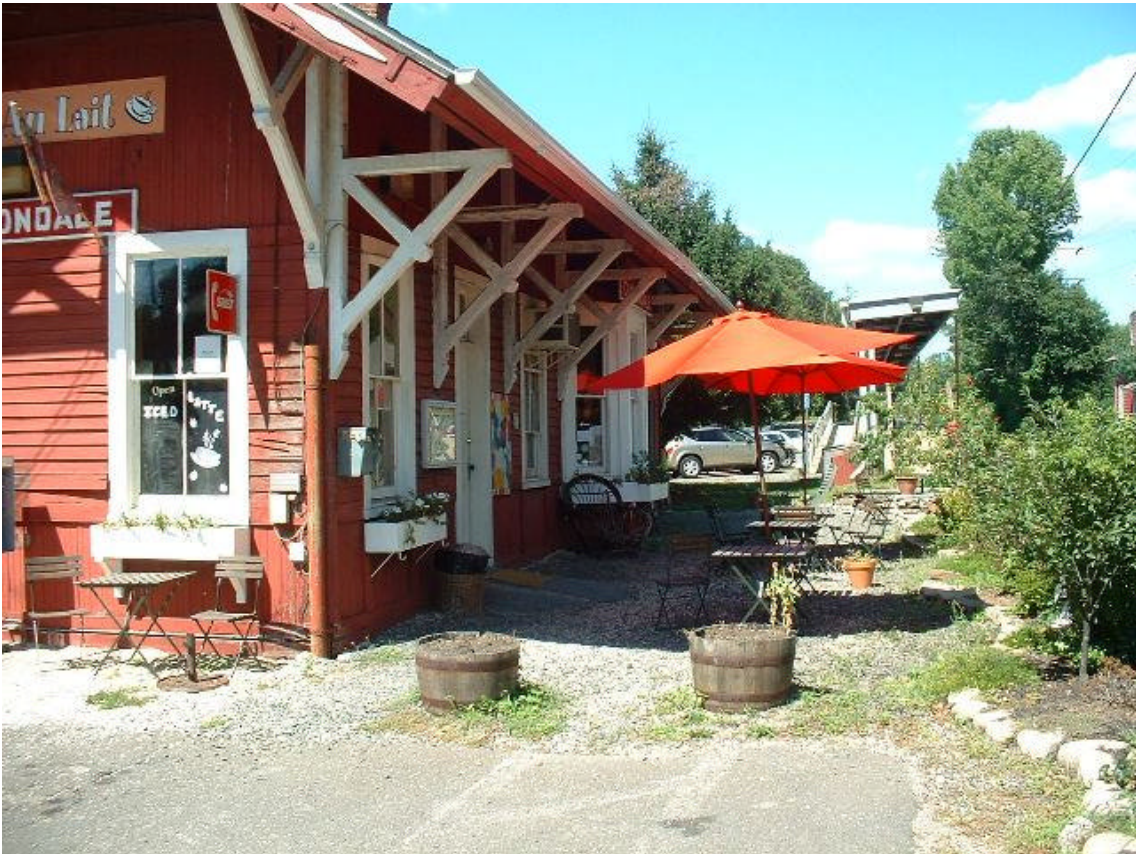
Cannondale – Landscaped Area Behind Coffee Shop

Walks/Paths – The station building at the Cannon Road entrance to the parking lot. Patrons must walk through the lot or behind the building to get to the platform. The area between the building and the tracks has been landscaped. Umbrella tables and chairs are available for coffee shop patrons.

- Replace aluminum platform, stair and ramp railing with black steel railing.
- Evaluate illumination levels throughout the station.
- Repave the parking lot.
- If the business is not available as a waiting room, add a shelter for waiting commuters. This can be placed in the landscaped area or extended out behind the platform.
