STAMFORD TRANSPORTATION CENTER

VISUAL INSPECTION REPORT

January 2007

Prepared by the Bureau of Public Transportation
Connecticut Department of Transportation

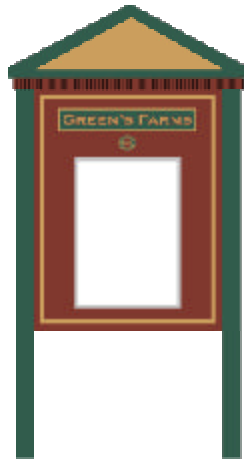
Kiosk (Historic)

- Update tunnel kiosk. Add kiosk to north and south entrances.
- Add station sign to north and south entrances.
- Place clocks on platforms.

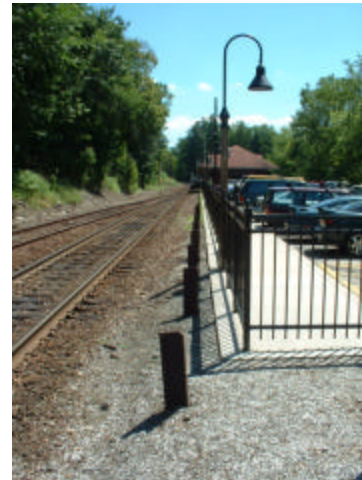
Fence, Walk and Post Mounted Light Next to Track

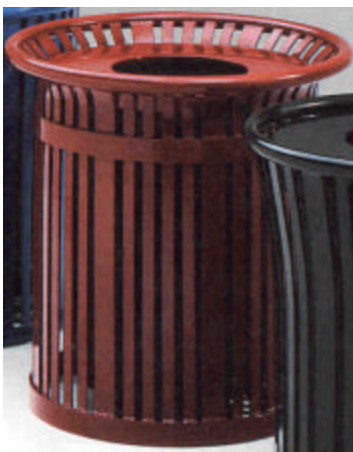
Trash Can (Black preferred)

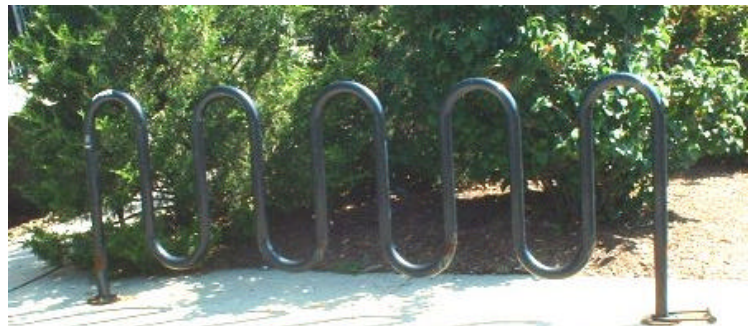
Bike Rack
