**Development of Guidelines for Reduction of  
Temperature Differential Damage (TDD) for Hot Mix  
Asphalt Pavement Projects in Connecticut  
Final Report**

Report No.  
2222-F-04-9

Connecticut Department of Transportation  
Bureau of Engineering and Highway Operations  
Research and Materials

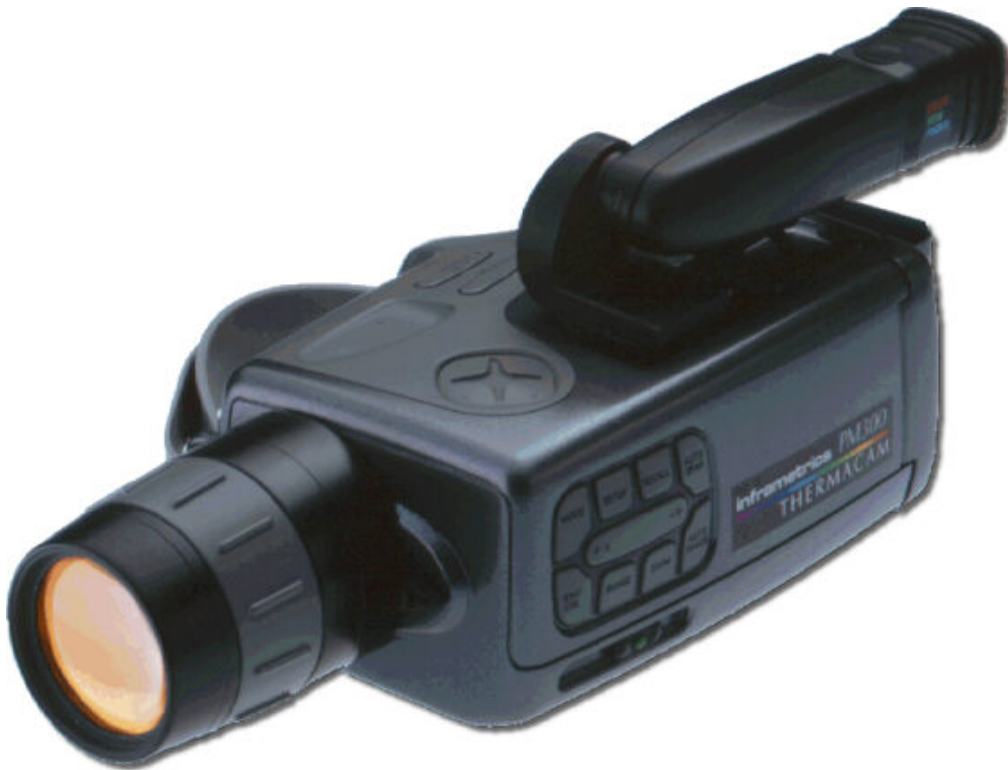
Photo 1. Inframetrics ThermaCAM PM380.

A ThermaCAM PM380 infrared camera (see Photos #1 and #2) was rented for one (1) month from Inframetrics, Inc, the camera's inventor and manufacturer. The ThermaCAM provided a 256 x 256 pixel image, temperature measurements from -10 to 450°C, and an accuracy of +/- 2°C. It operated on a commercially available camcorder battery. Precision 12-bit measurement data were stored instantly in the field as TIFF digital files on a removable FLASH PCMCIA memory card. Inframetrics TherMonitor95 software was used in the laboratory for post-image processing and report generation.

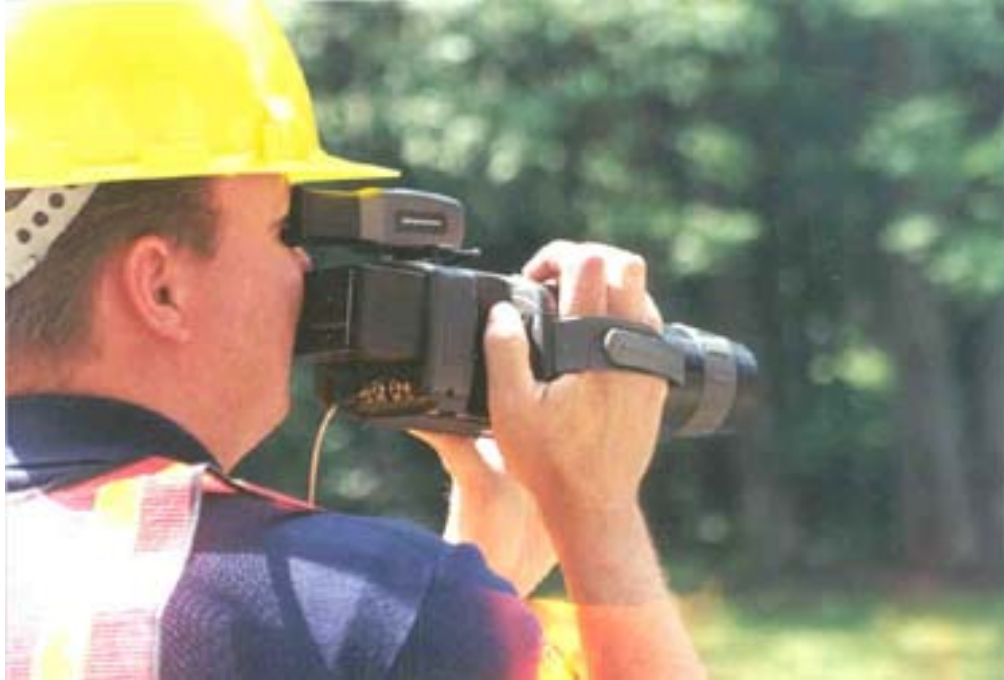
Photo 2. Infrared Camera in Use.

During paving operations, the infrared camera was used to look at the mix being discharged from the truck, to the paver and to the mat. Infrared video was recorded during rolling operations as the mat was compacted. Cold spots were located, marked and referenced to a predetermined x-y coordinate system within each of the monitored test sections.

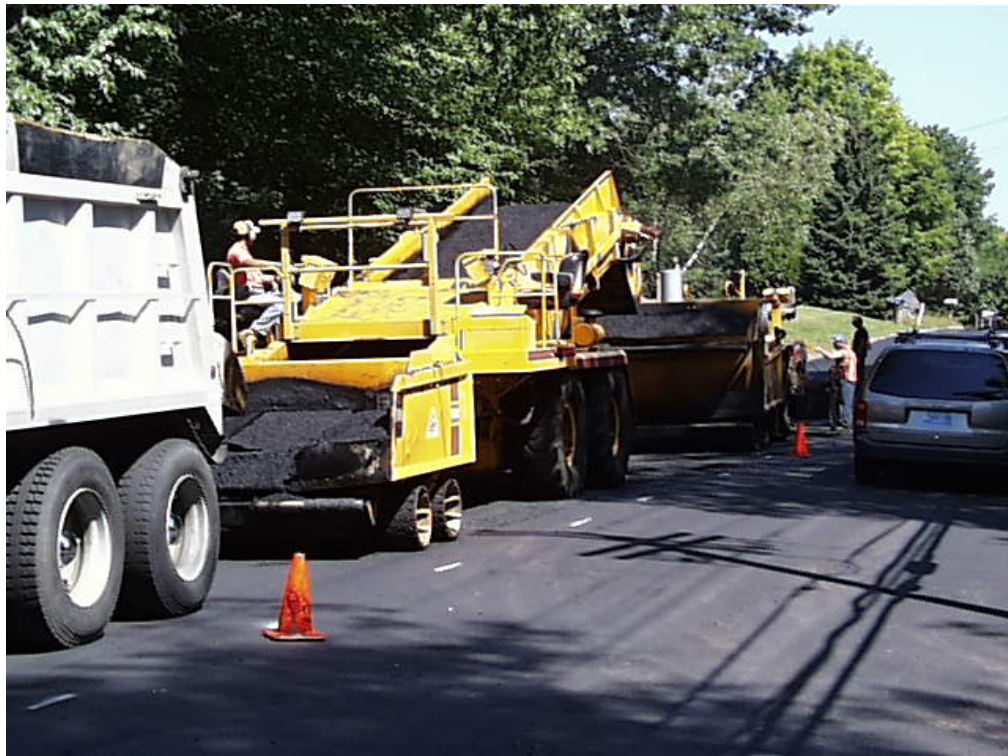
Photo 11. Blaw-Knox MC-30 Material Transfer Vehicle.

The MC-30 material transfer vehicle in combination with the remixing insert did appear to reduce the occurrence of thermal segregation in the 50-mm (2-inch) DOT Class 1 surface layer, but did not completely eliminate the problem (see Photo #12). An occasional cold spot did show in the pavement during construction. It was observed that the freshly laid pavement cooled quickly during rolling operations, and that additional temperature differentials developed in the mat during this cooling process. Compaction of the mat continued as the pavement cooled to the cessation temperature of 79°C (175°F). Cooler areas of pavement (cold spots), as seen with the infrared camera, were as low as 66°C (150°F) during compaction.

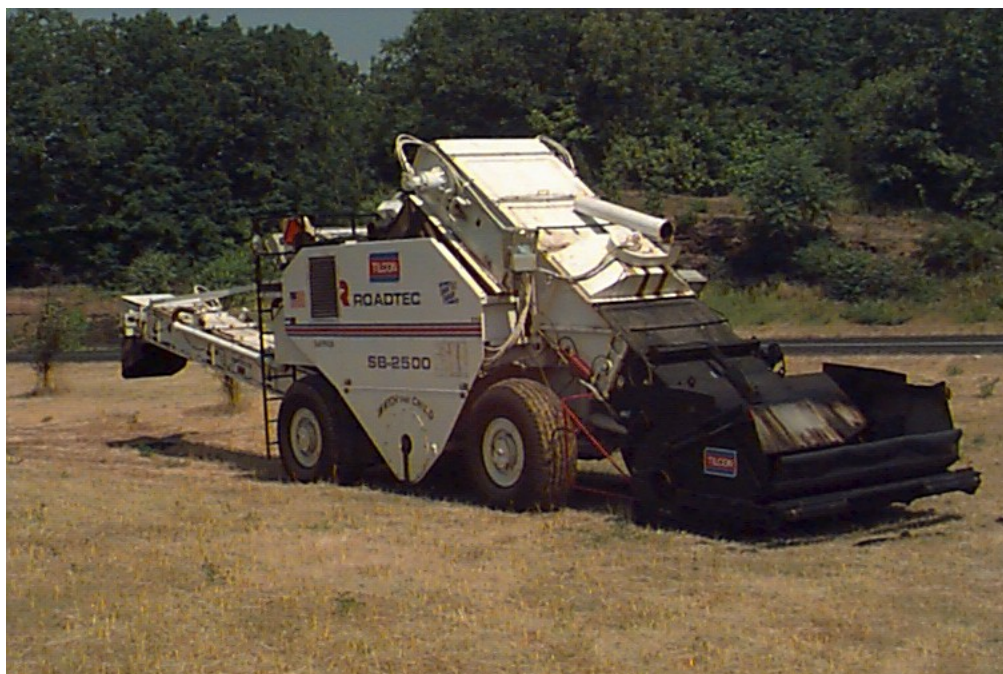
Photo 13. Roadtec Shuttle Buggy Material Transfer Vehicle.

Once paving operations had been established and all the equipment was warm, temperature differentials were virtually eliminated through remixing in the Shuttle Buggy (see Photo #14). It should be noted, however, that some temperature differentials did appear in the mat at the beginning of paving operations, when the equipment was cold. Also, it should be noted that the pavement cooled more quickly at night than had typically been observed for daytime construction. Remixing, obviously, has no affect on the rate at which a pavement cools after being placed.

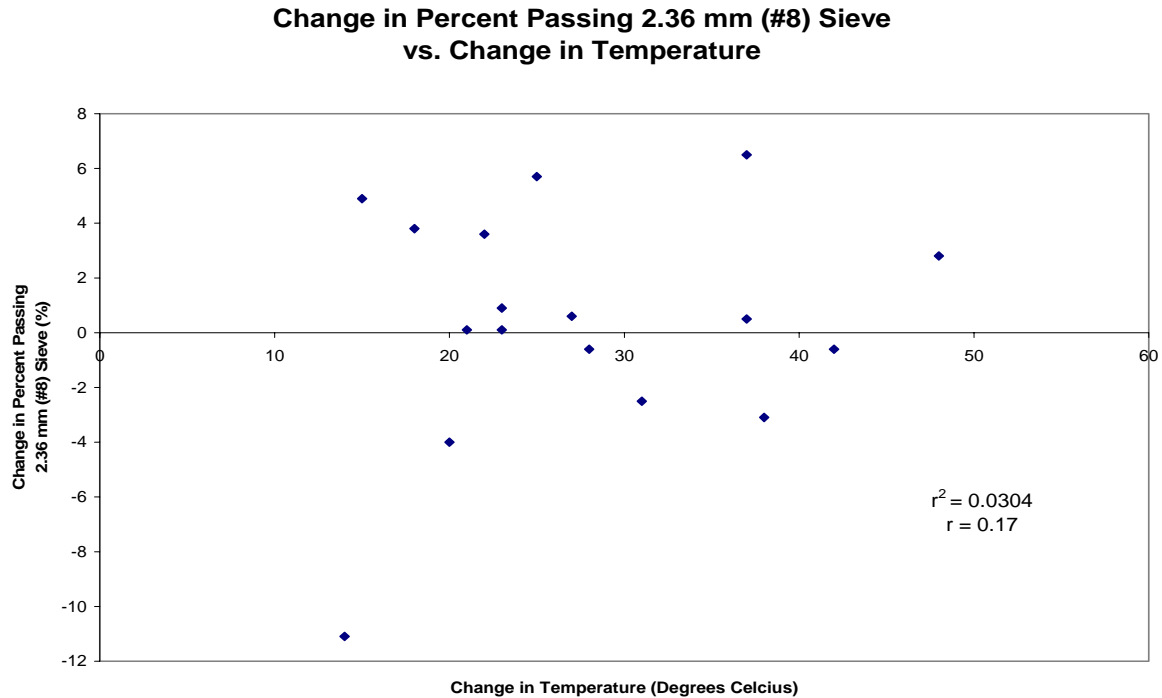
Lastly, in order to see if there was a relationship between temperature differentials and particle segregation, differences between percents passing the 2.36-mm (No. 8) sieve for each companion core were plotted against  $\Delta T$  (see Figure 13). Based upon observations of this scatter plot, it can be seen that a linear or curvilinear relationship between them did not exist, and the correlation was poor ( $r = 0.17$ ).

**Figure 13 – Relationship Between Temperature Differentials and Particle Segregation**

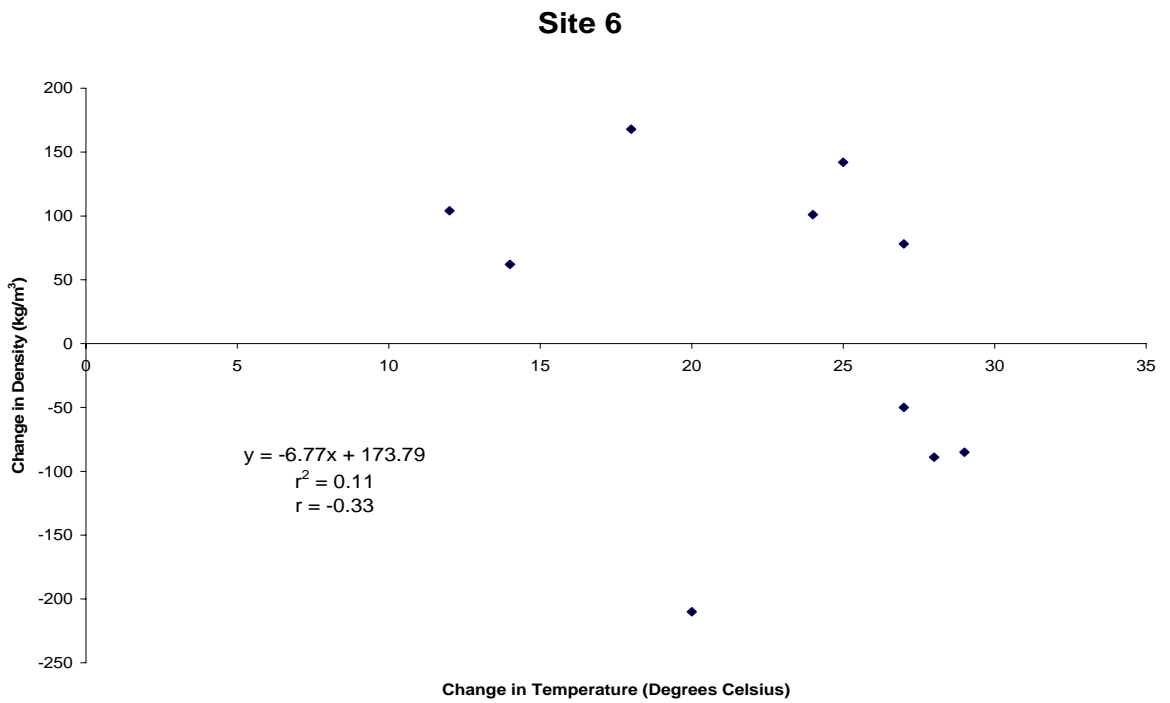
Scatter plots for each site showing relationships between change in density ( $\Delta\sigma$ ) and change in temperature ( $\Delta T$ ) are provided in Figures 26 - 31. While there appeared to be a general tendency for the cold spot/area densities to be lower than their counterparts, the linear association between  $\Delta T$ , as measured with the infrared camera, and  $\Delta\sigma$ , as measured with the nuclear gauge, was poor. At each site, the coefficient of simple correlation ( $r$ ) was low. The highest absolute value for  $r$  was 0.54 (Site 5), and  $r$  approached 0 at Site 4. Note: a coefficient of simple correlation of  $r=0$  indicates that there is no linear association, while a coefficient of  $r=-1$  or 1 indicates that the variables have perfect linear association. Ultimately, the scatter plots indicate very little definable relationships between  $\Delta T$  and  $\Delta\sigma$ .

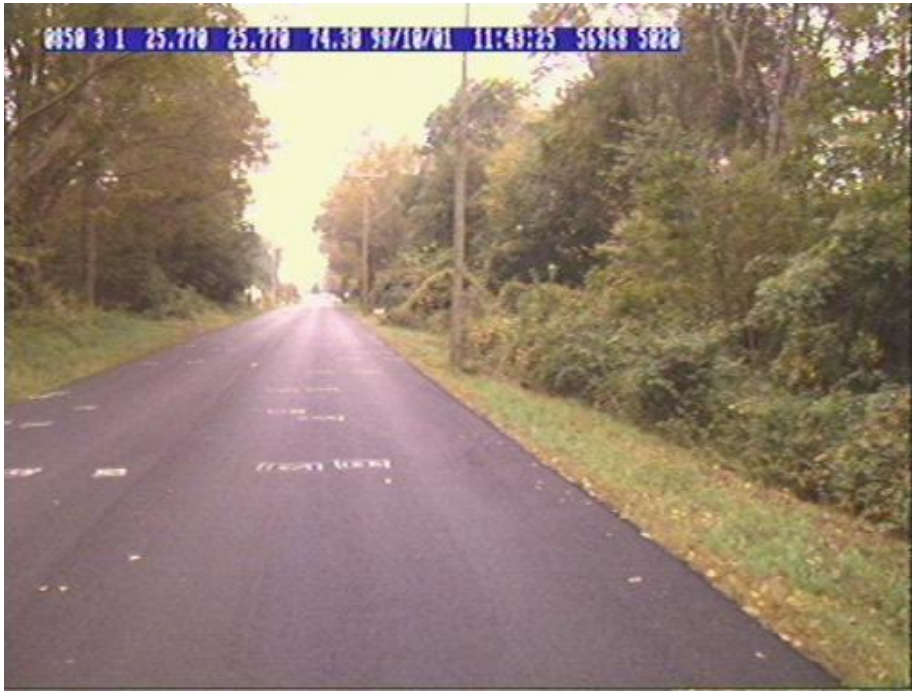
Photo 18 - 1998 Photo of Sites 1 & 2, Route 85 SB & NB in Colchester

At Sites 1 & 2 (see Photo 18), few areas of pavement distress were observed for the first three years. Low severity ( $0 \text{ mm} < \text{crack width} < 6 \text{ mm}$ ) longitudinal and transverse cracks appeared in the fourth year. During the fifth year survey, areas of pavement distress became much more apparent, possibly due to a harsh winter, as low and medium severity ( $6 \text{ mm} \leq \text{crack width} < 12 \text{ mm}$ ) longitudinal and transverse cracks were observed (see Photos 19-33). Many of the cracks reflected through from the underlying pavement, as can be seen by looking at the pre-existing condition of pavement in Photo 34. It is noteworthy that this occurred, in spite of the fact that the top 2-inches of pavement were milled off during resurfacing operations. Most significantly, relationships between areas of pavement distress and cold spot/areas observed with the infrared camera were not evident during the survey. Additional time (2 to 5 years) may be necessary for TDD to present itself in a pavement distress survey.

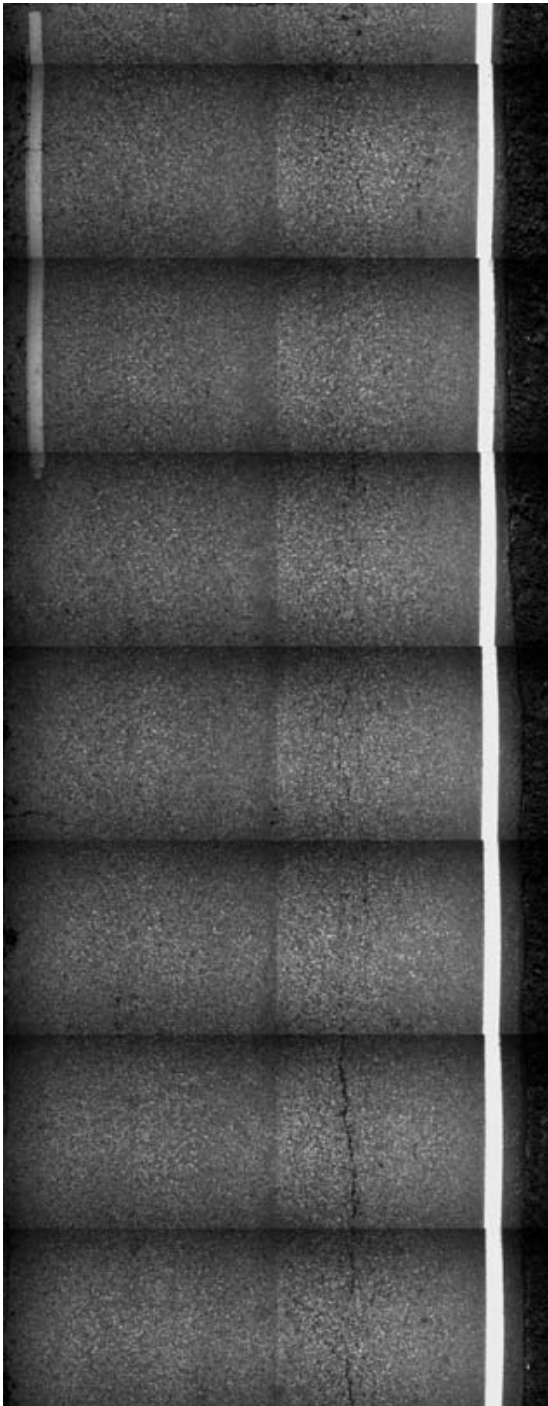
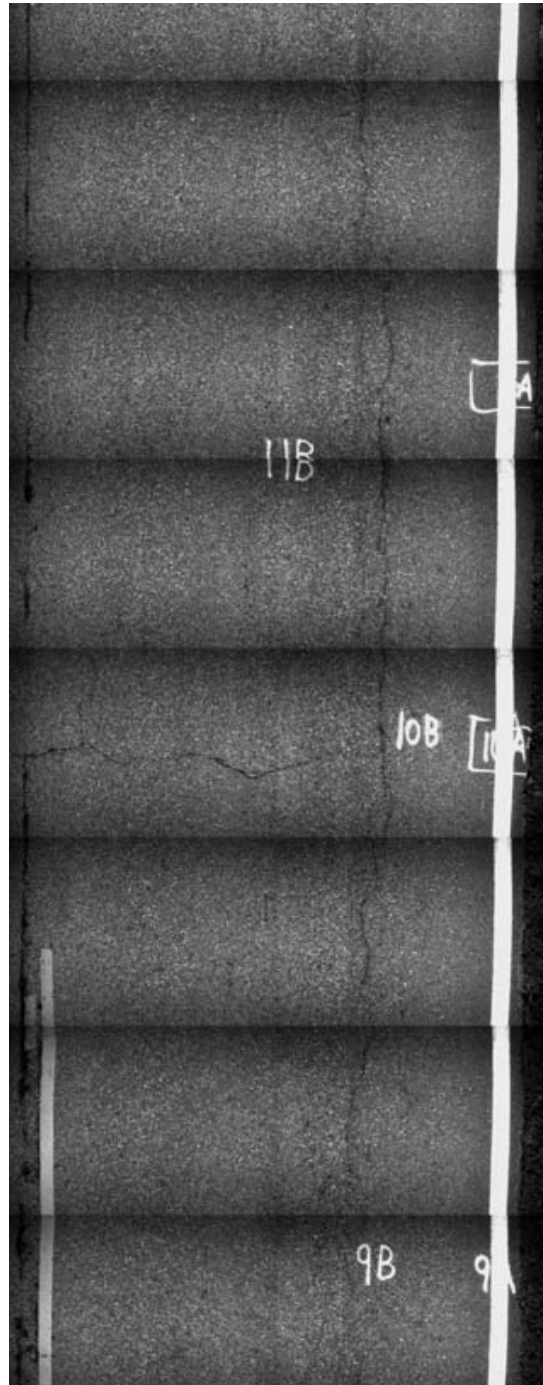
No Samples Within Area Shown

Samples 9 - 11 (A & B)

Photos 21 - Route 85 SB in Colchester, Samples 7 - 11

WiseCrax images of Sites 1 and 2 are shown in Photos 19-26 and Photos 27-33, respectively. Samples marked "A" represent cold spots, while those marked "B" represent normal temperature pavement. It should be noted that slight shading can be seen between the left and right sides of the WiseCrax images as a result of merging two separate photos (from separate booms equipped with cameras), and it does not represent pavement distress of any kind. At Site 2, core holes can be seen at locations for Samples 3 (Photo 27, not marked, but to the left and slightly below Samples 4), Samples 13 (Photo 29) and Samples 20 (Photo 31); and, at Site 2, they can be seen at locations for Samples 12 (Photo 23) and Samples 19 (Photo 24). Comparisons between areas marked "A" and "B" do not demonstrate a tendency for cold spots to deteriorate at a faster rate than normal temperature pavement. In fact, when looking at photos for Site 1, one may draw the conclusion that normal temperature areas (marked "B") deteriorate at a faster rate than the cold spots. At Site 1 (see Photos 19-26), several normal temperature samples (2B, 5B, 6B, 9B, 10B, 12B, 13B, 15B, 16B, 19-23B) were located along longitudinal crack lines, while their cold temperature counterparts show little or no deterioration. Upon examination of pre-1998 DigitalHIWAY images (see Photo 34 for example), however, it appears that many of the areas marked "B" are located along longitudinal crack lines that existed prior to 1998 pavement reconstruction. Therefore, conclusive statements regarding rates of deterioration between cold and normal temperature areas cannot be made,

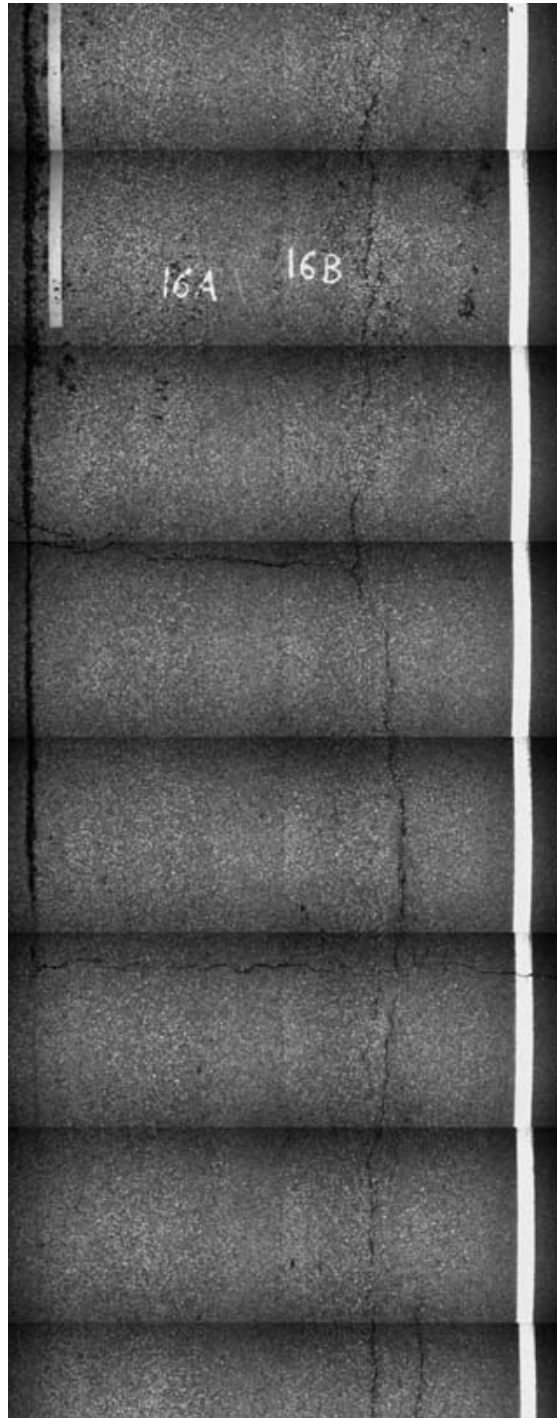
Samples 16 (A & B)

Photos 23 - Route 85 SB in Colchester, Samples 14 - 16

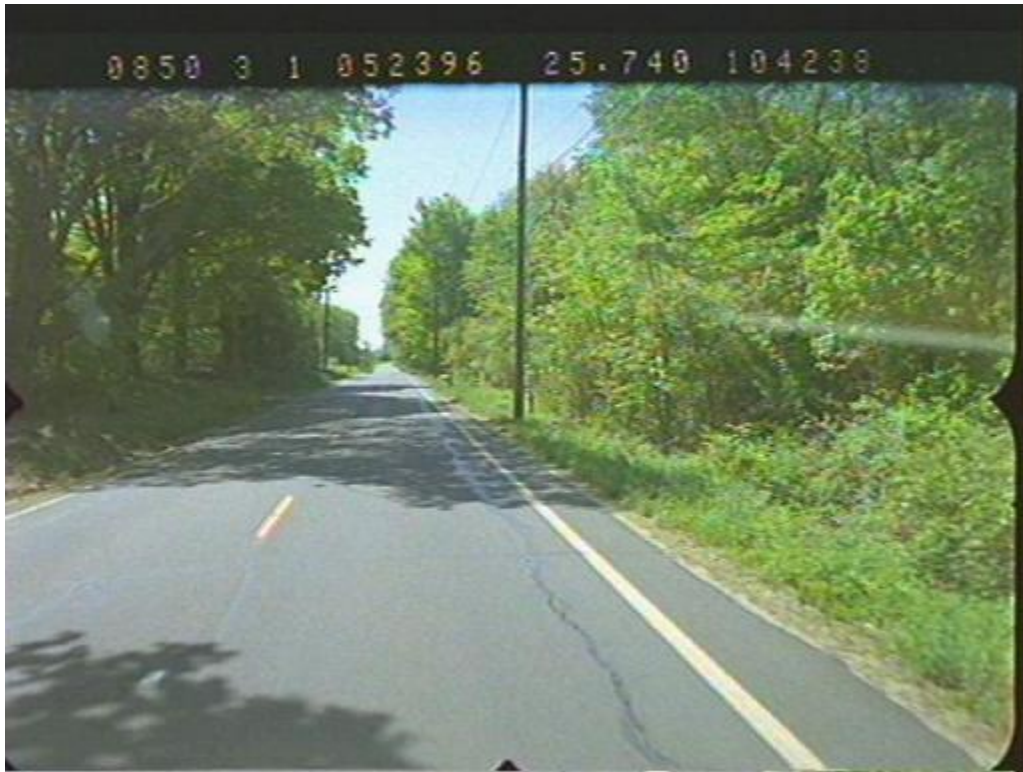
Photo 34 - 1996 DigitalHIWAY Image  
Note Location of Longitudinal Crack on Right

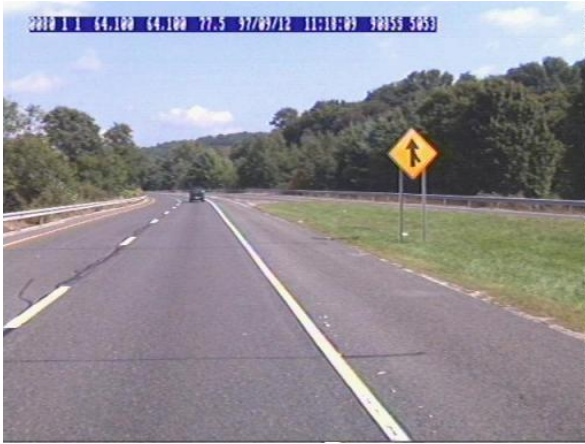
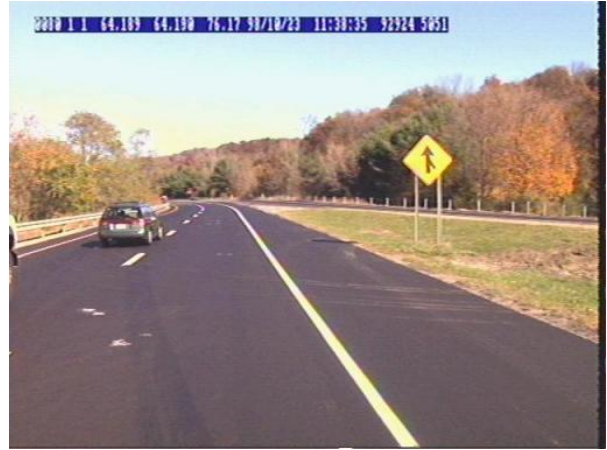
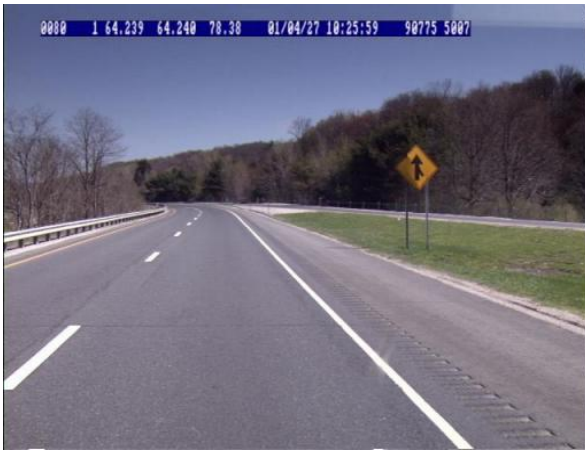
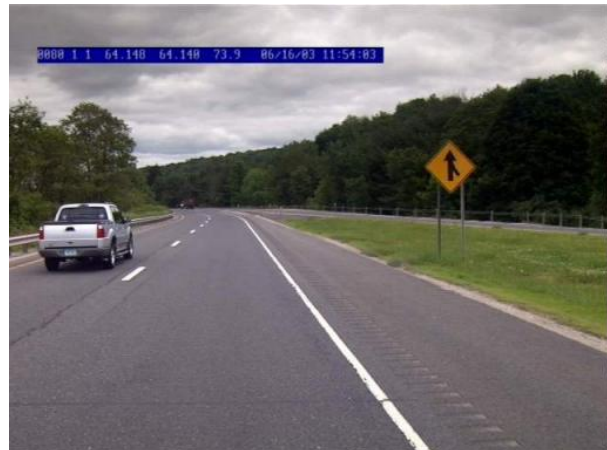
1997 - Prior to Milling and Paving

1998 - After Milling and Paving

2001 - Three (3) Years Later

2003 - Five (5) Years Later

Photos 35 - Route 8 NB in Thomaston (Site 3) at approximately 64.015 km.

Viewing DigitalHIWAY images from 1997, prior to 1998 resurfacing operations, it can be seen that the preexisting condition of pavement within the limits of Site 3 was good (see Photos 35). During the 5-year monitoring period, Site 3 pavement performed well, and few areas of distress were located. Some low severity longitudinal cracks developed at the longitudinal joints, outside the wheel paths, and three (3) full width medium severity transverse cracks were found within the limits of Site 3. One (1) of the transverse cracks appeared slightly offset from the saw-cut joint, suggesting the saw-cut joint was misplaced in relation to the PCC joint. As was the case for Sites 1 & 2, a clear relationship between pavement distress and cold spot/areas observed with the infrared camera was not evident.

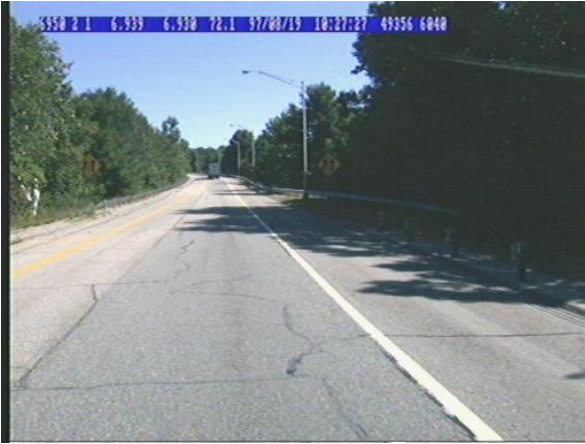
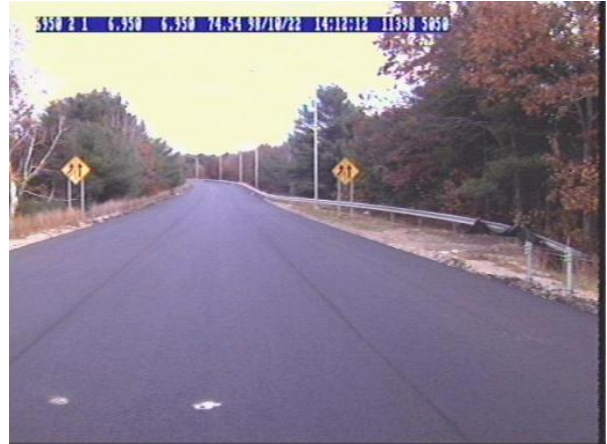
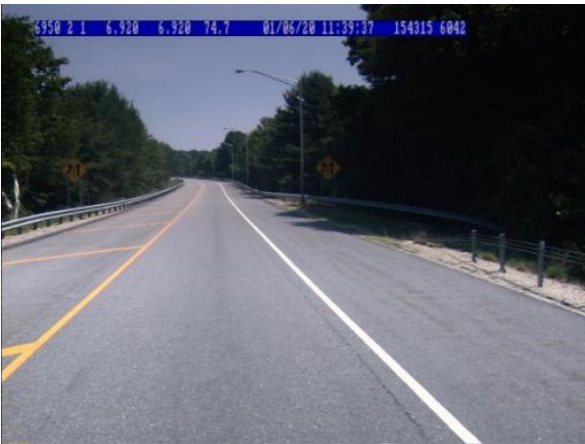
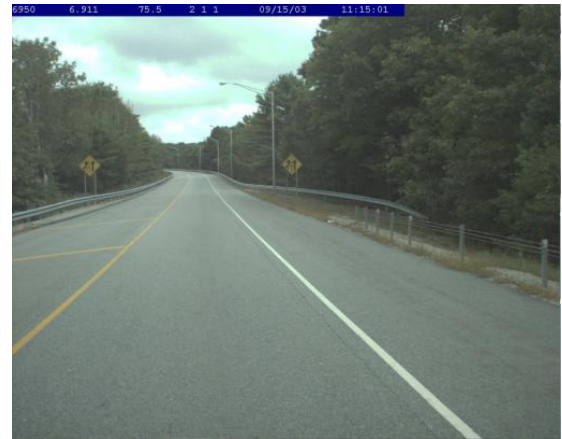
1997 - Before Paving Operations.  
Note: pavement was cold-in-place recycled for base.

1998 - Immediately after Paving Operations. Surface paved over cold-in-place recycled base.

2001 - 3-years After Paving Operations

2003 - 5-years After Paving Operations

Photos 36 - Route 695 EB in Killingly (Site 4) at approximately 6.930 km.

Interestingly, Site 4 was observed to have the fewest areas of pavement distress of all the sites monitored, even though it had the most profound and well defined occurrences of thermal segregation. This may be explained by the fact that a 50-mm (2-inch) DOT Class 1 surface layer was placed on top of a cold-in-place recycled base course, while the other sites were placed on top of existing pavements. Longitudinal cracks were observed along the length of the test site at the longitudinal joint locations, which occurred primarily outside the wheel paths (see Photos 36). One crack developed between three core holes drilled for Sample 3, most likely caused by a fracture line created by the core holes. Little or no additional cracking was seen during the surveys. None of the cracks appeared to be related in any way to thermal segregation or to the cold spot/areas monitored. Continued monitoring of Site 4 for TDD is recommended.

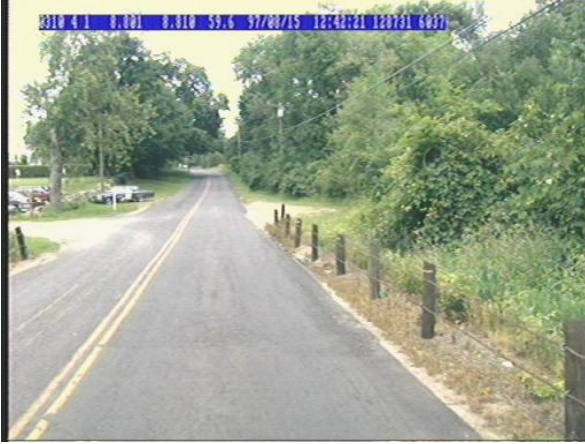
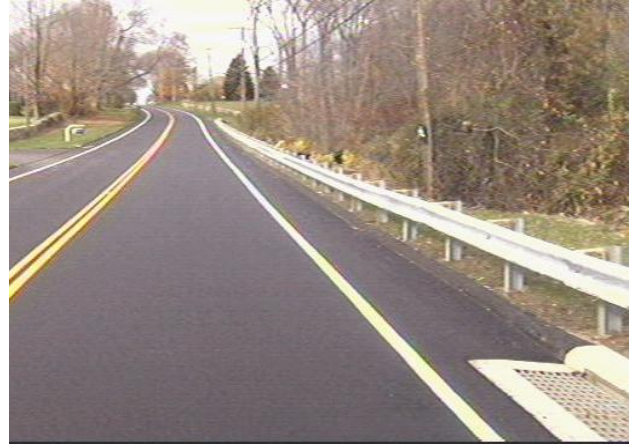
1997 - Prior to Paving Operations

1998 - After Paving Operations

2001 - Three (3) Years Later

2003 - Five (5) Years Later

Photos 37 - Route 31 WB in Coventry (Site 5) at approximately 8.797 km.

In 1998, the top three inches of pavement at Site 5 were milled off and then paved over with HMA. During the 5-year monitoring period, underlying cracks began to reflect through to the new surface layer. By the fifth year (2003), low to moderate fatigue cracking could be seen (see Figure B-4) during the distress survey. In addition, low to moderate longitudinal cracks appeared at the longitudinal joints, outside the wheel paths. With all the areas of pavement distress, it was difficult to tell whether the cold spot/areas had any effect. No trends or relationships between areas of distress and cold spot/areas were evident.

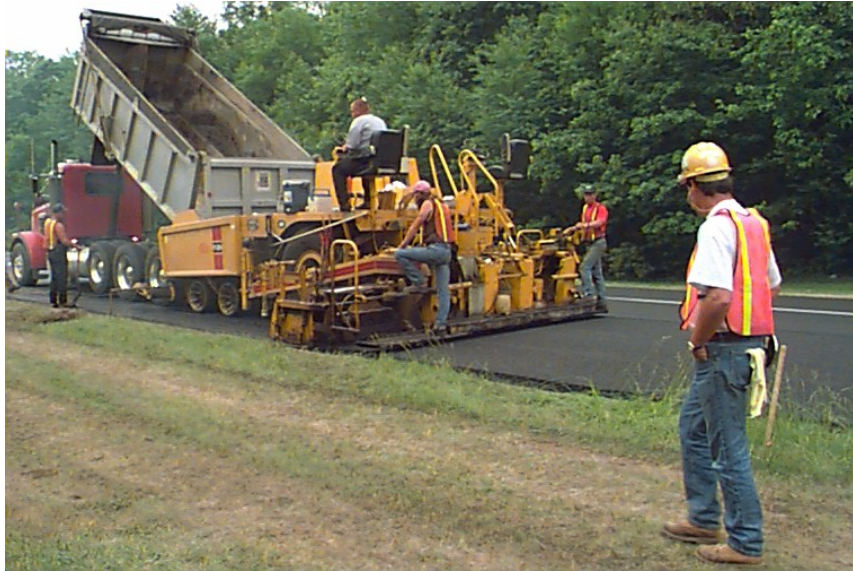
Photo A-1. Blaw-Knox PF-180H Paver Used at Sites 1 and 2.

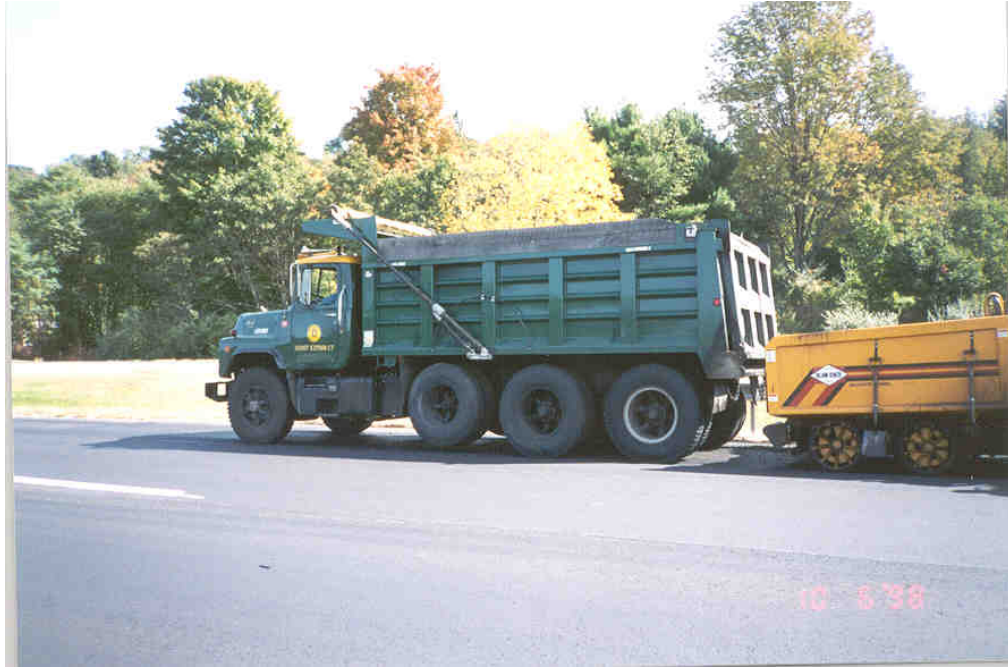
Photo A-2. Truck Used at Site 3, Route 8 in Thomaston.

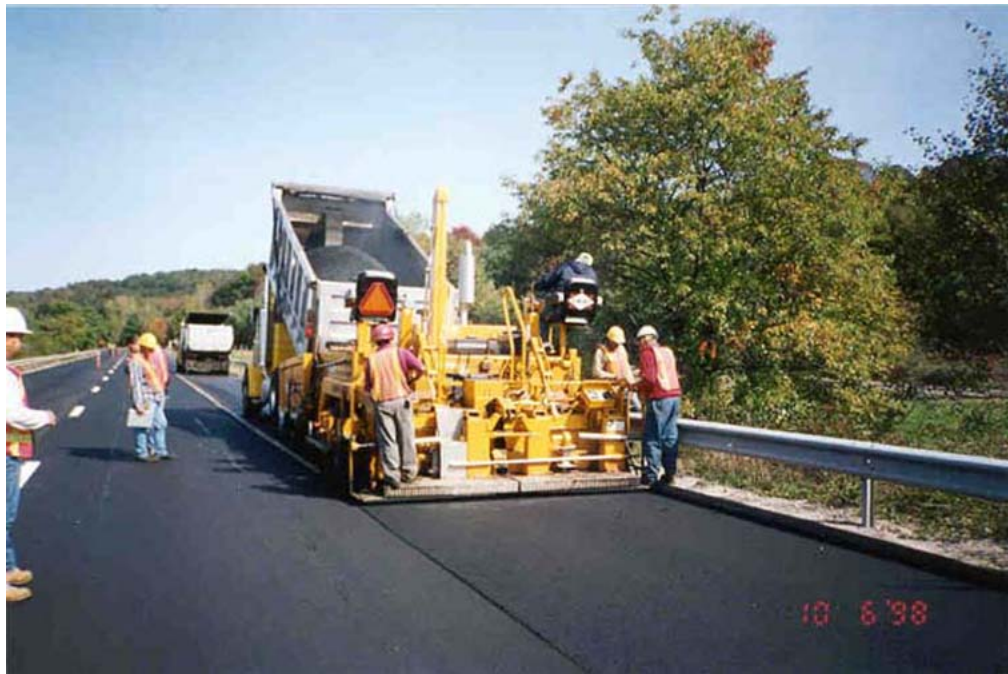
Photo A-3. Blaw-Knox PF-3200 Paver Used at Site 3.

A Blaw-Knox PF-3200 paver (see Photos #3 and #4), breakdown roller, intermediate roller and finish roller were employed. A 40-mm (1.5-inch) DOT Class 1 surface layer was placed on top of a 25-mm (1-inch) DOT Class 2 leveling course.

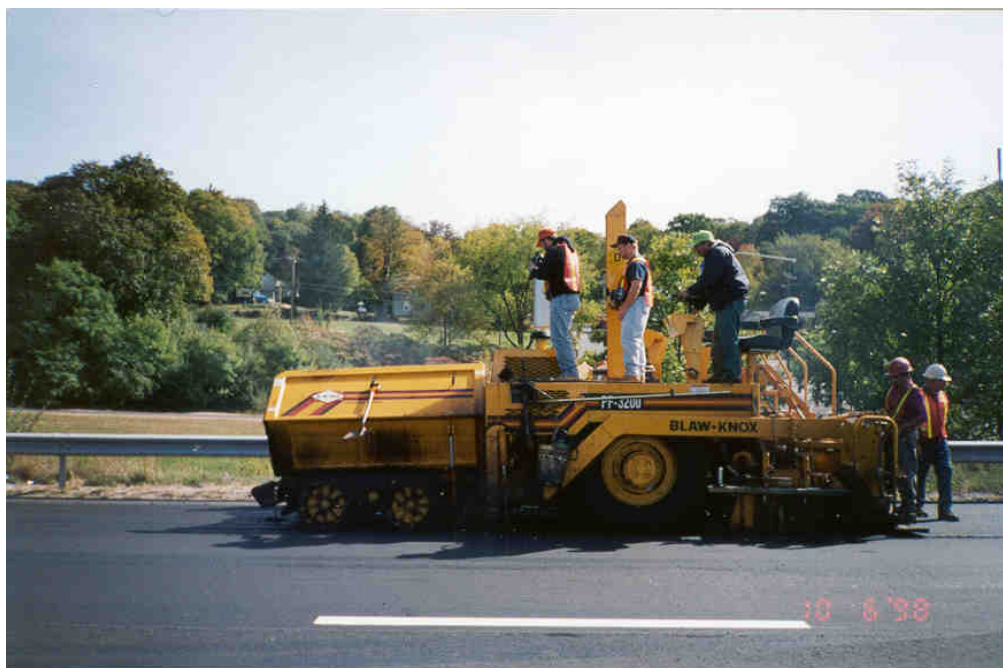
Photo A-4. Infrared Video Recorded From Top of Blaw-Knox PF-3200 Paver at Site 3.

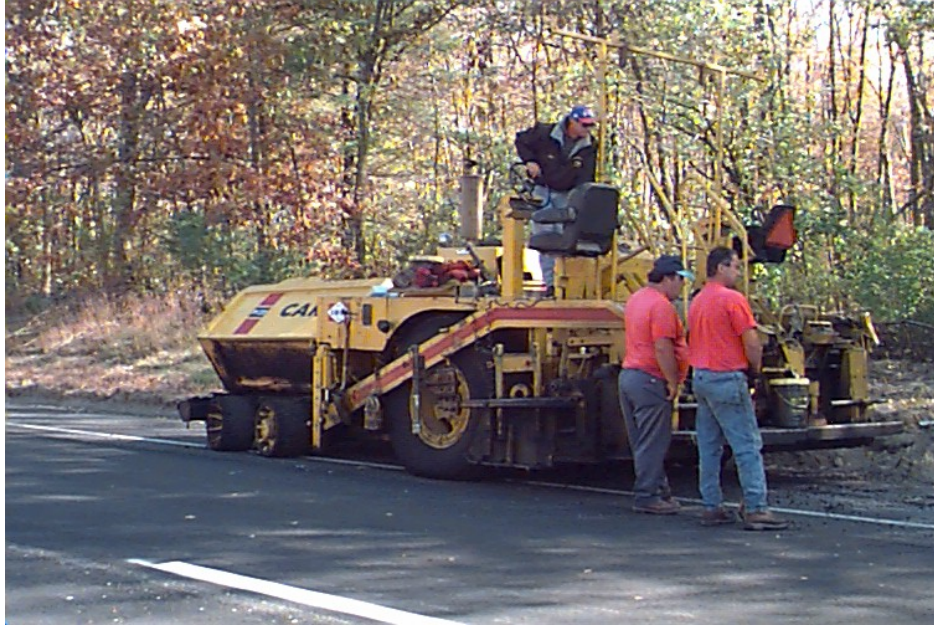
Photo A-5. Blaw-Knox PF-200 Paver Used at Site 4.

A Blaw-Knox PF-200 paver (see Photo #5), Ingersoll-Rand DD-90 breakdown roller, Caterpillar CB-534C intermediate roller and Ingersoll-Rand ST-75 finish roller were employed. A 50-mm (2-inch) DOT Class 1 surface layer was placed on top of a 4-inch, rejuvenated cold-in-place recycled base course. Note: a recycling train was used to mill, rejuvenate and replace the existing asphalt base course.

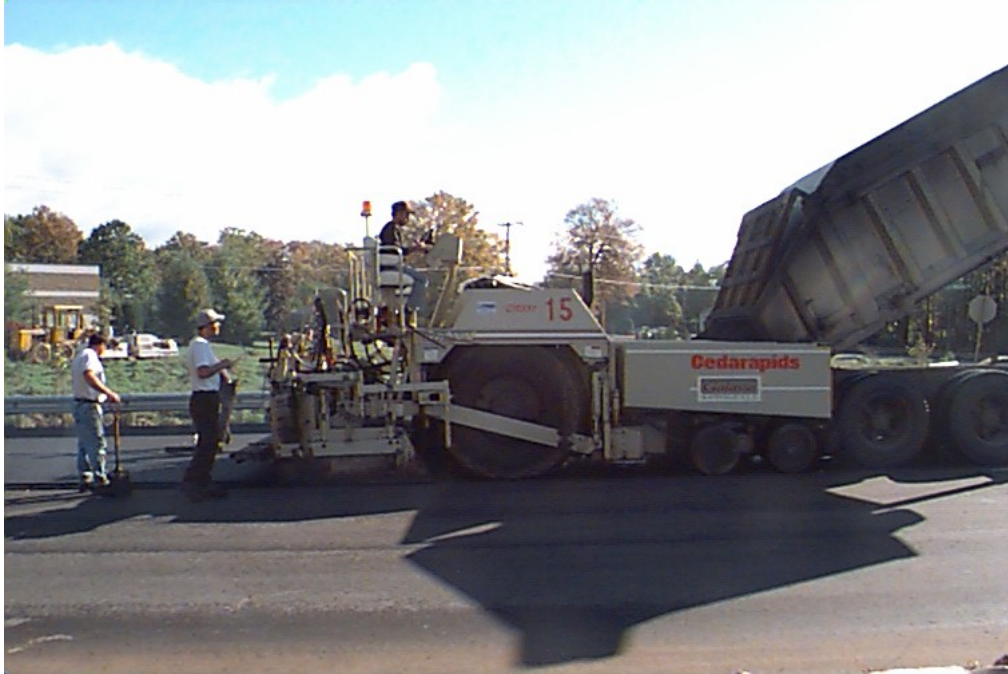
Photo A-6. Cedar Rapids CR-551 Paver Used at Site 6.

A Cedar Rapids CR-551 paver (see Photo #6), Ingersoll-Rand breakdown roller and Hyster C340C finish roller were employed. A 40-mm (1.5-inch) DOT Class 1 surface layer was placed on top of a 25-mm (1-inch) DOT Class 2 leveling course.
