**Evaluating the Long-Term Performance of Pavements
Thermally Imaged During Construction Phase 1:
Developing Spatial Tools for Location Identification**

Final Report – January 13, 2009

Report Number CT-2240-F-08-10

**Connecticut Advanced Pavement Laboratory
Connecticut Transportation Institute
University of Connecticut**

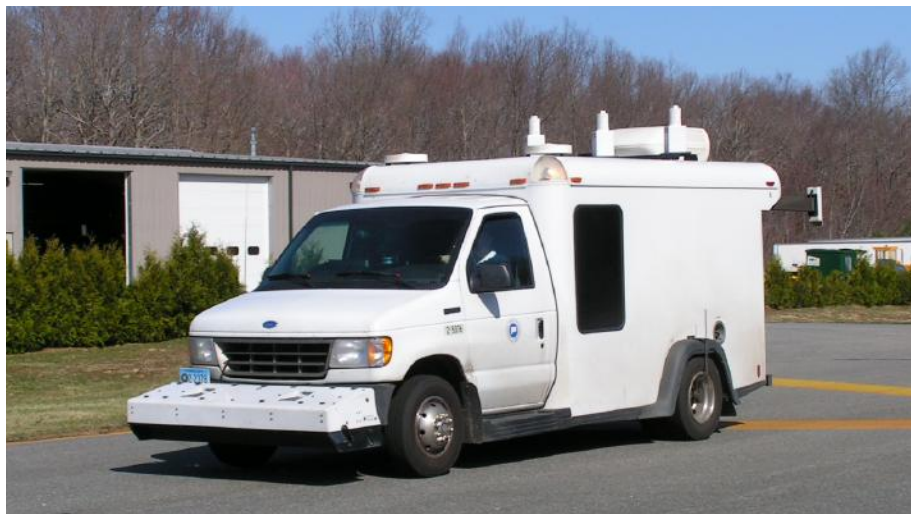
One tool already used by ConnDOT to annually monitor the condition of all state roads is the Automatic Road Analyzer (ARAN) Survey vehicles (Figure #2). ConnDOT's ARAN van also uses GPS in conjunction with multiple other sensors to monitor pavement condition and road geometry. The annual photo logging process includes capturing continuous still images of the road surface (Figure #3) using downward-facing cameras as well as side-facing and forward facing cameras which can be used to find landmarks and track the condition of the roadside (Figure #4).

Figure #2. ConnDOT ARAN Van

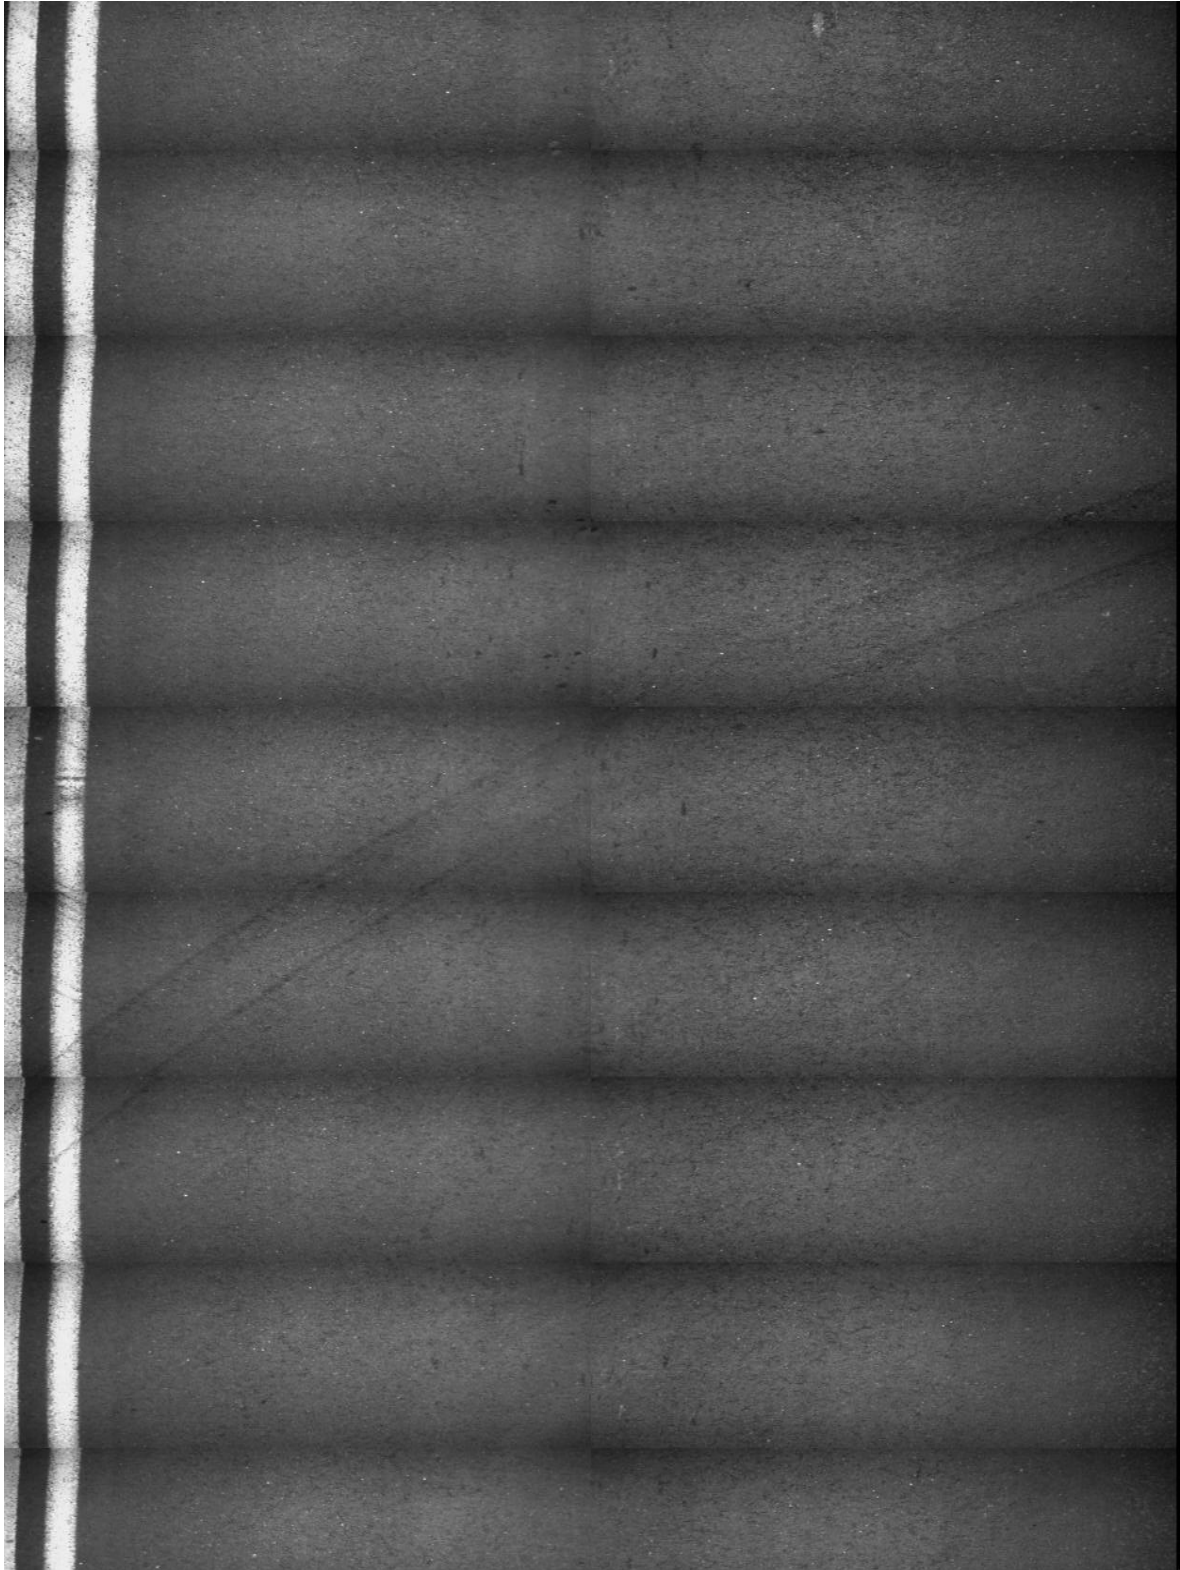
Figure #3 ARAN Downward Facing Image

Once the data had been collected and the files obtained by the research team, it was necessary to sort through the downward facing images and retrieve only those containing an image of one of the three points located on the Test Track. Thus for each run there were three downward facing images which could be used for comparison purposes.

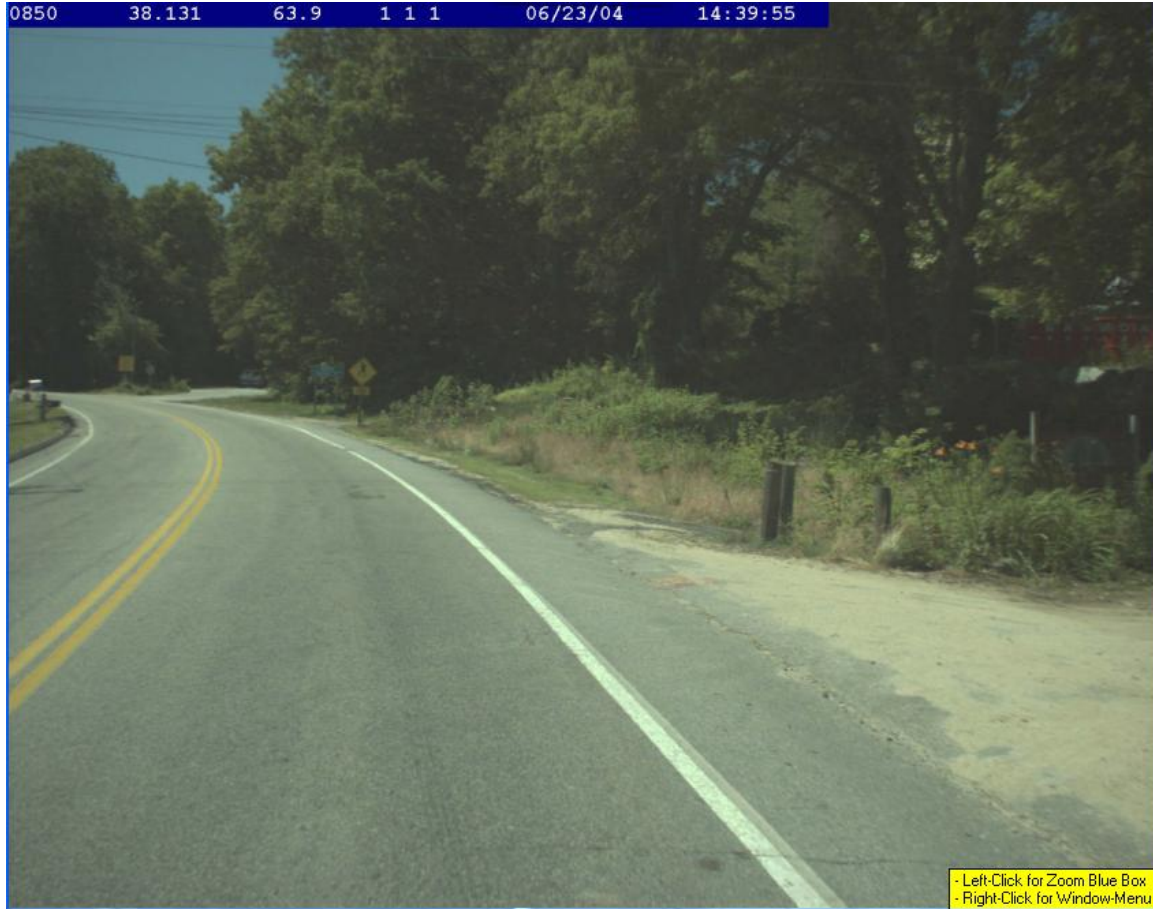
Figure #4 ARAN Forward Facing Image

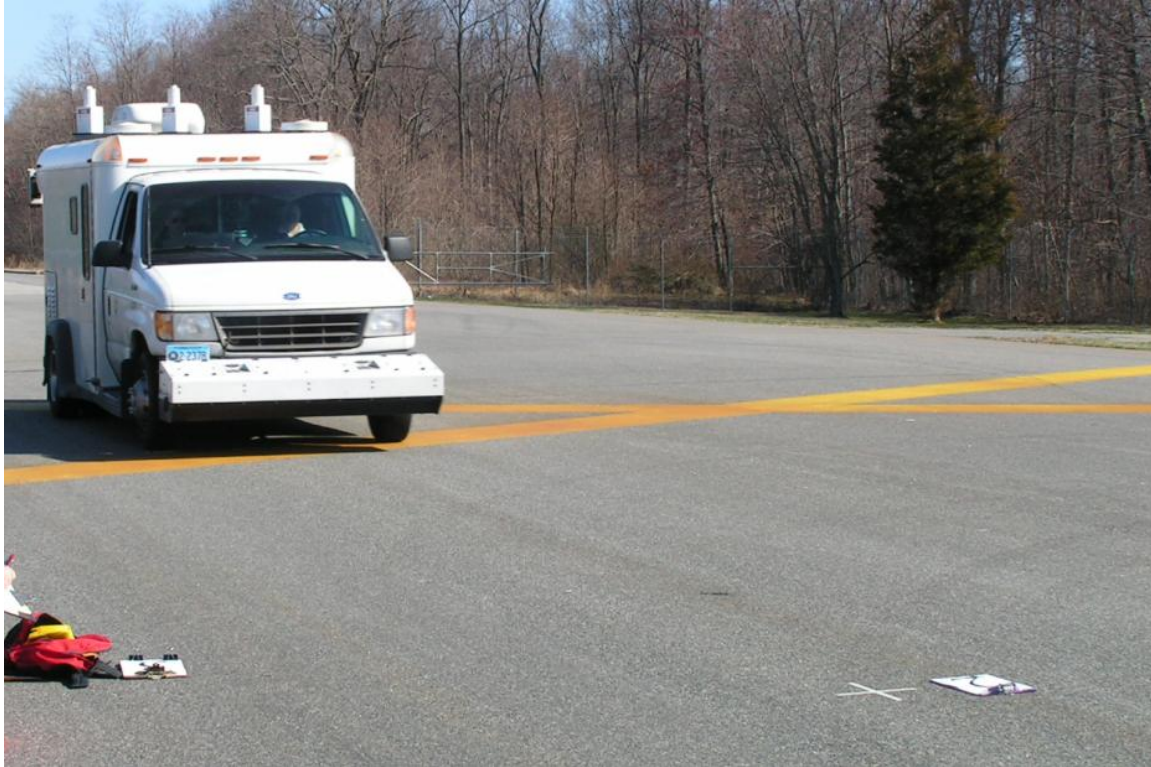
The second attempt to collect data at CU was made in the summer of 2005. Given the problems experienced during the first trial, the experiment protocol was changed by the research team. It was realized that if there were three located points as opposed to two, the ARAN operators would be able to regulate their speed more efficiently. Three points were then located with different distances in between. First the start point was selected and the mid point was selected ~ 1000 feet in the direction the ARAN Van would be traveling. The third point was selected ~ 400 feet from the mid point in the direction the ARAN Van would be traveling. These distances were approximated utilizing a rolling wheel and then measured exactly by the research team with a Total Station and finally confirmed by inverting using the GPS-determined positions. It was decided that each run would be assigned a number according to the run schedule in Appendix A. The run number would be placed on a clip board at the start point which would be photo logged for each run as the ARAN Van passed over it (see Figure #5).

Figure #5 ARAN Passing Located Point on Test Track

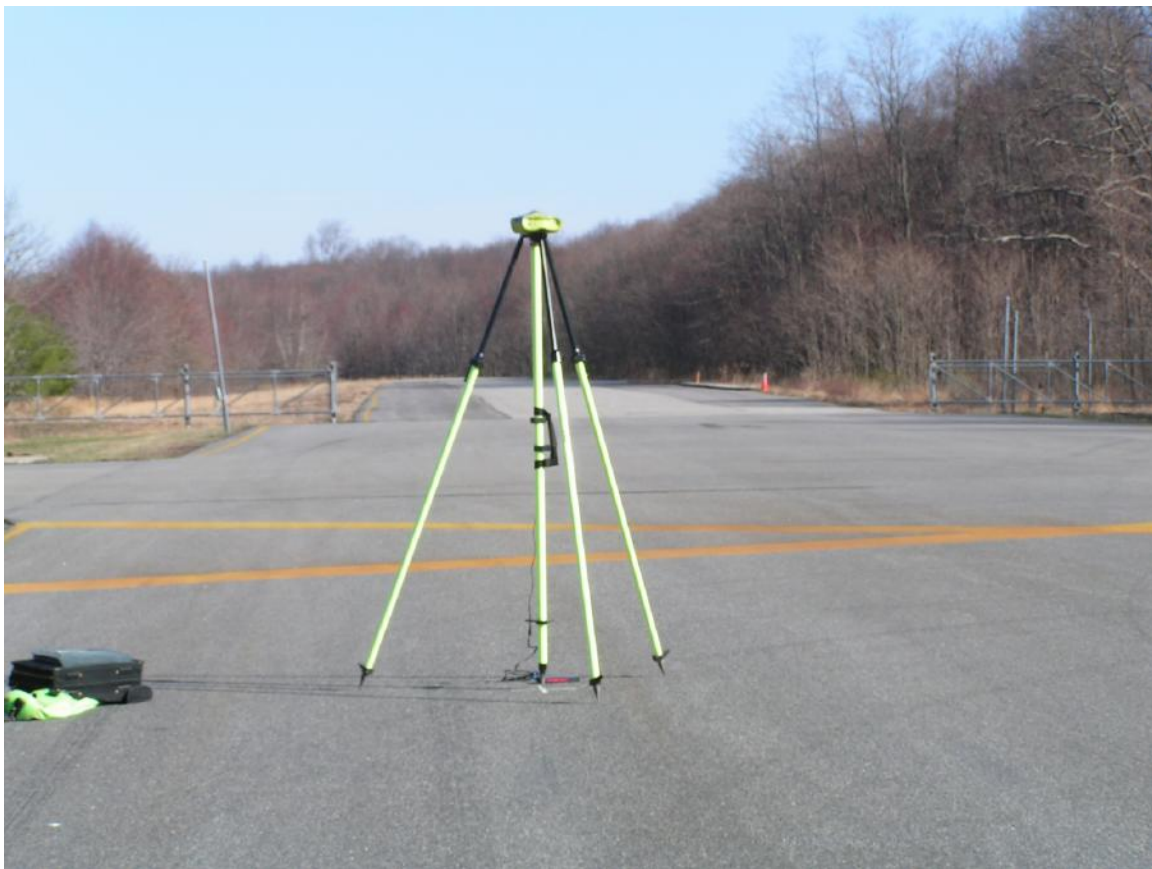
The third and final attempt to collect the data necessary to make the ARAN GPS accuracy and repeatability determination took place in the summer of 2006. There were no changes made to the experimental protocol as the protocol used for the second attempt was decidedly sufficient so long as all the data was collected as planned. Tom Meyer of NRME at the University of Connecticut was again on hand to locate the three points with the survey grade equipment shown in Figure #6.

Figure #6 Survey Grade GPS Equipment Used to Locate Points at CU Test Track

The equipment and overall process used to locate the points is very complex. The report submitted to the research team by Tom Meyer of NRME explaining the equipment, the process, and the accuracy of the locations is presented in Appendix B.

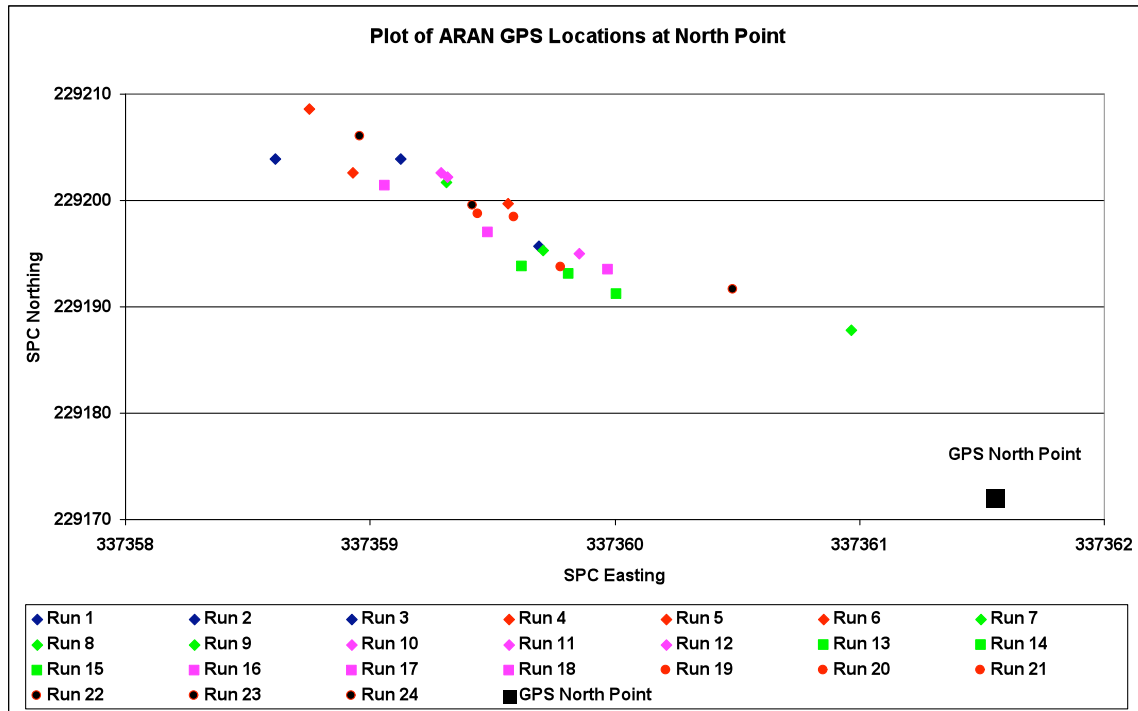
Figure #7. ARAN GPS Plot of CU Locations (North Point). Coordinates in meters.

The data series' were configured and grouped according to the run schedule in Table #1. It should be noted that the speeds for the north point are only approximate as the ARAN Van was attempting to get up to speed through this point.

It should be noted that Figures #7, #8 and #9 are plotted such that the x-axis is scaled 1 to 1 and the y axis is scaled 1-10. This was done because the offset for the northing in each run was substantially larger than the offset in the easting. The offsets in the northings for each of the locations ranged from 10 meters to in excess of 53 meters while the offsets for the eastings ranged from 0.6 meters to 5 meters. This could be due in part to the direction of travel primarily taking place in the North to South direction. The driver of the ARAN Van was very careful not to drift to the left or right while traveling down the test track over the three located points as well. This effort was confirmed while viewing the downward facing images which the vehicle collected during each run which showed the marked located points as well as the run number which was displayed on clip boards immediately adjacent to the marked points as shown in Figure # 10.

The level of error in the coordinates collected at the CU Test Track as shown in Figures #7, #8 and #9, indicate that there is currently no useful way to employ the ARAN GPS data in revisiting sites and locations of known distress or for monitoring purposes. The error found by the research team is thought to be systematic and is believed to be correctable. This data and problem were forwarded to the manufacturers of the ARAN GPS equipment by ConnDOT and this represents the state of this research at the present time. It is recommended that further investigation be conducted to determine the root cause for the errors found as well as to correct this issue and further pursue the use of the ARAN GPS data for documenting and utilizing geospatial data as needed for monitoring of distressed areas on Connecticut's pavements. The ARAN Vehicles are a promising means of logging roadway conditions in Connecticut. There is an extraordinarily high volume of data collected by the ARAN Vehicles yearly and if the connection between

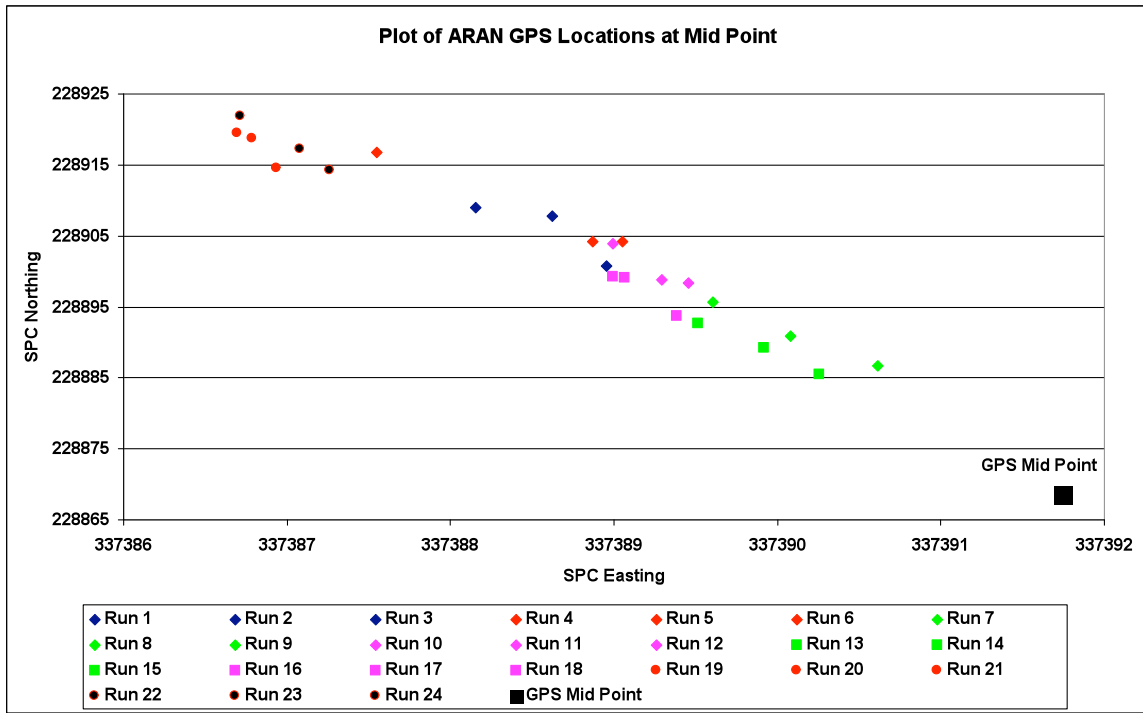
Figure #8. ARAN GPS Plot of CU Locations (Mid Point). Coordinates in meters.

The only real noticeable trend with the run plots is at the midpoint in Figure #8. The magnitude of the error clearly increases as speed increases and the speed groupings show this. This does not indicate the error was by any means mitigated, it simply indicates that as speed increases for the speed groups, the error increases as well. This does not hold steady for the end or south point as the speed groups are far more dispersed and there is no discernable trend as shown in Figure #9.

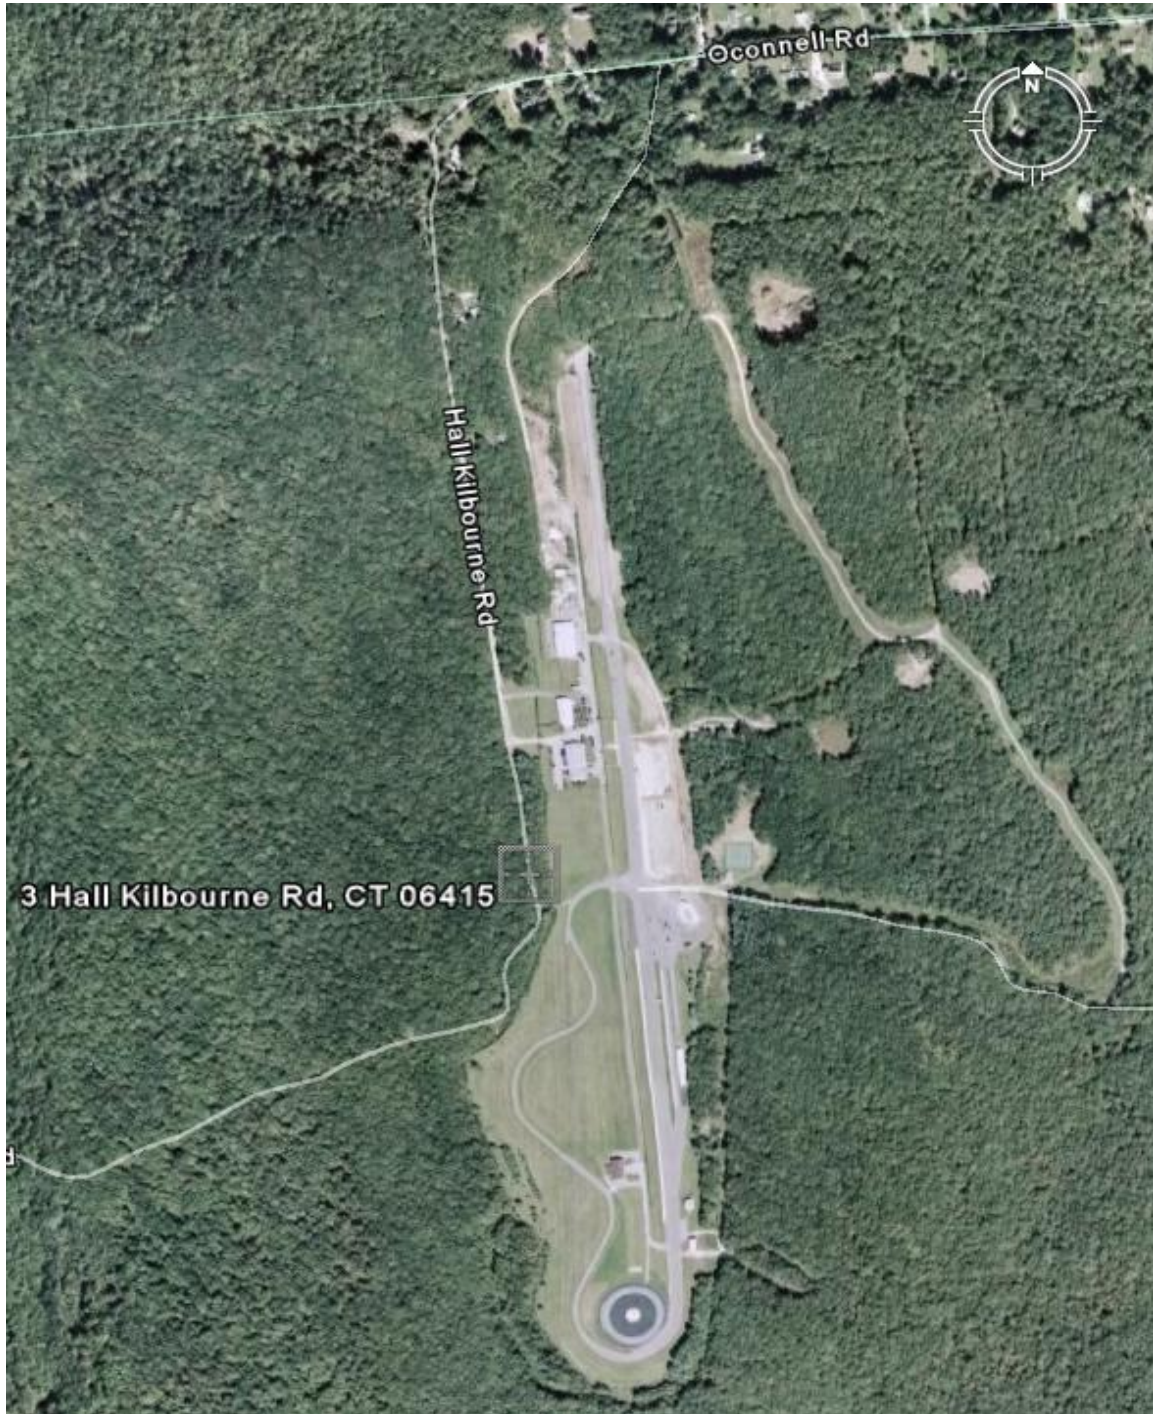
Movement in the East to West direction while traveling the Test Track is very minor as the track runs more North to South as shown in Figure #11 which is an extraction from Google Earth.

Figure #11 Consumers Union Automotive Test Division Test Track. Colchester, CT.

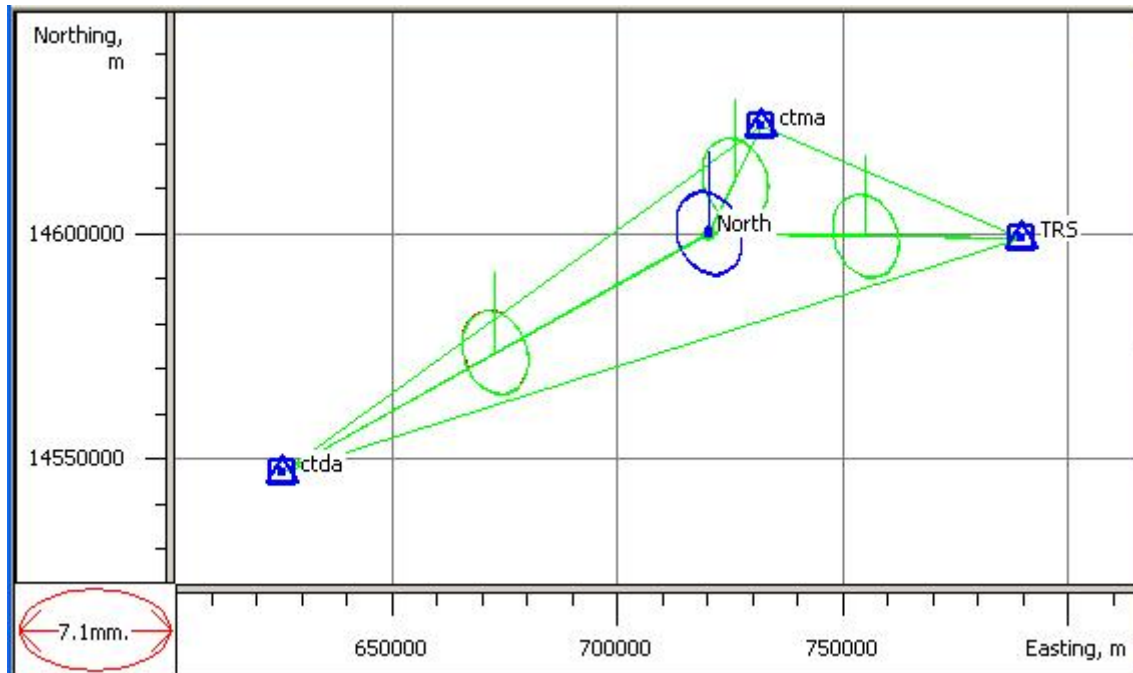
A view of complete networking and a closer look of networking among the points are shown below in the following figures. In the first figure, all of the test track markers appear coincident due to their relatively small separation compared with the distances between the control stations. Triangles indicate fixed horizontal coordinates and squares indicate fixed vertical (ellipsoid height) coordinates.

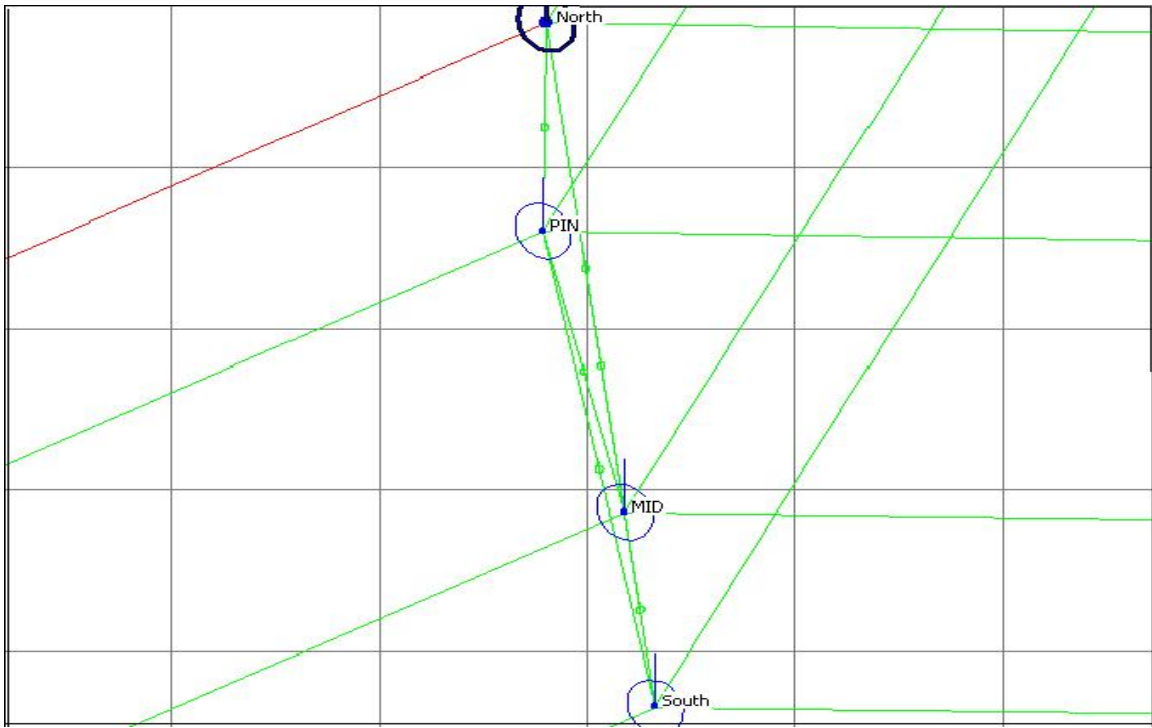
A closer view of the marks and the baselines is shown in the following figure.
