Utility Assessment and Site Feasibility Study

Sunrise State Park East Haddam, Connecticut

December 2010

Project No. 2010 0950 A10

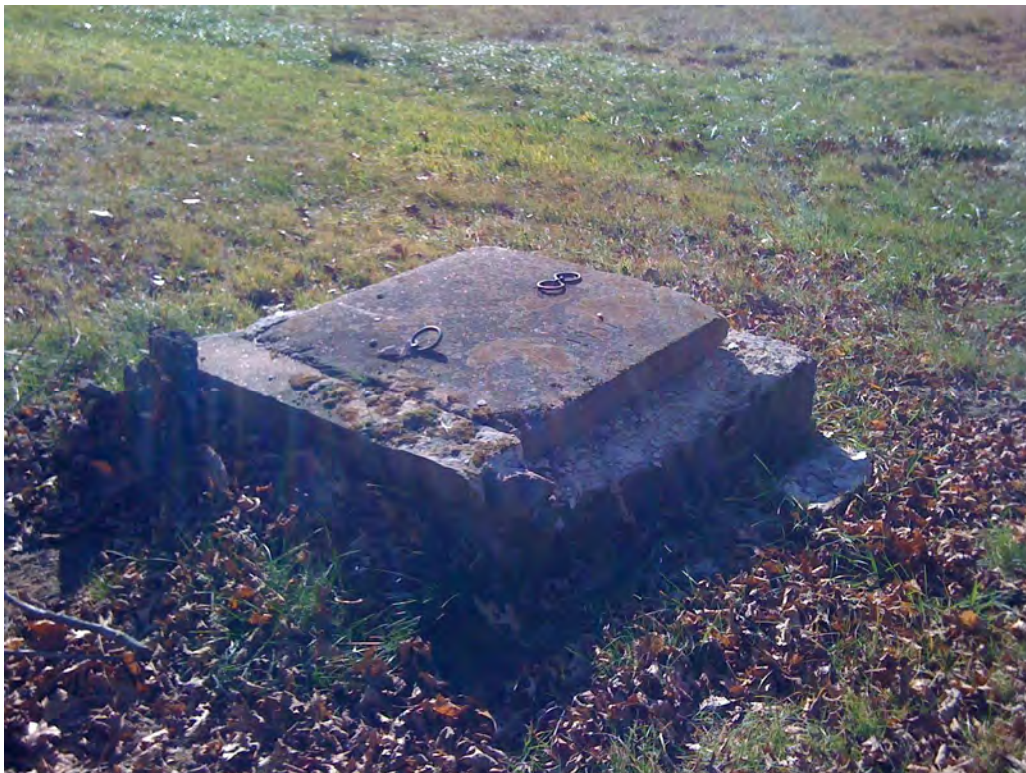
Photo 3-5 – Well #5A

- One or possibly two concrete-encased wellpoints (Wells #5A and #5B) were identified on the northern edge of the large wetland system west of Echo Village (*Appendix A*, Photos 3-5 and 3-6).

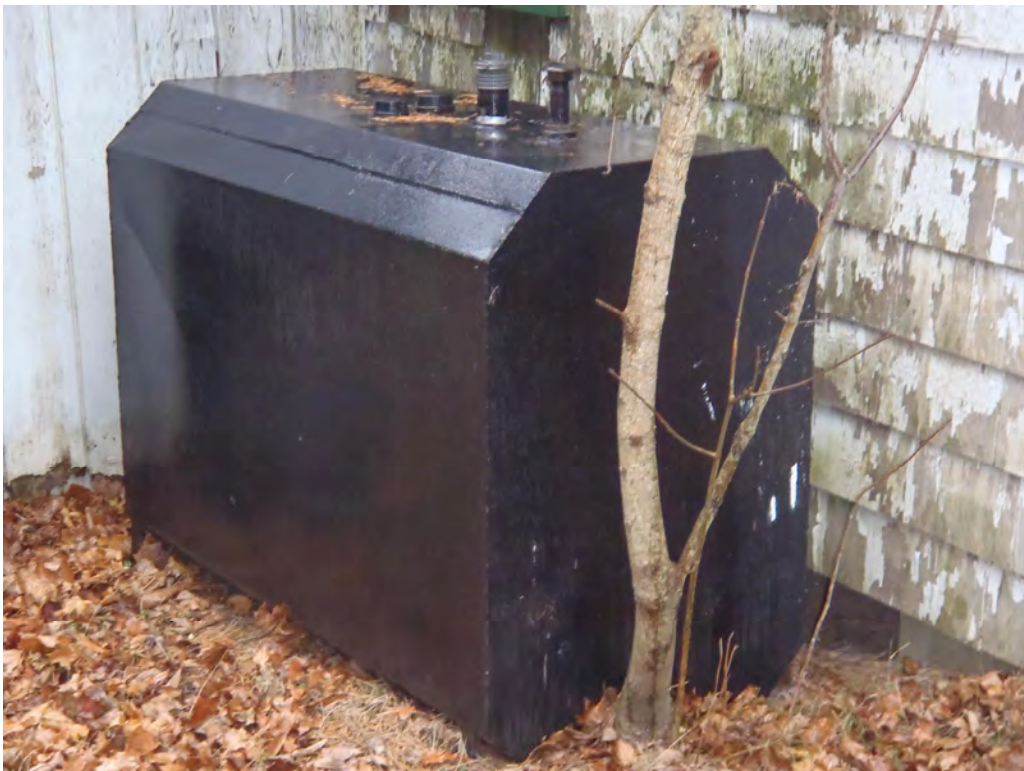
AOC		Description	Potential Release Mechanism
AOC-01	Above-ground Storage Tanks (ASTs)	<p>At least twelve ASTs were observed throughout the property during the Site visit (Photo 4-1). The majority of the ASTs were 275-gallon fuel oil storage tanks. No significant staining was observed beneath the tanks. ASTs were located adjacent to the following Site buildings:</p> <ul style="list-style-type: none"> • Building #80 – Guest Rooms (“White House”) • Building #48 – Guest Cabin (“Coco Villa”) • Building #59 – Spa • Building #65 – Maintenance Storage Building • Building #66 – Maintenance Building • Building #43 – Guest Cabin (“Stag”) • Building #25 – Guest Cabin (“Ambassador”) • Building #29 – Guest Cabin (“Dixie”) • Building #78a&b – Barbeque Hall • Building #56 – Garage Behind Apartment • Building #79 – Apartment Building • Building #62 – Guest Rooms (“New Motels”) 	<p>Although a release of hazardous material and/or petroleum to the shallow soil and groundwater may have occurred due to overfills, tank or dispenser leaks, there was no staining of the ground surface beneath the ASTs, indicating that a release at AOC-01 is unlikely. The ASTs appeared to be in relatively good condition (no significant rusting or holes).</p>

Photo 4-1 – AOC-01 (Example AST)

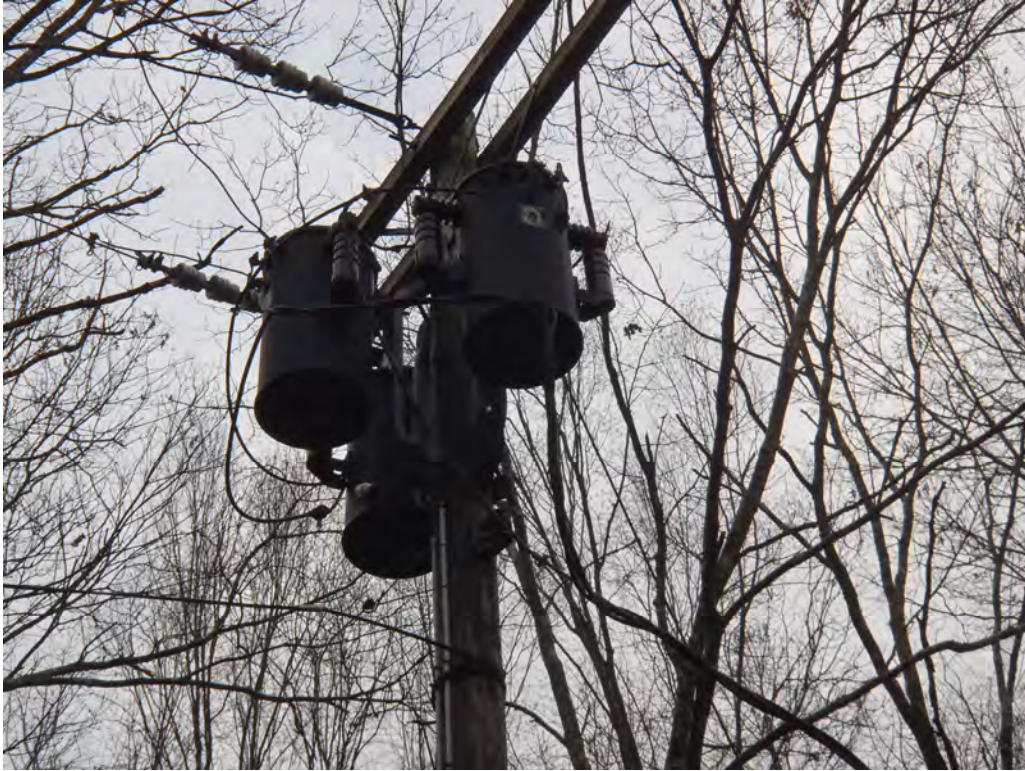
AOC		Description	Potential Release Mechanism
AOC-02	Pole-mounted Transformers	<p>Seven pole-mounted transformers were observed on the Site (Photo 4-2). Five of the poles had three transformers and two of the poles had only one transformer. Pole-mounted transformers were adjacent to the following areas and/or Site buildings:</p> <ul style="list-style-type: none"> • Entrance to the Park along Echo Farm Road • Building #68 – Miniature Golf Hut • Building #58 – Along the road adjacent to the Wading Pool • North of Building #59a-d – Spa • Building #45 – Guest Cabin • Building #69 – Main Office Building • Building #78a&b – Barbeque Hall 	<p>Prior to the 1970s, transformer oil commonly contained PCBs for thermal stability and insulating properties. The US EPA initiated the Toxic Substances Control Act in 1976 to regulate the manufacture, use and disposal of PCBs and PCB-containing fluids. Since the Site was historically occupied by the Sunrise Resort prior to the 1970s, it is likely that the transformers contain PCB-oil. Leaks from the transformers would have impacted the ground surface directly below each pole.</p>

Photo 4-2 – AOC-02 (Pole-Mounted Transformers)

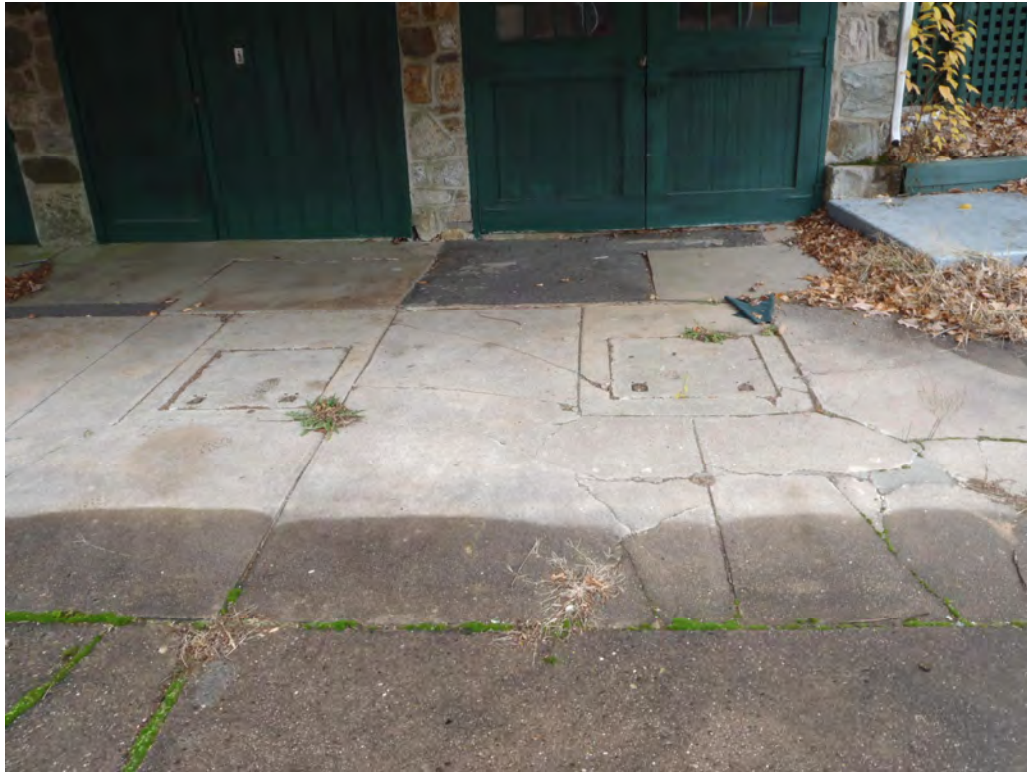
AOC-07	Abandoned Underground Storage Tank (UST)	A gasoline UST was reportedly abandoned in-place beneath Building #79 (Apartment Building (Photo 4-6)). The material and method used to abandon the tank in-ground is unknown.	A release of hazardous material and/or petroleum to the shallow soil and groundwater may have occurred due to overfills or tank or dispenser leaks.
AOC-08	Maintenance Garage (Building #66)	This building is used as a garage for tools and equipment. During the Site visit, the following items were stored in the maintenance garage: approximately forty 5-gallon containers, one 55-gallon drum of oil, fifty 1-gallon paint containers, one drum of oil, fertilizer, heating oil sludge, paint, gas, batteries and transmission fluid (Photos 4-7, 4-8 4-9). A floor drain was observed in the garage bay area (Photo 4-10). Five monitoring wells are located in the areas north and west (downgradient) of the garage.	There is the potential that hazardous material has impacted the shallow soil in this area as a result of spillage from containers. The floor drain within the garage bay may have provided a pathway for which contaminants to have impacted shallow soil beneath the structure.

Photo 4-6 - AOC-07 (Suspected UST)

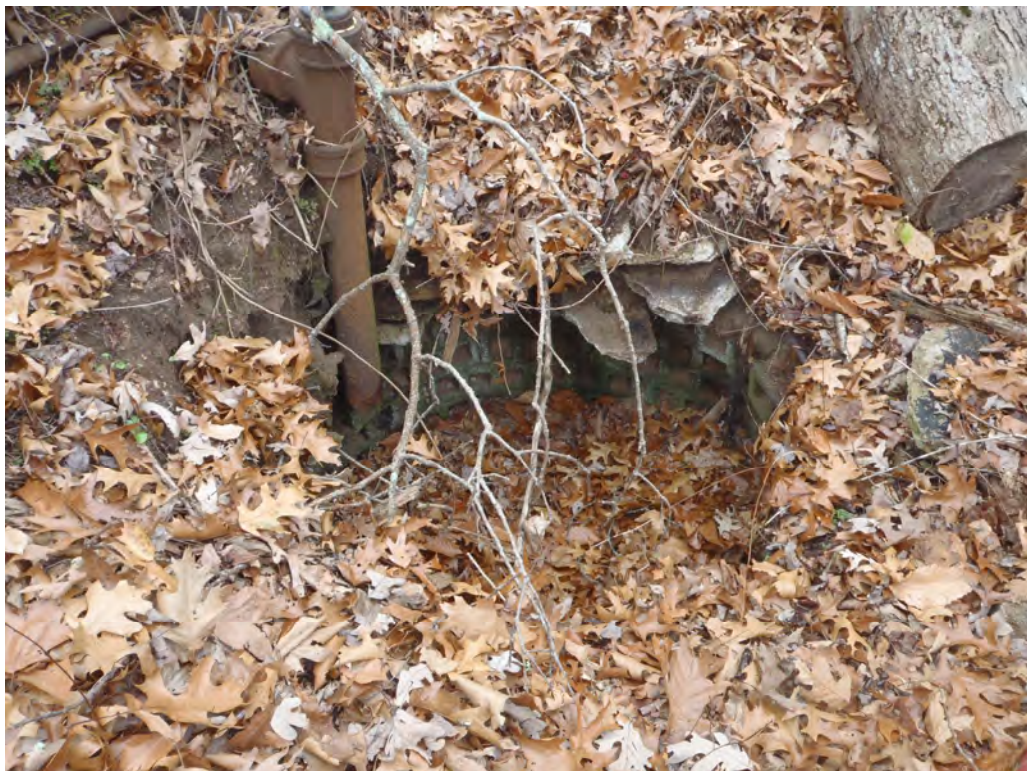
Photo 4-11 - AOC-10 (Sample Drywell)

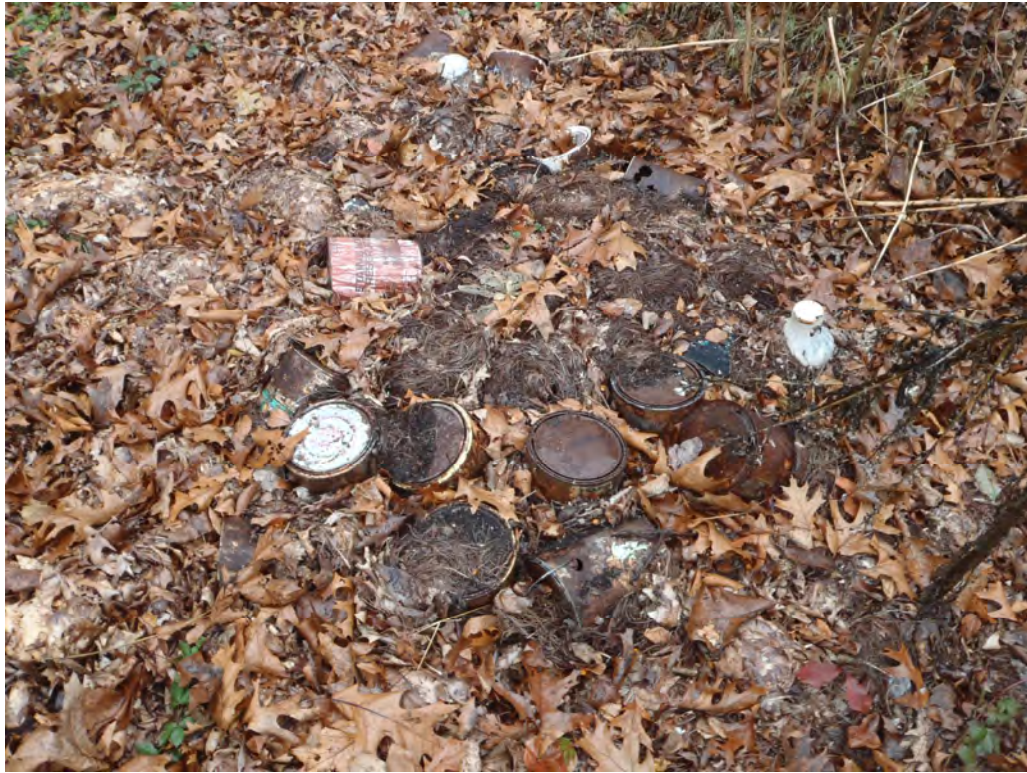
Photo 4-12 - AOC-13 (Debris Area)

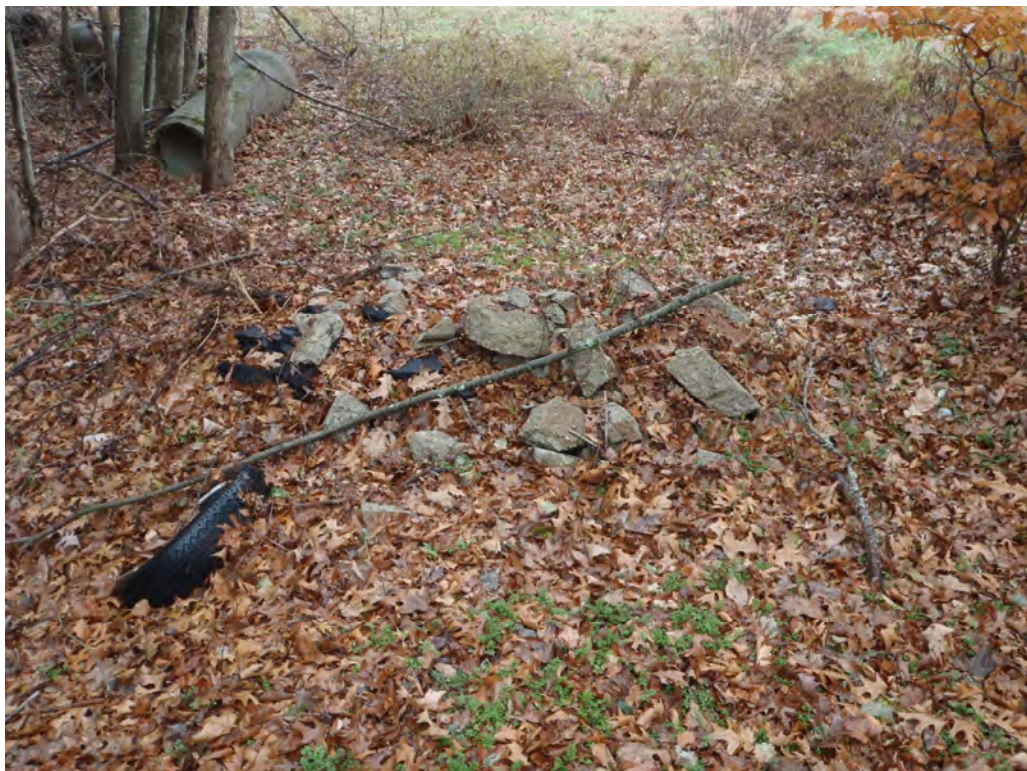
Photo 4-13 - AOC-13 (Debris Area)
