Reach Level Assessment

SURVEY REACH ID: <u>NR-4</u>		WTRSHD/SUBSHD:		DATE: <u>11/23/09</u>		ASSESSED BY: <u>SG+CM</u>	
START TIME: <u>10:15</u> AM/PM	LMK: <u>FORMATION</u>	END TIME: <u>11:45</u> AM/PM	LMK: <u>ARMY</u>	GPS ID:			
LAT <u>41° 43' 04"</u> LONG <u>72° 43' 24"</u>		LAT <u>41° 48' 18"</u> LONG <u>72° 43' 34"</u>		DESCRIPTION:

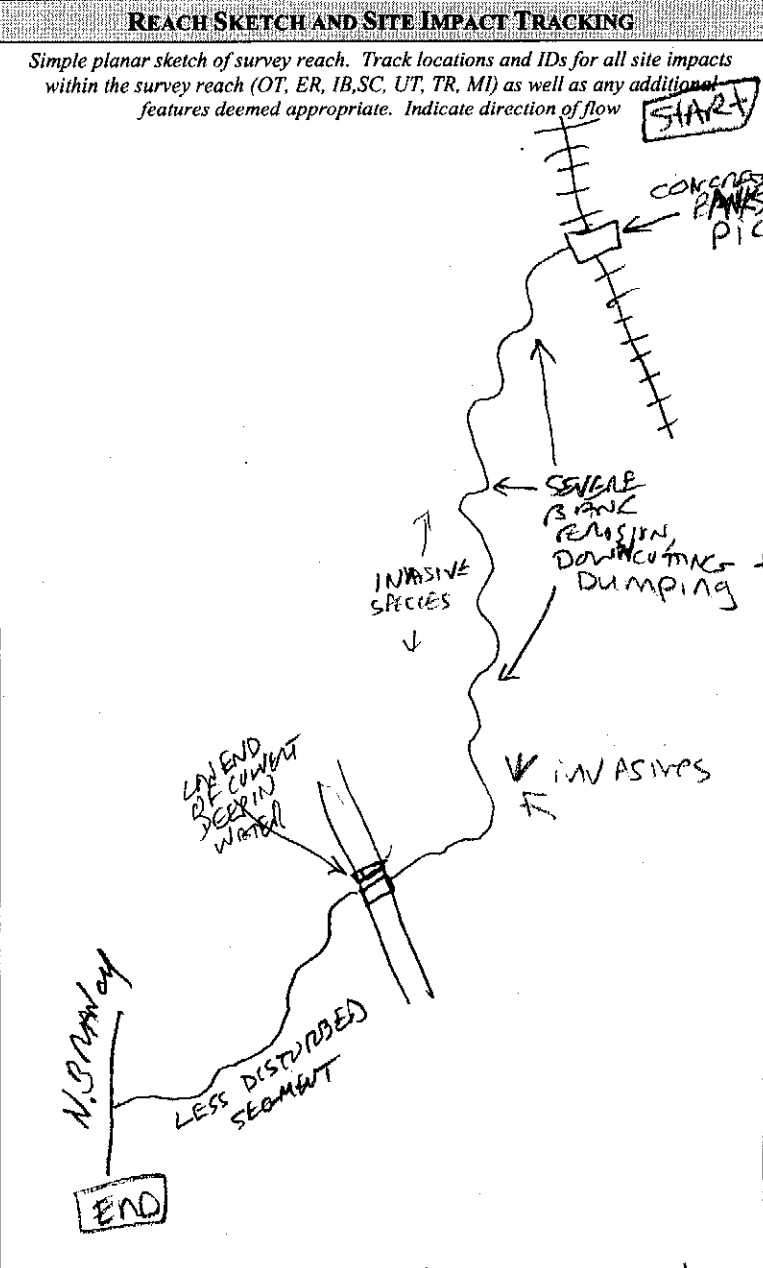
NOTES: (biggest problem you see in survey reach) Dumping, flashy flow, or invasive plants, SEDIMENT LOAD.

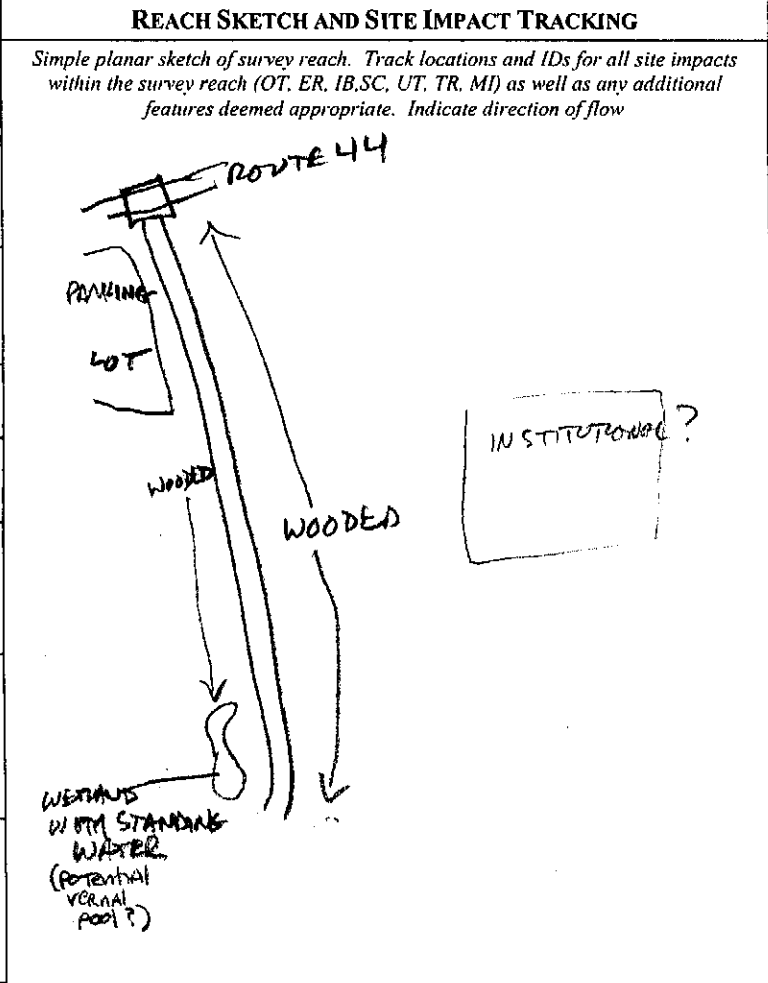
NOTES: (biggest problem you see in survey reach) Debris, parking lot adjacent to nearly 1/2 of right bank to this reach, stormwater cut fall pipes in need of repair.

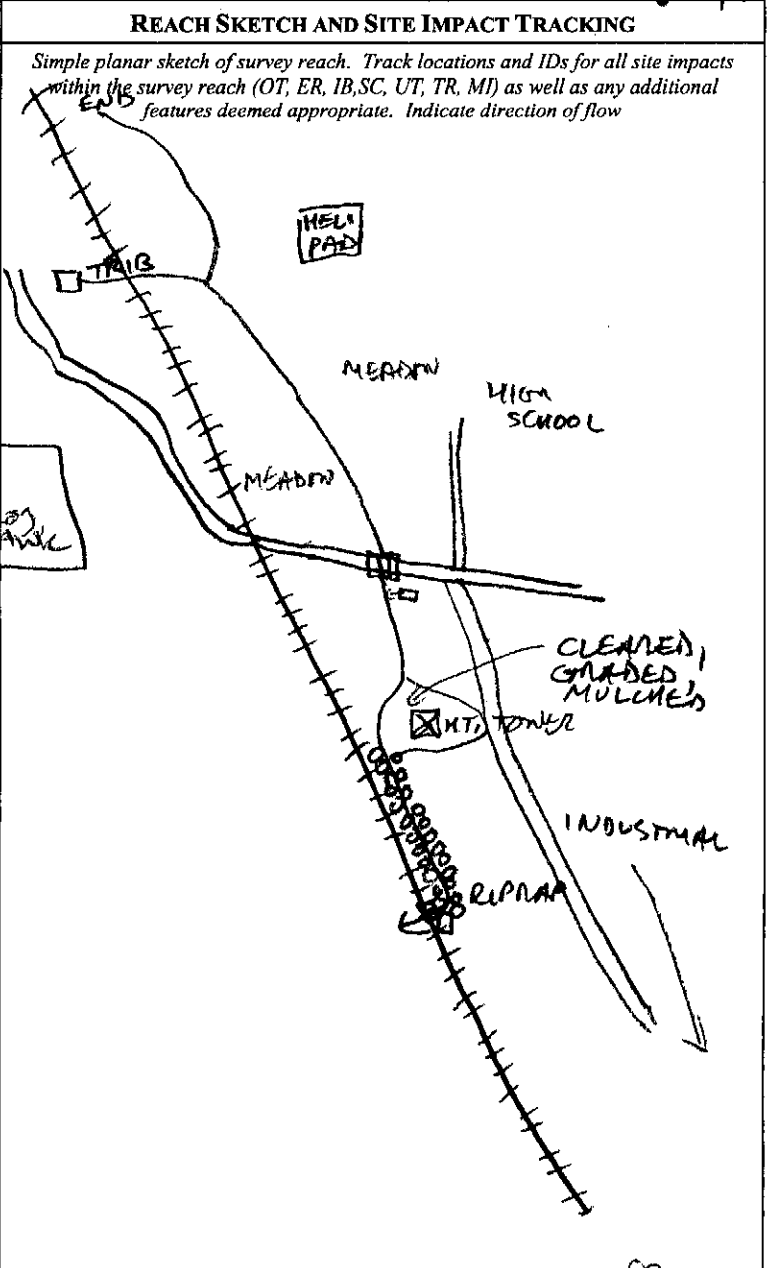
NOTES: (biggest problem you see in survey reach) Impacted buffer: lacks tall trees + wide buffer, mostly herbaceous with some shrubs, saplings + vines. AREAS of RIP-RAP, adjacent to Reel, road, Railroad tracks

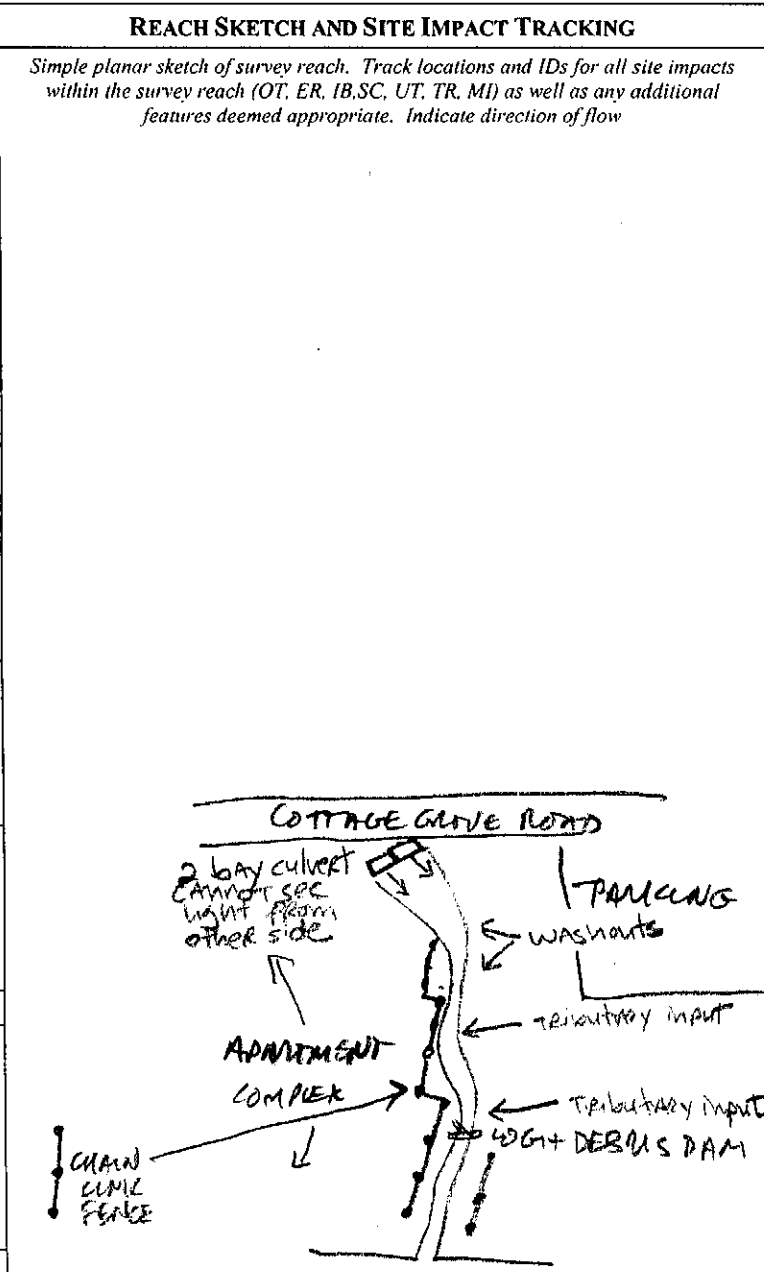
NOTES: (biggest problem you see in survey reach) STORMWATER RUNOFF NOT WELL MANAGED.

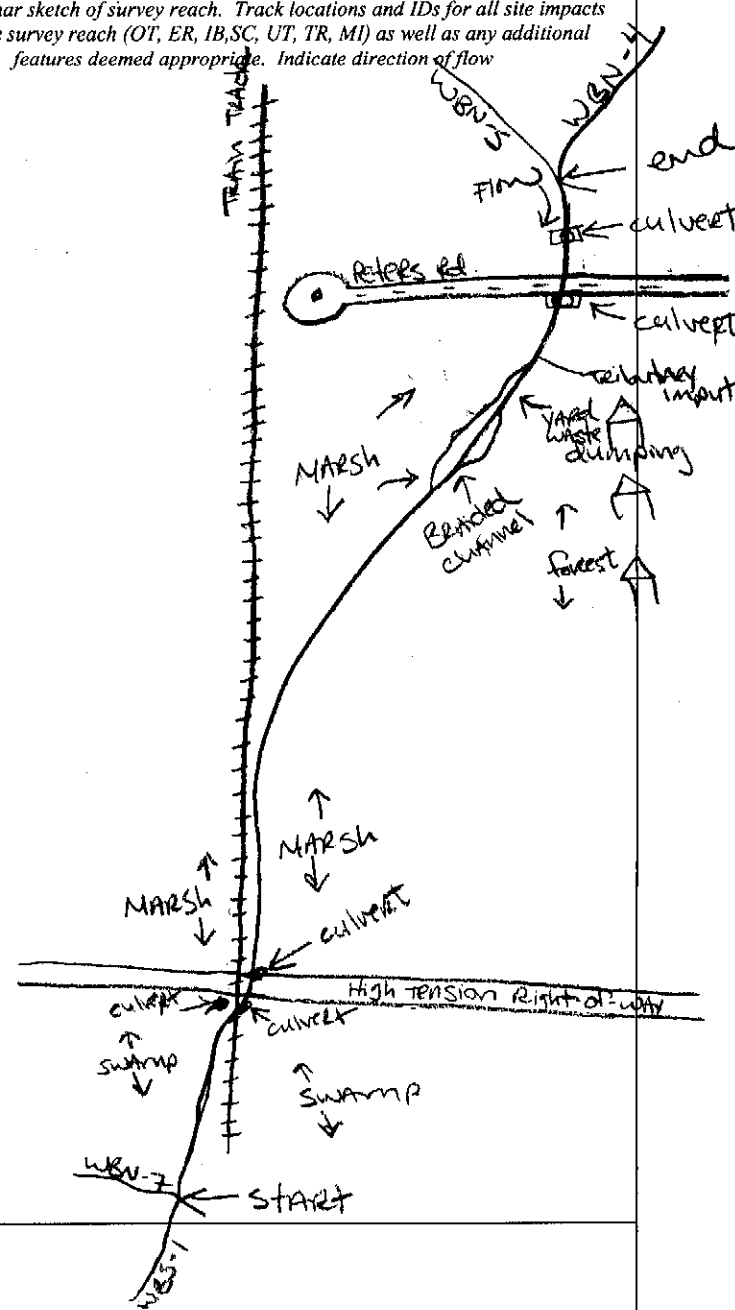
REACH SKETCH AND SITE IMPACT TRACKING

NOTES: (biggest problem you see in survey reach)
 stone toe of RAILROAD tracks

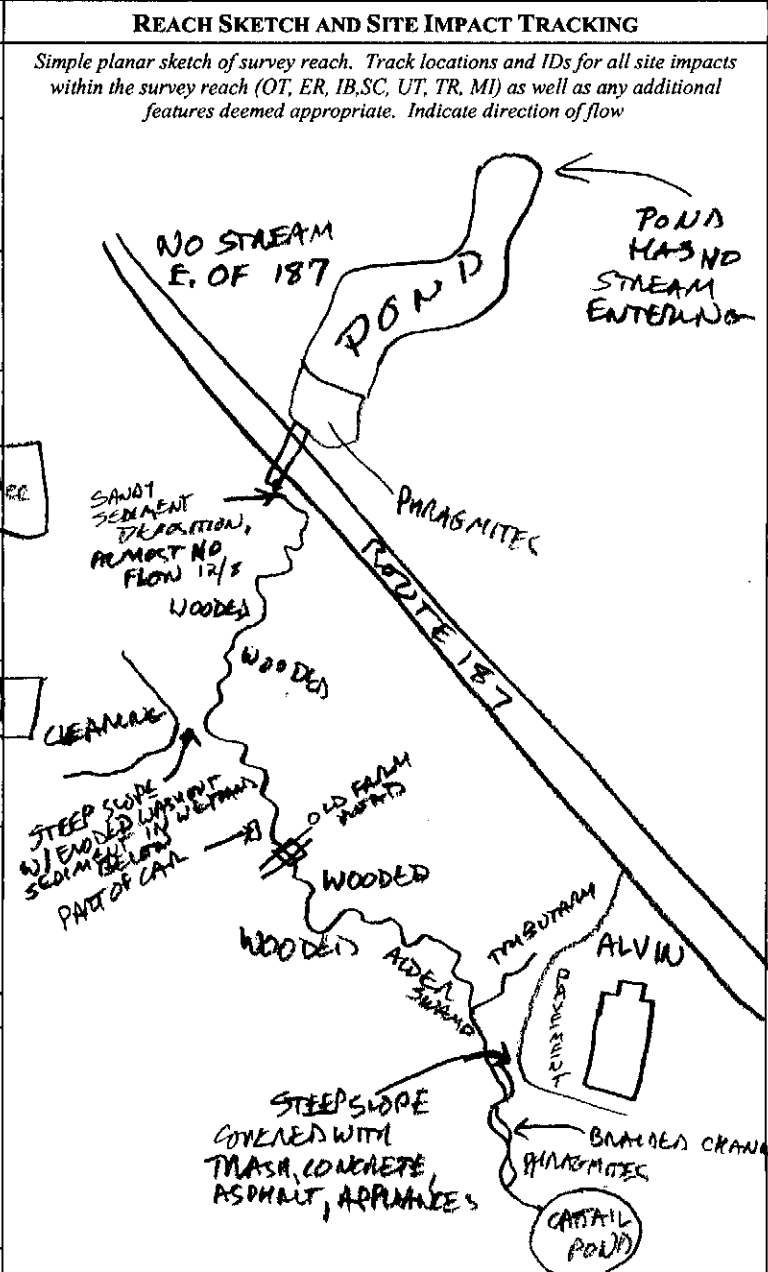
NOTES: (biggest problem you see in survey reach)
DUMPING + TRASH BEHIND ALVIN BLDG.
SANDY SEDIMENT DEPOSITION FROM ROUTE 187 AND DUDLEY TOWN ROAD INDUSTRIAL SITE.

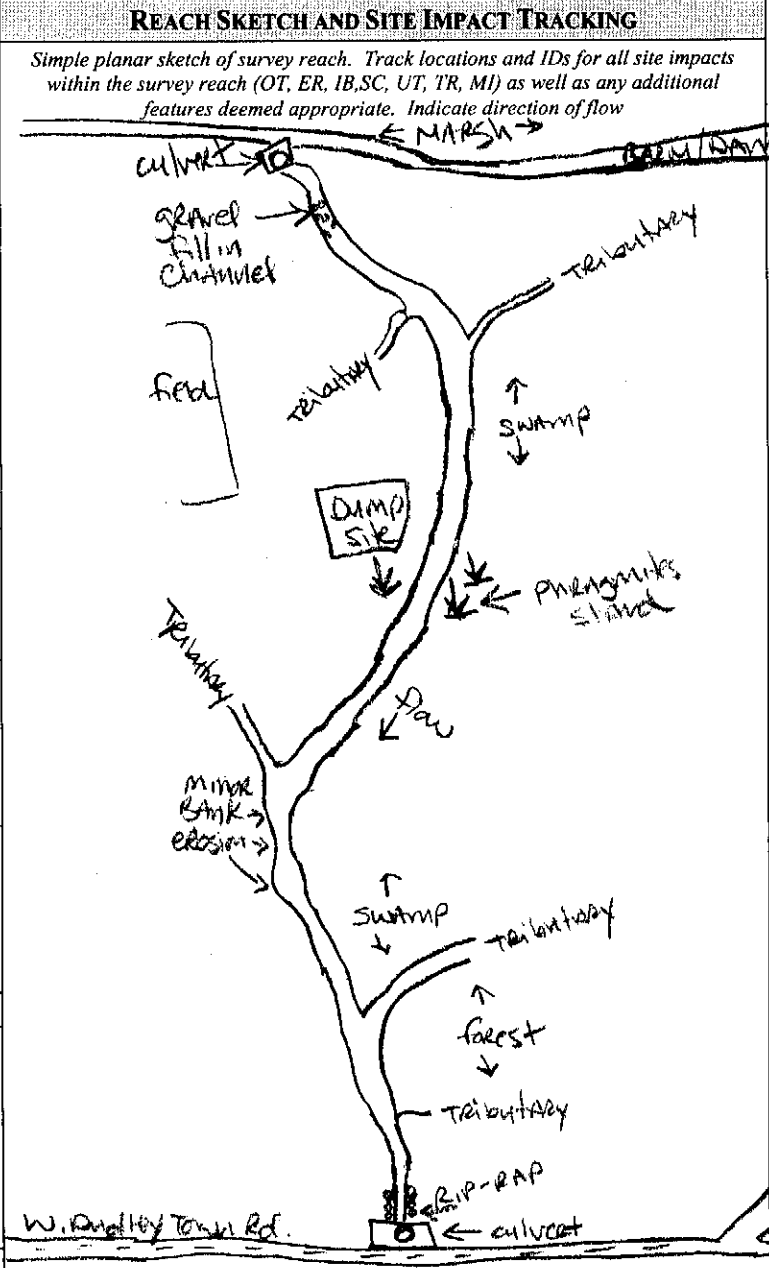
NOTES: (biggest problem you see in survey reach) Dumping, trash

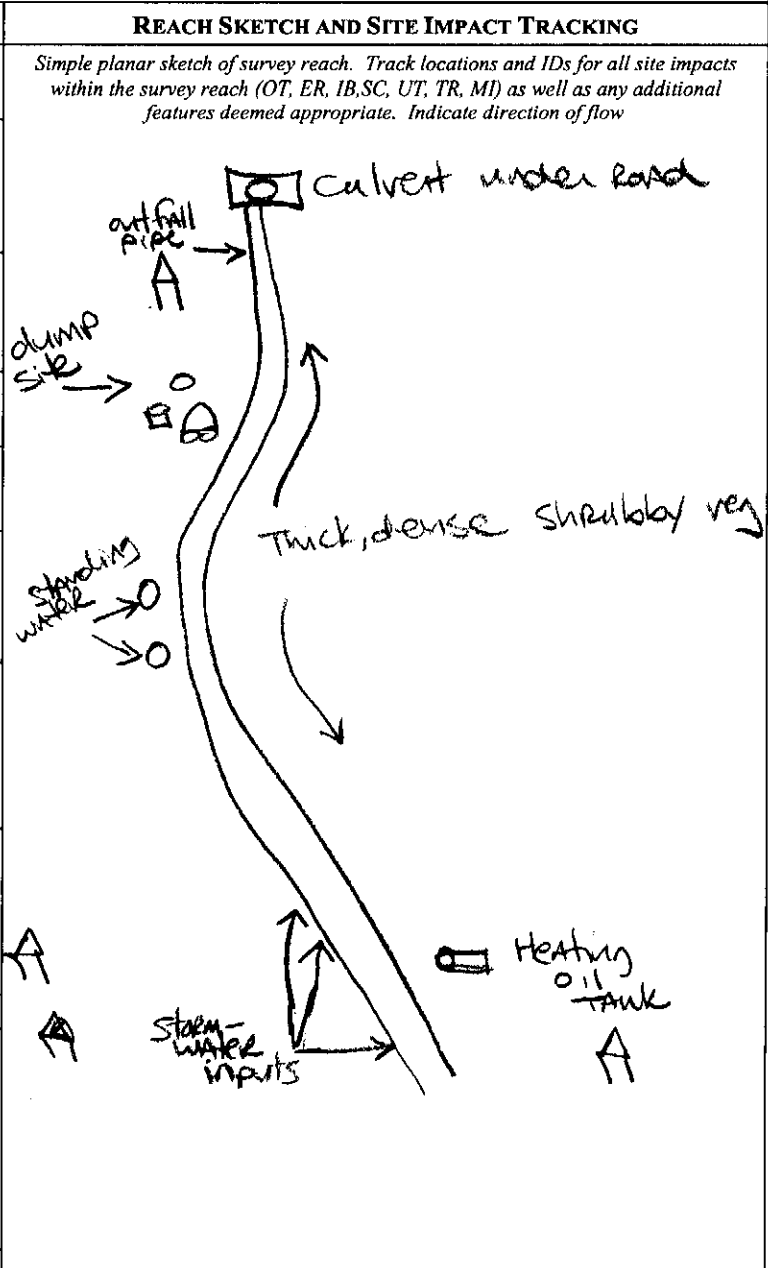
NOTES: (biggest problem you see in survey reach) Dumping, including old car, heating oil tank, oil drums, store, toilet, sink, tires. Some invasive plants (multiflora rose, knotweed, garlic mustard, barberry).
